Summary of Report: PA-09-182

Al Kasik Location Command

SUBJECT: Report on the Al Kasik Location Command, Al Kasik, Iraq (SIGIR Report Number PA-09-182)

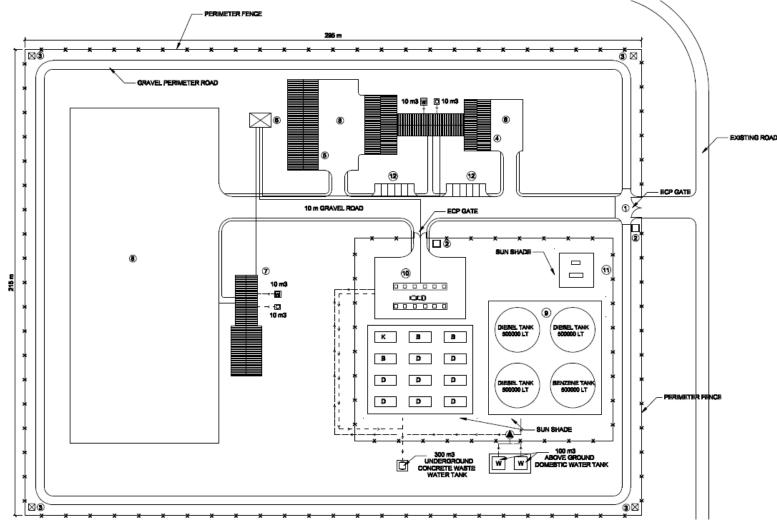
Figure 1. Original site layout design (Courtesy of USACE)

The project proposed to expand the facilities at the location command by adding additional buildings, infrastructure, and equipment. The initial task order's design indicated that all improvements would occur in one area and require power generation and septic holding capabilities (Figure 1).

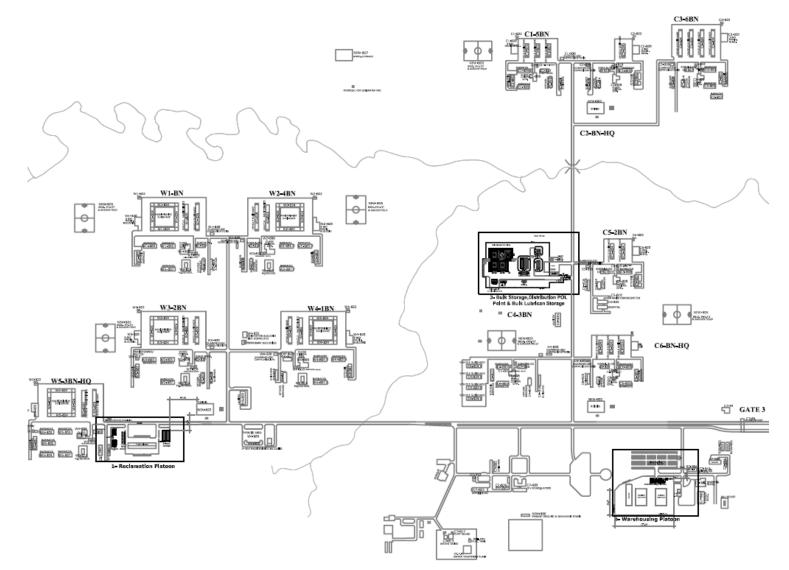
Figure 2. Final site layout design (Courtesy of USACE)

However, the configuration of the project was changed in subsequent design submissions, placing the improvements at several locations throughout the existing facilities. The new design eliminated the need for additional electrical generation by utilizing the existing facility's infrastructure (Figure 2).

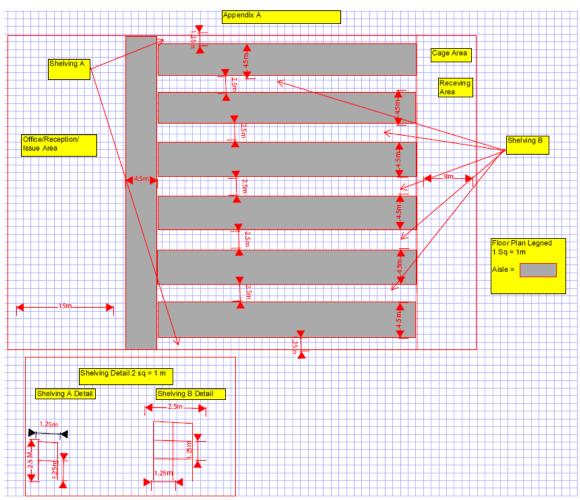
Figure 8. Schematic of pallet rack configuration and layout (Courtesy of USACE)

The SOW provided specific requirements for the pallet rack system⁸ including overall rack dimensions, layout requirements, and specifications to support a minimum load of 1,000 pounds per 2m-long unit (Figure 8).

In addition, the contractor was required to secure the pallet racks to the floor to "...prevent the shelving system from tipping through normal day-to-day operations."

- The contractor should perform a final check of the rack system after construction completion and to verify that all bracing is installed and all legs are securely fastened to the floor slab.
- The water and sewer piping create a conflict with the installation of the sanitary manhole and could potentially contaminate the water supply.
- The raft foundation contained no provisions to continue the reinforcing steel through the construction joint or provide fuel proofing to prevent leaks.

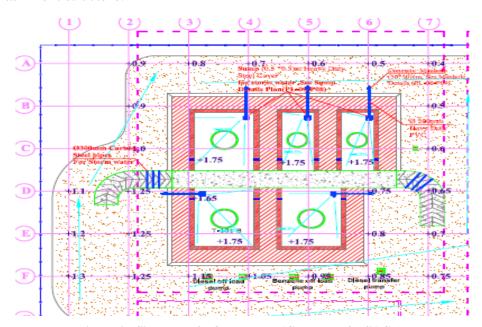
Figure 9. Site plan of POL platoon (Courtesy of USACE)

The contractor's design of the bulk fuel storage facility consisted of five vertical cylindrical steel storage tanks (Figure 9). The plans showed an earthen dike containment system⁹ around each tank. An access drive was shown elevated above the earthen dike, bisecting the containment area. The fill for the drive was contained between two reinforced-concrete retaining walls. No lining was specified for the containment structure.

The design for the facility included earthen containment dikes around the individual storage tanks. The plans included detailed sections of the dikes. The design drawings did not specify any type of liner for the containment system. Without the protection of an impervious liner, a containment event may contaminate the underlying soils, requiring extensive cleanup operations.

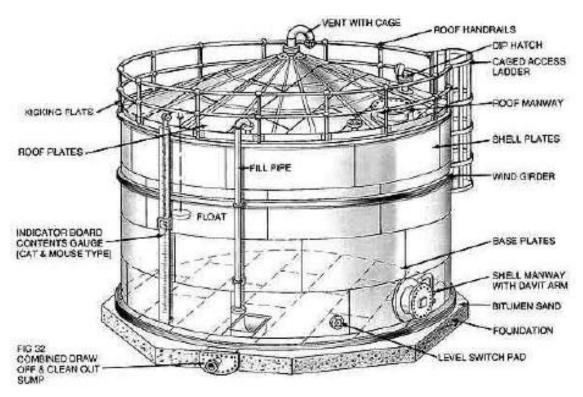
Figure 10. Proposed bulk storage tank (Courtesy of USACE)

The steel storage tanks were specified by the contractor as a third-partymanufactured product. The specifications for the tanks were included in the project documentation. The tanks submitted by the contractor are 250,000- and 500,000liter field-welded steel tanks (Figure 10), supported on a reinforced concrete raft foundation.

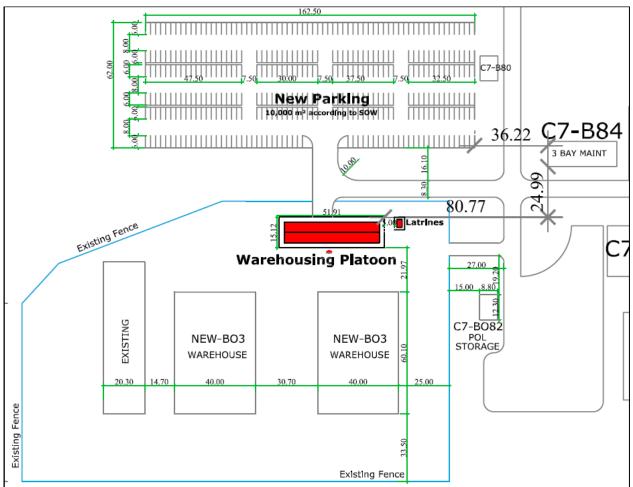
Figure 15. Warehousing platoon layout (Courtesy of USACE)

At the time of the site assessment, the contractor was working in the warehousing platoon section. The warehousing platoon section consisted of an administration building, exterior latrine, a 10,000 square meter parking lot with site lighting, and installation of pallet racks in an existing warehouse (Figure 15).

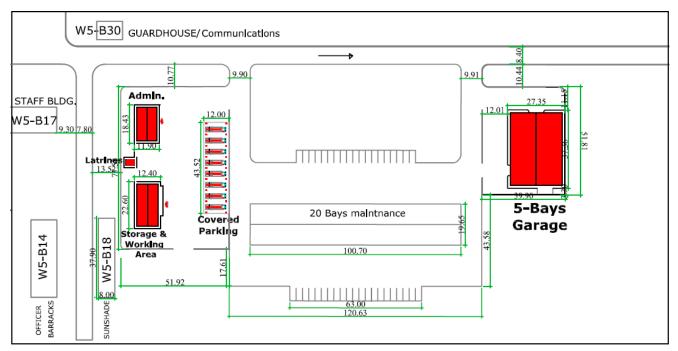
Figure 16. Reclamation platoon layout (Courtesy of USACE)

At the time of the site assessment, the contractor was also working in the reclamation platoon section, which comprised a maintenance garage, storage and maintenance building, administrative building, latrines, and a covered parking area (Figure 16).

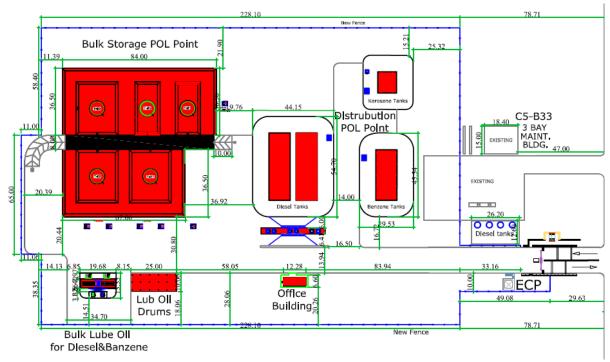
Figure 17. Bulk storage, distribution, and POL point platoon layout (Courtesy of USACE)

At the time of the site assessment, the contractor was also working in the bulk storage, distribution, and POL point platoon section. The bulk storage, distribution, and POL point platoon section comprised constructing an office building; latrines; security facilities; lube oil drum storage; bulk storage; and diesel, benzene, and kerosene storage (Figure 17).
