BUILDING ENCLOSURE INVESTIGATION: DETROIT AIR TRAFFIC CONTROL TOWER

2009.10.26

Prepared For:
Parsons – Technical Center
Michael J Rapuano

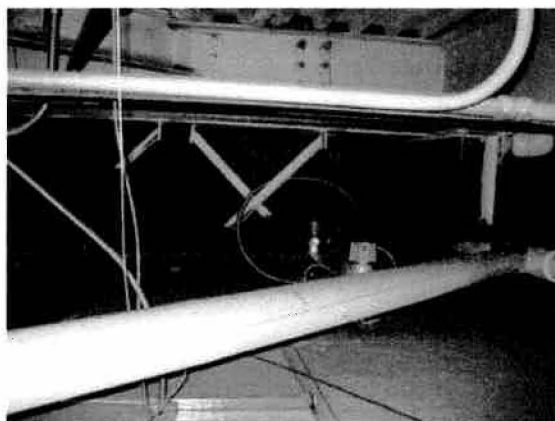
Water stains and drips were noted on the interior face of the exterior metal cladding panel in drop ceiling area of the CAB. The water stains appear to be originating in the parapet construction of the exterior penthouse catwalk above the CAB.

Figure 4: Dropped ceiling plenum above the CAB

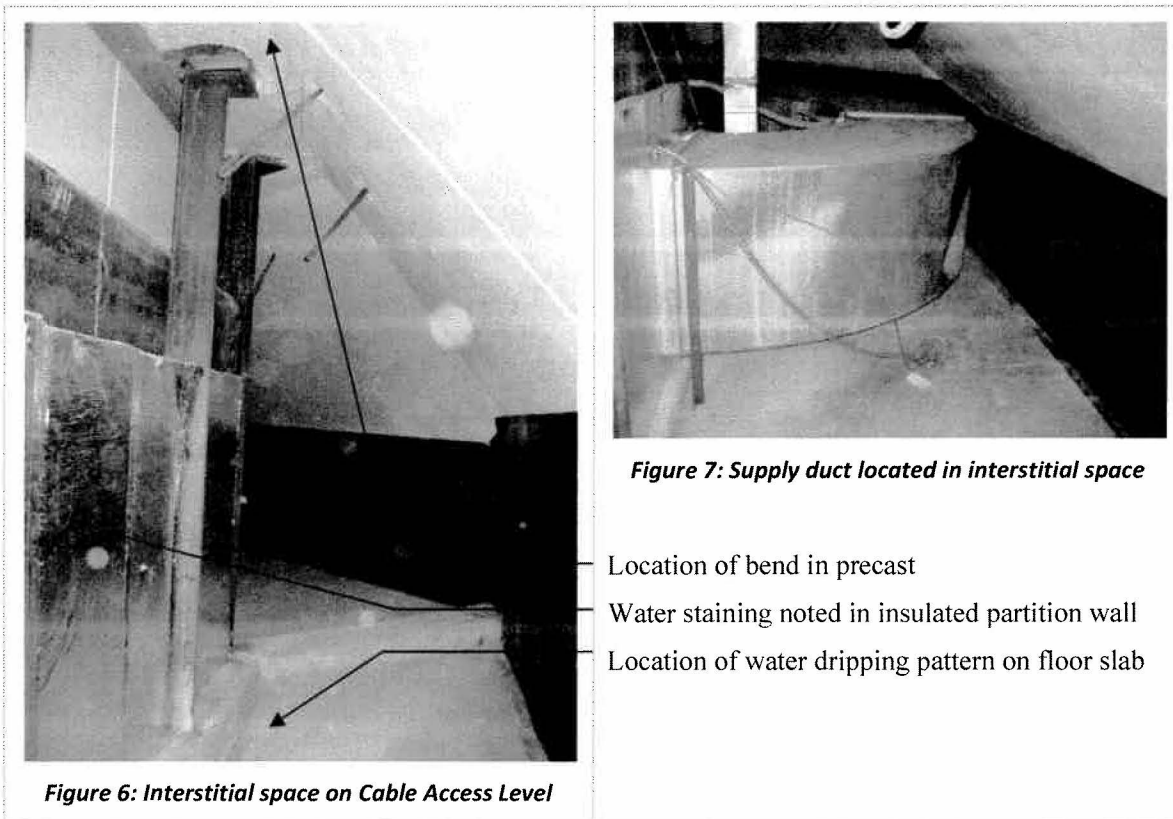
The interstitial space between the drywall and precast concrete was accessed via an access door. Signs of water dripping were noted on the floor of the concrete slab in a regular pattern along the perimeter of the interstitial space. The location of the water dripping correlated with the bend in the exterior precast panel above. The space was used to house a supply duct for the CAB above. The duct entered into the interstitial space and wrapped approximately ½ of the length of the space.

Water staining and deterioration were also noted on the insulated drywall partition that separates the interstitial space from the main conditioned space.

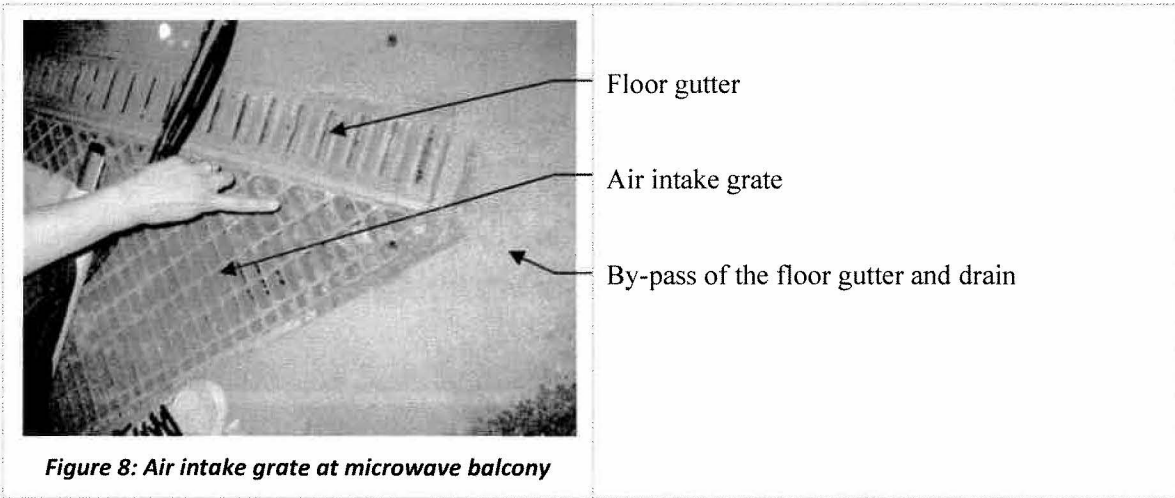
The exterior catwalks and microwave balconies are designed to be exterior of the primary enclosure separation. While the microwave balconies are shielded from the elements they would be considered to be exterior spaces. Two of the microwave balconies are used for air intake for the mechanical ventilation system. The air enters the balcony through louvered doors and then passes to the intake plenum through large metal floor grates. A gutter system is installed in front of the metal grate to intercept any rainwater. The gutter does not continue around the perimeter of the grate.

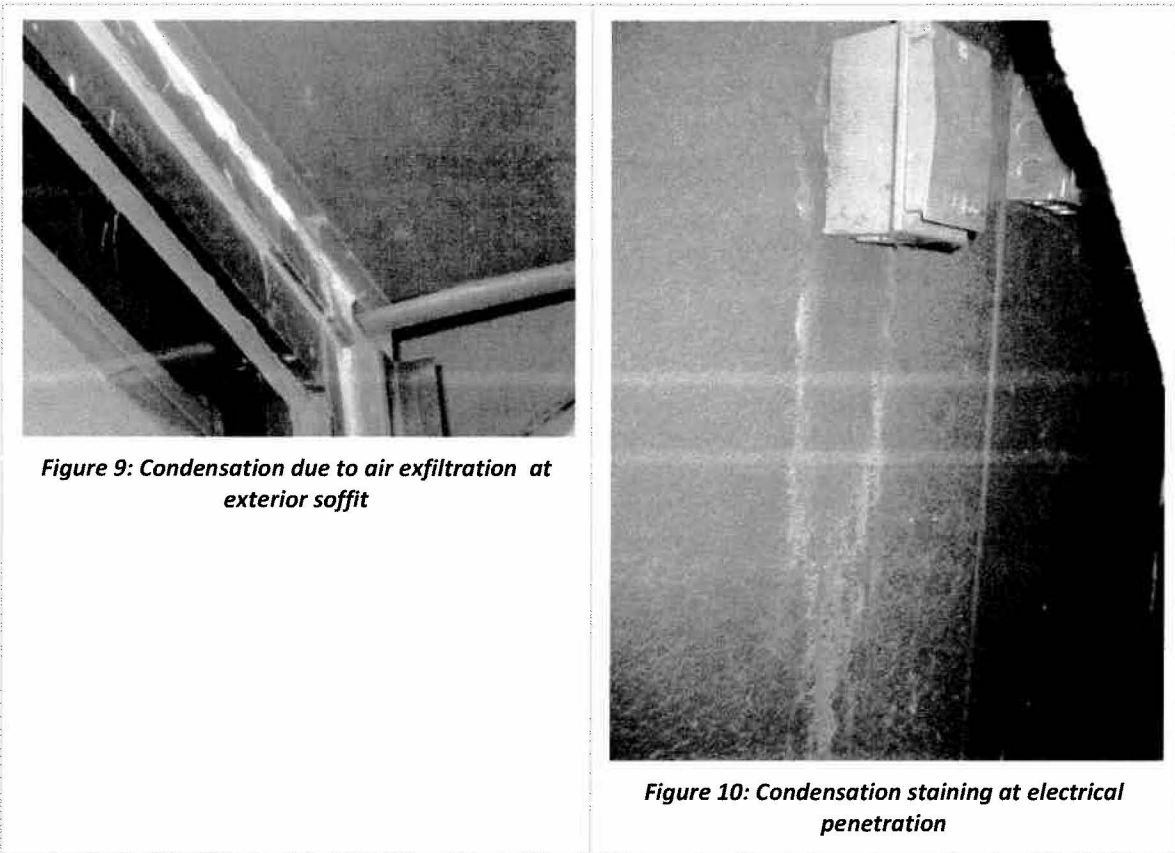
Water staining was also noted at insulated metal panel joints (and penetrations) and at soffit locations on the Junction level.

The condensation staining noted on the exterior soffit panels on the Junction level is due to air exfiltration condensing within the soffit construction. Investigation of the area revealed a lack of air barrier continuity above the dropped ceiling installation. This issue does not pose a durability or health and safety concern as the condensation is occurring exterior of the enclosure.

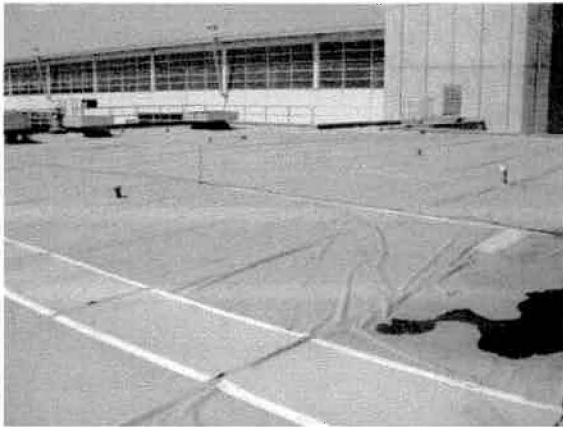
The base building roof system appears to be a light weight vinyl type roof membrane that is mechanically attached at the membrane seams. The connection of the roof membrane to the parapet and other roof curbs appeared to be done by returning the membrane up the curb and clamping the top of the membrane with a retaining bar. Many of the connection details appear to be poorly done.

Figure 25: Overall roof

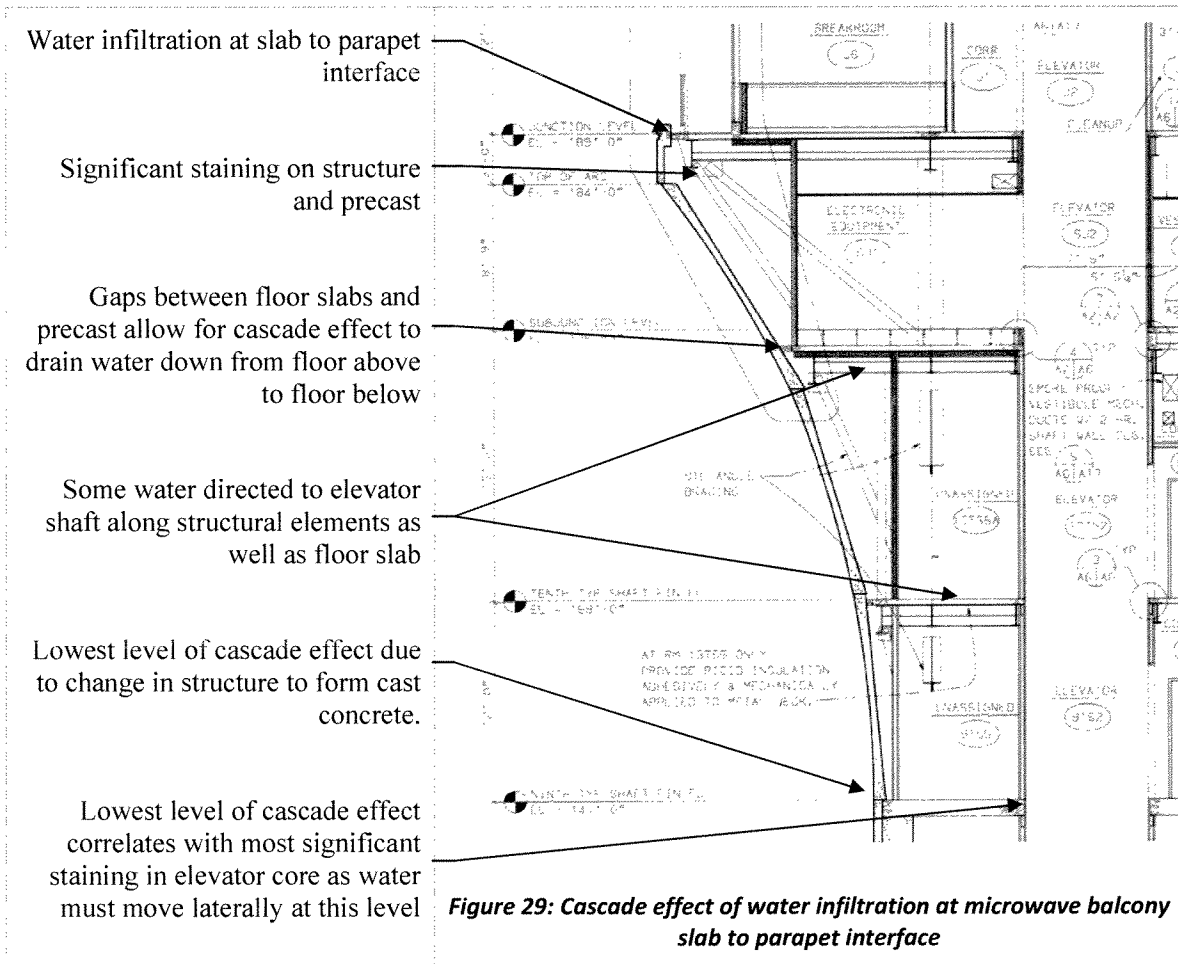
FIGURE 29: CASCADE EFFECT OF WATER INFILTRATION AT MICROWAVE BALCONY SLAB TO PARAPET
INTERFACE 15

Based on our observations the primary location for water infiltration is associated with the slab to parapet interface at the corners of the microwave balconies on the Junction level. Water infiltration at these locations is resulting in the significant water staining of the steel structure and precast concrete panels observed at the 45 degree corners on Sub Junction down to Level 9 of the tower due to a cascading effect of water leaking from the floor above down to the floor below. Based on the staff reports, it is also likely that this water infiltration is the primary cause of the liquid water staining in the elevator core at the Sub Junction down to Level 9 as some of the water is intercepted by structural elements and the floor slab, and is directed towards the elevator core. Correction of the infiltration at these locations will address the major source of water infiltration into the building.

The water intrusion that is occurring at the slab to curb interface at the corners of the microwave balconies is accounting for the majority of the moisture intrusions problems for the building. The following measures are recommended to repair the source of infiltration.

1. Remove the base of the metal panels as required to expose the slab to curb interface. (The panels will need to be supported with new anchors attached to the metal columns)
2. The old panel base angle anchors are recommended to be removed.
3. A backer rod and sealant joint should be installed in the exposed gap between the concrete deck and precast curb.
4. A minimum 6” wide flexible membrane flashing (compatible with the liquid applied waterproof traffic coating) should be installed over the new sealant joint extending a minimum 6” on either end over existing deck waterproof traffic coating (at the concrete slab to curb interface).
5. A new deck waterproofing system should be installed to completely cover and embed the flexible membrane flashing.
6. The exterior of the area area should be covered with a new metal flashing to divert water out and away from the microwave balconies.

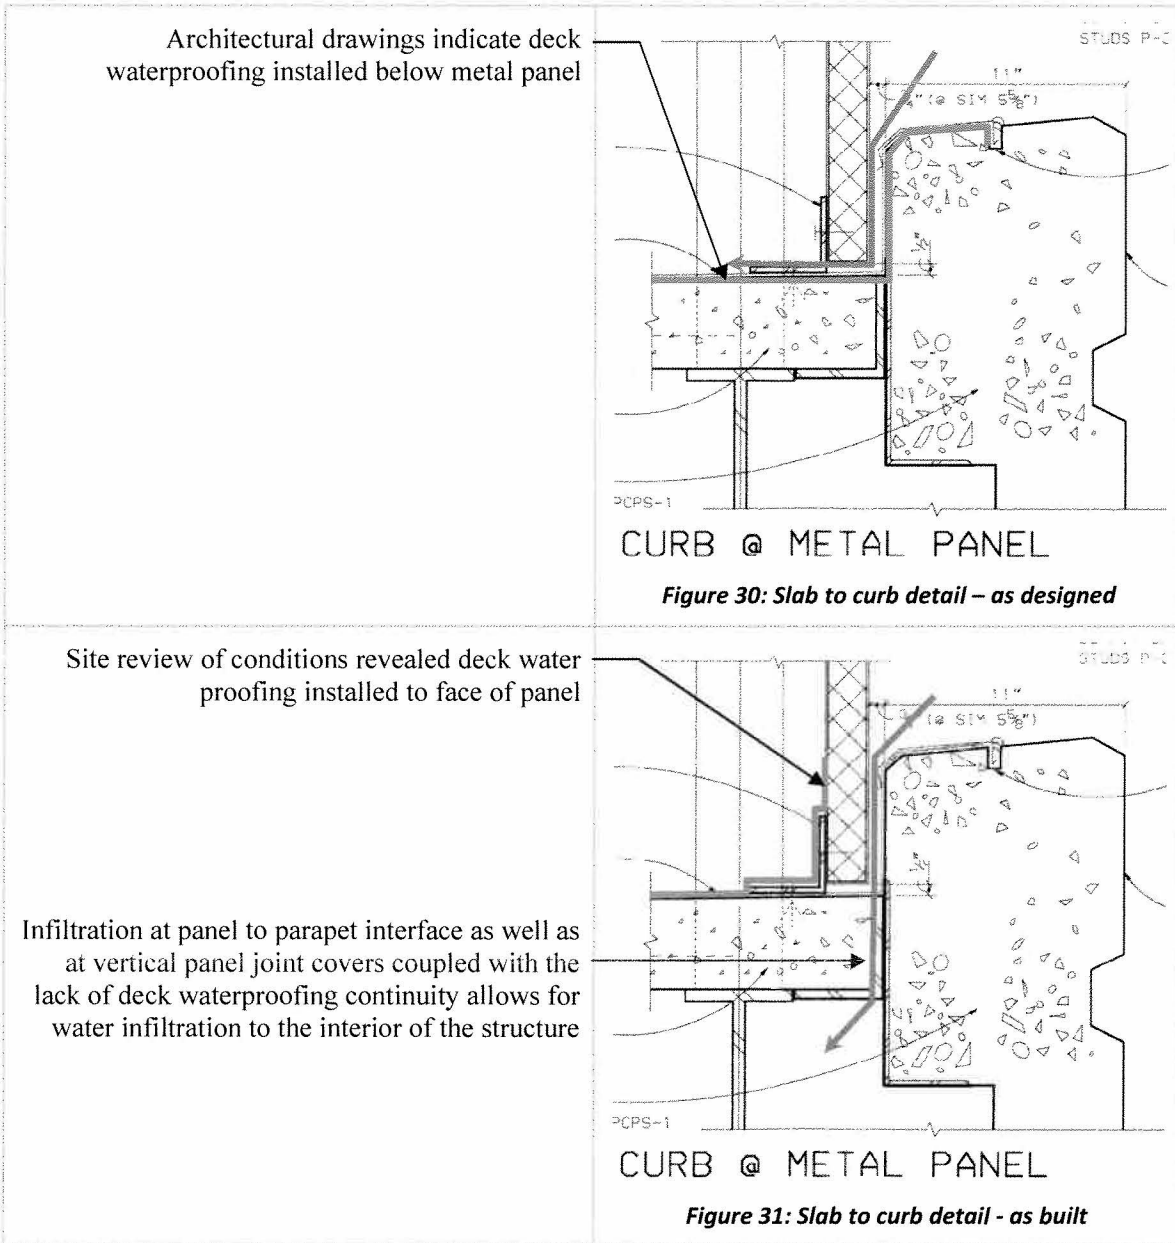
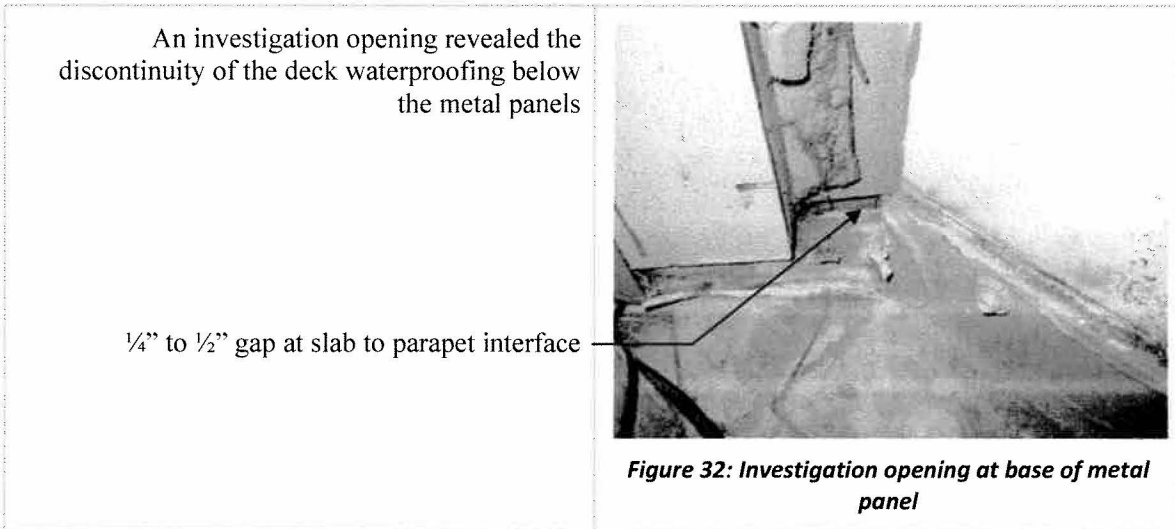
The architectural drawings were reviewed to examine the proposed construction of the slab to parapet interface. Based on the drawing review the waterproof traffic coating was intended to be installed prior to the installation of the insulated metal panel cladding. It was suspected based on visual review of the area, that the construction sequence had led to the panels being installed prior to the installation of the deck waterproofing. This change in installation sequence would result in a void between the slab edge and the precast parapet and a path for water infiltration.

Given the shape of the parapet, a gutter between the metal panel to parapet interface is created, concentrating rain water at the interface. A visual inspection of the interface revealed sealant joints between the parapet flashings and the metal panels. These sealant joints had failed in some locations allowing for water to infiltrate between the panel and the parapet. In addition, the joints between the metal panels were not sealed allowing for water to infiltrate between the panels.

In order to confirm the construction, sections of the insulated metal panel at the corners of the microwave balconies were removed. The investigation openings revealed a 1/4" to 1/2" gap between the concrete slab and the precast parapet. This confirmed the hypothesis.

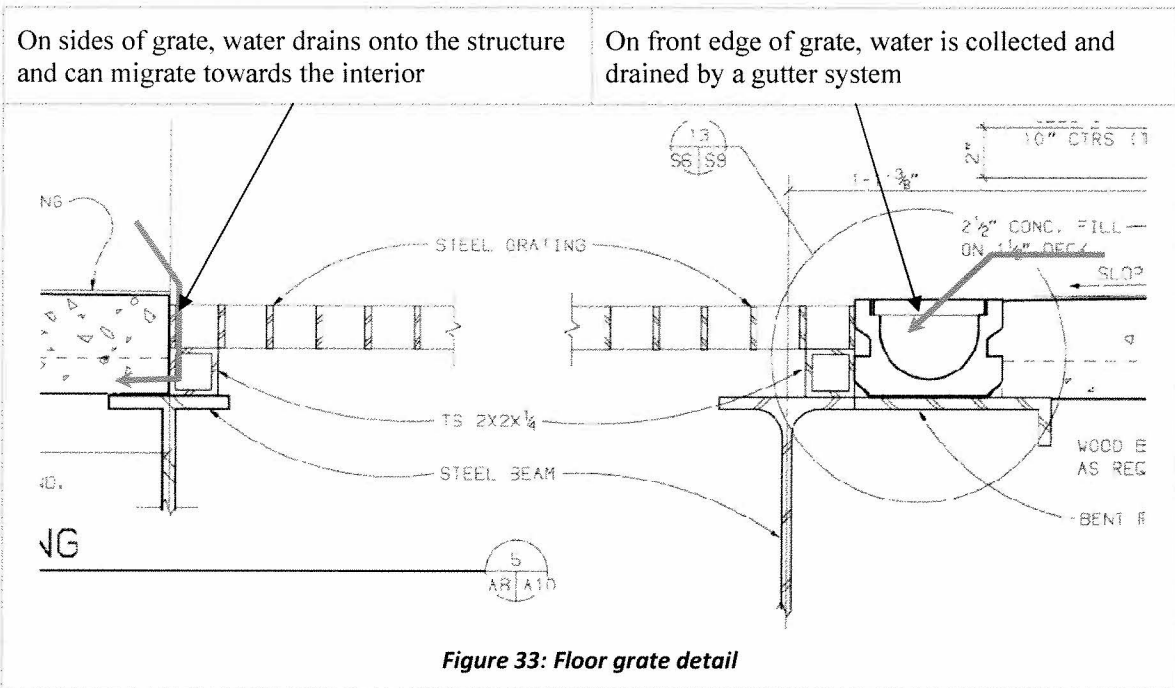
A secondary water intrusion location was identified at the air intake grate in the microwave balconies. The grates are designed with a gutter to intercept any exterior rainwater from draining down into the air intake plenum below. The gutters are not continuous beyond the front edge of the floor grate allowing for water to by-pass the gutter on both sides, and drain down onto the structure that supports the metal floor grate. This allows for water to infiltrate into the interior by traveling along the structure to the interior.

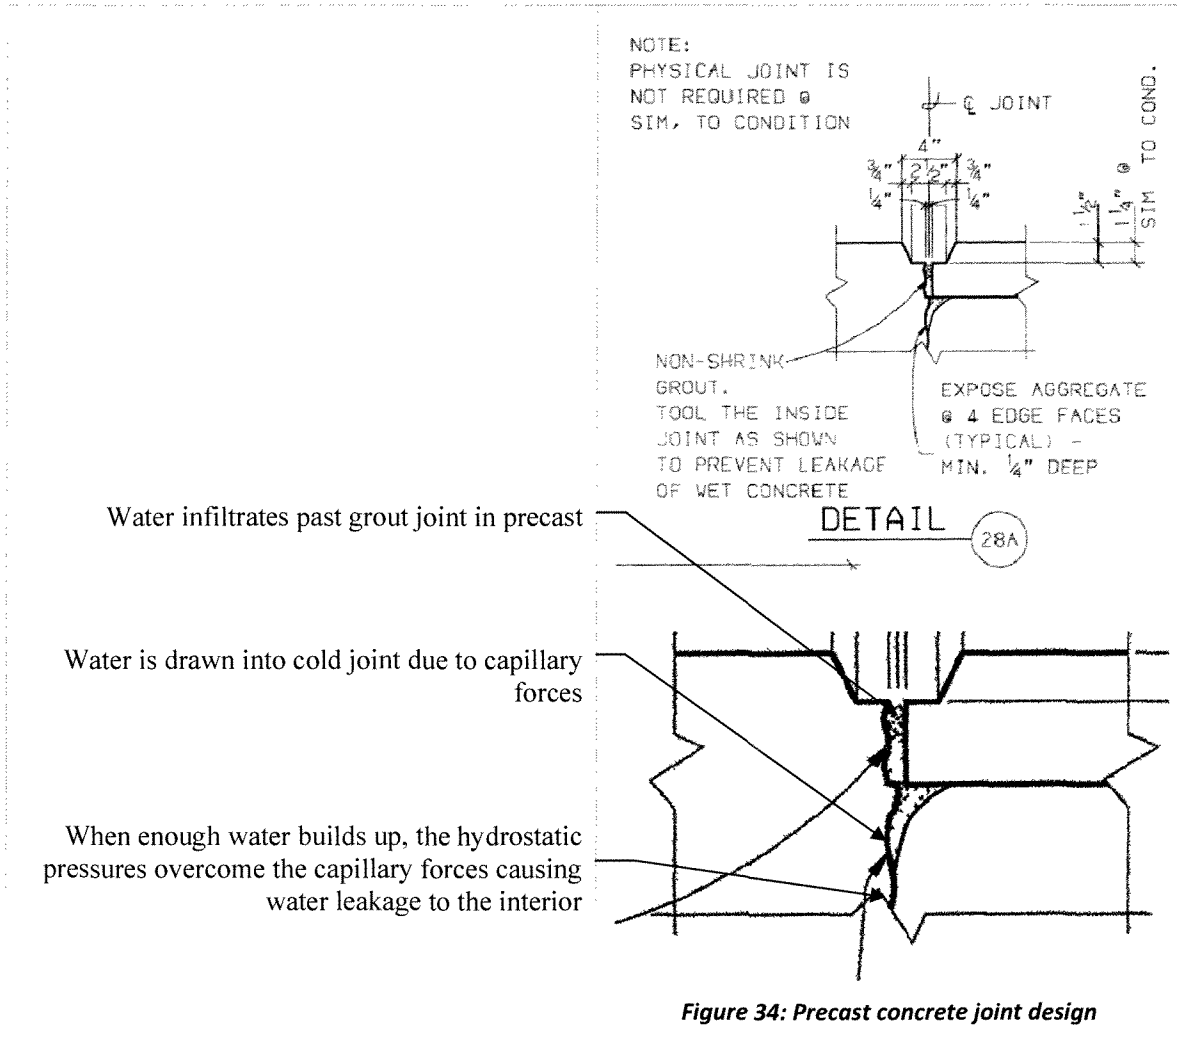
Water intrusion events occurring on Level 8 and below are related to water infiltration at exterior precast joints of the concrete structure. The building was constructed by using precast concrete

panels joined together with formed and cast-in-place concrete. The exterior joints are filled with a non-shrink grout. This joint is not waterproof and allows for water infiltration into the small gap behind the grout at the precast panels. Once the water penetrates past the exterior grout, it gets drawn into the cold joints of the concrete due to capillary forces. With enough water, the hydrostatic pressure created by gravity overcomes the capillary forces holding the water in the cold joint, and liquid water will flow to the interior (and exterior) resulting in water leakage through the concrete structure.

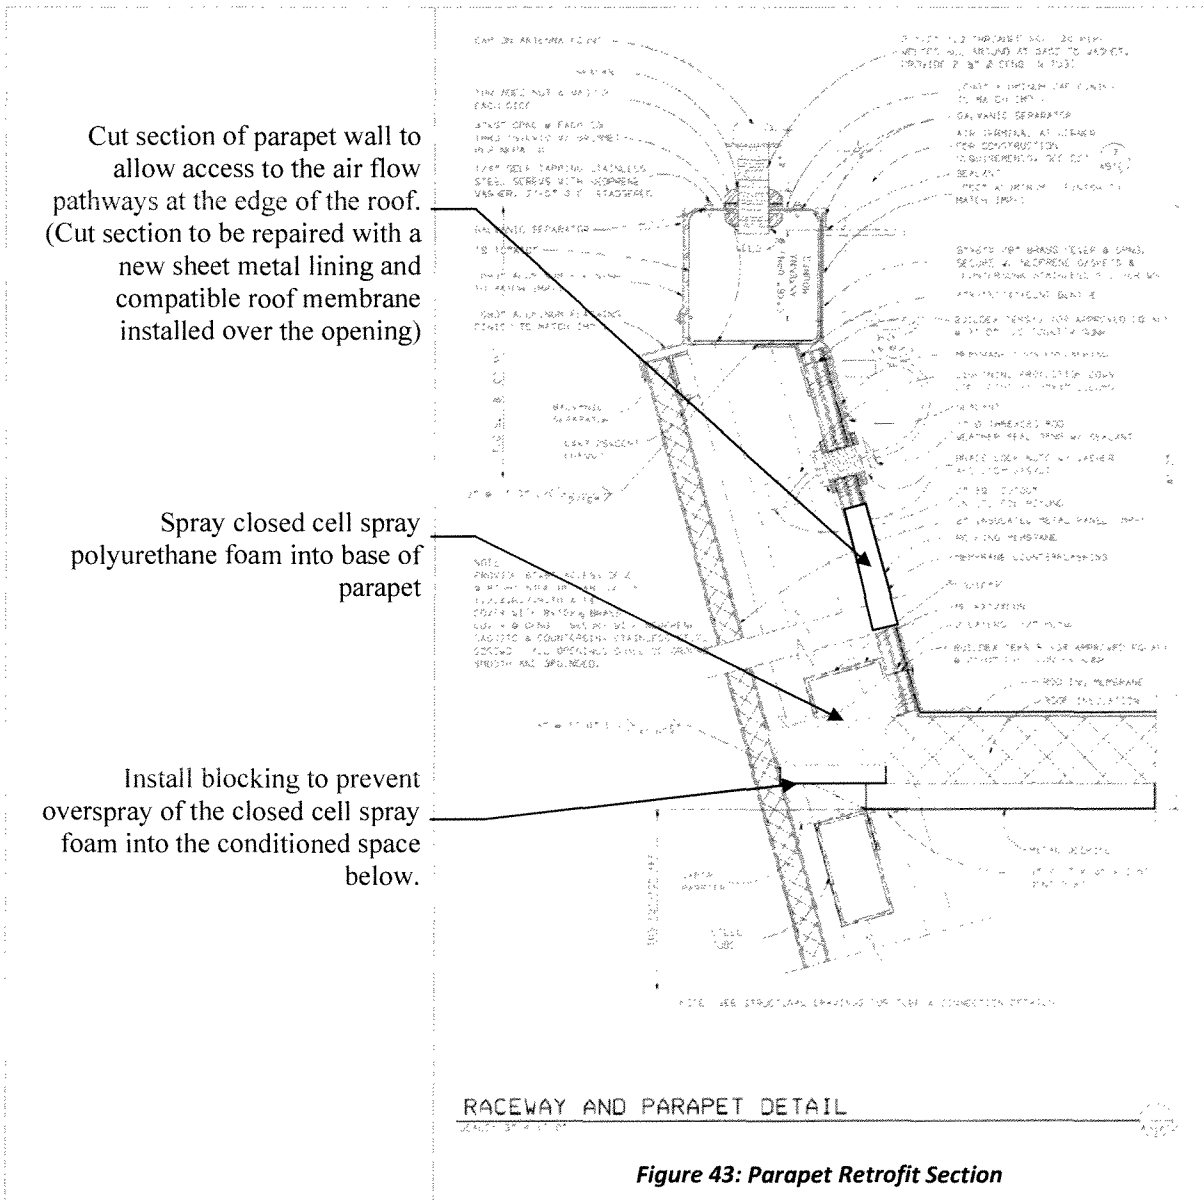
Figure 43: Parapet Retrofit Section

The staining that was noted on the interior face of the insulated metal panels in the dropped ceiling area of the CAB was a function of condensation within the parapet construction of the penthouse catwalk.

It was suspected that no provision for air sealing had been made during the initial construction to prevent warm interior air from leaking up into the parapet construction. Air infiltration into the parapet from the space below will result in condensation accumulation due to the exposed cold surfaces of the parapet construction. If sufficient condensation builds up, it will drain back down to the interior in liquid form often being mistaken for a roof leak.

It is recommended to cut a 12” tall section of the parapet facing (on the catwalk side) around the entire perimeter of the catwalk to expose the air infiltration location at the roof deck level. The area should be blocked at the top of the roof deck in order to provide a backing for a closed cell spray foam insulation and air seal to be installed. The blocking material can be a range of products from plywood to sections rigid insulation board (such as XPS), the intent for the product is to prevent overspray of the closed cell foam into the conditioned space below. After the area is sealed, the inner face of the parapet should be covered with a sheet metal backing and a new compatible roof membrane installed to seal the opening. The roof should be properly flashed with the parapet cap flashing.

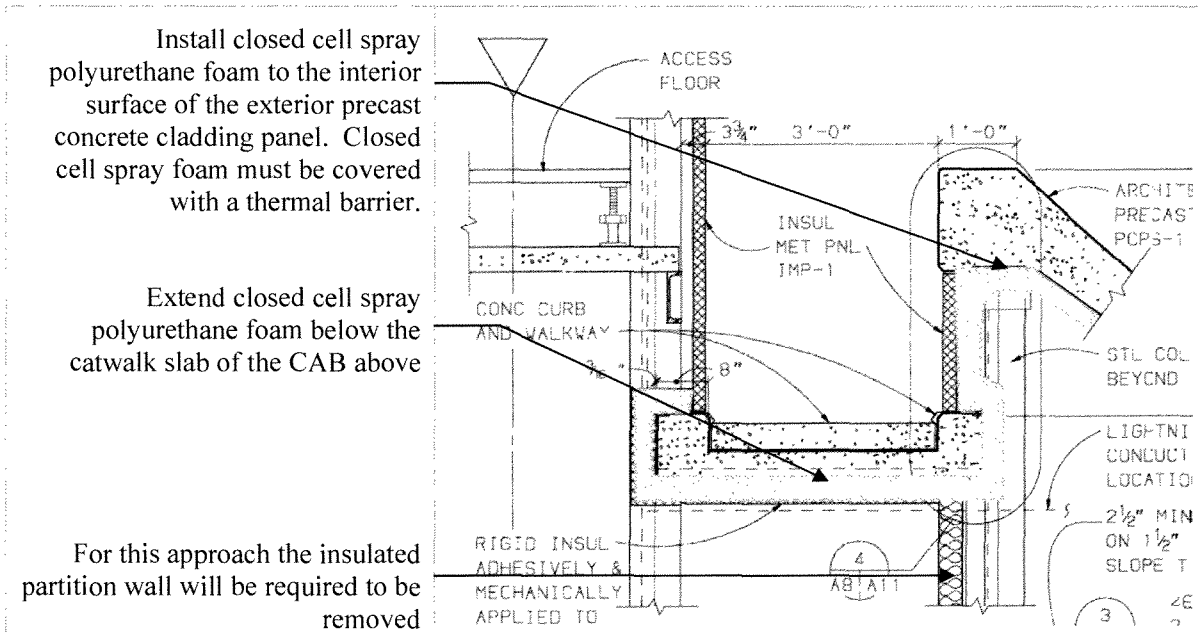
Figure 44: Cable Access Retrofit Section 1

The condensation noted on the surface of the exterior precast cladding panels on the cable access level is due to interior air coming in contact with the cold surfaces of the un-insulated concrete. In this location, the condensation is exacerbated due to the presence of the supply air duct that is run through approximately half of the perimeter. The pressurized supply duct leaks warm conditioned air into the space increasing the available moisture for condensation.

It is recommended to install a layer of closed cell spray polyurethane foam to interior surface of the exterior precast. Closed cell spray foam used in this location will control condensation by increasing the first condensing surface temperature (now located at the inside surface of the spray foam), and improve the overall thermal efficiency and air tightness of the building. The following sections show the intent for the locations for the closed cell spray foam.
