Office of the Naval Inspector General

OSC Case Control Number DI-09-1294
NAVINGEN Case Control Number 200900425
NAVSEA Case Control Number 090015L

Report of Investigation

Subj: ALLEGED FAILURE TO REPORT CRANE MISHAP AT NSWC CARDEROCK
BAYVIEW DETACHMENT, BAYVIEW IDAHO

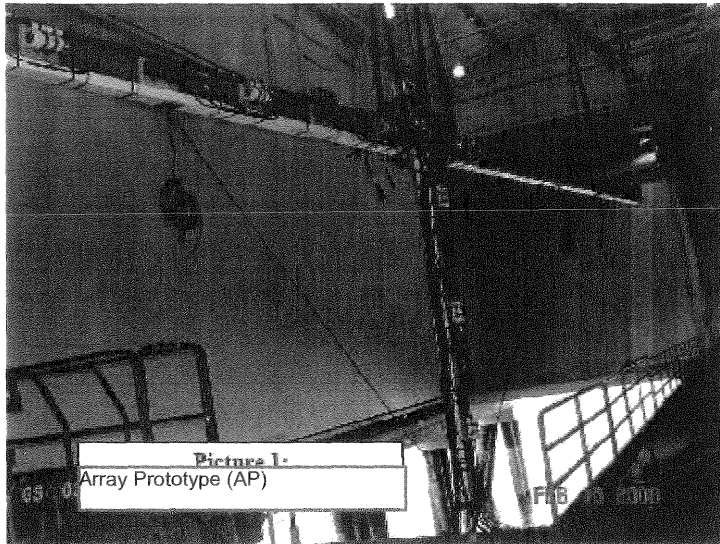
Picture 1:
Array Prototype (AP)

The damaged components (part of the "load") consisted of two pieces of the array system, an aluminum mounting/alignment bar and two electrical cables. The AP (picture 1) was connected to the HRA (picture 2) via the mounting/alignment bar (picture 3). The bar failed while the load was being transferred from the crane to the pull-down winch system. As a result of the bar failure, two electrical cables came under tension and their connectors were broken. Four other cables remained undamaged. It has been calculated that a load of 2,350 lbs. was on the crane when the aluminum bar failed. Crane B-17 is rated for 16,300 lbs. at the radius used during this job.

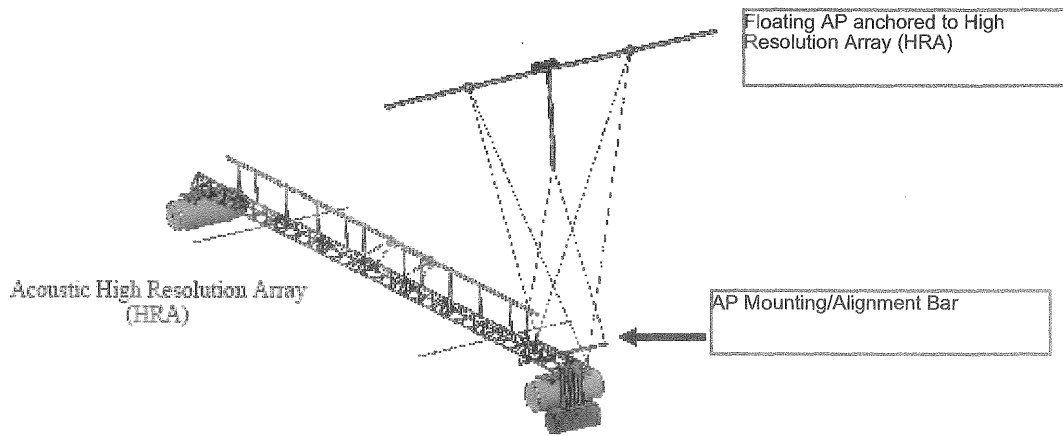
Picture 2:
High Resolution Array with AP Deployed
