Technical Memorandum No. MERL-2012-11

Coatings for Mussel Control — Three Years of Laboratory and Field Testing

U.S. Department of the Interior Bureau of Reclamation Technical Service Center Denver, Colorado

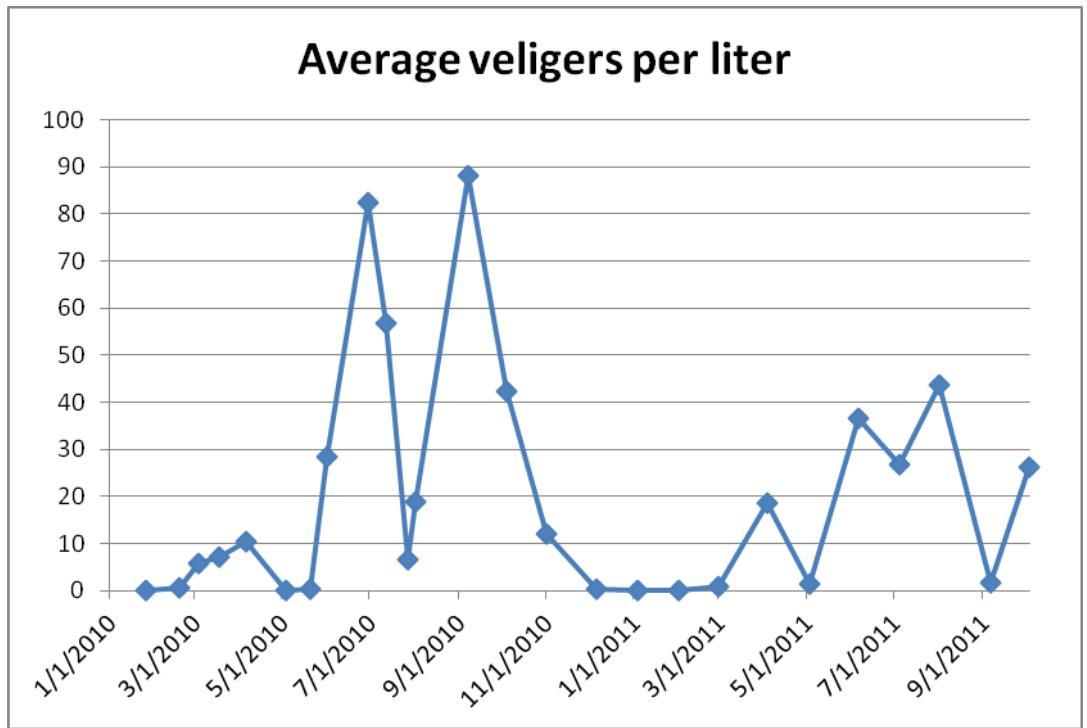
Figure 9.—Average number of veligers per liter of water from January 2010 through October 2011.

Results of the veliger sampling program indicate that the majority of mussel reproduction appears to occur in the warmer months between March and November. Comparing the veliger counts to water temperatures shows the mussels appear to have greater reproduction rates when water temperatures are above 58 $^{\circ}$ F.

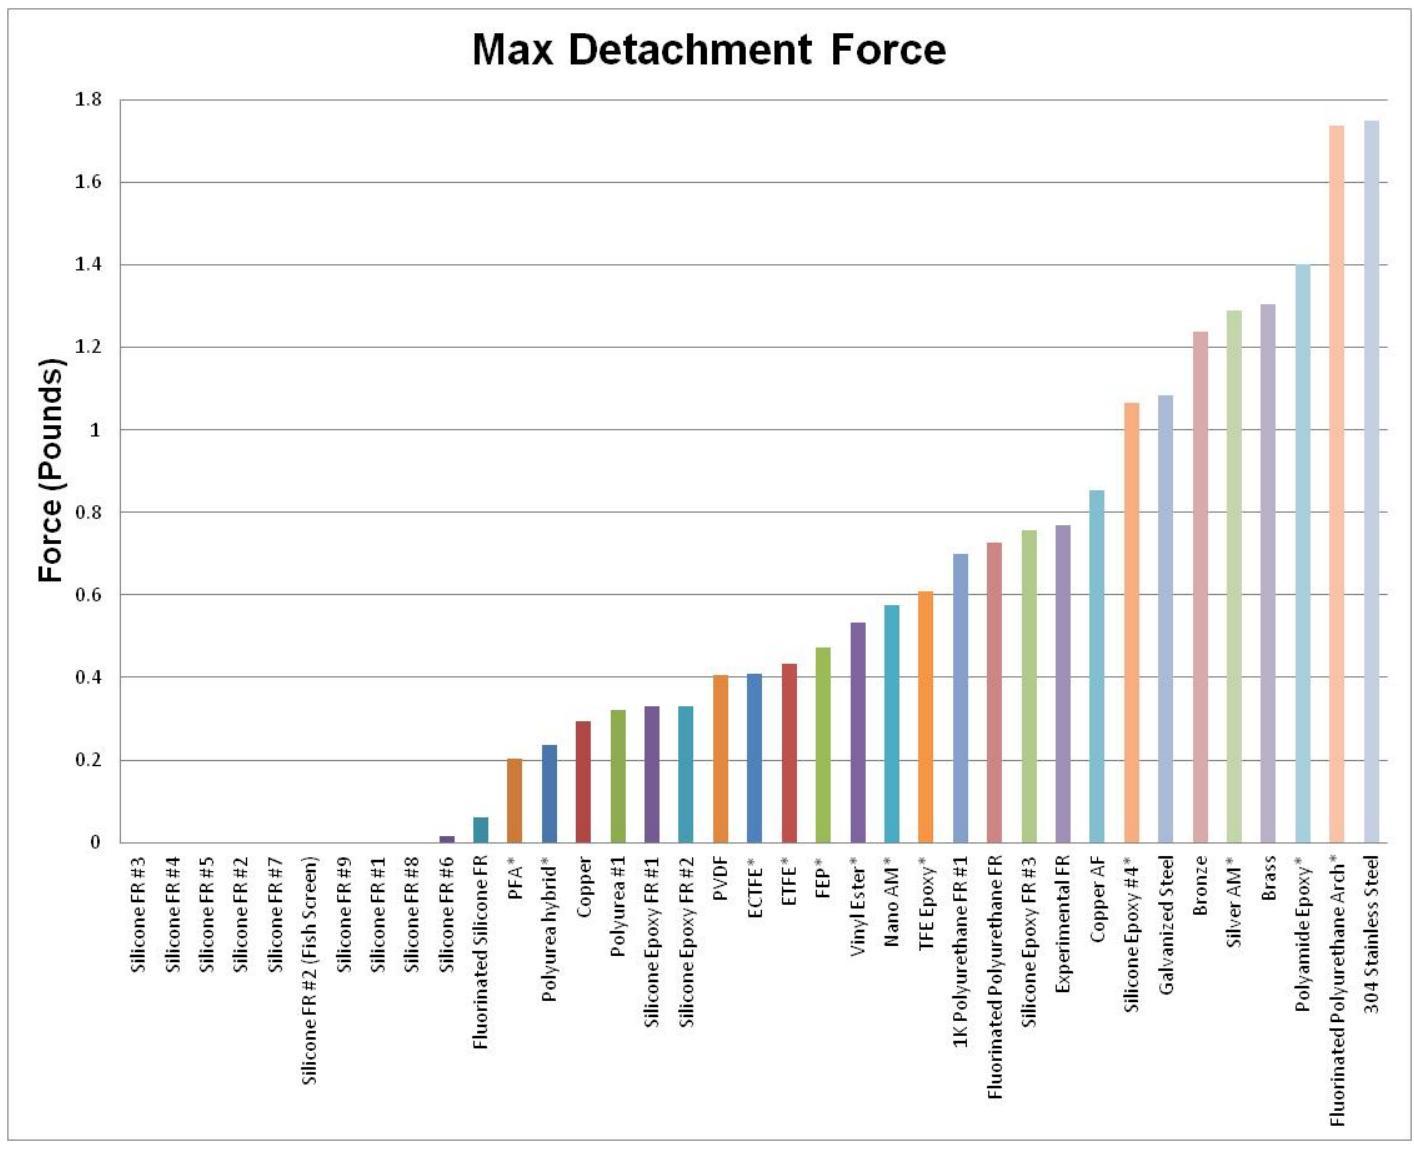
Figure 11 shows the maximum force to remove individual mussels from the coated surfaces. The force gauge instrument was very sensitive, but all readings below 0.02 pound were assigned a zero force due to increased possibility for human error. Figures 12 and 13 show blockage after 1 and 2 years, respectively.

Figure 11.—Maximum attachment force on coated test plates suspended in static water. The symbol * means that the coating is not marketed specifically for fouling control.

The silicone FR #6 is actually a tie coat of one of the silicone foul release coatings and does not release the fouling as easily as the silicones. Figure 11 shows that the mussels barely attach to the surface of the tie coat (silicone FR#6 requiring only 0.02 pound of force to remove a mussel). This was the lowest measureable force for any of the coatings tested that actually allowed the mussels to attach to the surface. This coating system was selected to demonstrate the self-cleaning process. Silicone FR #6 fouled up to approximately 25 percent from May 2010 to November 2010 as shown in figures 15 and 16. Between November 2010 and May 2011, Silicone FR #6 fouled up to 50 percent as shown in figure 17. Sometime between May 2011 and November 2011, the mussels sloughed off and the November inspection showed the grate to only be 17 percent blocked as shown in figure 18. There appears to be a critical flow rate or drag force when the fouling sloughs off. It is well known that the critical flow rate for mussels to attach to any surfaces is 4.9 ft/sec [5]. Therefore, it can be assumed that there are different critical flow rates for fouling to be released from the various types of foul release coatings. We believe that the force to remove mussels is dependent

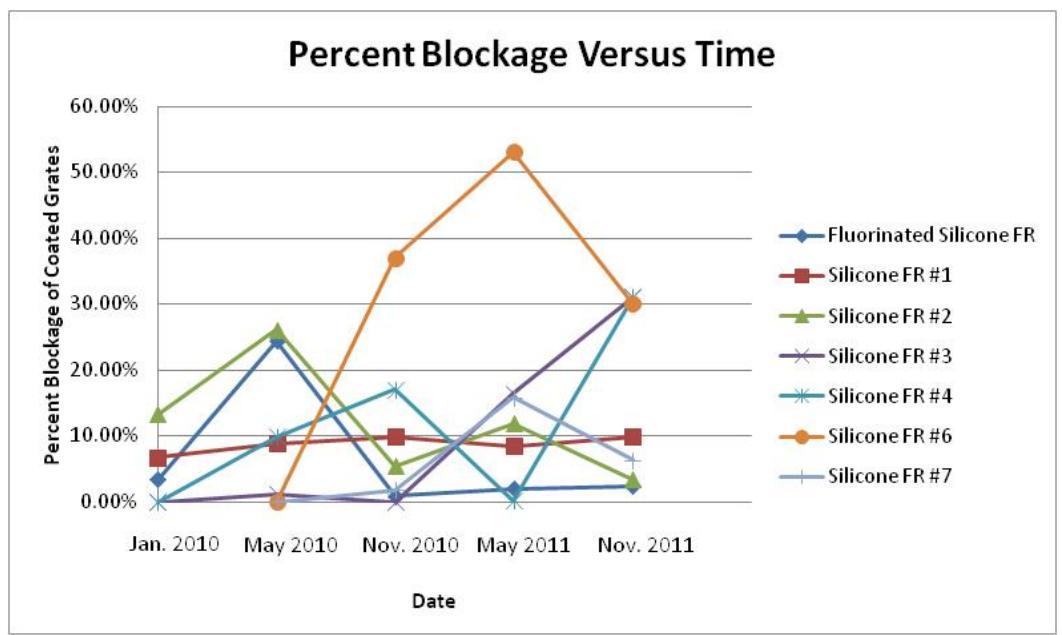
accumulation of algae, slime, and bryozoans. Quagga mussels do not attach to the silicone surfaces. For some foul release coatings, there was a decrease in percent blockage of the grate from season to season as seen in figure 14. The silicone and fluorinated silicone foul release coatings showed releases once fouling had built up enough for drag forces to exceed the bond strength and peel the fouling off the surface. Another possible explanation is that during the summer months flow rates and hence velocities are higher due to an increased power demand (peaking power) and water demand for irrigation which subjects the fouling on the silicone and fluorinated silicone foul release coatings than during the spring inspections. The velocity range during the summer months (or when all units are operating) was between 1.8 and 2.4 ft/s. The sloughing off has only been documented with the silicone and fluorinated silicone foul release systems.

Figure 14.—Percent blockage of the silicone foul release coatings seasonal variation.

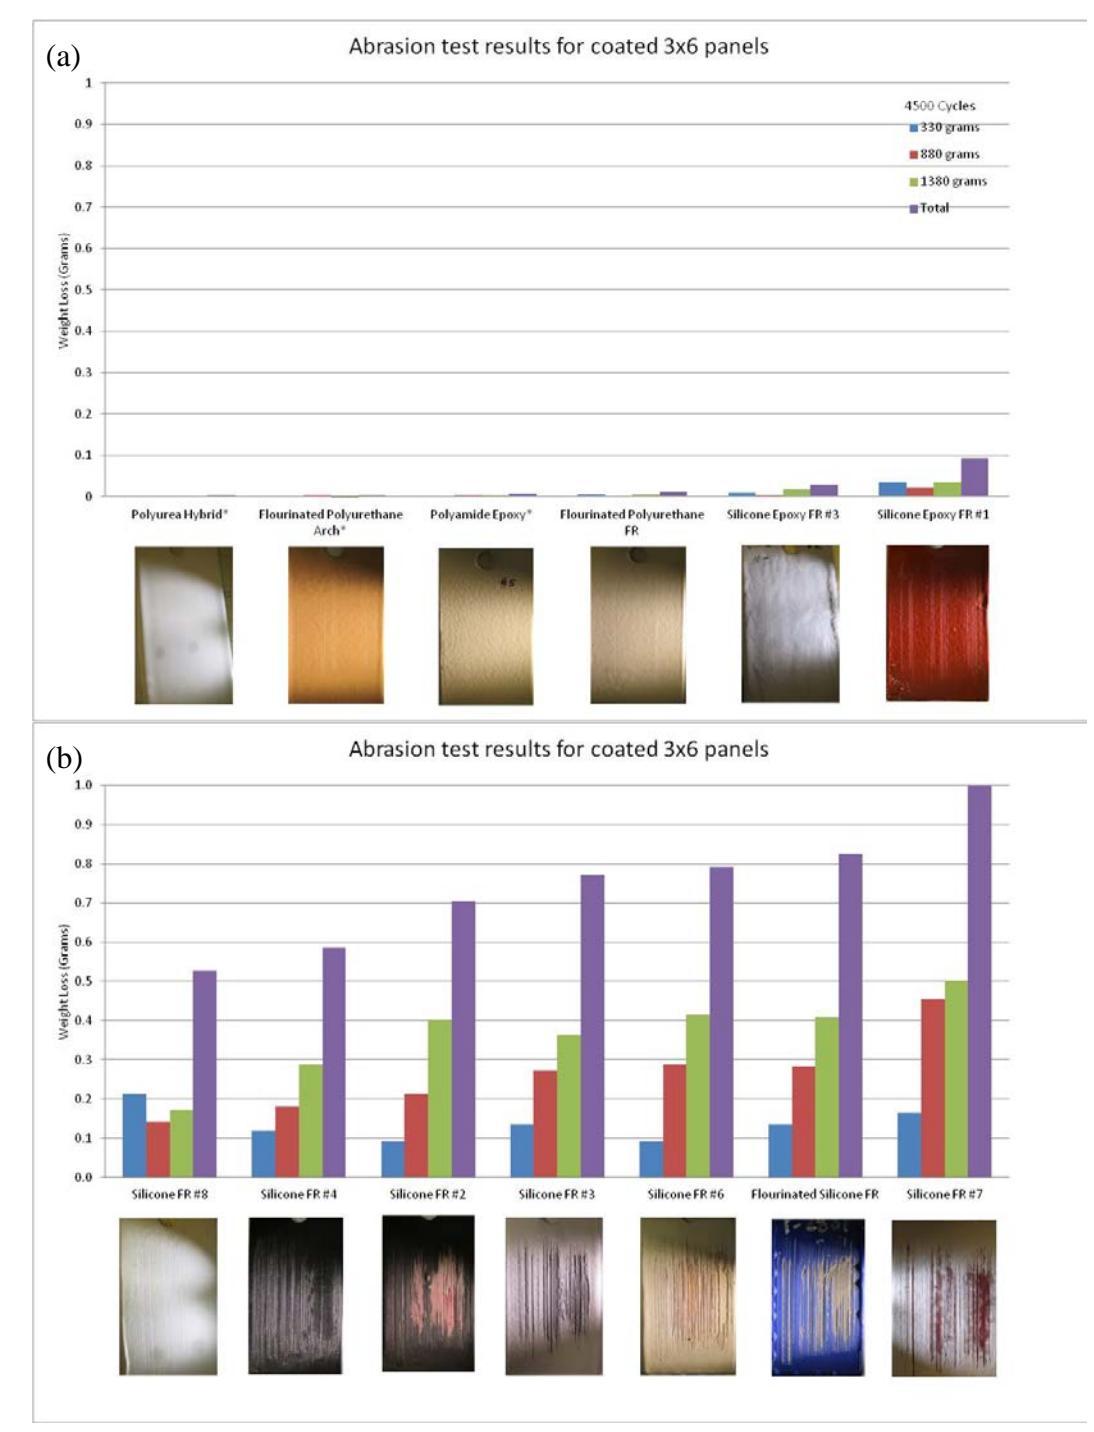
In general, the harder coatings were far more durable than the softer coatings. However, one notable exception was the polyurethane-urea hybrid control sample, which was both soft and durable. The abrasion test results for the more durable coatings are given in figure 22a; results for silicone-based coatings are shown in figure 22b.

Figure 22.—Abrasion test results for (a) control samples and durable foul release coatings and (b) silicone foul release coatings.

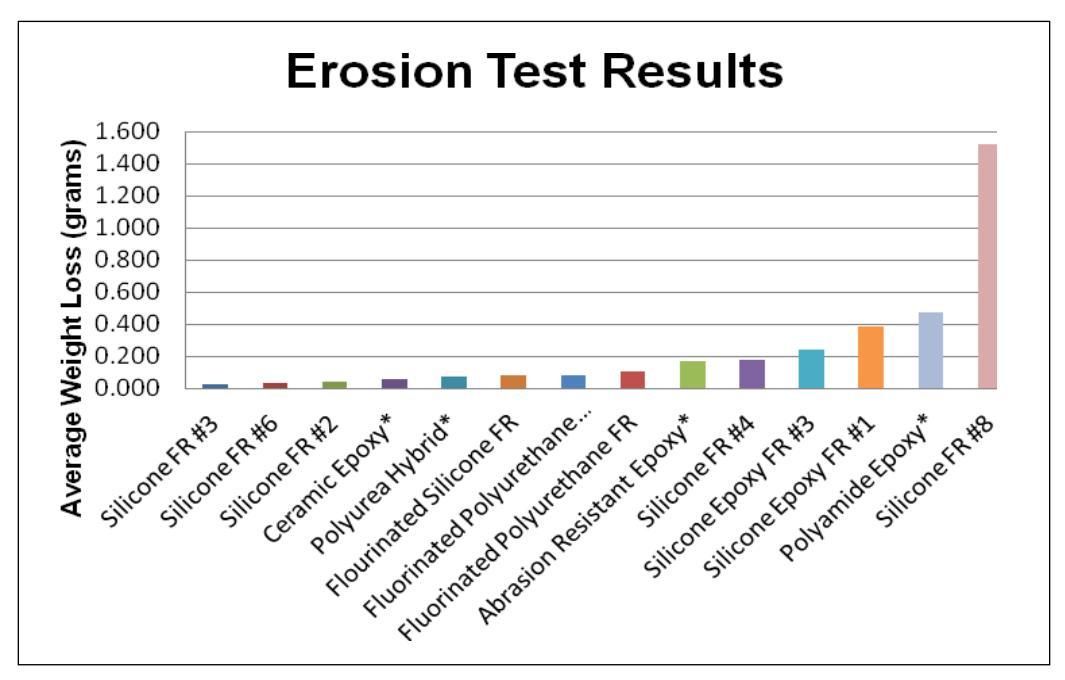
The most notable physical change observed on the samples was a loss of gloss. It was difficult to gage the damage using visual inspection, so the samples were weighed to quantify the damage. Figure 24 shows the silicone foul release coatings exhibited excellent erosion resistance, comparable to an abrasion resistant epoxy. It outperformed the polyamide epoxy by more than 10 times less weight loss. One notable exception was Silicone FR #8, which experienced damage far greater than any other coating system. Silicone FR #8 was also unique in that the cured coated panel had a very oily feel in comparison to the other samples. Some silicone foul release coatings also outperformed a ceramic epoxy specifically designed to withstand erosion. However, the densities of the materials were significantly different, and the coating thickness loss was more important than the weight loss. Unfortunately, some of the coating densities were unknown, so the data could not be compared using the calculated thickness loss.

Figure 24.—Erosion test results for foul release coatings and controls. "*" denotes non-foul release systems.
