United States-  
Environmental Protection  
Agency

# CHEMICAL ACCIDENT INVESTIGATION REPORT

## TERRA INDUSTRIES, INC. NITROGEN FERTILIZER FACILITY PORT NEAL, IOWA

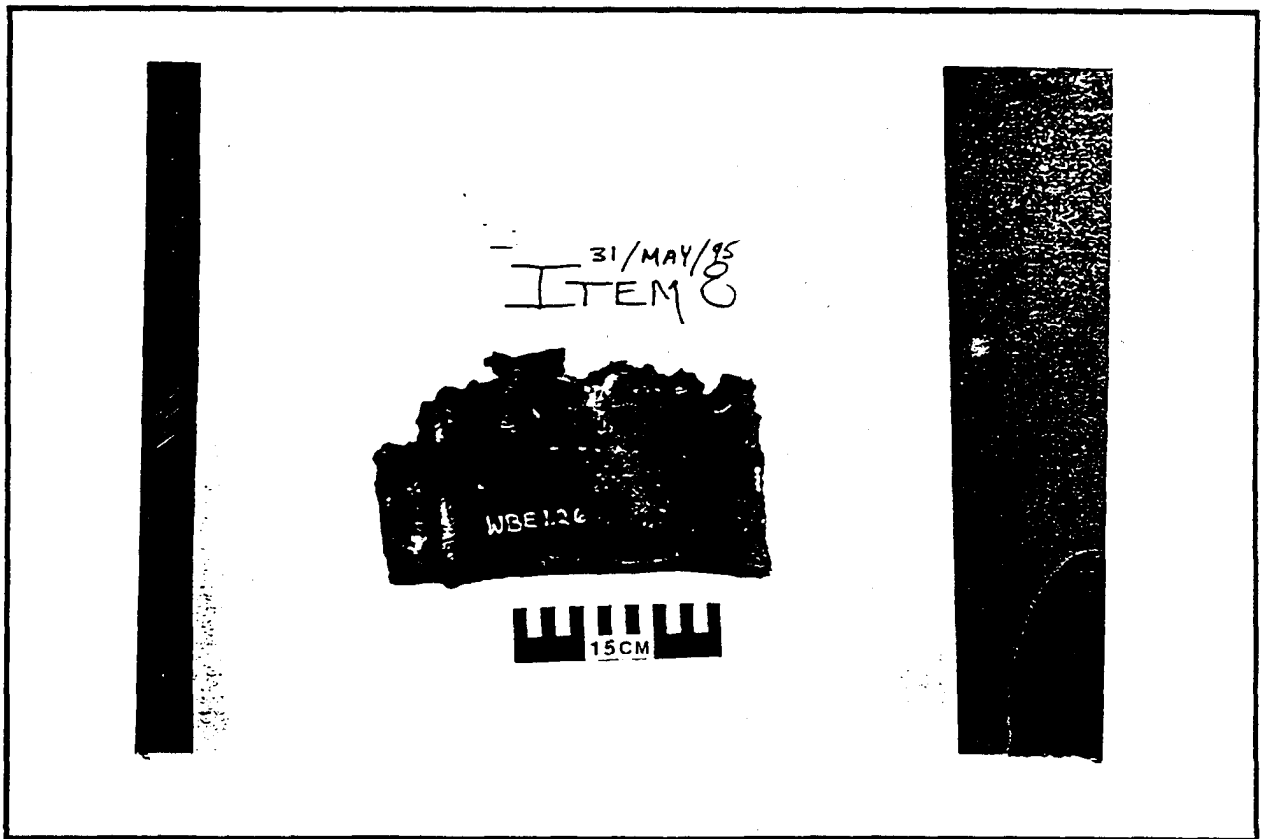
Photo 7 - 3  
Neutralizer Fragment

Metallurgical analytical results indicated that the fragment displayed a high-temperature discolored surface and severe erosion in one direction (*Photo 7-2*). The adjacent area showed little discoloration. The opposite surface exhibited severe tearing and fracturing with evidence of high-temperature discoloration (*Photo 7-3*). Unetched cross sections exhibited high-temperature oxidation on the inside diameter with severe surface tearing/seams or laps. The etched cross-sections displayed evidence of severe surface movement and cold working with a one-directional heavy force. Of the fragments analyzed, metalographic analysis suggests that the highest temperature, internal pressure and velocity was located in the area of Item #8. This sample exhibited the most severe surface distortion and high-temperature grain structure change.

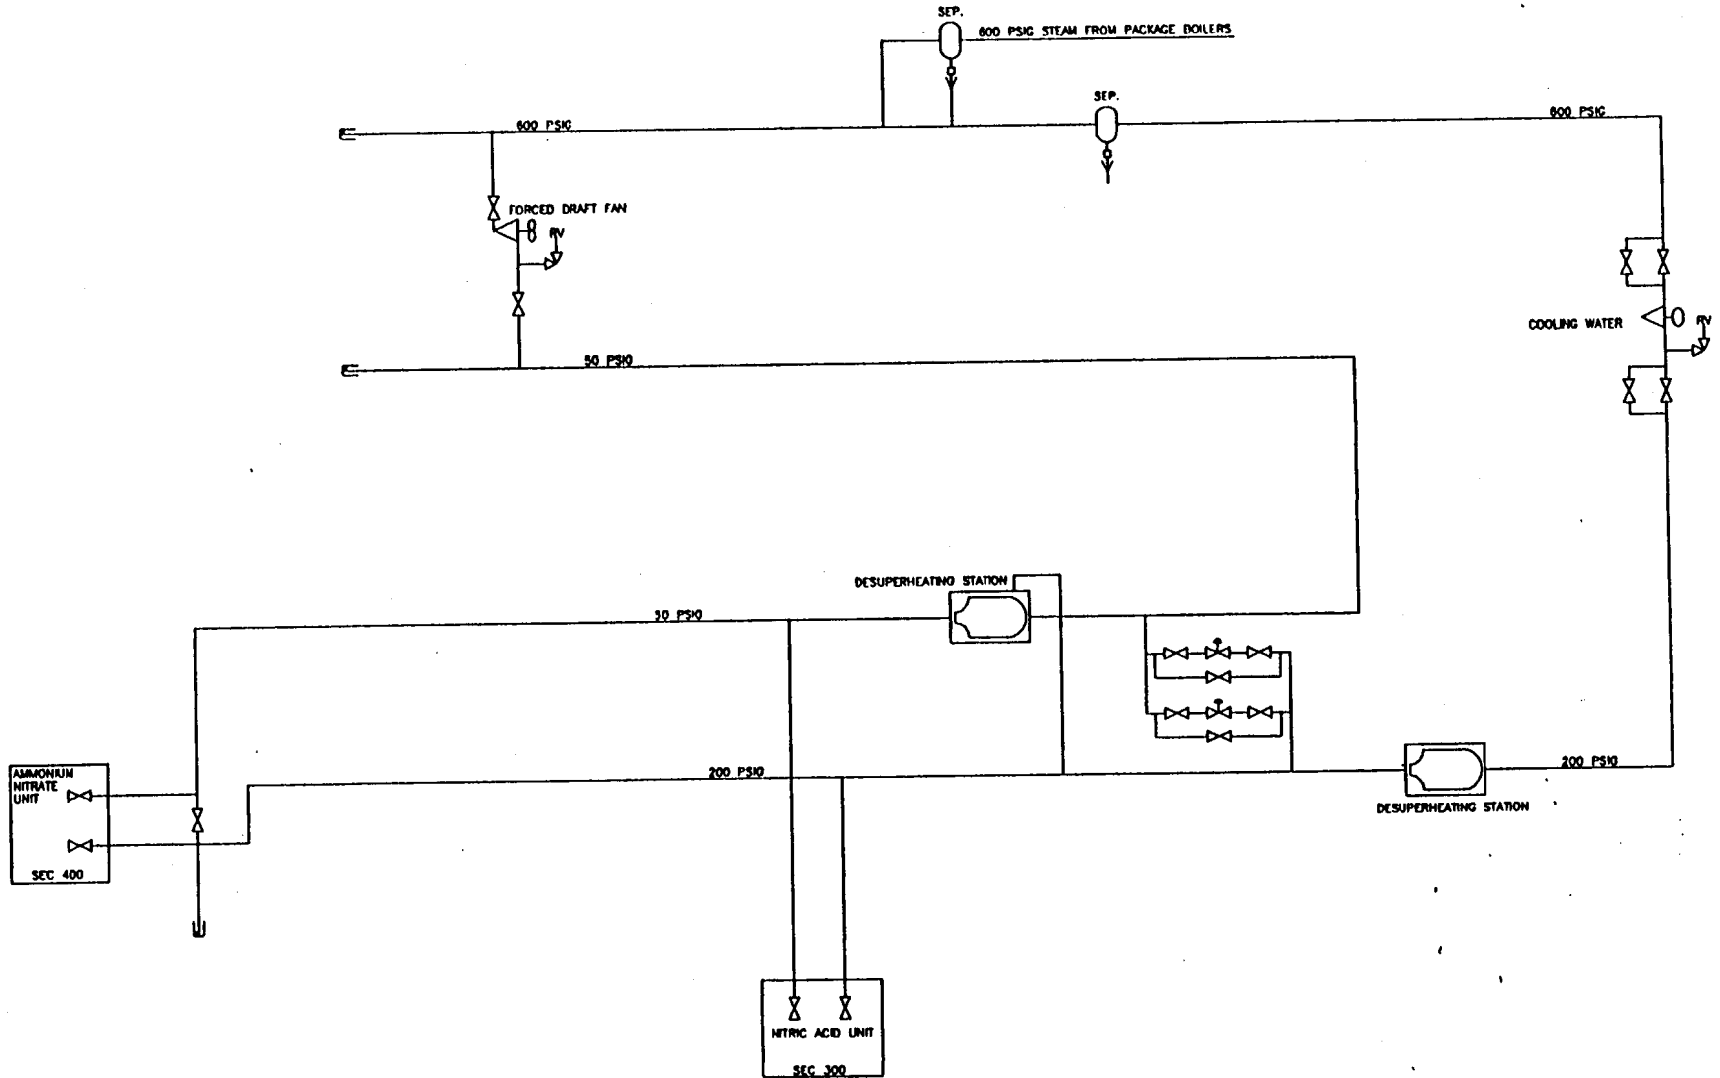
FIGURE 7 - 4  
STEAM DISTRIBUTION SYSTEM (PARTIAL)

The investigation team concluded that the steam distribution system had the potential to supply superheat during high demand events such as the slow roll of the nitric acid compressor.

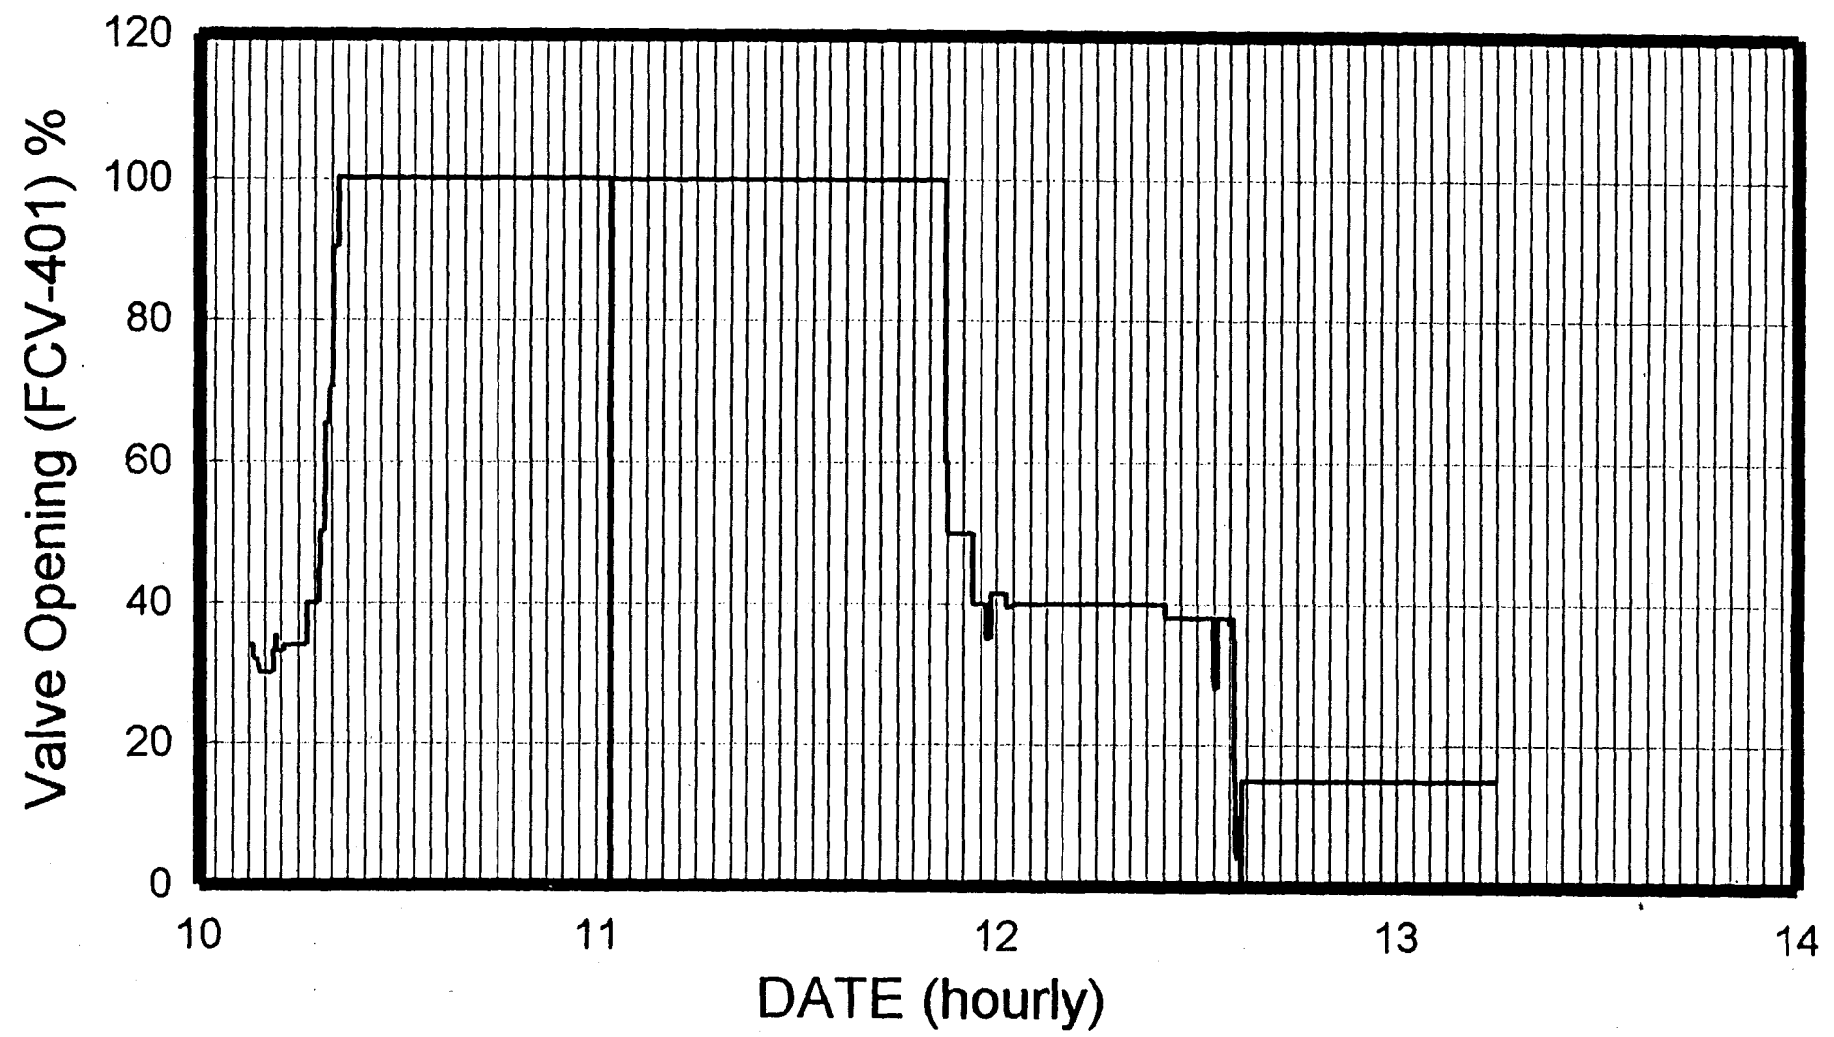
Figure 7-5

The investigation team graphed AN plant DCS data provided by Terra to document conditions in the AN plant for three days preceding the explosion. DCS data indicated that from 0903 hours on December 10 through 2050 hours on December 11, the neutralizer nitric acid control valve (FCV-401) was 100% open (*Figure 7-5*). Outside operator grab sample analyses for these periods indicate a rundown pH in the 7.0 range, heavily on the free ammonia side of the AN pH curve (*Figure 7-6*). Urea offgas flow during this period ranged from 70-85%. It appeared to the investigation team that when the urea plants were operating efficiently, the supply of nitric acid to the AN plant was limited and would not maintain the specified pH range of 5.5-6.5.

Interviews with Terra employees indicated that acid supply to the AN plant had been a periodic problem for a few years prior to the installation of the scrubber [ID-14, ID-23]. Terra increased the nitric acid pump capacity to overcome the problem, but periodic shortages still occurred in the AN plant, apparently due to losses in the piping resulting from a combination of pipe diameter and length. The investigation team determined that when the AN scrubber was installed, the nitric acid supply for the scrubber was taken from the same nitric acid line that supplied the neutralizer without increasing the capability to supply nitric acid to the AN plant.

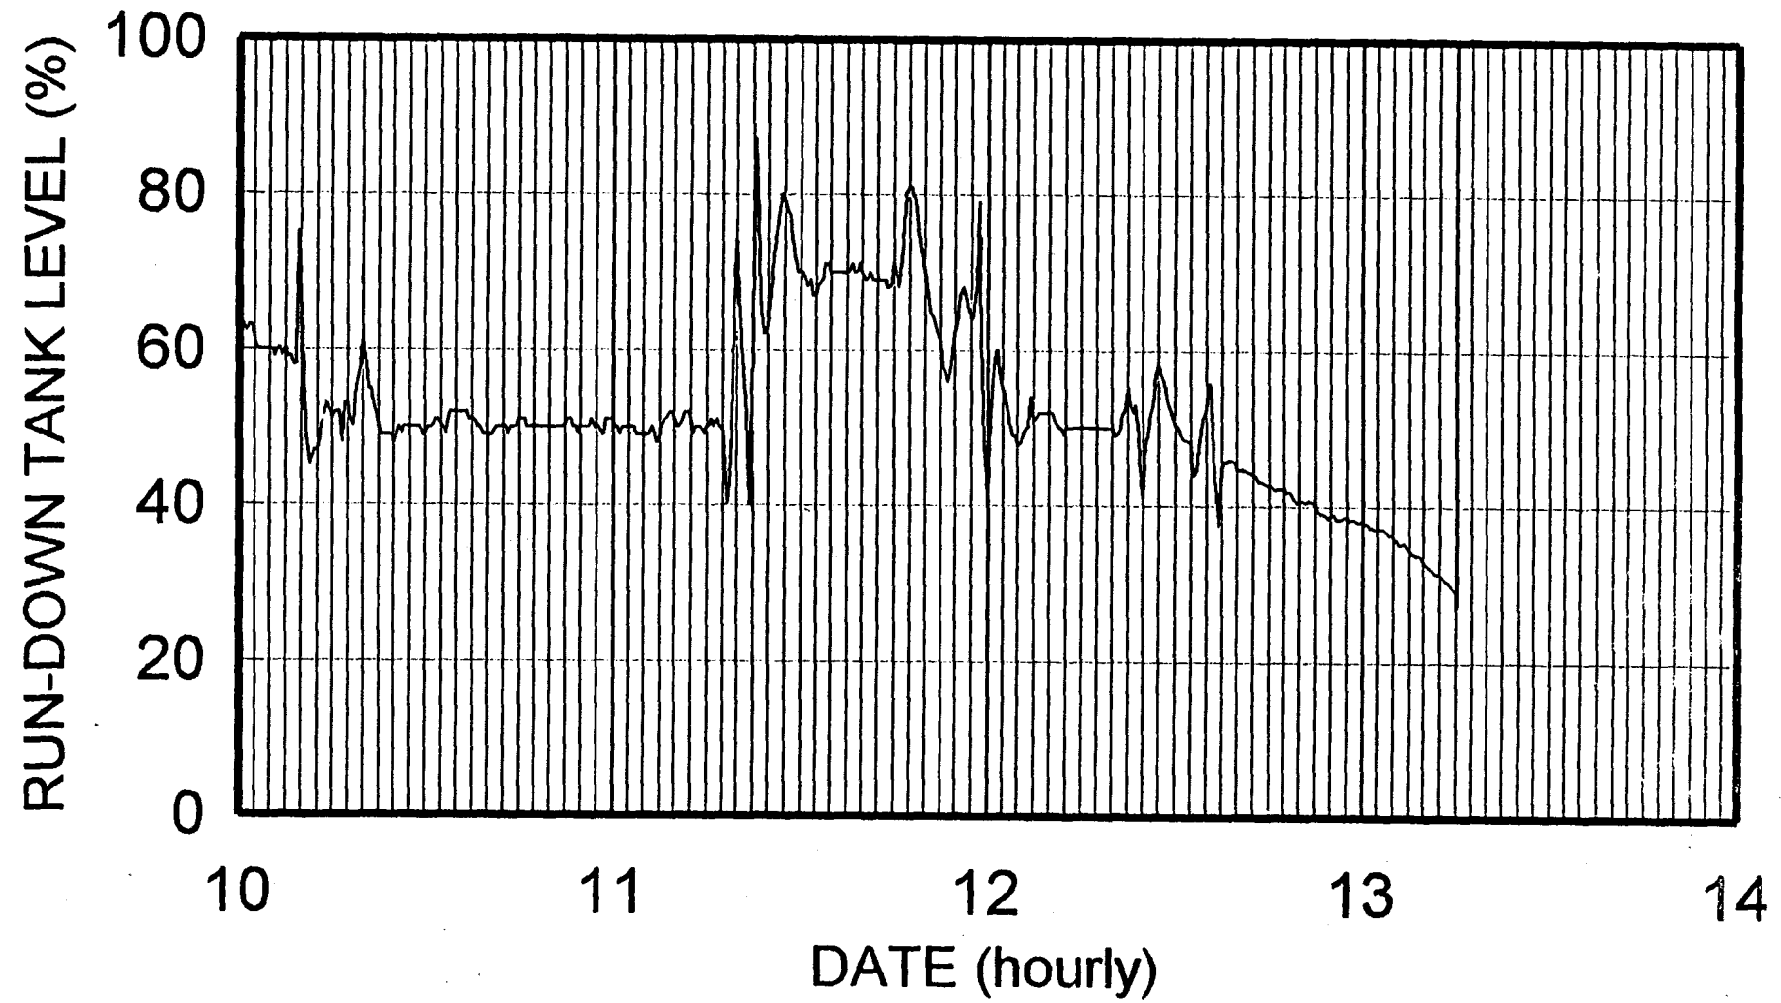
FIGURE 8-1

2. The indicated level in the rundown tank (DCS data) steadily declined at a rate of approximately 50 gallons per hour from the time that the AN plant was shut down until the explosion. The rate of decline of the DCS indicated rundown tank level remained constant over this time period. (*Figure 8-1*)

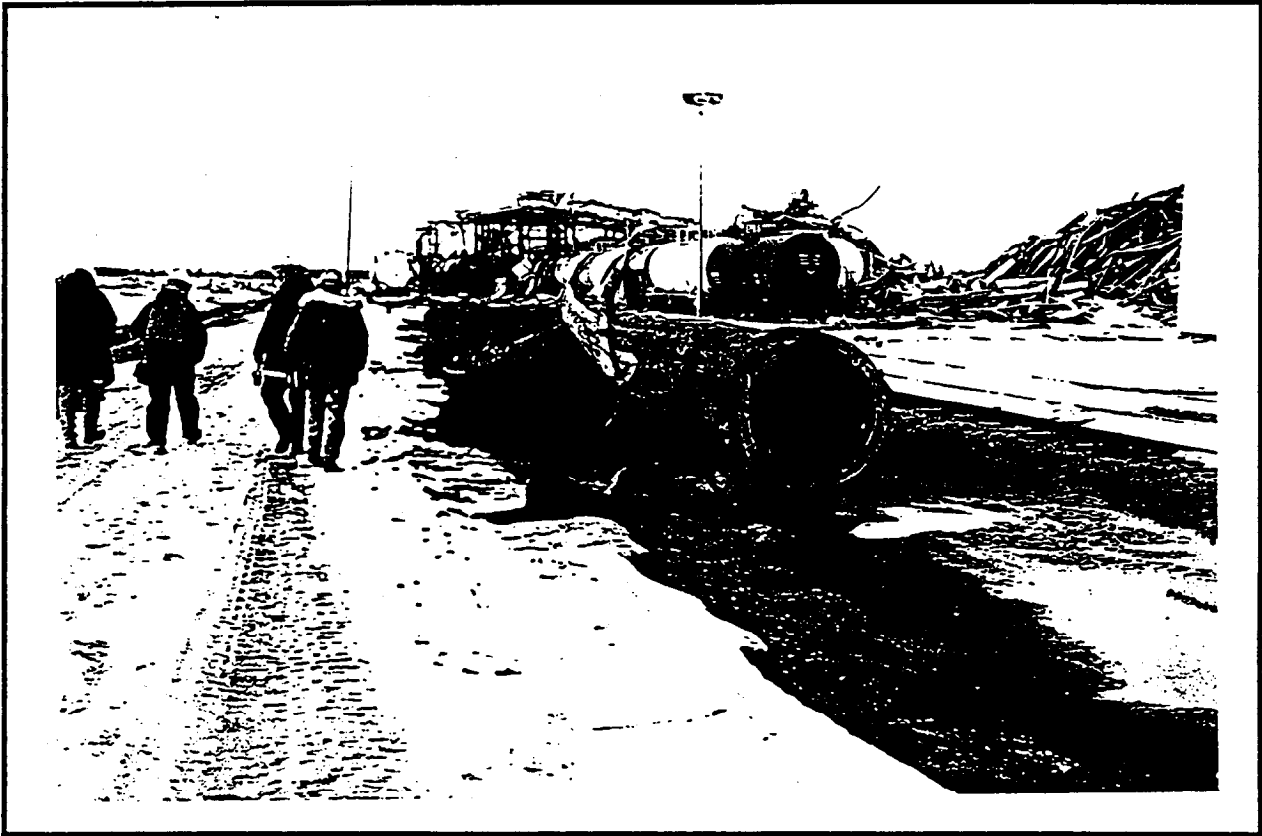
Photo 8 - 14  
Chemical Stripper Trajectory

1. Reverse trajectory sighting of damage to a nearby water tank (*Photo 8-12*) and the ends of two pressure ammonia vessels (*Photo 8-13*) indicated that the neutralizer was the source of the penetrating fragments.
2. Reverse trajectory sighting of reinforcing bar angles, anchor bolt directions, and prill tower footing bolts and pads converged on the original neutralizer site.
3. Reverse trajectory sighting of a chemical stripper originally located near the AN plant indicated the explosion origin to be along a line that intersected with the original neutralizer site (*Photo 8-14*).
4. Reverse trajectory sighting of scrubber sections and the ammonia vaporizer indicated the explosion origin to be along a line that intersected the original neutralizer site.

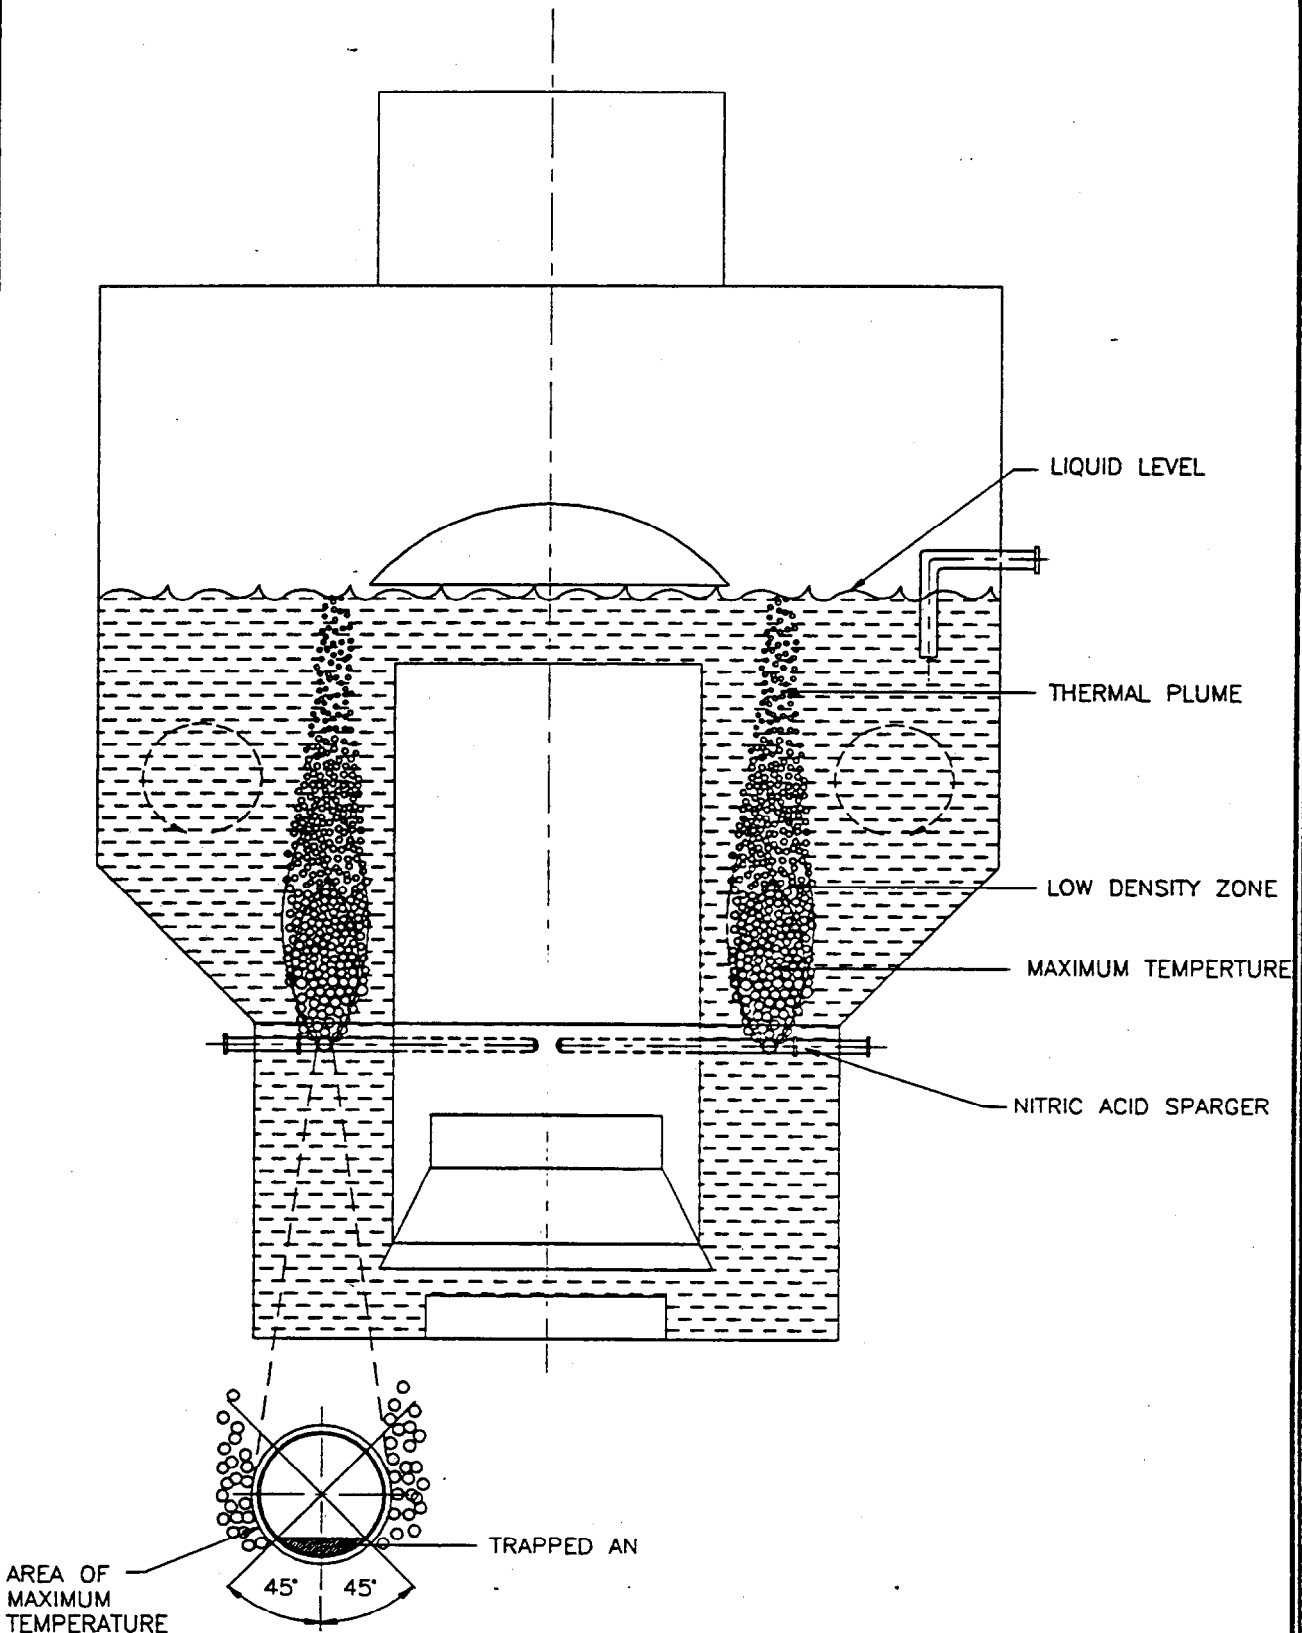
FIGURE 8 - 4  
THERMAL AND LOW DENSITY ZONES IN NEUTRALIZER

Calculations indicated that continued steam heating would have resulted in a high temperature (near the temperature of the steam) and a low-density zone to develop directly around or above the sparger. Sensitizing factors lowered the thermal decomposition activation energy of the AN. The combination of energy in the input steam and the addition of superheat (possibly due to high steam demands in the nitric acid plant) exceeded the activation energy of the AN, resulting in the onset of thermal decomposition. The initial dissociation reaction was endothermic, and would have been quickly overcome due to its close proximity to the heating source. As heat continued to be transferred into this zone, the reaction became exothermic and self-sustaining [ 13]. At this point, large volumes of gases would have been formed. The effect of the rapidly expanding gas would have been twofold:

1. Adiabatic compression of the bubbles in the AN solution resulted in a more rapidly expanding wave front (deflagration propagation) [ 1]; and
2. Overcoming the vent capacity of the neutralizer, rundown tank, and scrubber system that, in turn, resulted in additional confinement until the vessels failed [21].

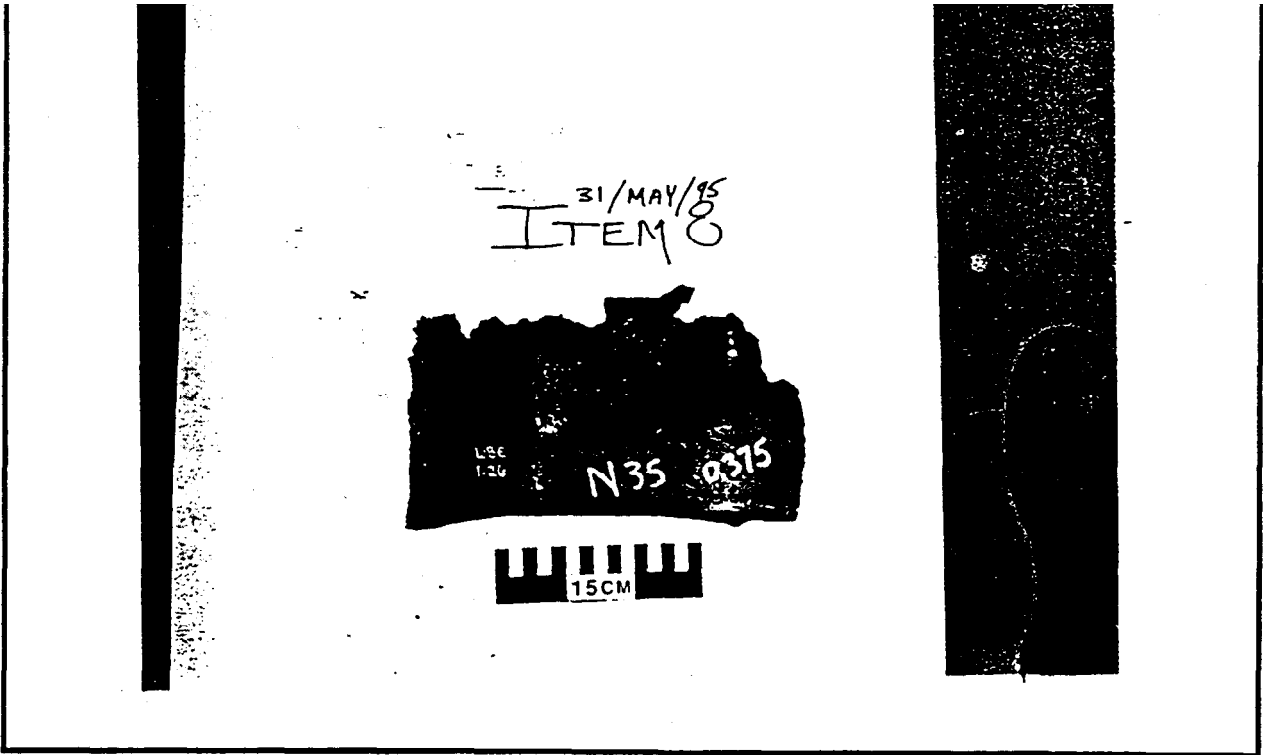
Photo 8-17  
EPA Item #8 (Neutralizer)

2. Pitting of some neutralizer fragments that were located near the spargers exhibits characteristics of cavitation, which implies that the process causing the deformation involved high velocity bubbles (*photo 8-17*).

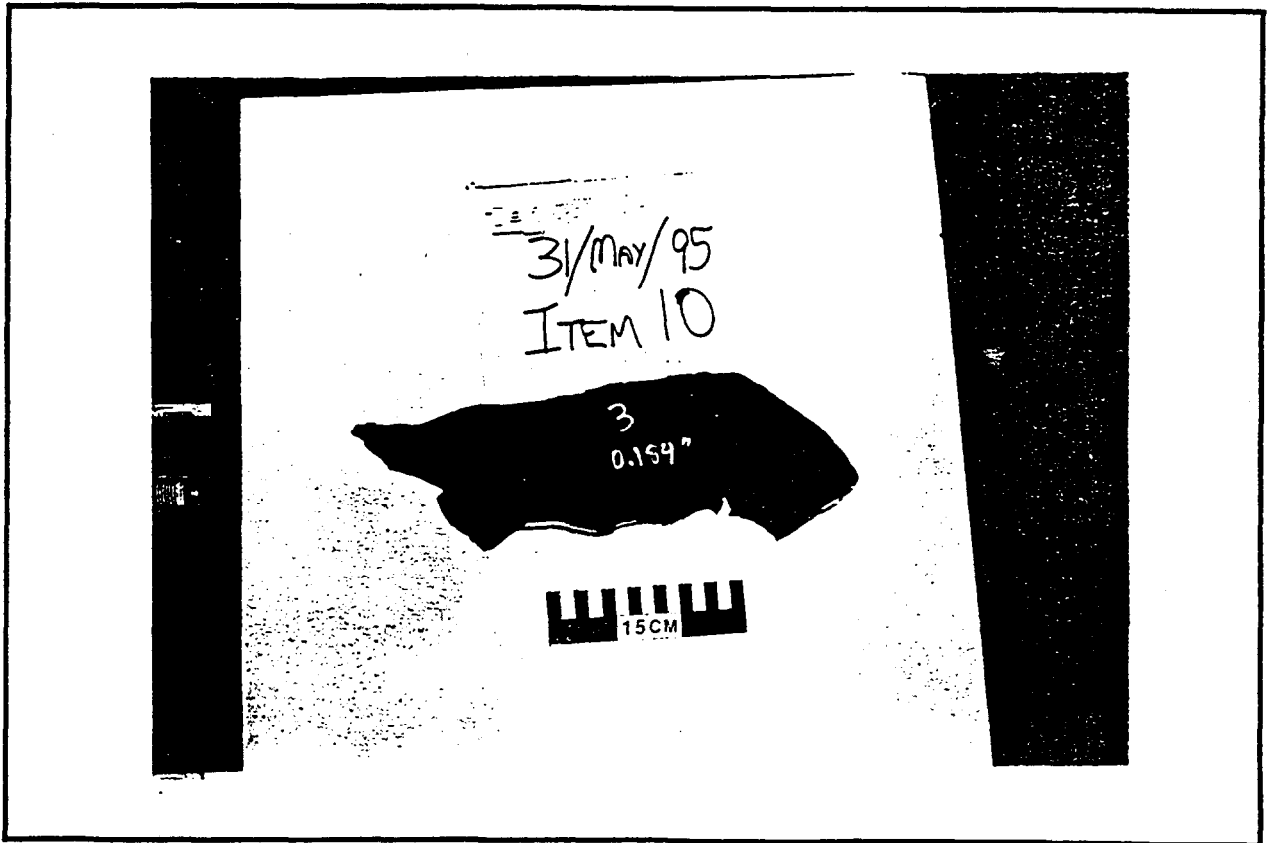
Photo 8 - 18  
EPA Item #10 (Rundown Tank)

The investigation team determined that the explosion in the rundown tank most likely occurred as a result of impacts of high-energy metal fragments originating from the exploding neutralizer.

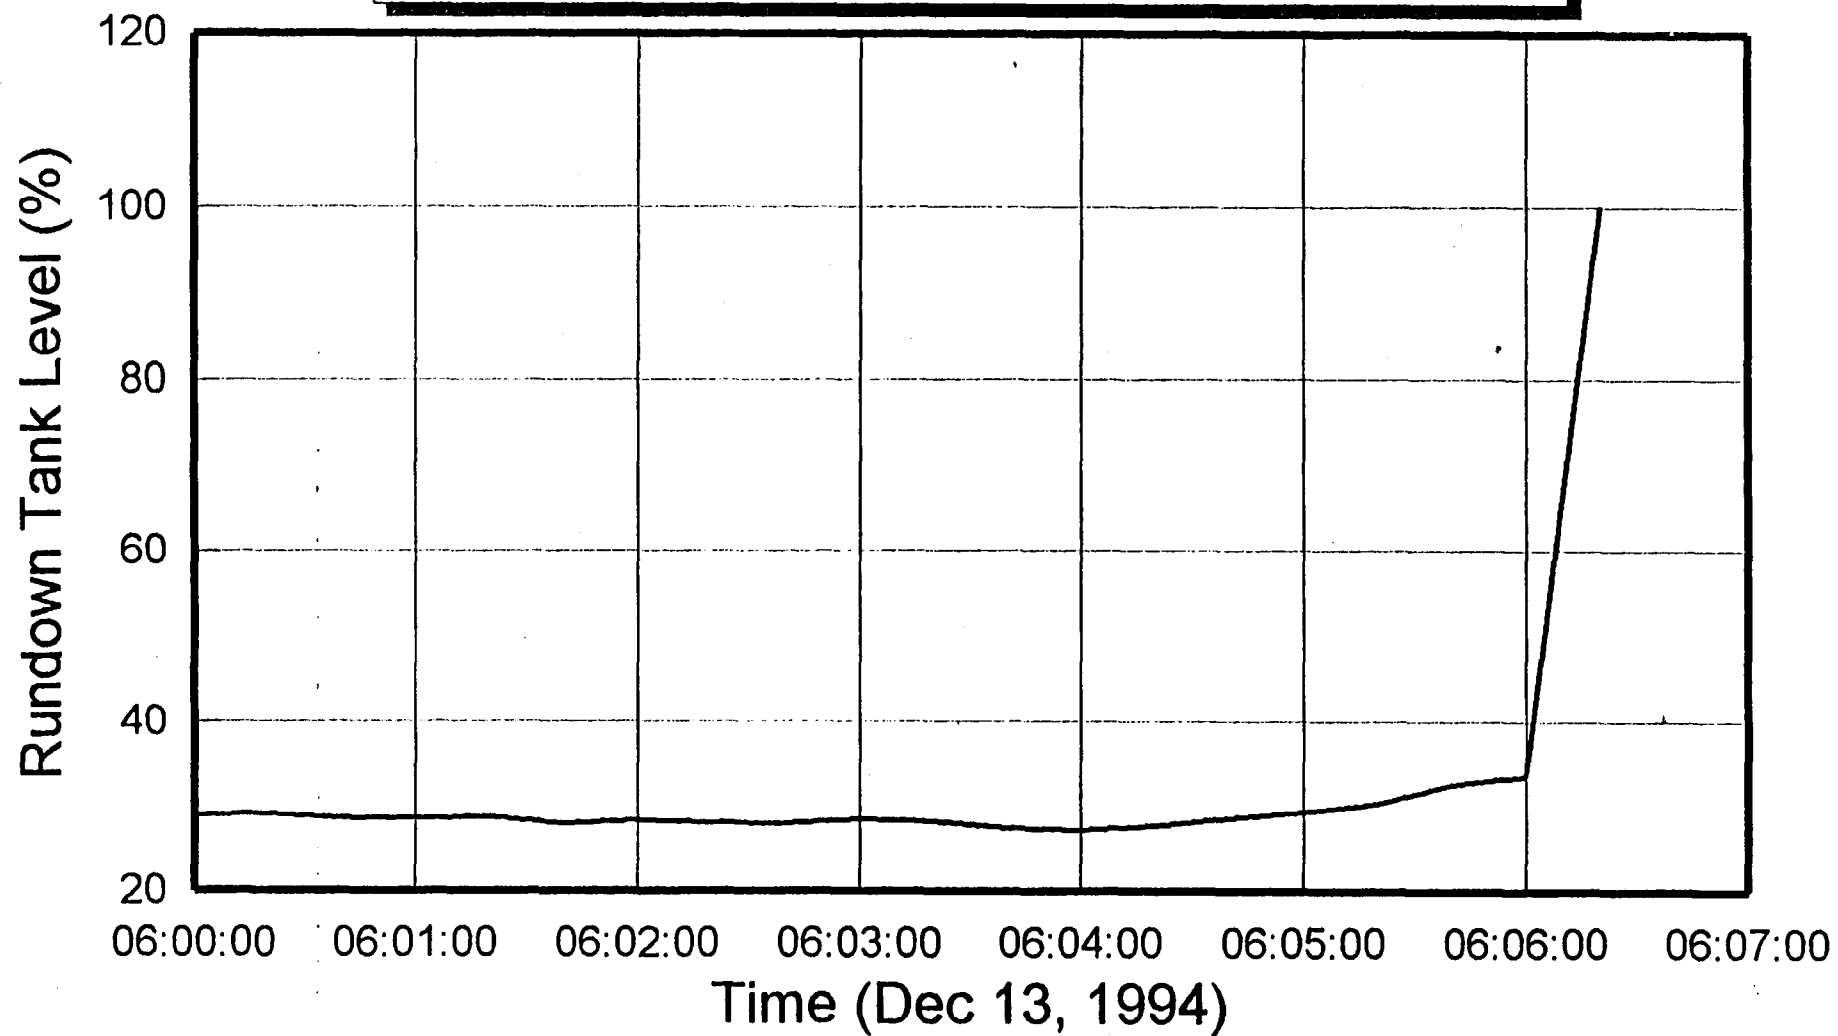
FIGURE 8-5

3. The rundown tank was equipped with steam coils that were attached to a steam header, but steam was not applied because of problems with the coils.
4. The pH of the rundown tank solution was determined to be approximately 1.0 and analytical data indicated the presence of chlorides.
5. Approximately 2 minutes before the explosion (DCS time), the level indication showed an exponential increase to an indicated level of 100% at the approximate time of the explosion (*Figure 8-5*).

1. A process pump was operating. The investigation team determined that both process pumps had been shut down and blocked in and steam had been applied to the AN product lines from the process pumps to storage.
2. The rundown tank was leaking. The investigation team was unable to totally disprove this possibility, but ambient temperatures would contraindicate that ammonium nitrate would continue to release from the rundown tank at the low rate indicated without crystallizing.
3. Impact of cold weather on the rundown tank level sensors and associated piping. The investigation team determined that work orders had been issued requesting that these sensors be insulated, but they had not been insulated prior to the explosion. The investigation team determined that this was the most likely cause of the declining level.
