United States  
Environmental Protection  
Agency

# CHEMICAL ACCIDENT INVESTIGATION REPORT

## TERRA INDUSTRIES, INC. NITROGEN FERTILIZER FACILITY PORT NEAL, IOWA

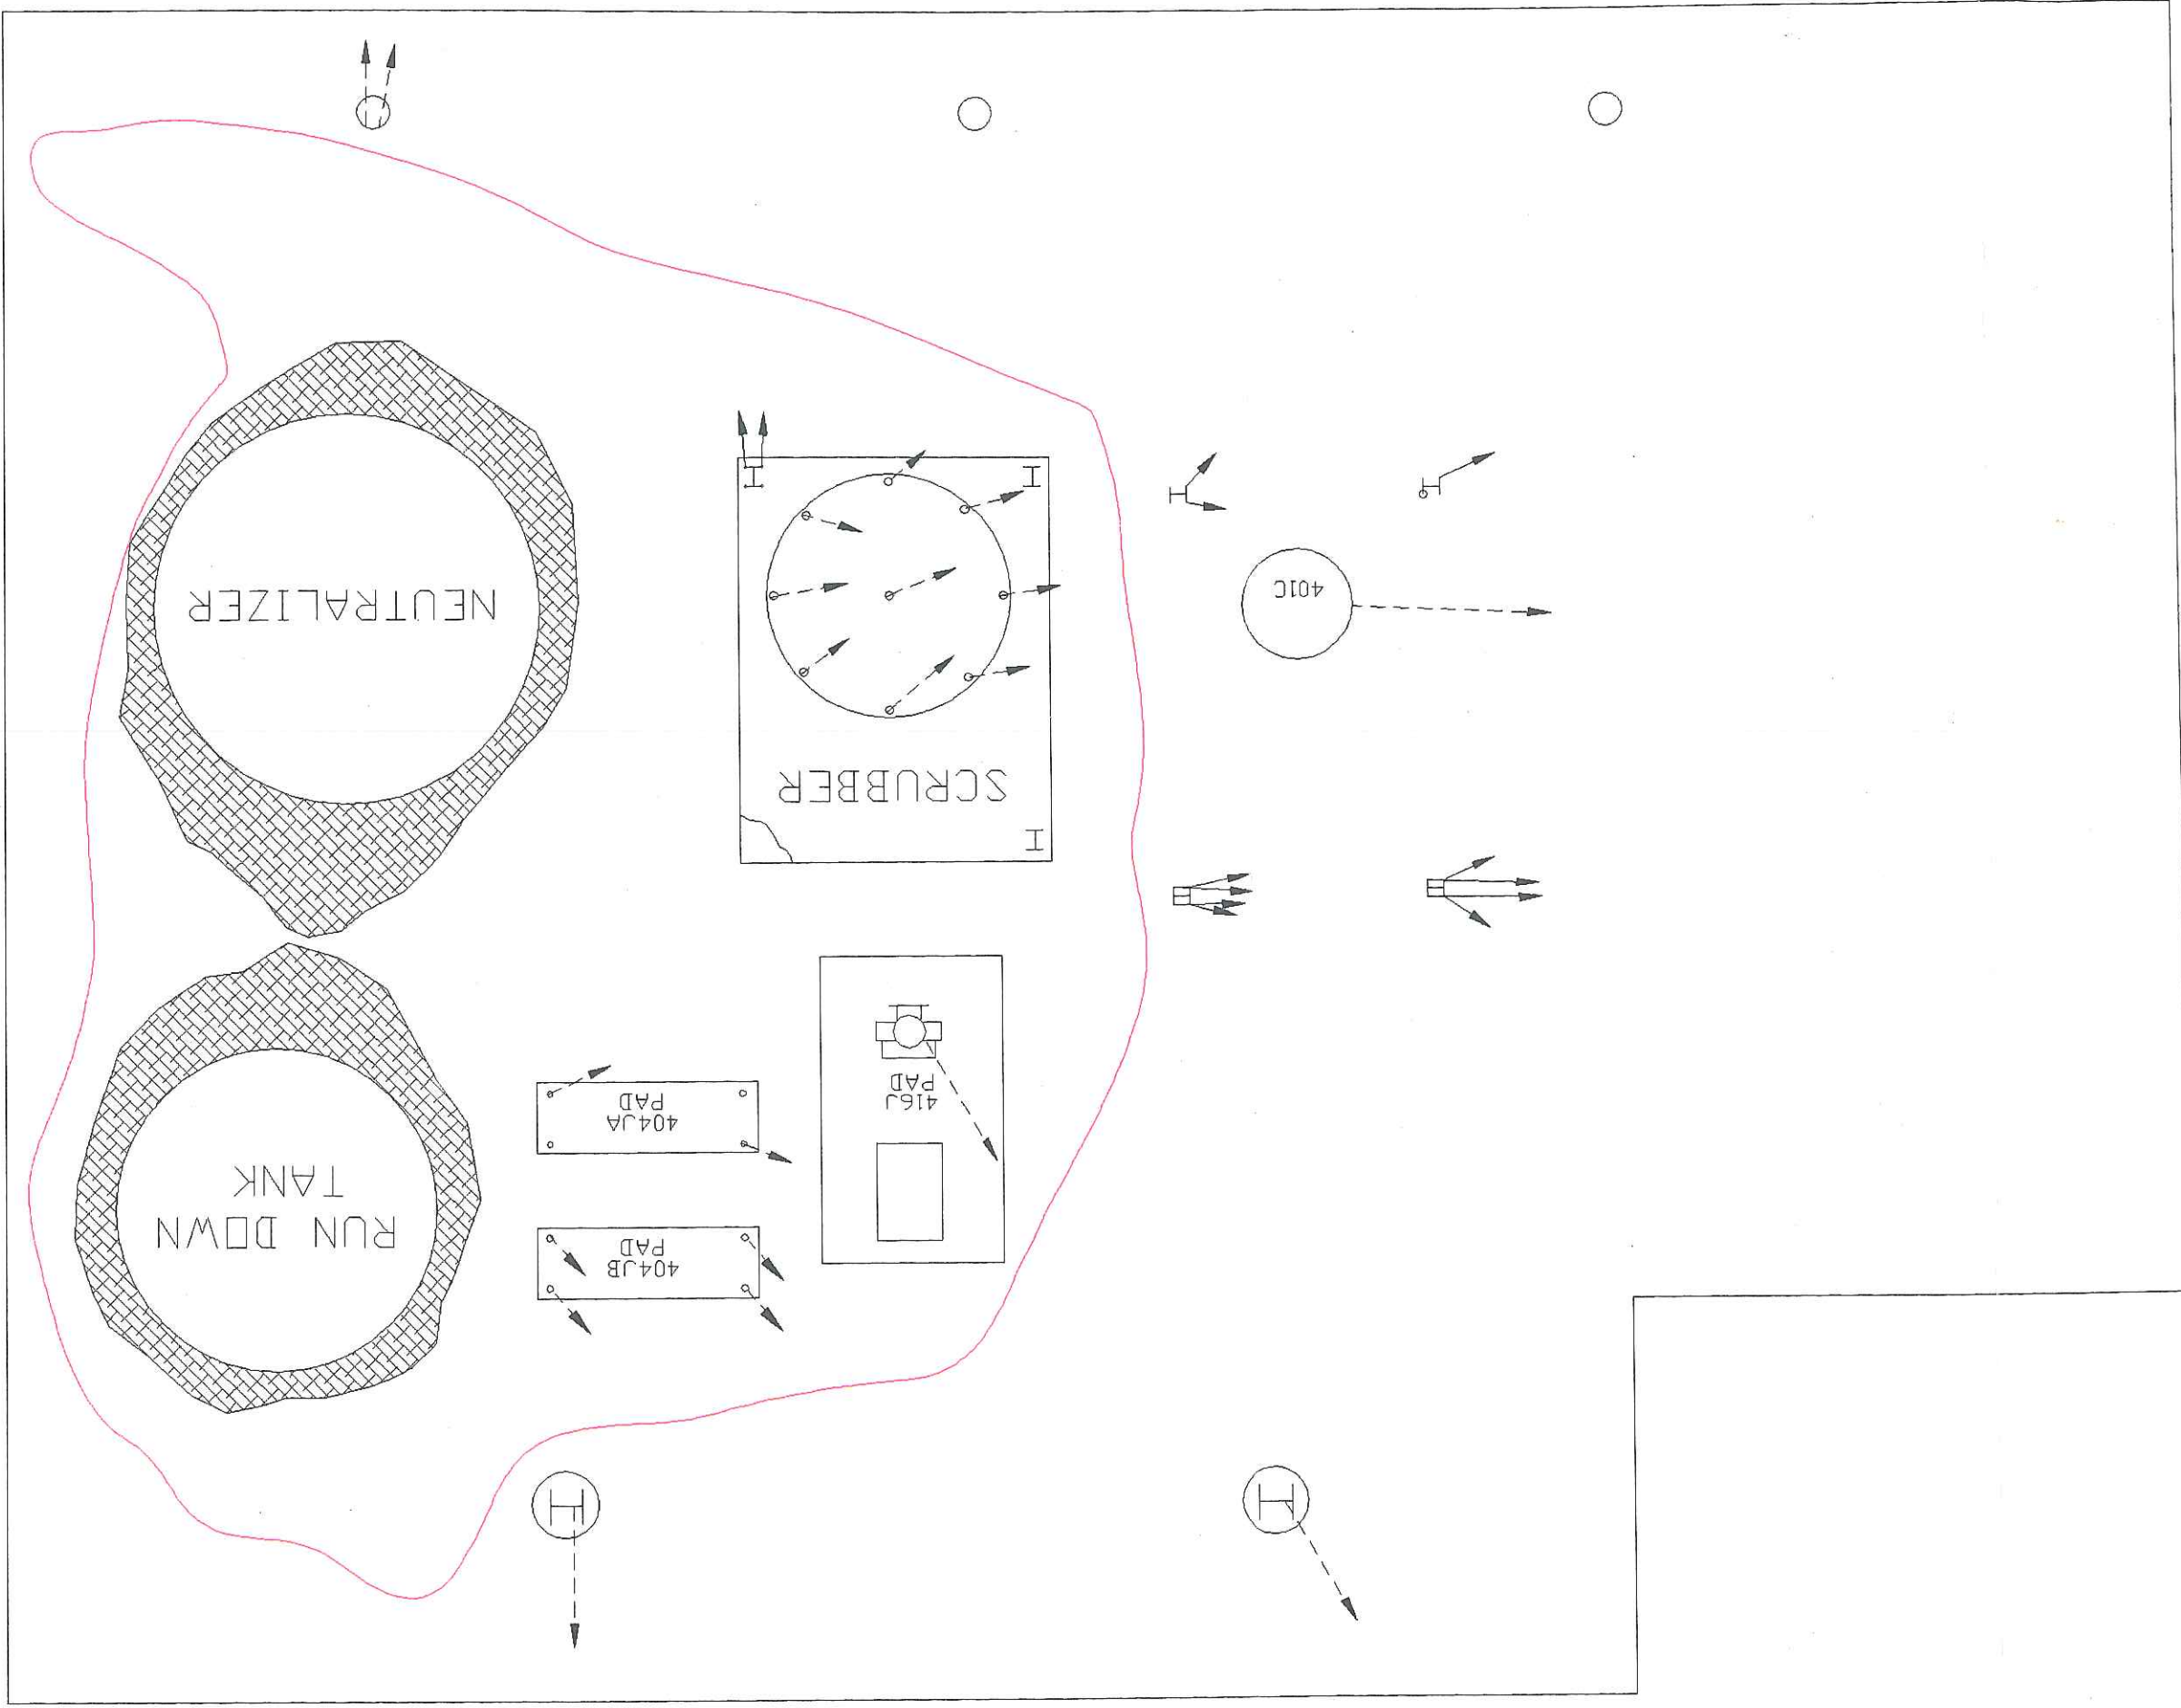
FIGURE 3 - 1  
STRUCTURAL DEFORMATION DIRECTION DIAGRAM

Initial site investigation included sketching and photographing the Terra facility to determine the location of the explosion(s) and photographing explosion debris and damage to facilities off site. Initial observations included sketching collateral damage patterns to determine the location of the explosion(s). The investigation team concluded that more than one explosion occurred in the area identified by Terra personnel as the AN plant. Craters in this area were located in the AN plant at

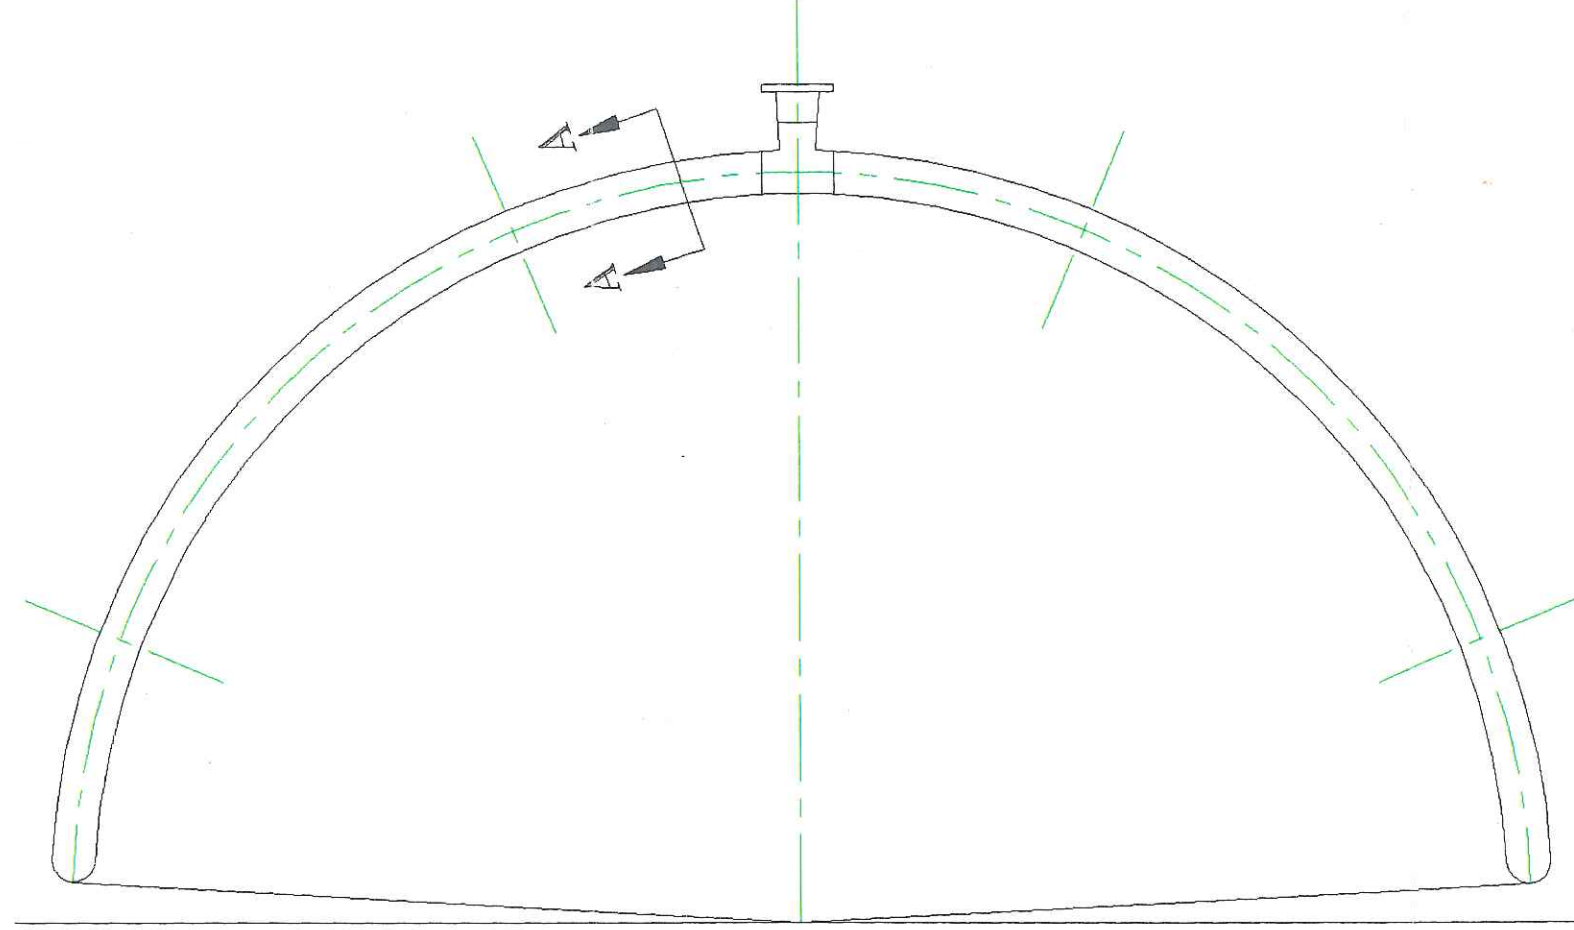
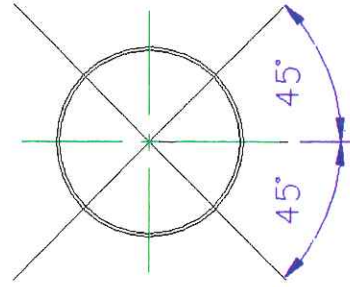
NITRIC ACID SPARGER DETAIL

The neutralizer and the nitric acid spargers were inspected during the September, 1994 facility turnaround. Interviews and depositions of Terra employees vary in reference to the description of the neutralizer and spargers, but all agree that the neutralizer and the nitric acid spargers visibly appeared to be in good condition when inspected during turnaround.

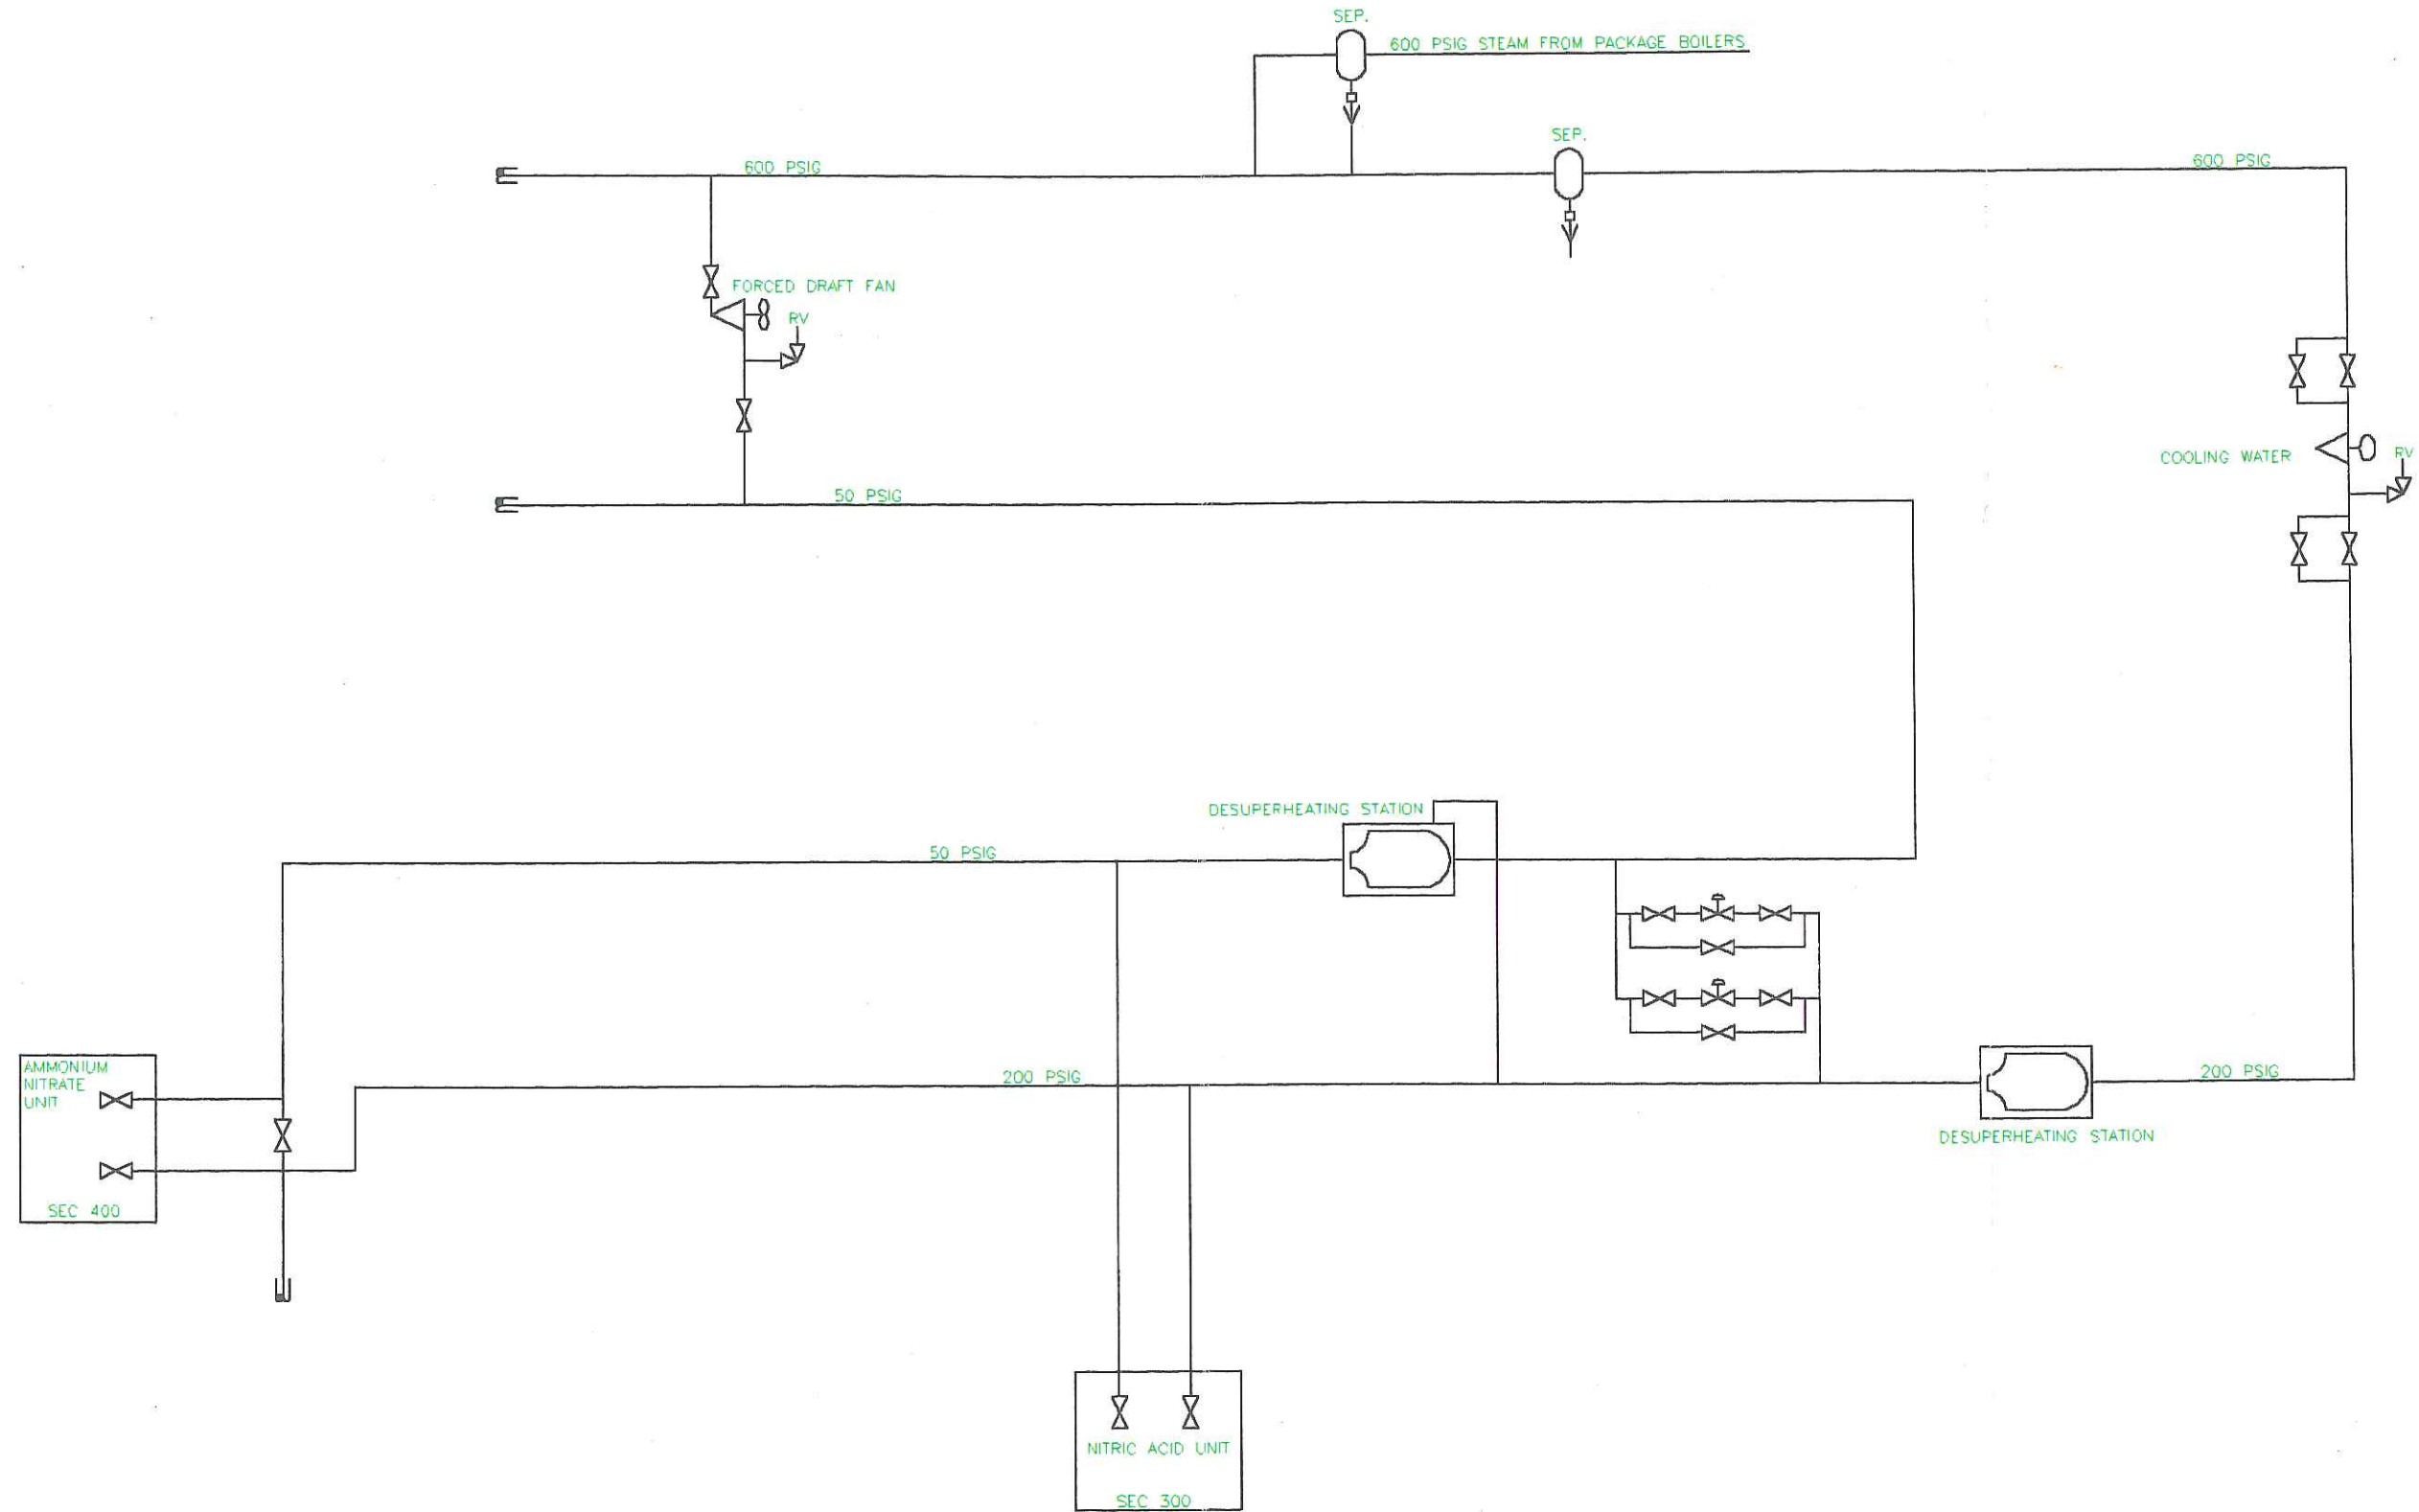
FIGURE 7 - 4  
STEAM DISTRIBUTION SYSTEM (PARTIAL)

The investigation team concluded that the steam distribution system had the potential to supply superheat during high demand events such as the slow roll of the nitric acid compressor.

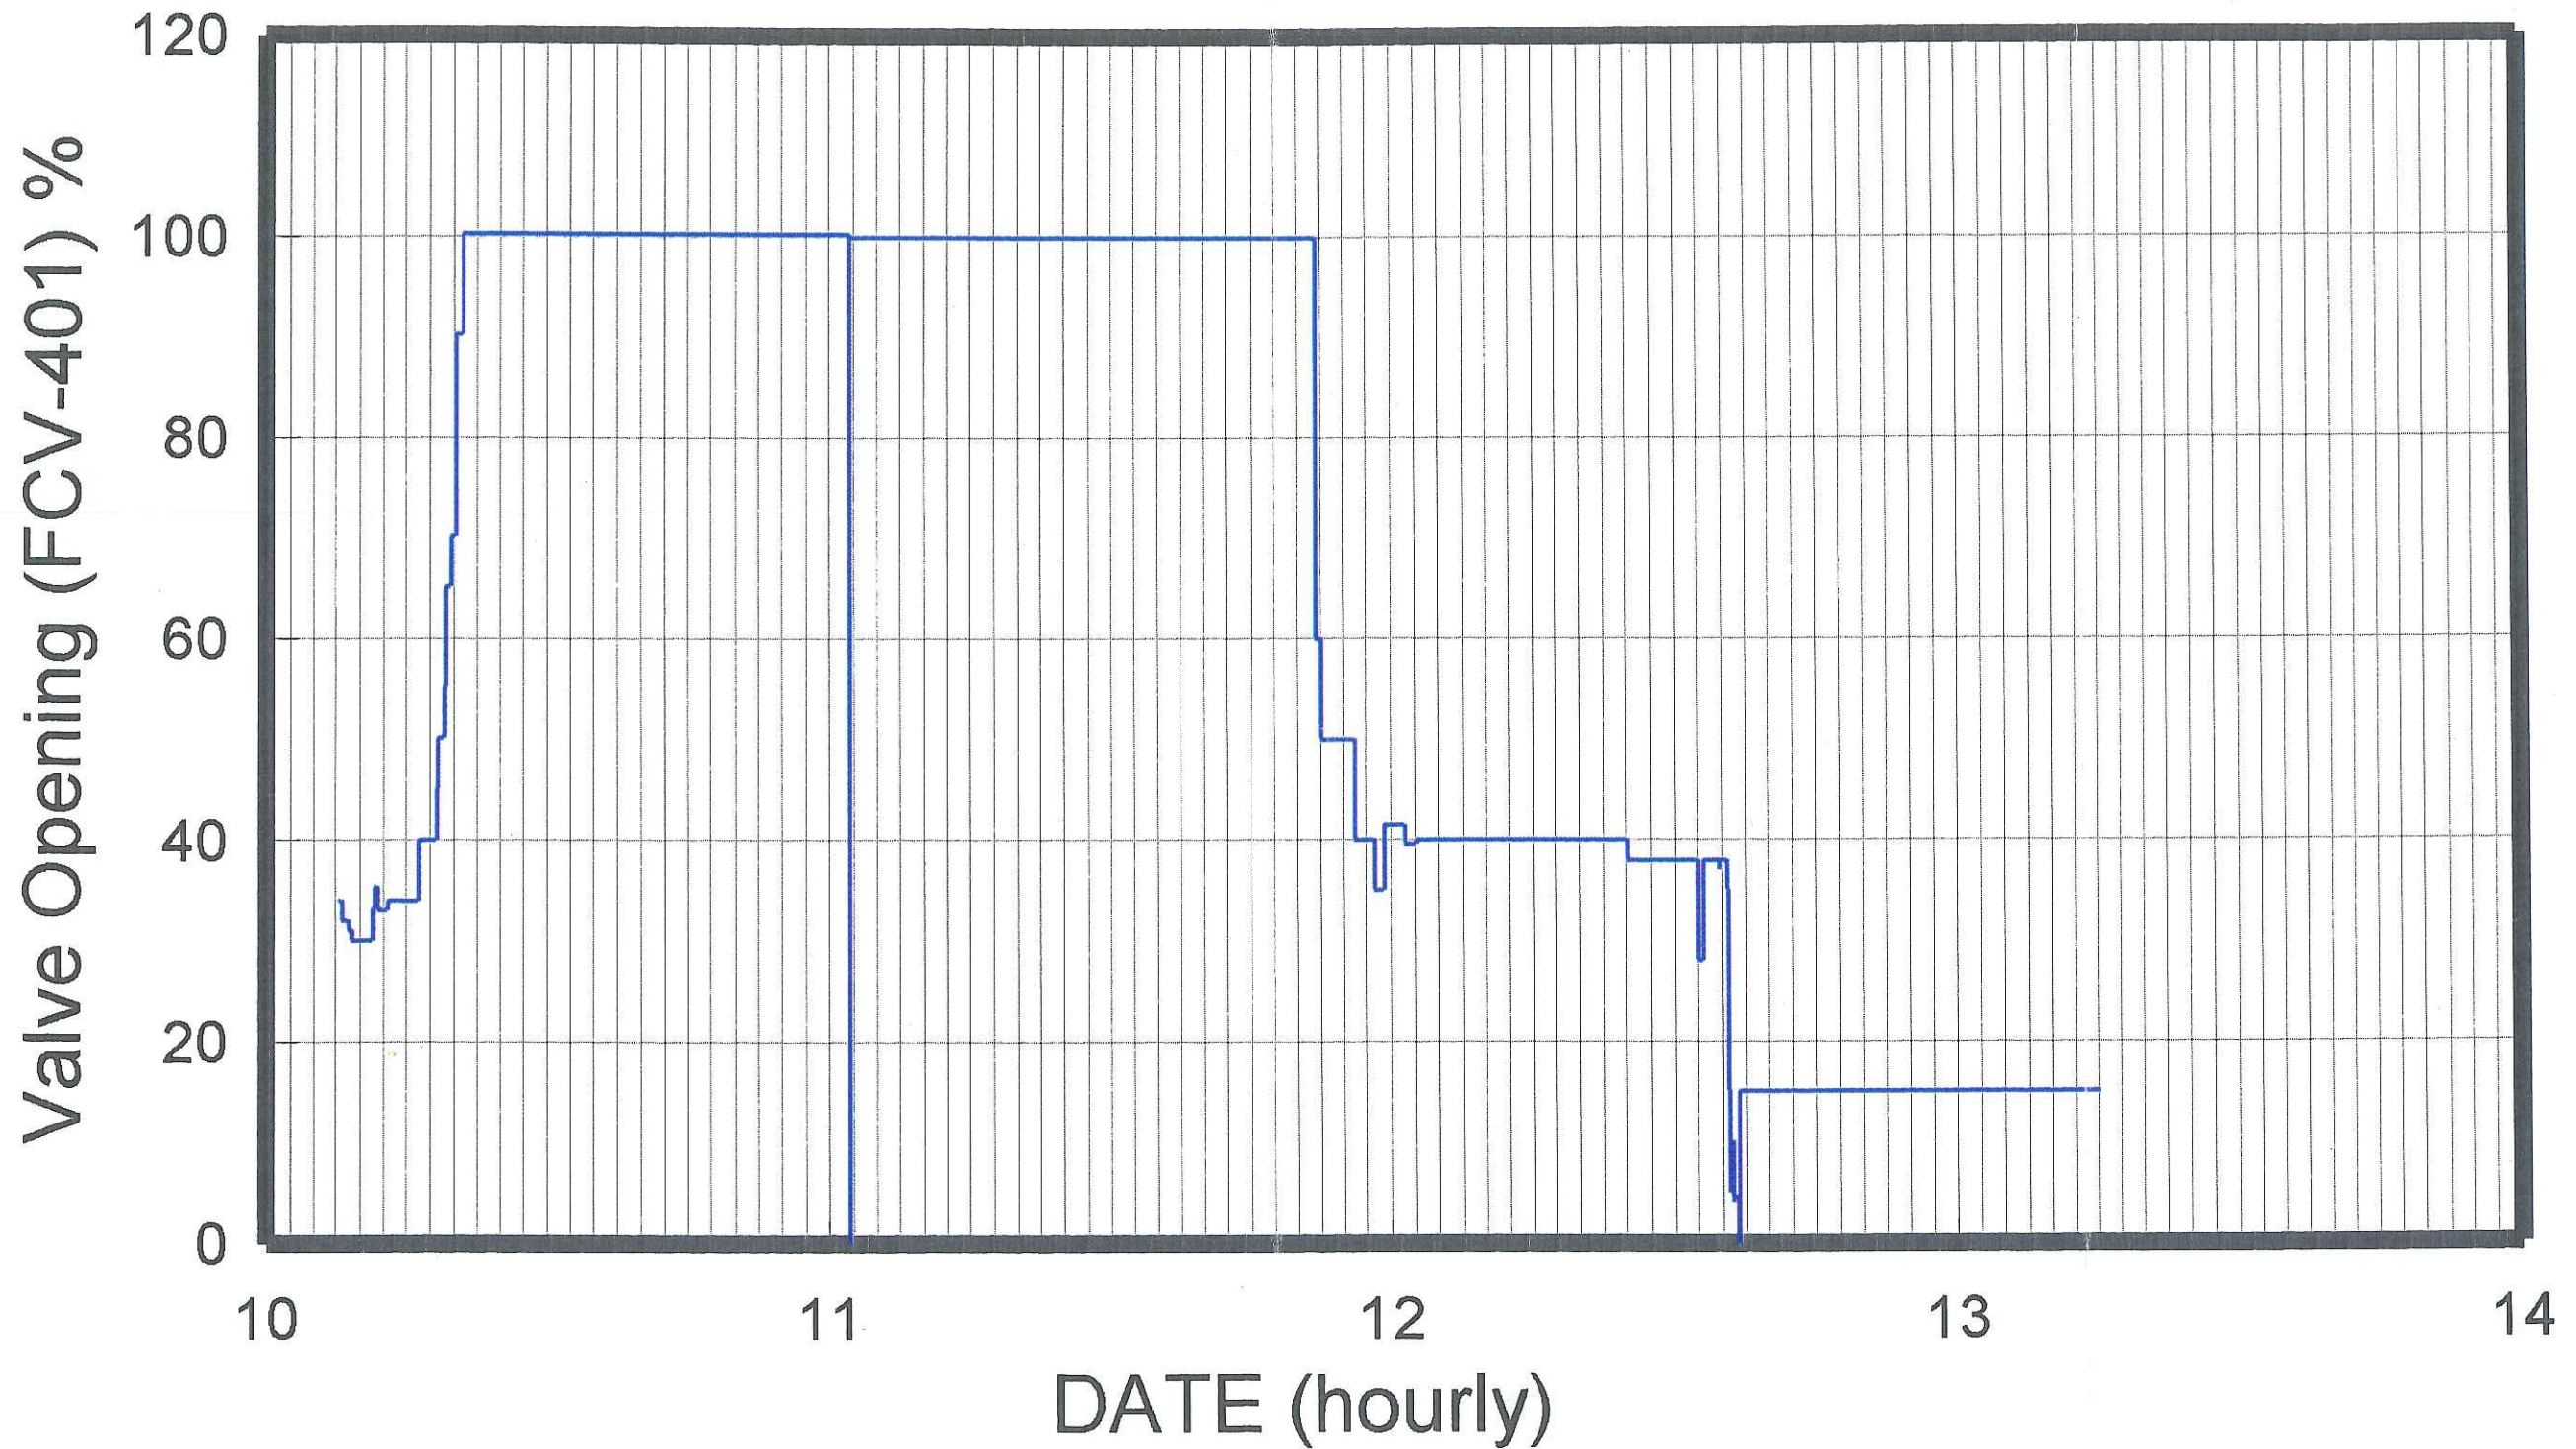
FIGURE 7 - 5

Interviews with Terra employees indicated that acid supply to the AN plant had been a periodic problem for a few years prior to the installation of the scrubber [ID-14, ID-23]. Terra increased the nitric acid pump capacity to overcome the problem, but periodic shortages still occurred in the AN plant, apparently due to losses in the piping resulting from a combination of pipe diameter and length. The investigation team determined that when the AN scrubber was installed, the nitric acid supply for the scrubber was taken from the same nitric acid line that supplied the neutralizer without increasing the capability to supply nitric acid to the AN plant.

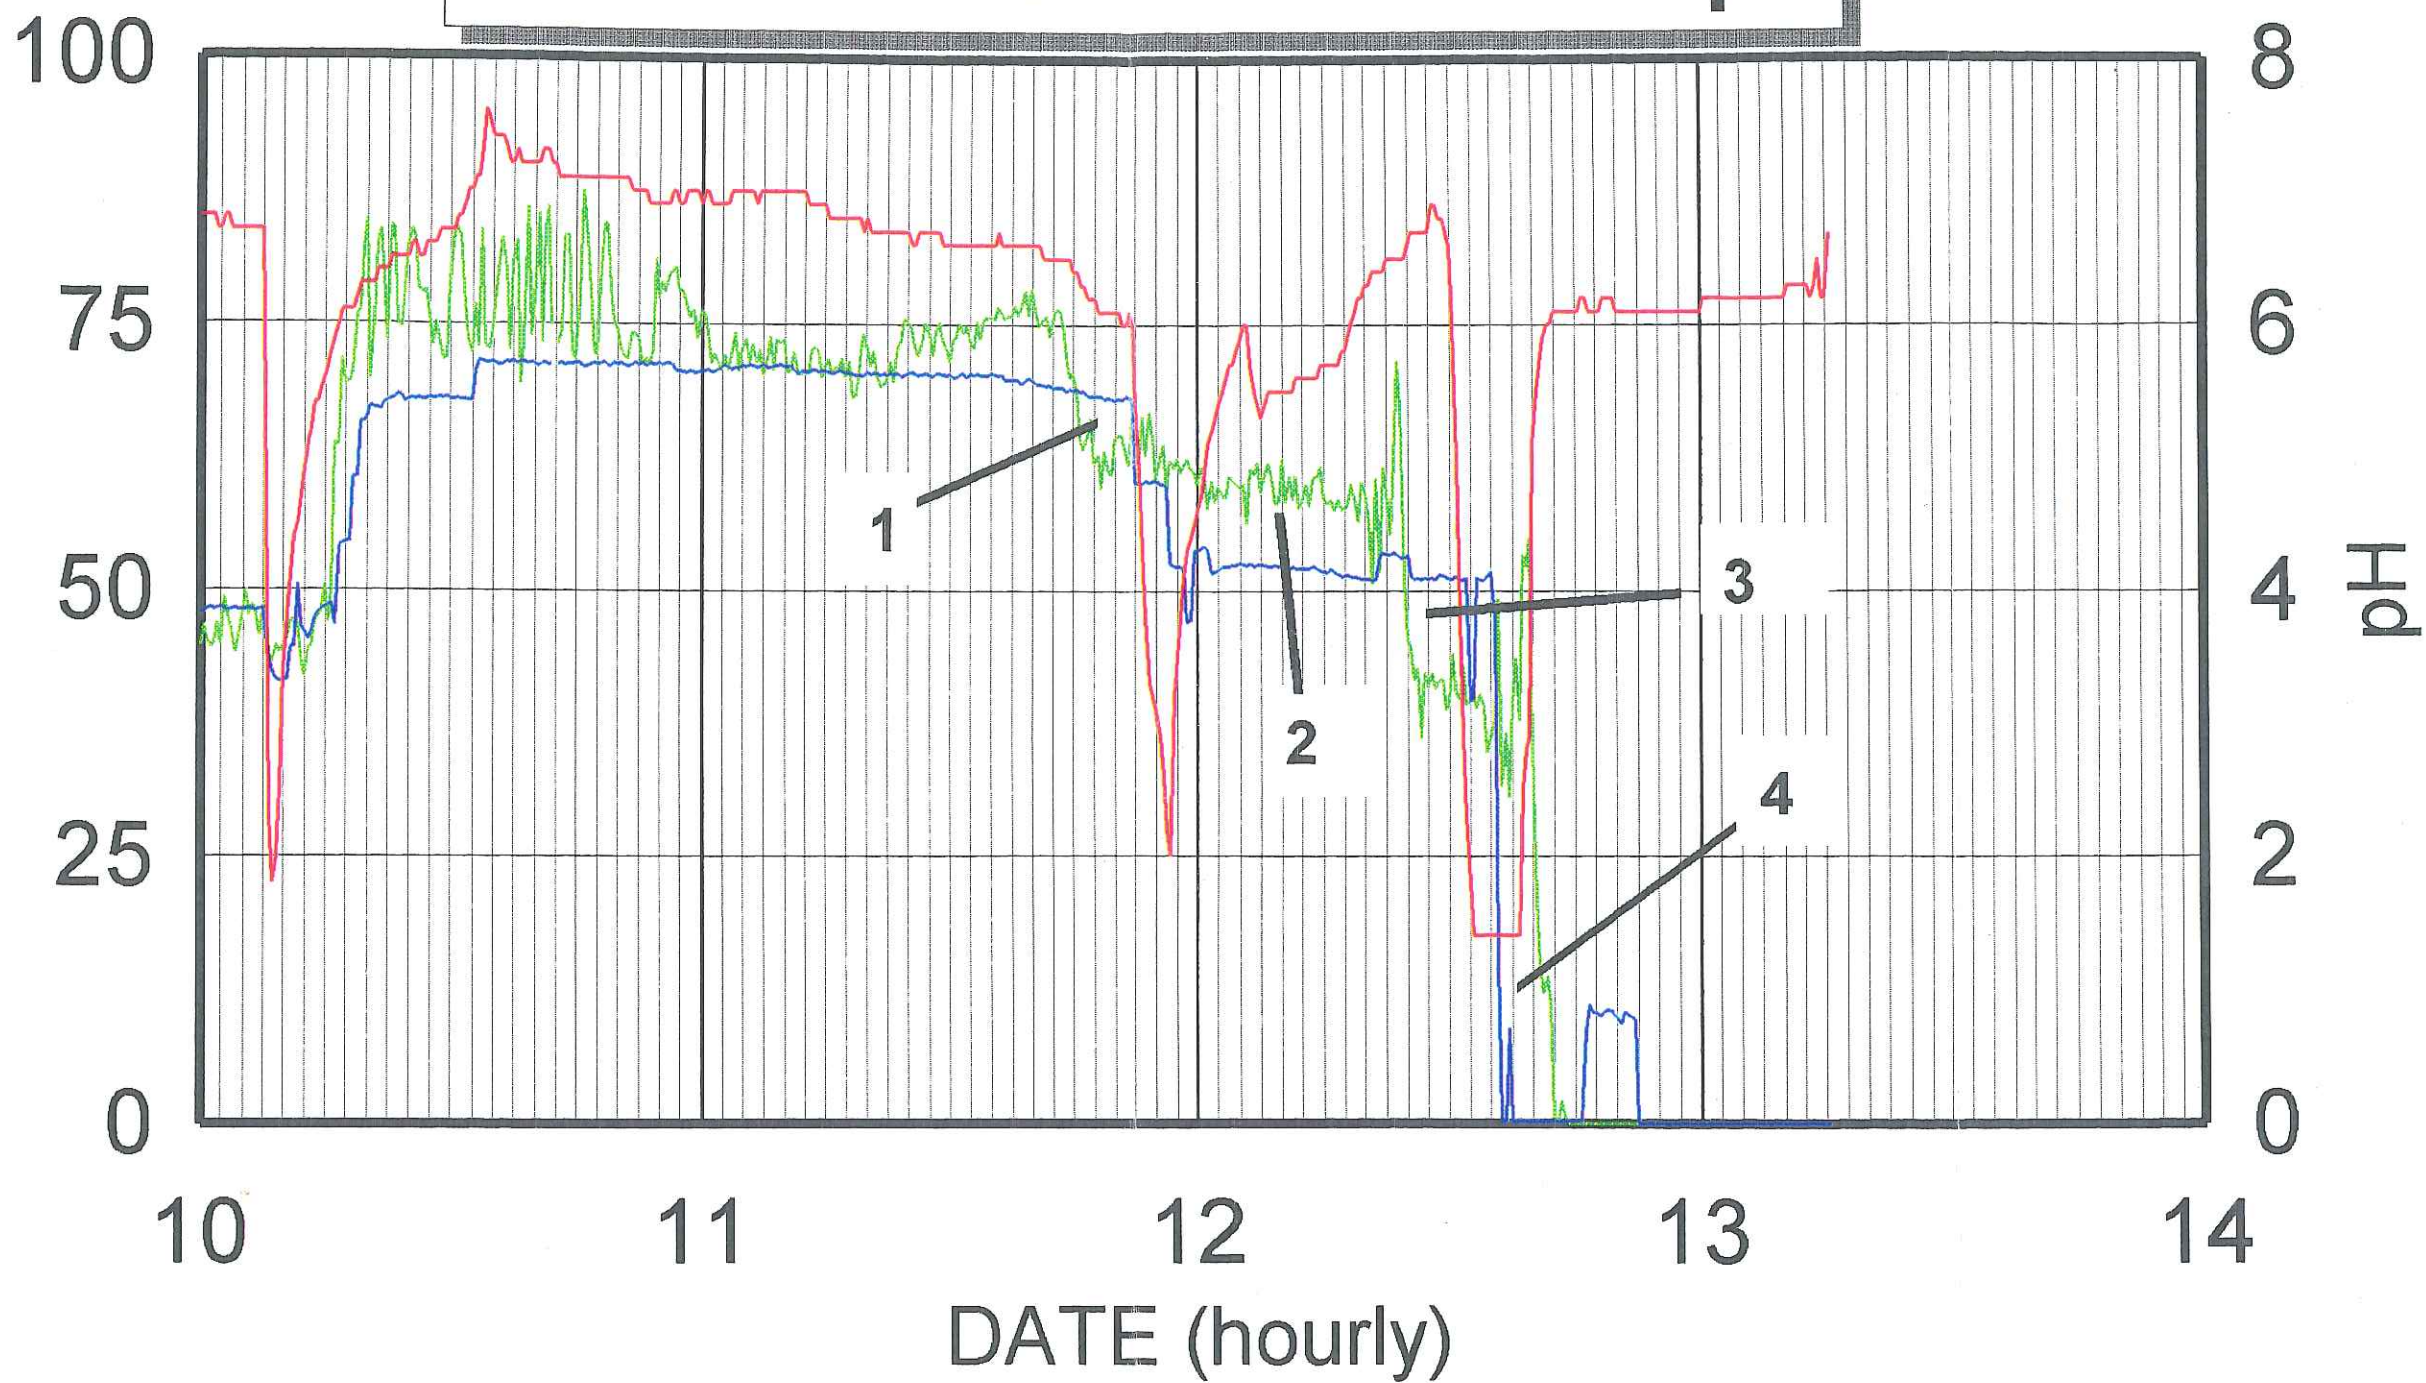
FIGURE 7 - 7

When operated in the automatic mode, the AN DCS monitors urea offgas flows and the ratio controller adjusts the nitric acid flow rate to follow the offgas fluctuations. This feed-forward control loop anticipates pH changes and adjusts nitric acid flow accordingly. In cascade mode, the pH control loop, a feed-back loop, monitors the pH of the neutralizer output and fine tunes the nitric acid valve to maintain the selected pH (set point). However, the DCS was operating in the manual mode for the duration of the graphed data, with one short attempt to put the DCS in cascade mode that occurred at 0431 hours on December 10. The DCS data indicates that nitric acid control adjustments significantly lagged behind urea offgas fluctuations (reductions) on December 10, December 11, and during shutdown on December 12 (*Figure 7-7*). The DCS was in manual mode, and operator adjustments of the acid valve position lagged changes in the offgas flow rate. This caused an acid condition in the neutralizer each time. The ratio controller monitored the offgas changes, but was not engaged in either the automatic or cascade mode.

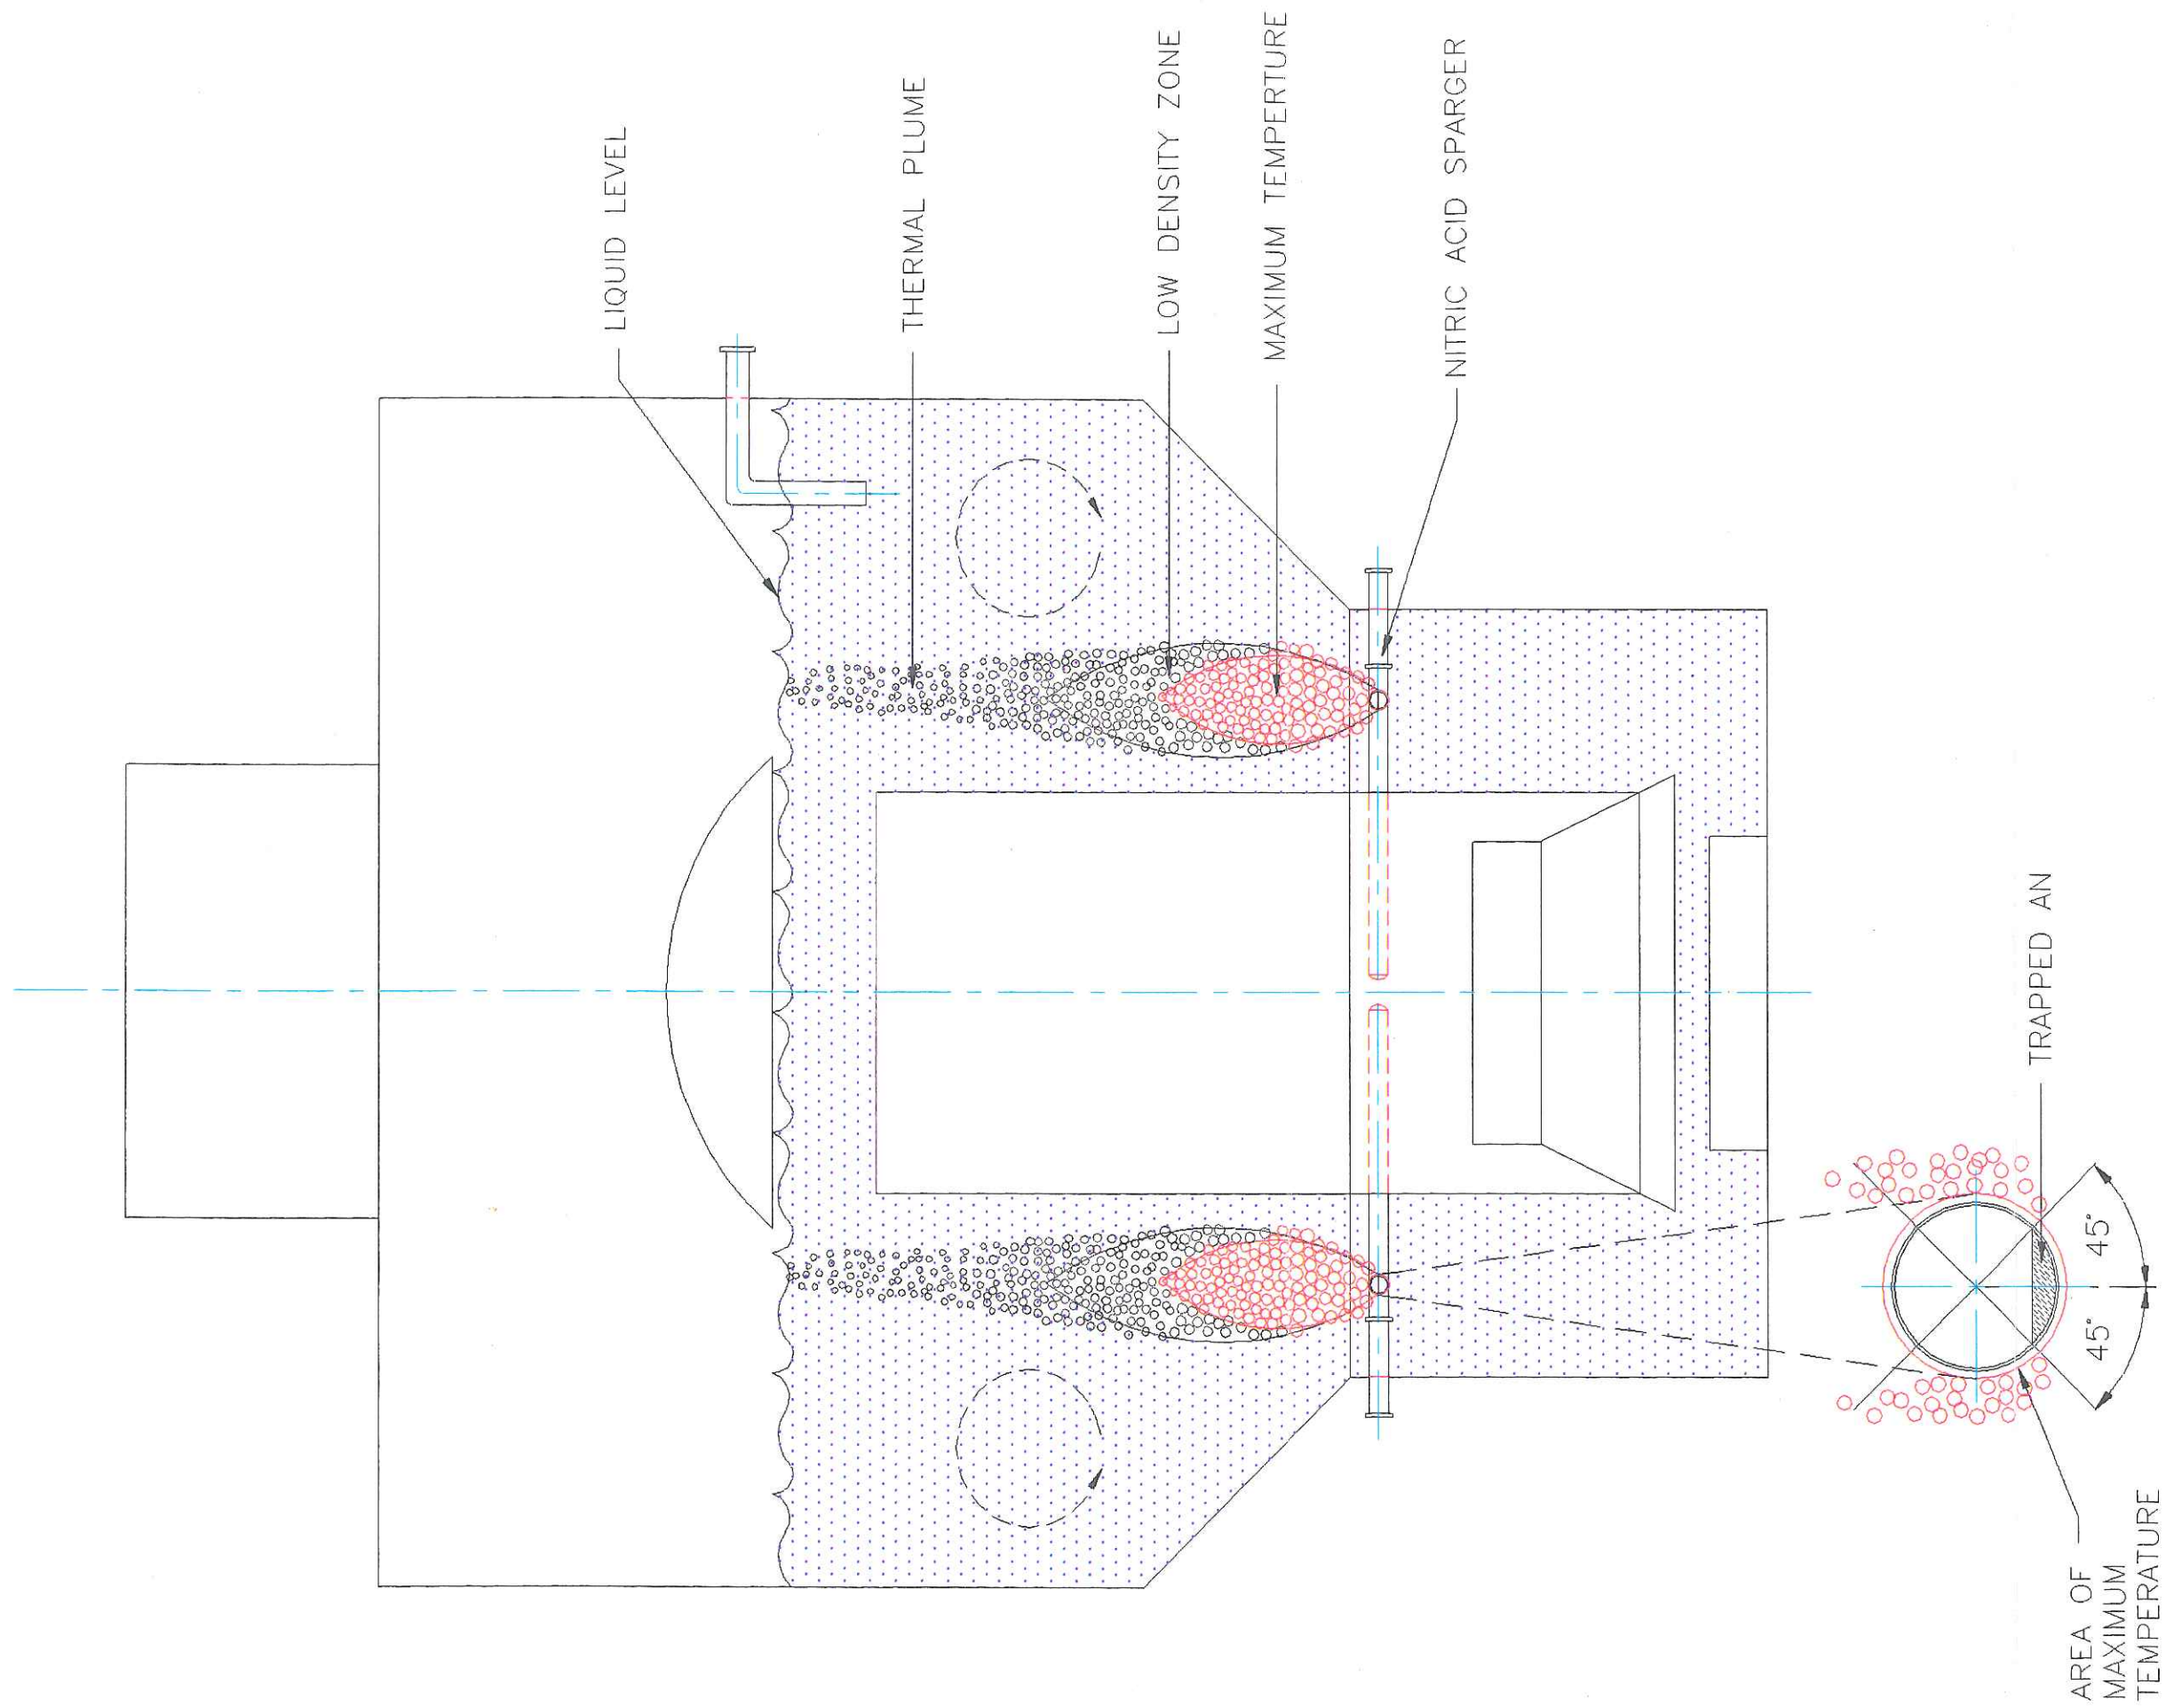
CUT CROSS SECTION OF NEUTRALIZER

Calculations indicated that continued steam heating would have resulted in a high temperature (near the temperature of the steam) and a low-density zone to develop directly around or above the sparger. Sensitizing factors lowered the thermal decomposition activation energy of the AN. The combination of energy in the input steam and the addition of superheat (possibly due to high steam demands in the nitric acid plant) exceeded the activation energy of the AN, resulting in the onset of thermal decomposition. The initial dissociation reaction was endothermic, and would have been quickly overcome due to its close proximity to the heating source. As heat continued to be transferred into this zone, the reaction became exothermic and self-sustaining [13]. At this point, large volumes of gases would have been formed. The effect of the rapidly expanding gas would have been twofold:

1. Adiabatic compression of the bubbles in the AN solution resulted in a more rapidly expanding wave front (deflagration propagation) [1]; and
2. Overcoming the vent capacity of the neutralizer, rundown tank, and scrubber system that, in turn, resulted in additional confinement until the vessels failed [21].
