United States  
Environmental Protection  
Agency

# CHEMICAL ACCIDENT INVESTIGATION REPORT

## TERRA INDUSTRIES, INC. NITROGEN FERTILIZER FACILITY PORT NEAL, IOWA

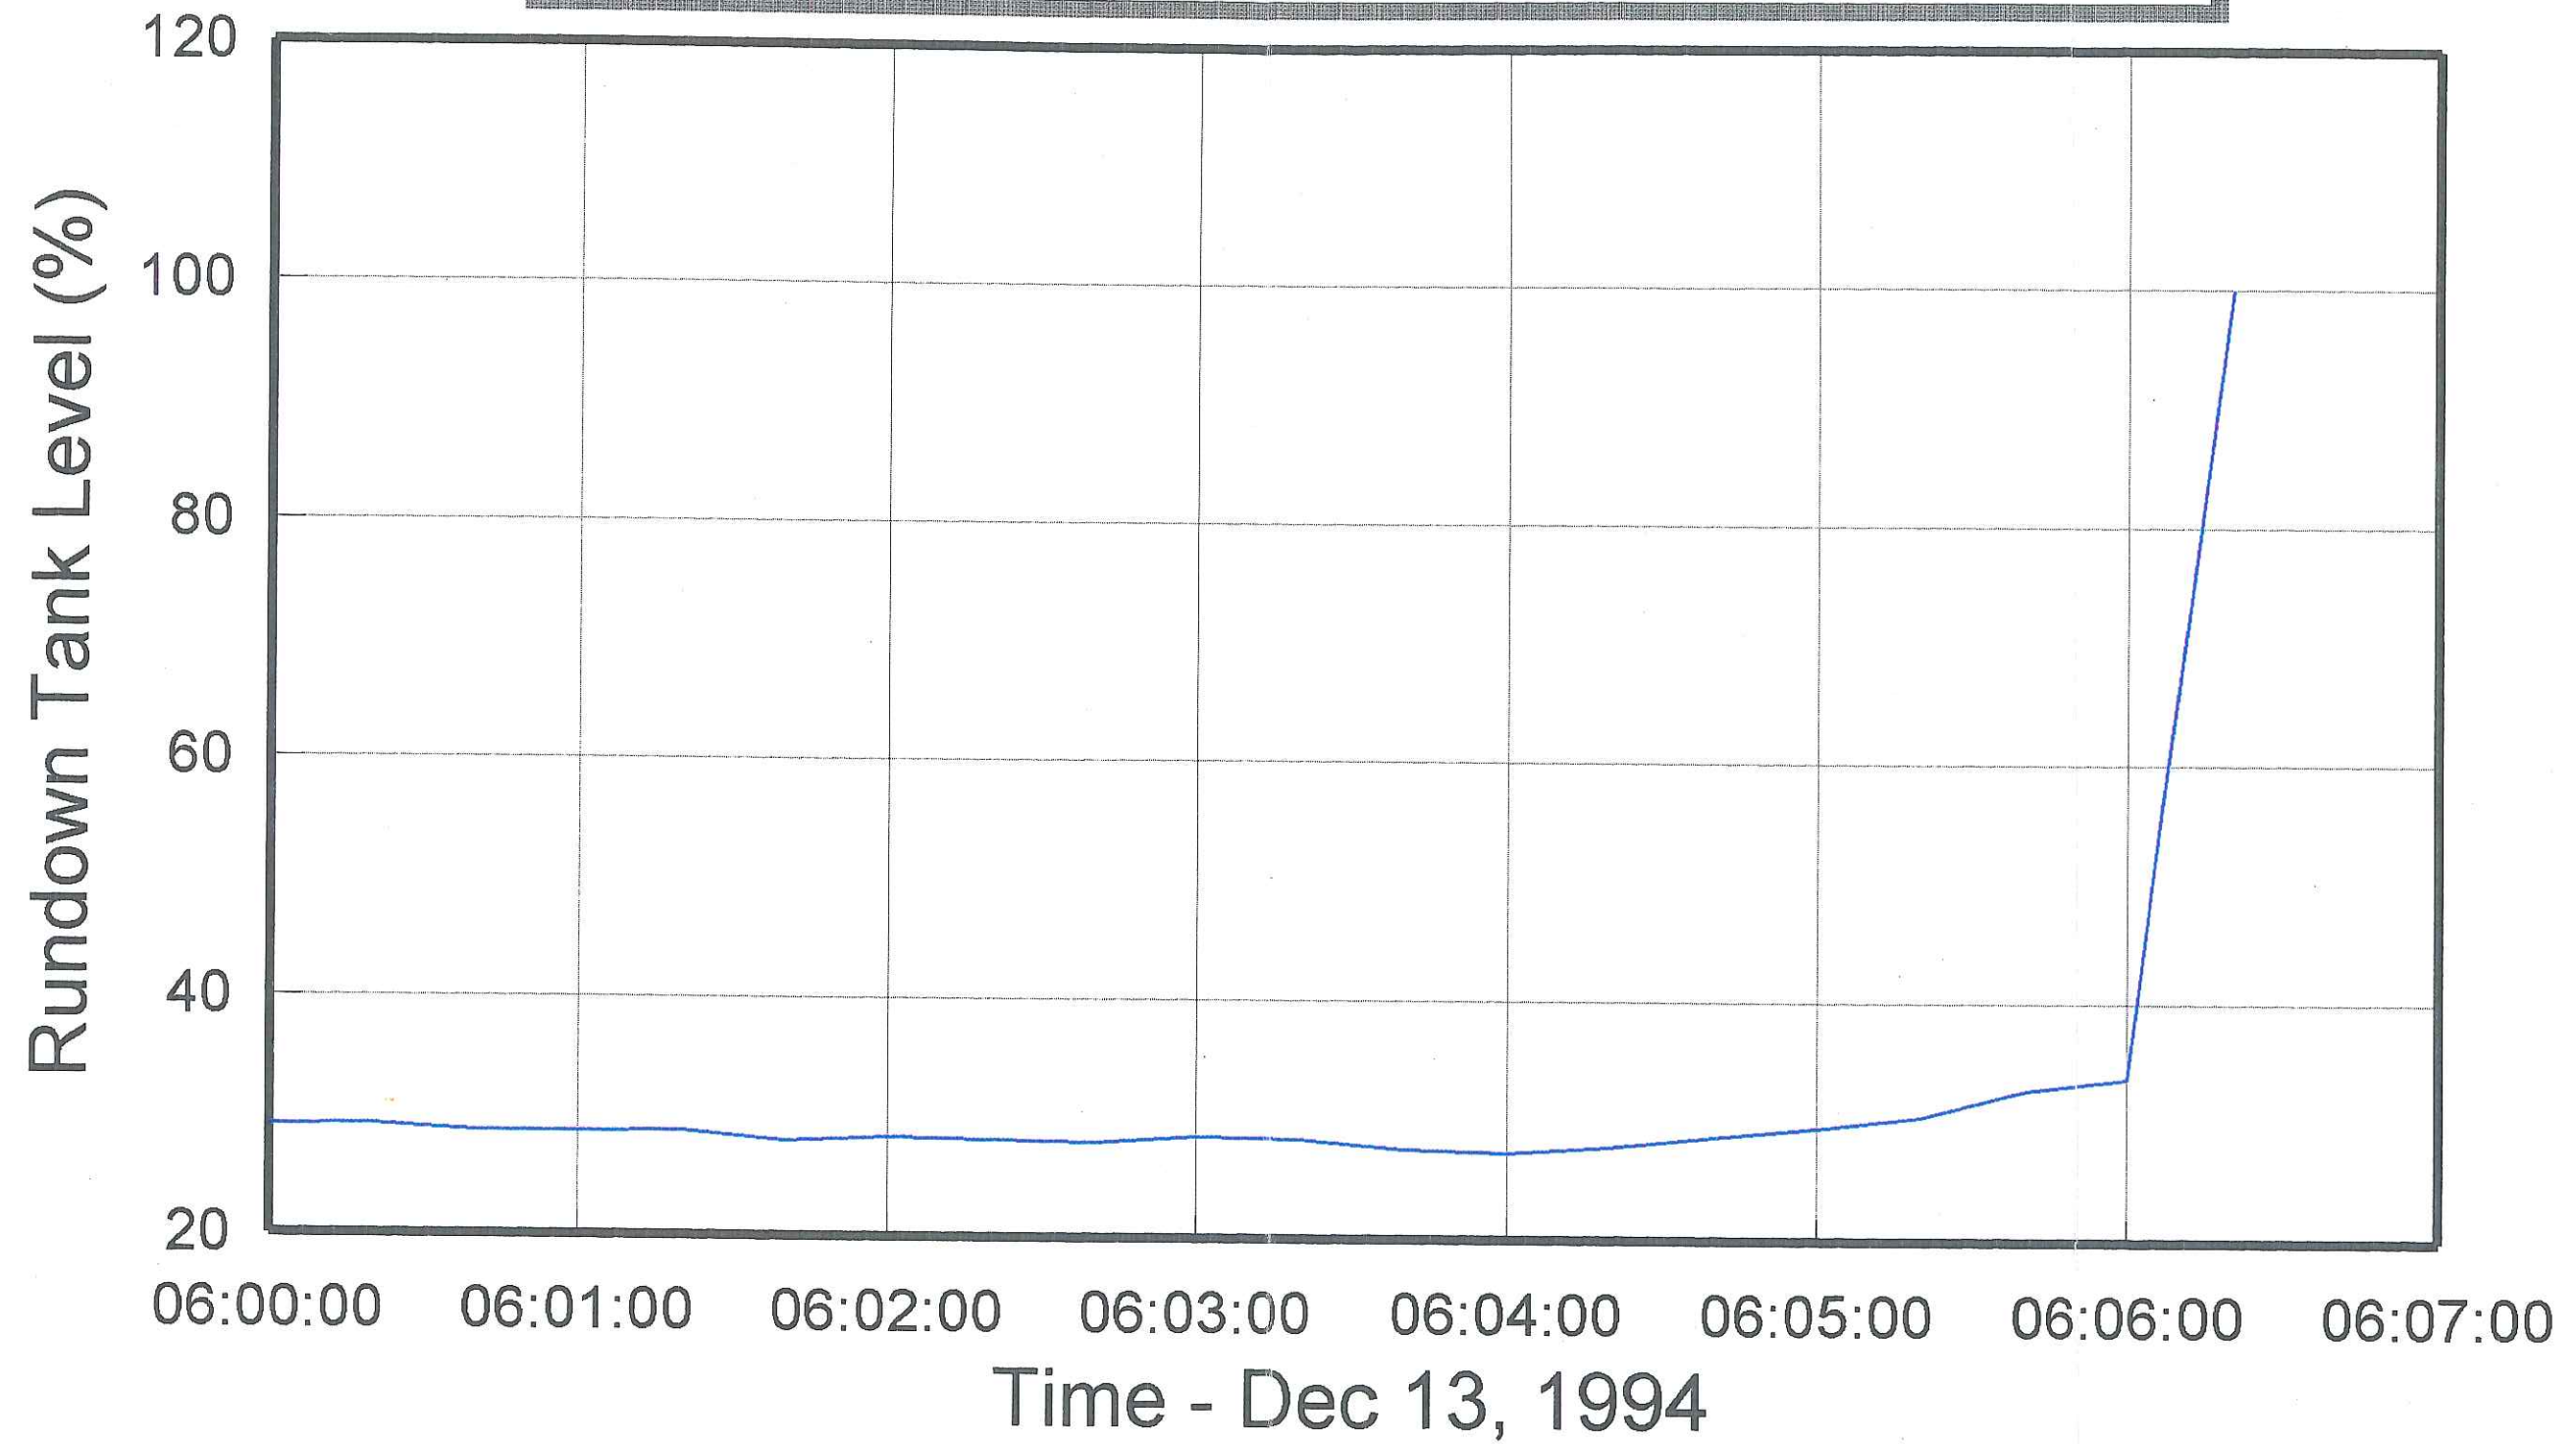
**Figure 8-5, Rundown Tank Level, Last 6 Minutes**

3. The rundown tank was equipped with steam coils that were attached to a steam header, but steam was not applied because of problems with the coils.
4. The pH of the rundown tank solution was determined to be approximately 1.0 and analytical data indicated the presence of chlorides.
5. Approximately 2 minutes before the explosion (DCS time), the level indication showed an exponential increase to an indicated level of 100% at the approximate time of the explosion (*Figure 8-5*).

1. A process pump was operating. The investigation team determined that both process pumps had been shut down and blocked in and steam had been applied to the AN product lines from the process pumps to storage.
2. The rundown tank was leaking. The investigation team was unable to totally disprove this possibility, but ambient temperatures would contraindicate that ammonium nitrate would continue to release from the rundown tank at the low rate indicated without crystallizing.
3. Impact of cold weather on the rundown tank level sensors and associated piping. The investigation team determined that work orders had been issued requesting that these sensors be insulated, but they had not been insulated prior to the explosion. The investigation team determined that this was the most likely cause of the declining level.

The investigation team determined that the explosion in the rundown tank most likely occurred as a result of impacts of high-energy metal fragments originating from the exploding neutralizer.

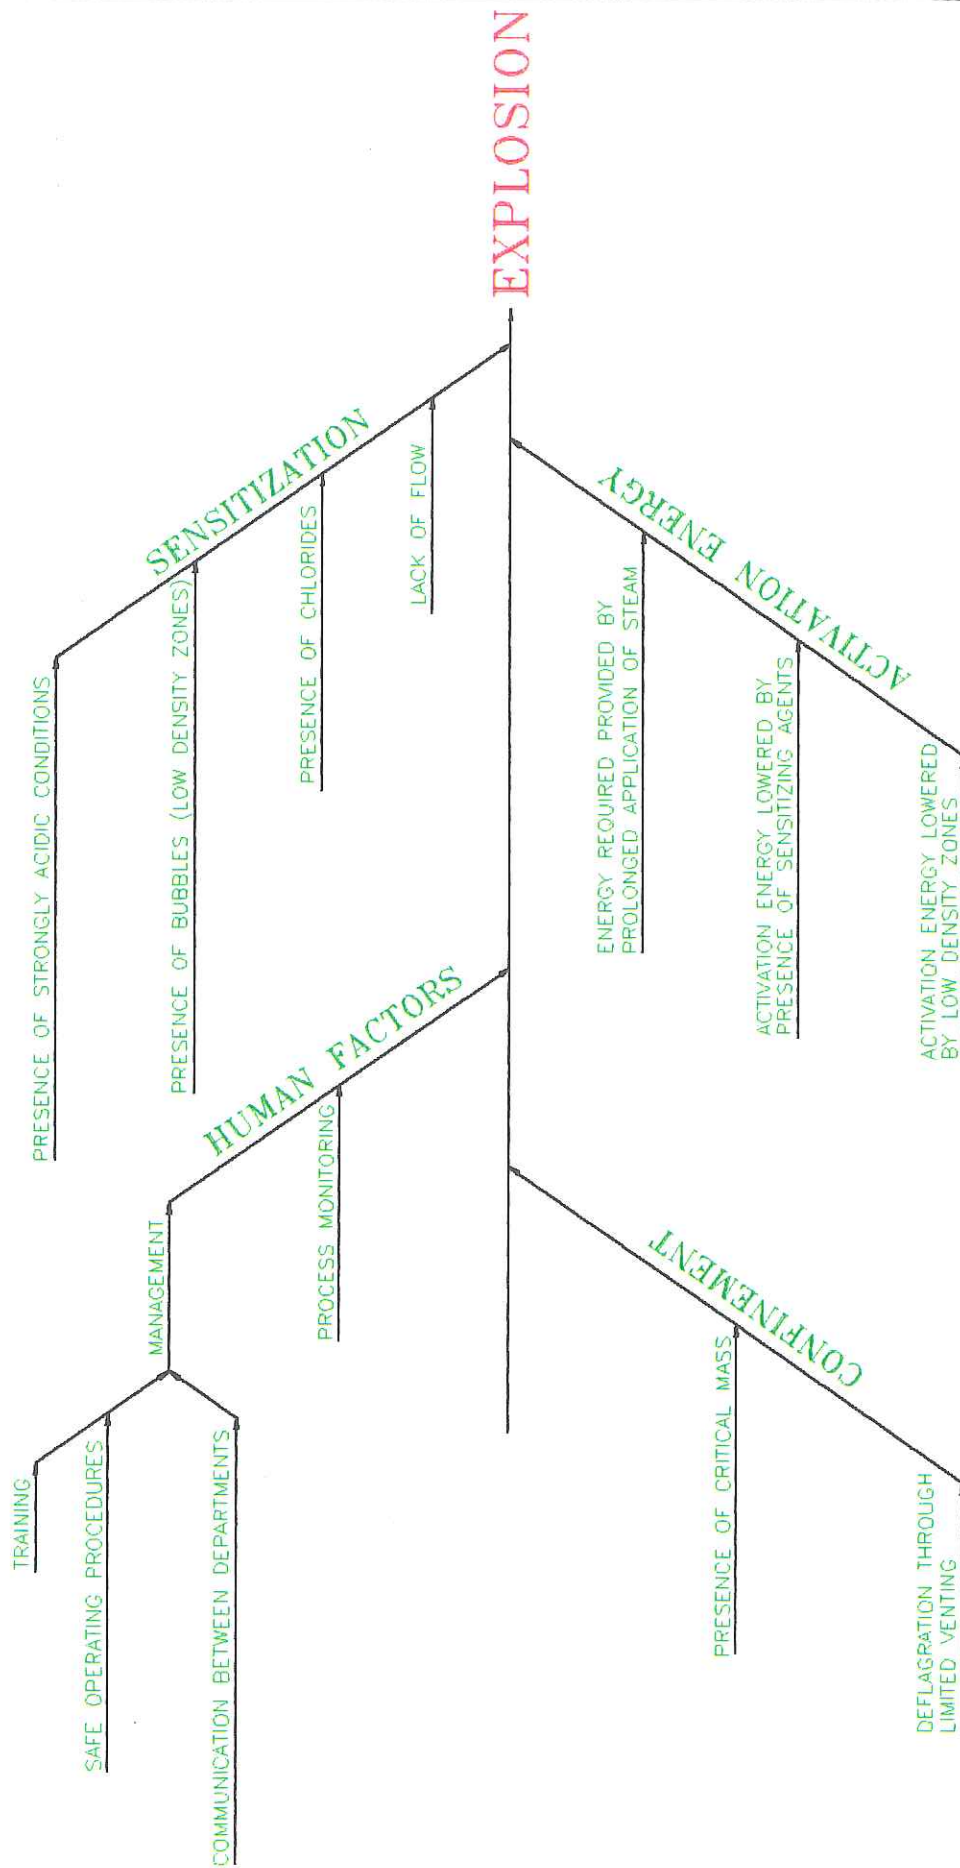
FIGURE 10 - 1  
EXPLOSION FACTOR FLOW CHART

operation procedures at the Terra Port Neal ammonium nitrate plant. The lack of safe operating procedures resulted in conditions in the plant that were necessary for the explosion to occur. The significant conditions that caused the explosion were:

1. Strongly acidic conditions in the neutralizer and rundown tank;
2. Prolonged application of 200 psig steam to the neutralizer nitric acid spargers;
3. The creation of bubbles and low density zones in the neutralizer;
4. Lack of flow in the neutralizer and rundown tank;
5. The presence of chlorides in the neutralizer and rundown tank; and
6. Lack of monitoring of the ammonium nitrate plant after the plant was shut down with the process vessels charged.

1. Conduct a thorough, formal process hazard analysis (PHA) of the ammonium nitrate process according to industry guidelines and practices. Current process safety information including piping and instrumentation diagrams, plant drawings, process chemistry, chemical hazard information and expertise in the technique used are necessary to conduct this evaluation. The findings and recommendations generated by the PHA should be promptly addressed and resolved and should address modifications, safeguards or controls to eliminate, reduce or manage chemical and process hazards.

5. Develop a program to maintain the on-going mechanical integrity of the ammonium nitrate unit. Facility management should consider use of predictive failure analyses and aggressive preventive maintenance systems as part of their mechanical integrity program.
