EPA/OSHA JOINT CHEMICAL ACCIDENT INVESTIGATION REPORT

Napp Technologies, Inc.
Lodi, New Jersey

Executive Summary/Overview

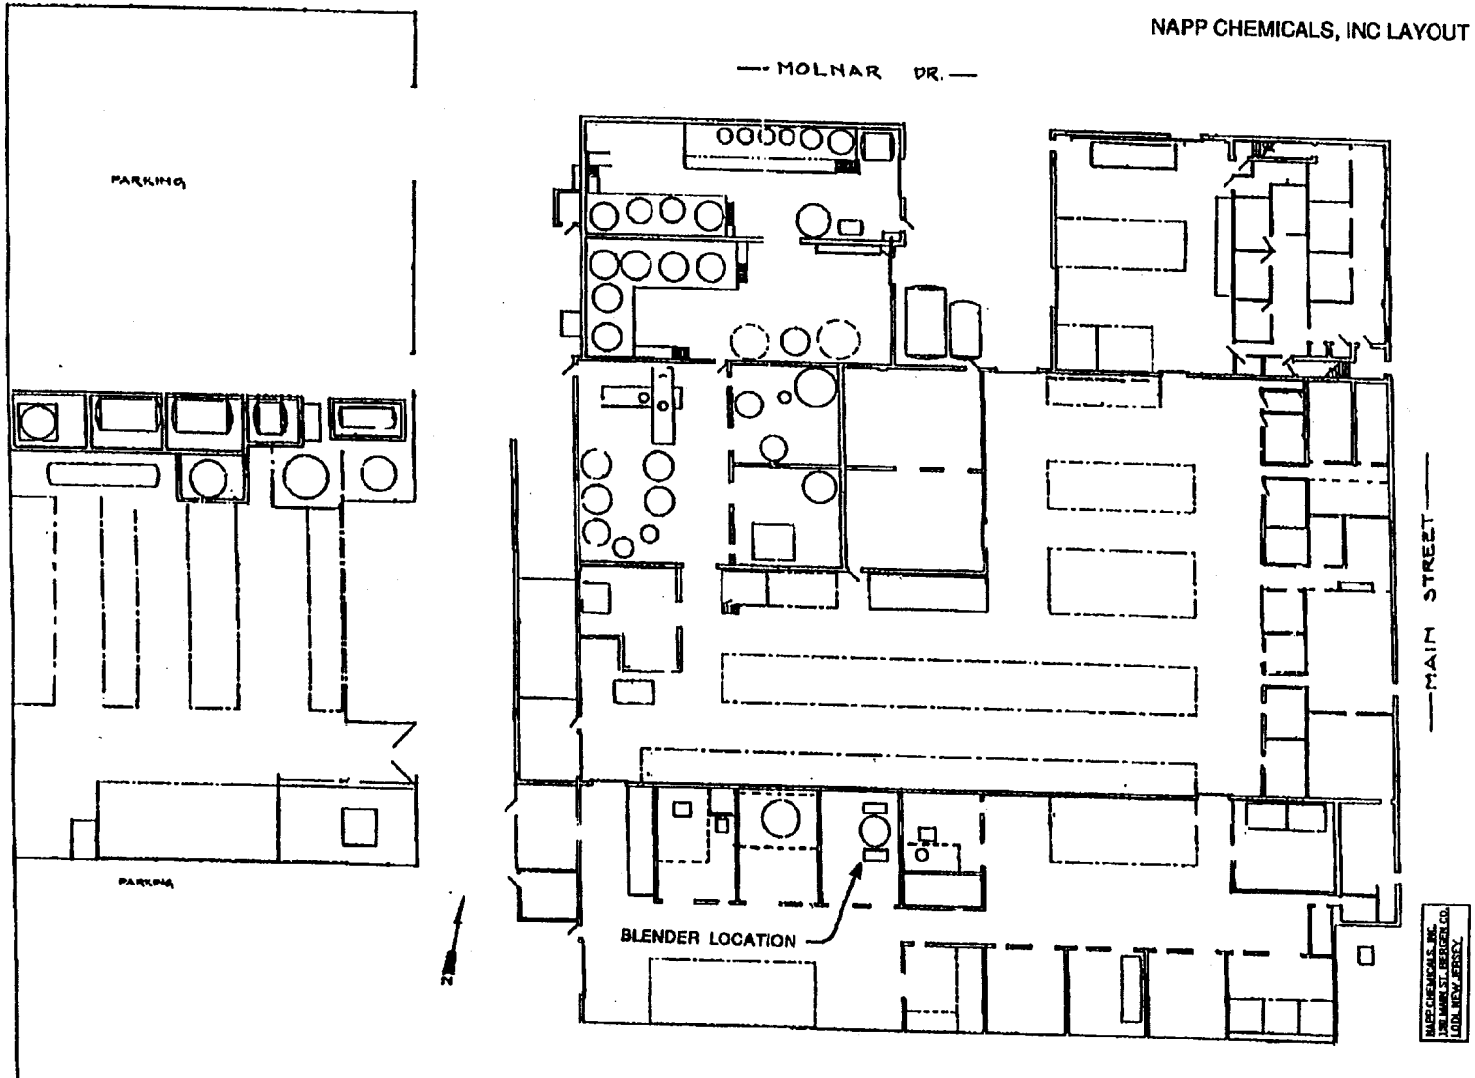
FIGURE 1

The Patterson-Kelley (PK) 125 blender used in the GPA blending operation was located in the PK-125 Blending Room, located in the Pulverizing and Blending Department on the South side of the facility, near the main warehouse area (see Figure 1).

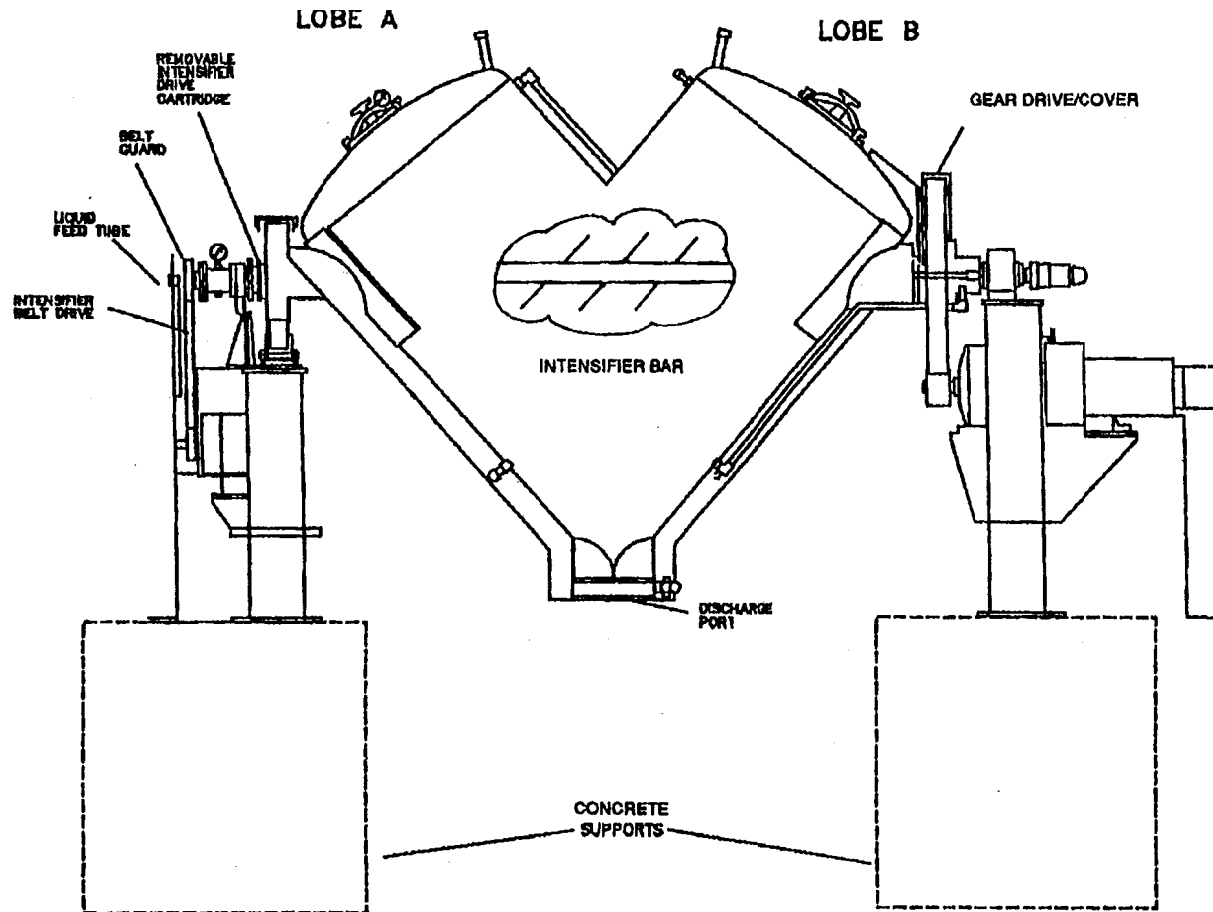
FIGURE 2

Patterson-Kelley 125 Blender

Figure 2 shows a typical Patterson-Kelley V-shaped blender. Patterson-Kelley builds each blender with options and features as specified by the purchaser. The blender at Napp had a working capacity of 6 cubic meters (125 cubic feet). It was approximately 6 meters wide (19 feet), including supports, and 3 meters (10 feet) high. The blender is a double-lobed stainless steel shell shaped like a heart. It is supported on its widest dimension by a horizontal trunnion attached to support tubes set in cement footings. It is insulated with a rigid foam material and encased in a steel jacket containing a water/glycol mixture for cooling and heating. The two access covers on top of the blender are used for loading raw materials, and one port is located at the bottom for off-loading product. A gear to one side of the blender (right side of Figure 2) rotates the shell of the blender through a 360-degree arc. Several water lines enter the jacket on this side. On the other side (left side of Figure 2) of the blender, a vacuum tube housing enters the blender. A graphite seal located inside the vacuum tube separates the seal's cooling water from the internal area of the vacuum tube and the blender. The purpose of the vacuum tube housing is to: (1) act as a conduit for establishing vacuum conditions when the blender is used for drying and other operations; and (2) contain other concentric lines, shafts, etc., including a liquid feed line (added by Napp) and the shaft used to rotate an intensifier bar (I-bar). The purpose of the I-bar is to enhance the mixing of materials being blended. The purpose of the feed line is to allow the controlled introduction of liquids to the materials being blended. The PK-125 blender can be used with or without the I-bar in service. The I-bar, Figure 3, transverses the inner walls of the blender connecting the inner sides of the blender on the same plane as the trunnion. See Figures 4-8 showing a larger but similar blender and associated equipment.

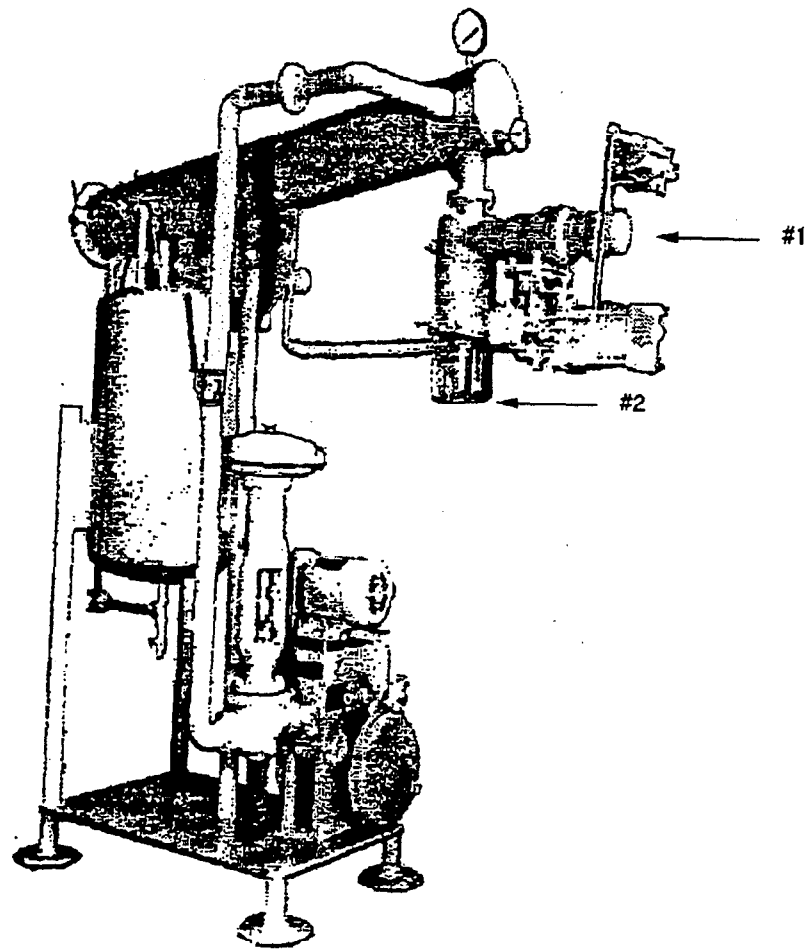
FIGURE 3A: TYPICAL VACUUM COLLECTION SYSTEM As SUPPLIED BY PATTERSON-KELLEY. # 1 SHOWS APPROXIMATE LOCATION OF INLET FROM BLENDER VACUUM LINE; # 2 SHOWS VACUUM SEPARATOR BOWL.

Between midnight and 4:30 a.m. on April 21, 1995, the third shift attempted to inject benzaldehyde into the batch on two occasions; each attempt failed. Operators observed the benzaldehyde running back into the vacuum separator. During each attempt to add the liquid, the blender was rotated for about two minutes with the intensifier bar running. Suspecting that product was blocking the spray tip of the nozzle and preventing the injection of the liquid, operators opened the blender twice and removed and washed the spray nozzle. Operators reportedly observed a slight dusty powder wafting within the head space of the blender. This was reported to the shift supervisor, who then checked the inside of the blender and directed the operators to remove and clean the nozzle. After the final attempt to charge benzaldehyde into the vessel it was determined that no fresh benzaldehyde remained. It was by then approximately 5:00 a.m. and coming to the end of the third shift. The shift supervisor told the operators to perform a lock and tagout of the blender.

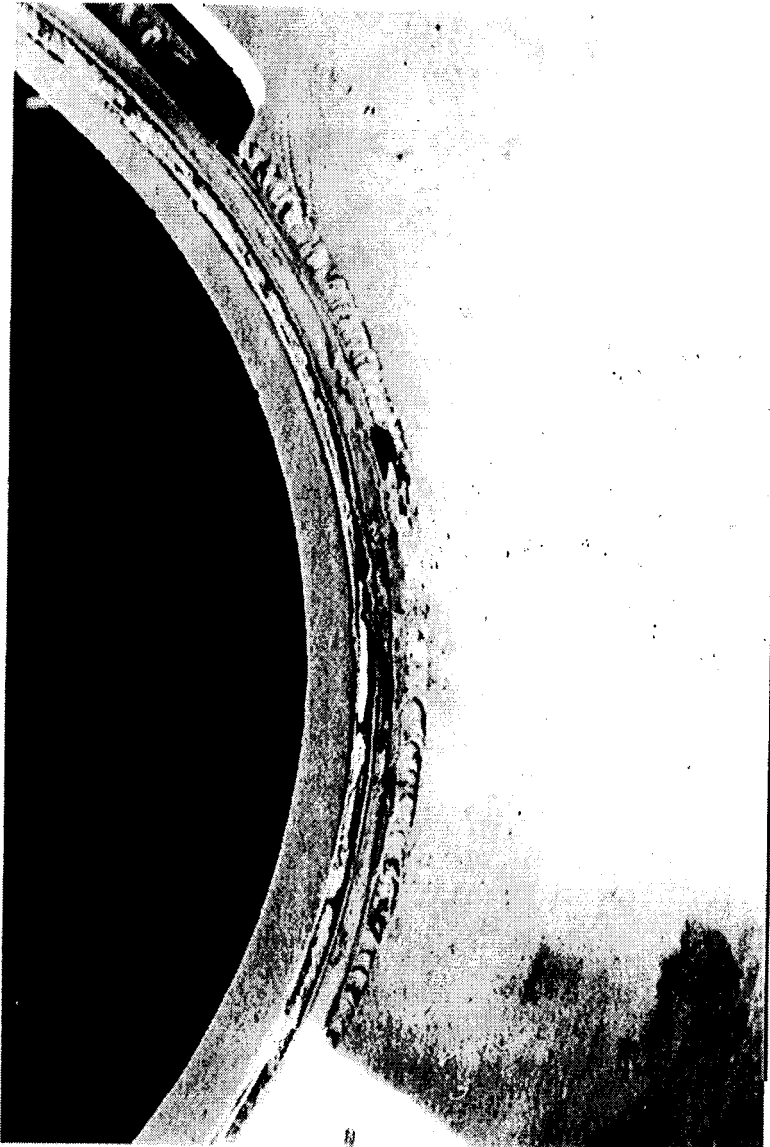
Figure 4: One of the top loading ports on the 150 cubic foot blender showing how the insulation jacket is attached (weld) and access door tabs.

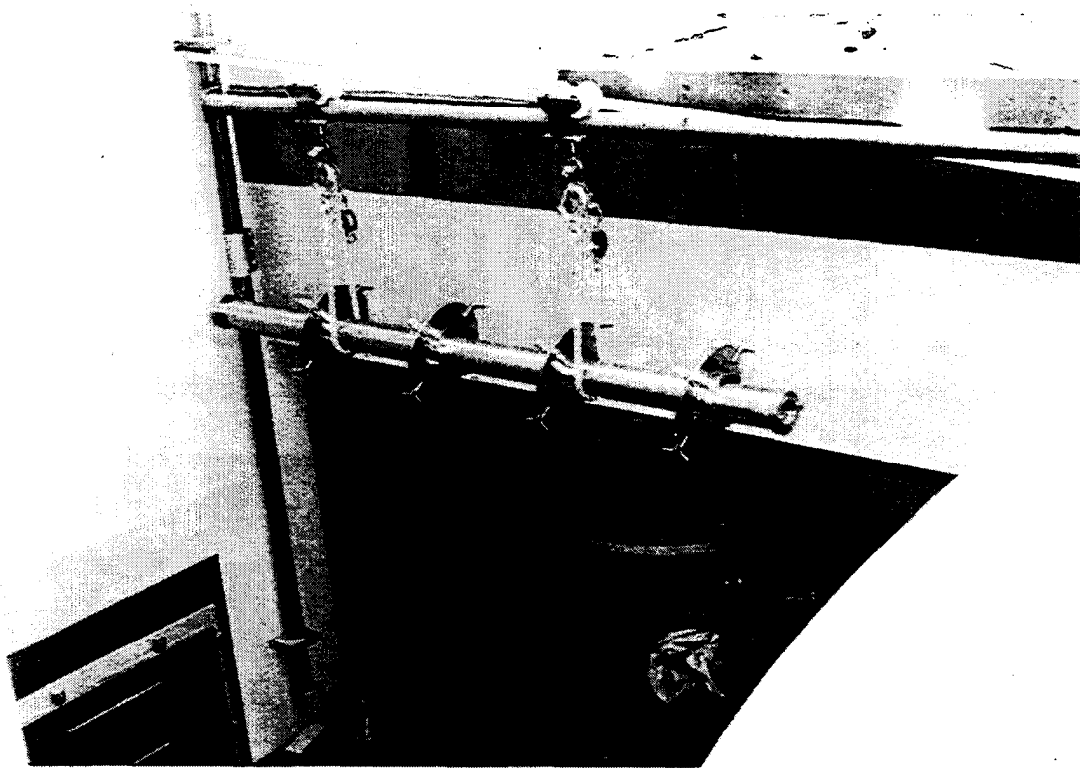
Figure 6: The intensifier bar for a PK-150 cubic foot blender shown in its storage position.

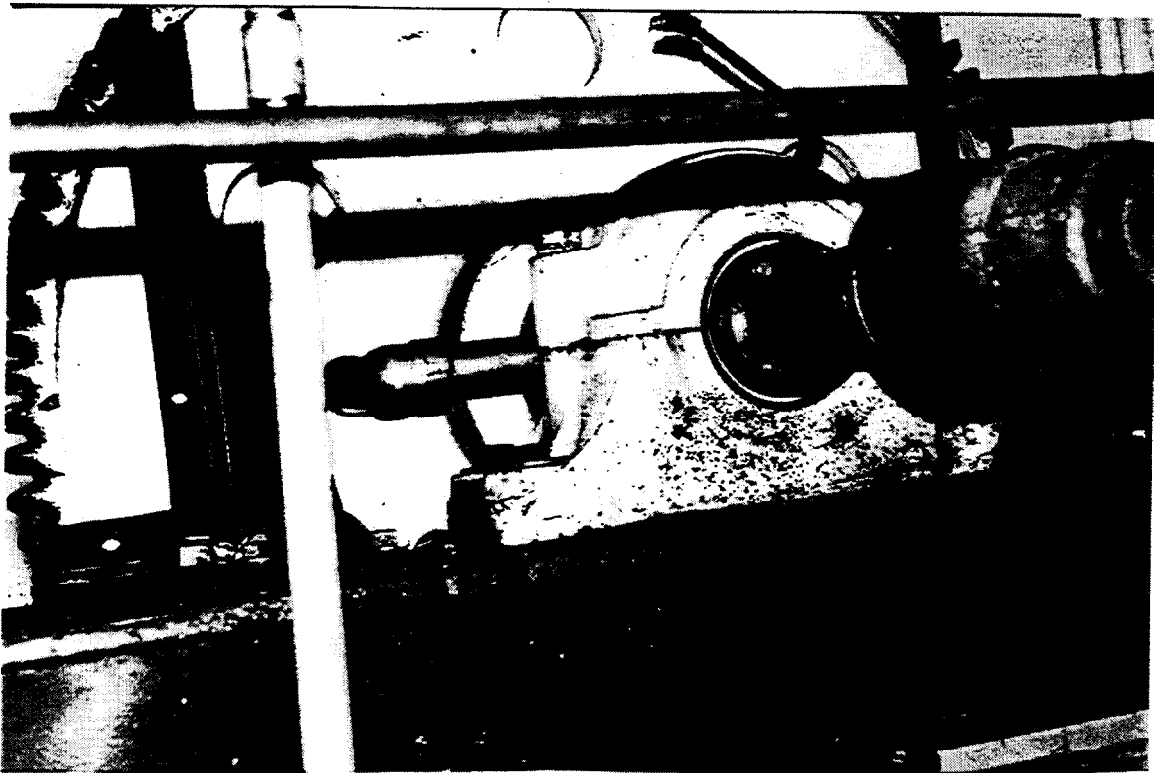
Figure 7: The gear drive and bearing that supports one side of a 150 cubic foot blender.

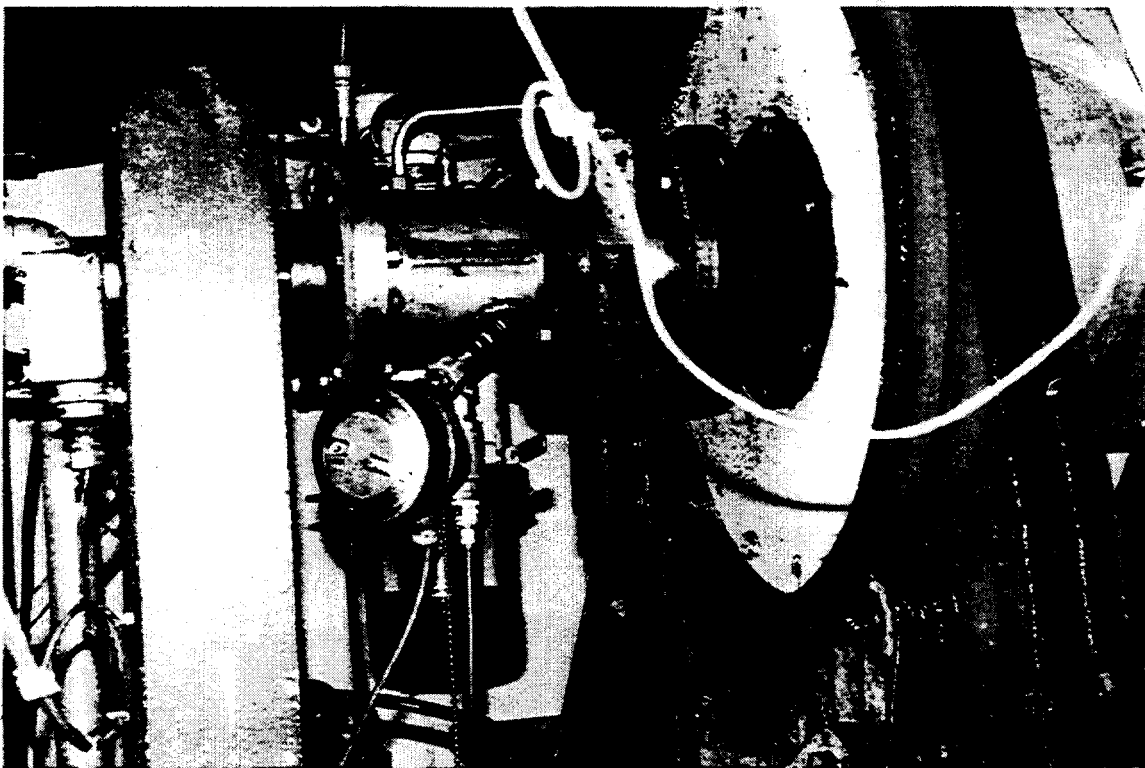
Figure 8: The other side support (intensifier bar drive side) of a 150 cubic foot blender.

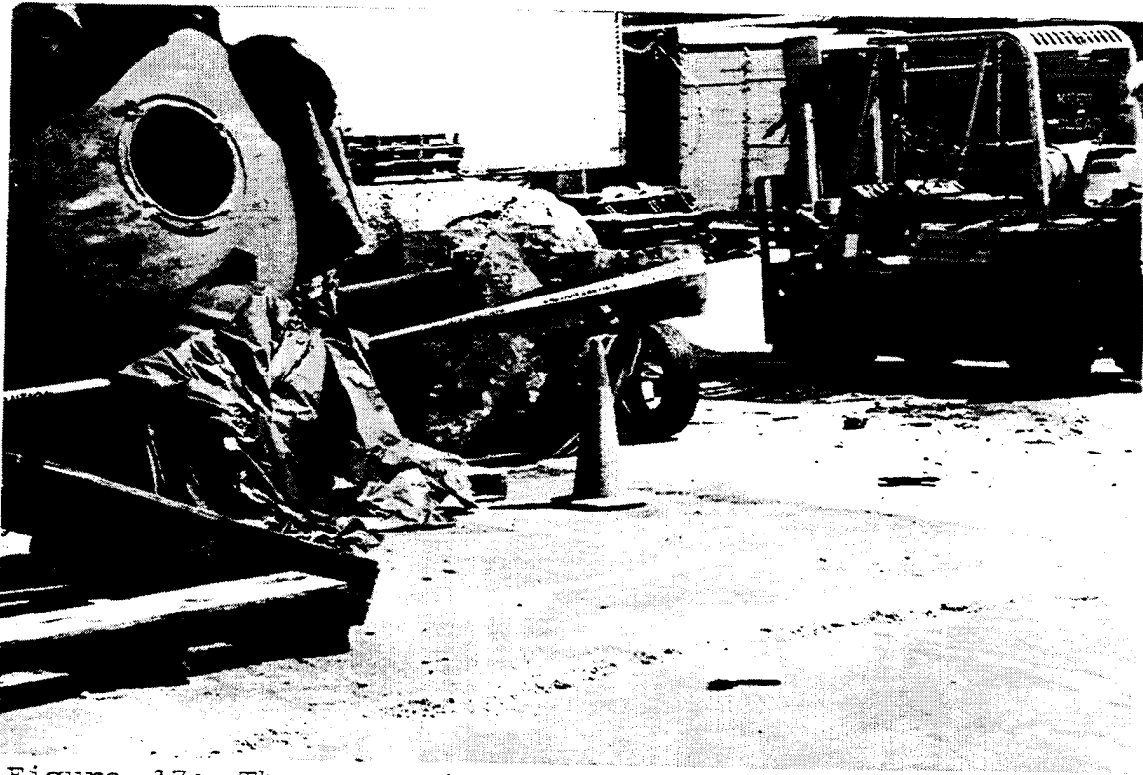
Figure 17: The concrete support and bracket that secured the bearing on the gear drive side of the blender.
