EPA/OSHA JOINT CHEMICAL ACCIDENT INVESTIGATION REPORT

**Surpass Chemical Co., Inc.
Albany, NY**

Accident Investigation Report
Surpass Chemical Company, Inc., Albany, New York, April 8, 1997

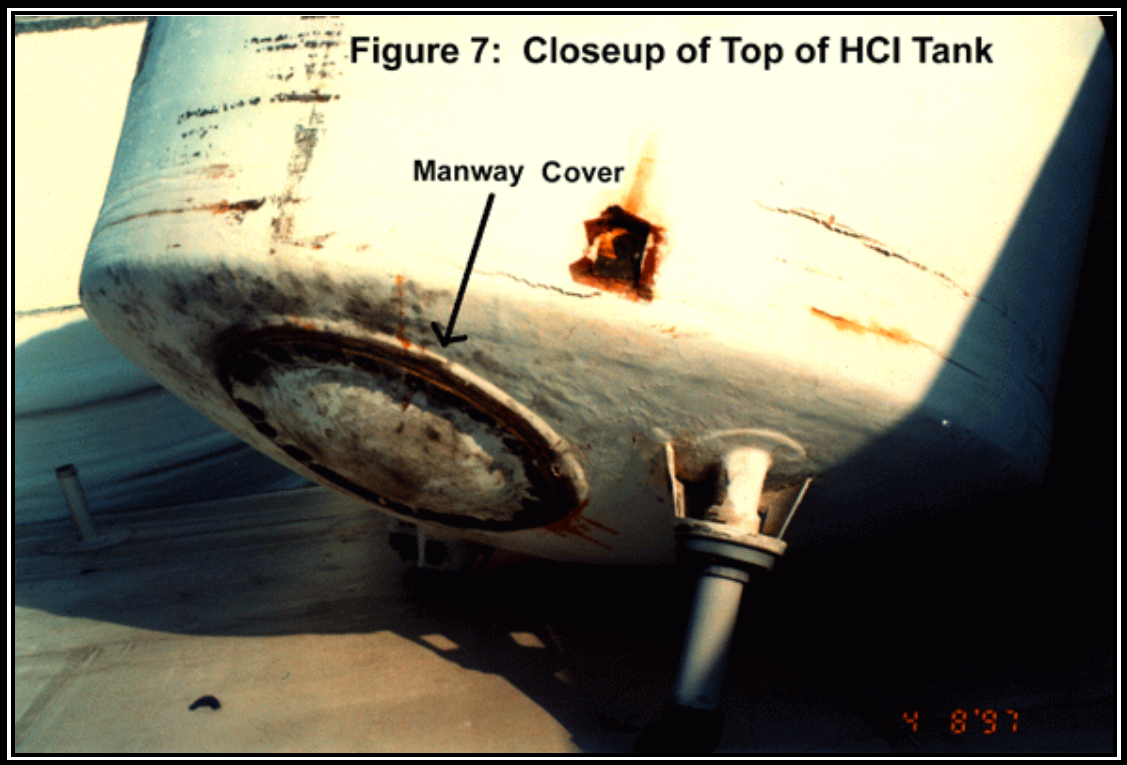
Figure 5: Top of HCl Tank

The HCl tank head separated at a point about 5 feet from the top of the tank and flew about 15 feet west to the roof of an adjacent building. **Figure 4** shows the separated tank after the incident, and **Figure 5** shows the top of the tank. The bottom of tank failed in the knuckle area where the cylindrical part of the HCl tank meets the flat bottom, as shown in **Figure 6**. The tank bottom remained on the platform. The cylindrical part of the fiberglass shell began to unwind itself at the top edge (see **Figures 4 and 5**). The shell also remained on the platform but collapsed, leaning toward the west building wall (see **Figure 6**). The scrubber tank was not affected by the tank failure; it was found intact in its original position after the incident, as shown in **Figure 7**.
