PERFORMANCE OF FLEXIBLE DITCH LININGS

FHWA/RD-86/114

Final Report

September 1985

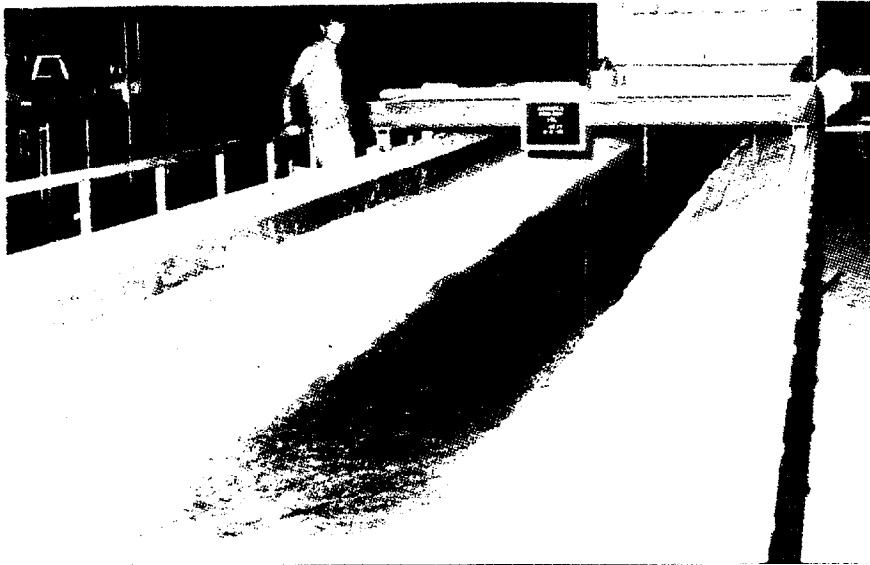
Figure 44. -- Hold-Gro Liner During Testing. Note the Liner Floating at the Waters Edge.

- 1) All failures were due to erosion, not liner failure.
- 2) Paper came loose from the liner even at low flow velocities.
- 3) At all flows, water was observed flowing under the liner.
- 4) The non-damaged liner (both paper and yarn still intact) generally floated at all flow depths, when the average flow velocities were below 3 ft/sec (figure 44).
- 5) The liner tends to move in the direction of flow (figure 45).
- 6) Liner damage was minimal in all tests. The paper came loose and washed away, but the woven yarn net remained intact (figure 45).
- 7) Erosion appeared to occur at a steady rate throughout the entire 30 minute test.
- 8) Most erosion occurred on the side slope of the ditch.
- 9) A large portion of the eroded soil was deposited behind staples and in front of the anchor at the foot of the test ditch.

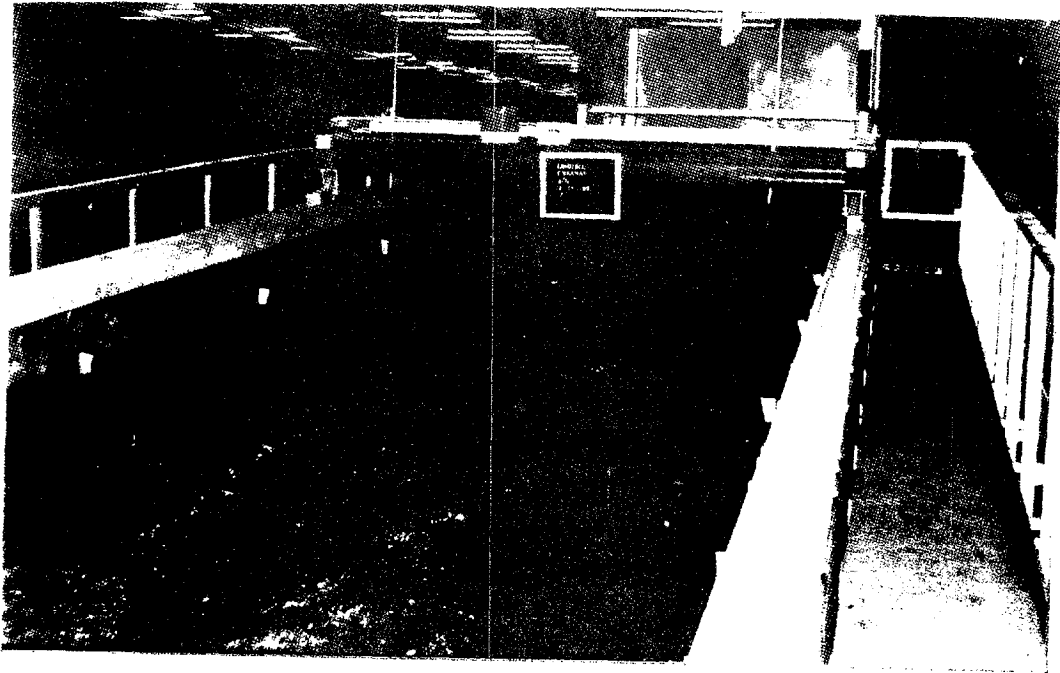
Figure 51.--Enkamat liner during testing.

- 1) Erosion appears to occur at a steady rate throughout the entire 30 minute test.
- 2) Erosion damage was minimal in all tests.
- 3) Most erosion occurred on the side slopes of the ditch around the wood survey stakes (figure 52).
- 4) The liner was observed stretching at high slopes with high water flows.

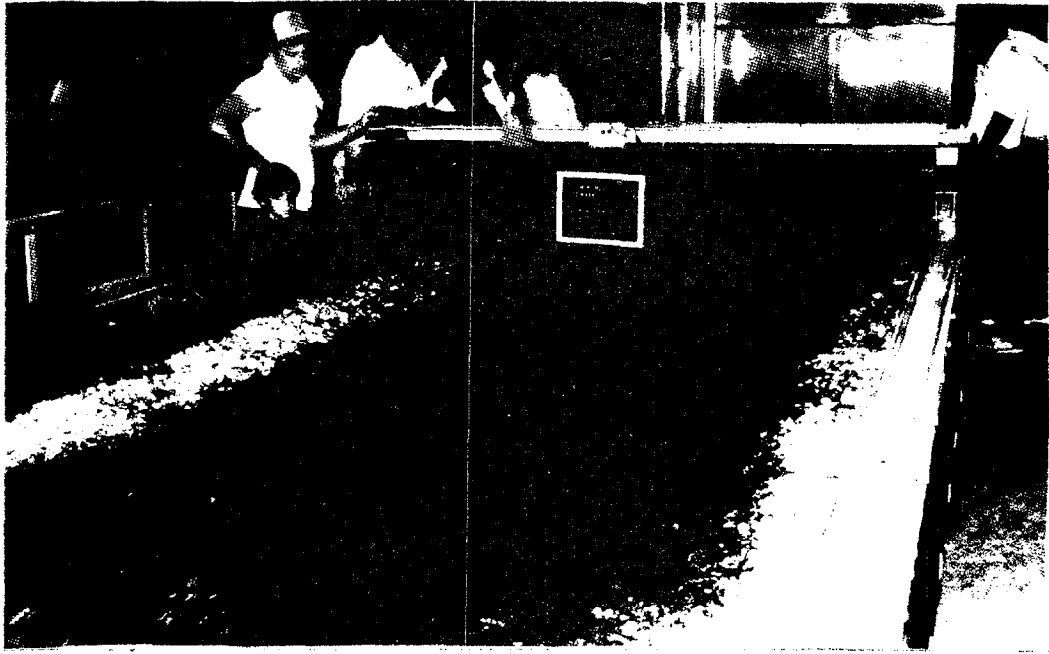
Figure 54.--Testing of loose gravel liner.

- 1) All failures were due to liner failures, not erosion failure.
- 2) The gravel appears to move down the ditch at a steady rate throughout the entire 30 minute test.
- 3) The failure at 1 percent slope had a moderate rate of failure with the gravel on the side slope of the ditch being deposited on the bottom of the ditch (figure 55).
- 4) The failure at 2 percent slope had a moderate rate of failure with the gravel at the upstream portions of the test ditch moving to the downstream portions of the ditch.
- 5) The liner failure at 3 percent slope was a rapid failure.
- 6) Erosion damage was minimal in all tests.

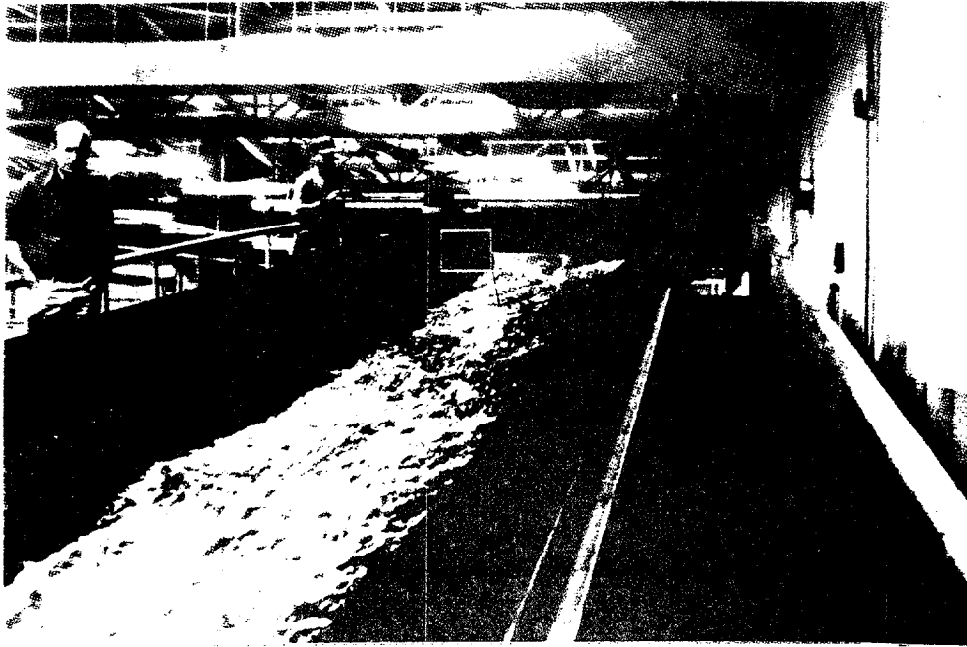
Figure 60.--Testing of jute netting liner.

- 1) Erosion appeared to occur at a steady rate throughout the entire 30 minute test.
- 2) Erosion damage was minimal in all tests.
- 3) High water flows at high slopes appeared to unravel the jute netting between staples (figure 61).
- 4) The longitudinal jute strands appear to offer adequate protection in the areas where the liner was unraveled.
