# UNITED STATES COAST GUARD

## REPORT OF INVESTIGATION INTO THE ALLISION OF THE COSCO BUSAN WITH THE DELTA TOWER OF THE SAN FRANCISCO-OAKLAND BAY BRIDGE IN SAN FRANCISCO BAY ON NOVEMBER 7, 2007

MISLE ACTIVITY NUMBER: 3095030

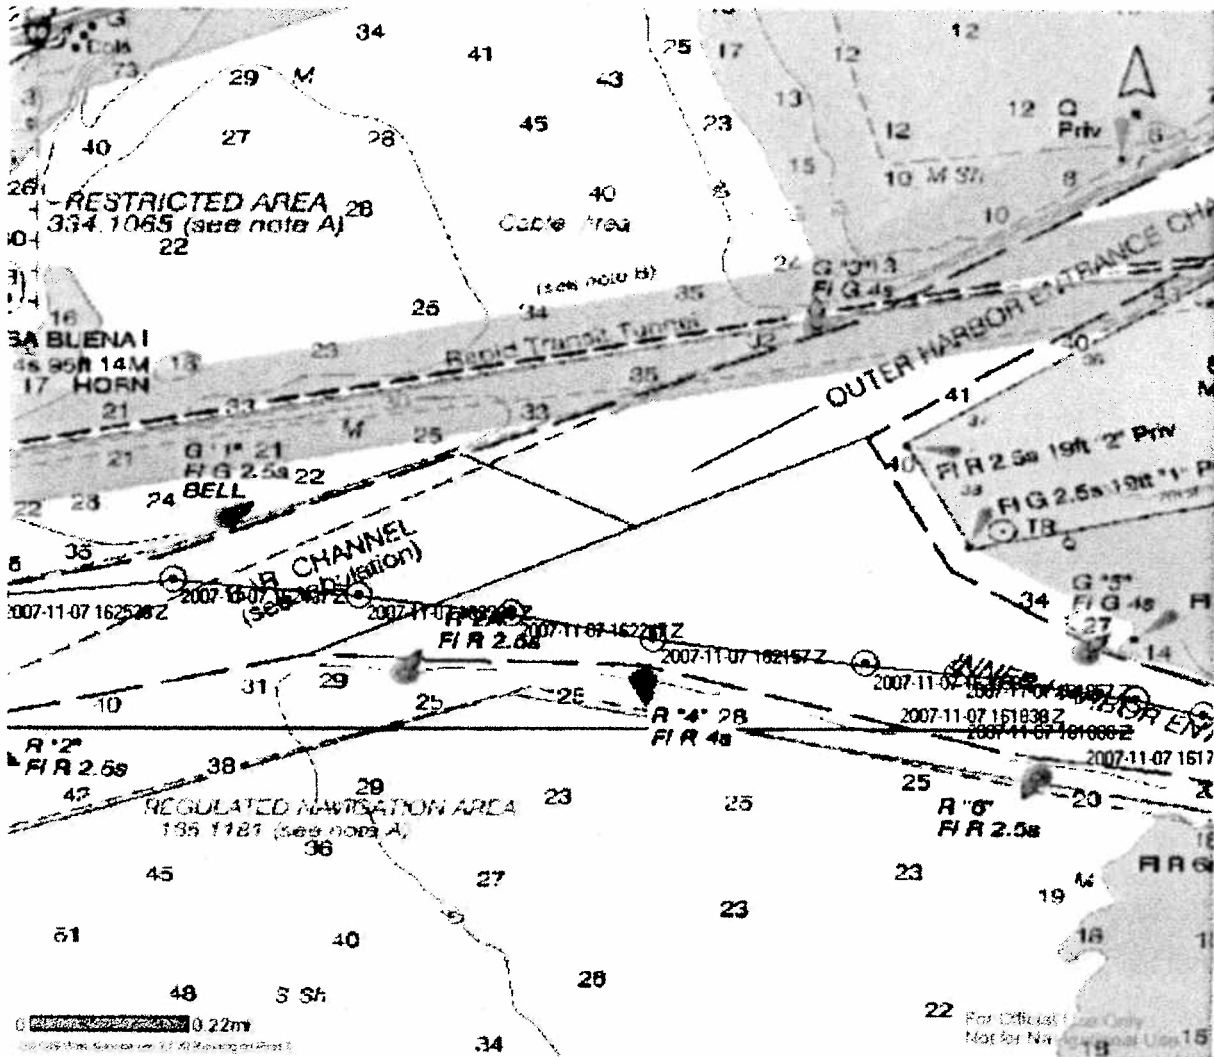
Figure 3. This image was prepared by the Coast Guard Office of Information Resources. Times shown are in Zulu (Greenwich Mean Time (GMT)), which can be converted to local time by deducting eight hours. This image shows the COSCO BUSAN's AIS trackline (indicated in blue) from Lighted Buoys "5" and "6" to Lighted Buoy "1."

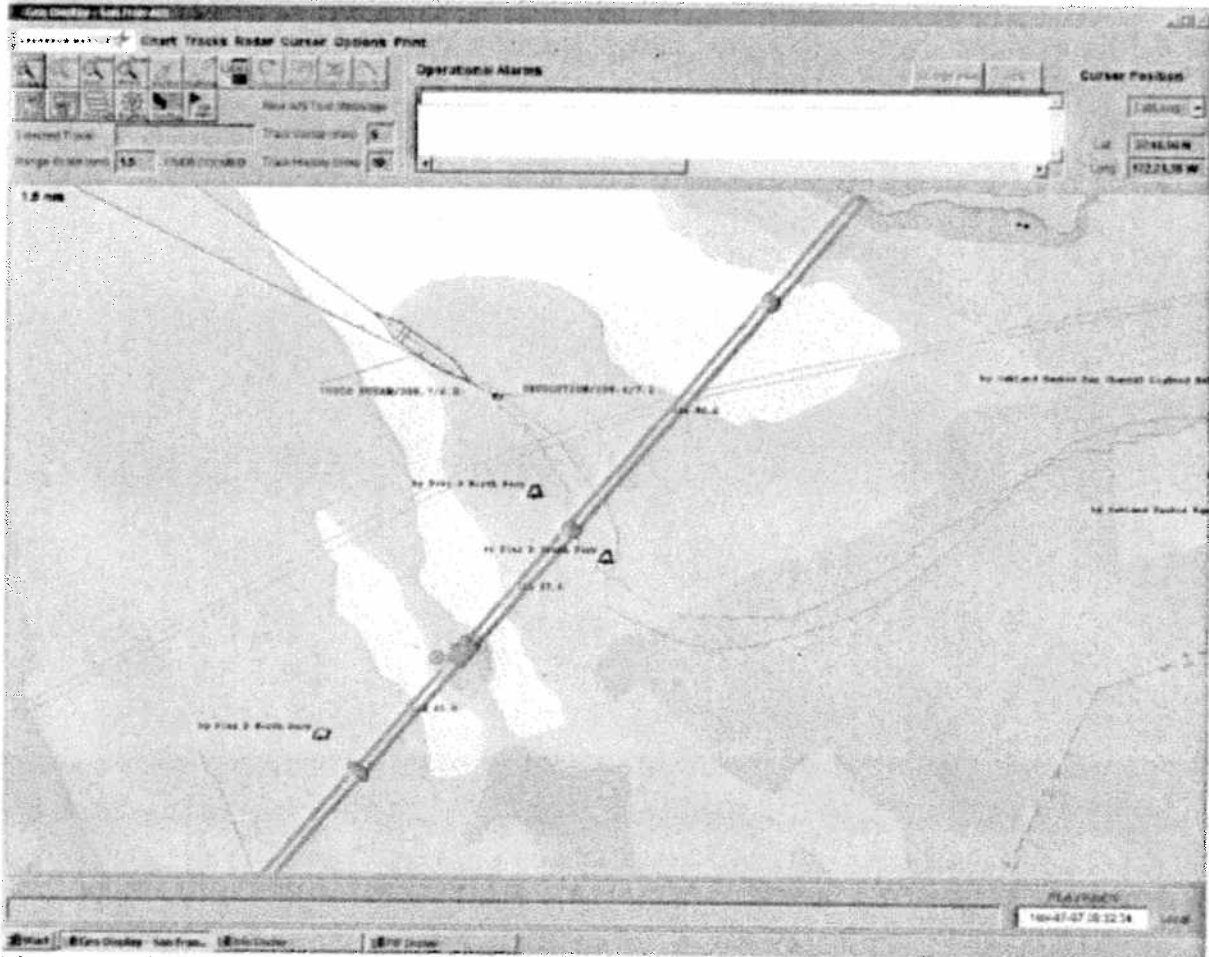
Figure 5. This image was recovered from the Coast Guard Vessel Traffic System (VTS) after the casualty. The green lines are the tracklines of the M/V COSCO BUSAN and the Tug REVOLUTION respectively. Note how the tug crossed the wake of the COSCO BUSAN as the ship maneuvered.

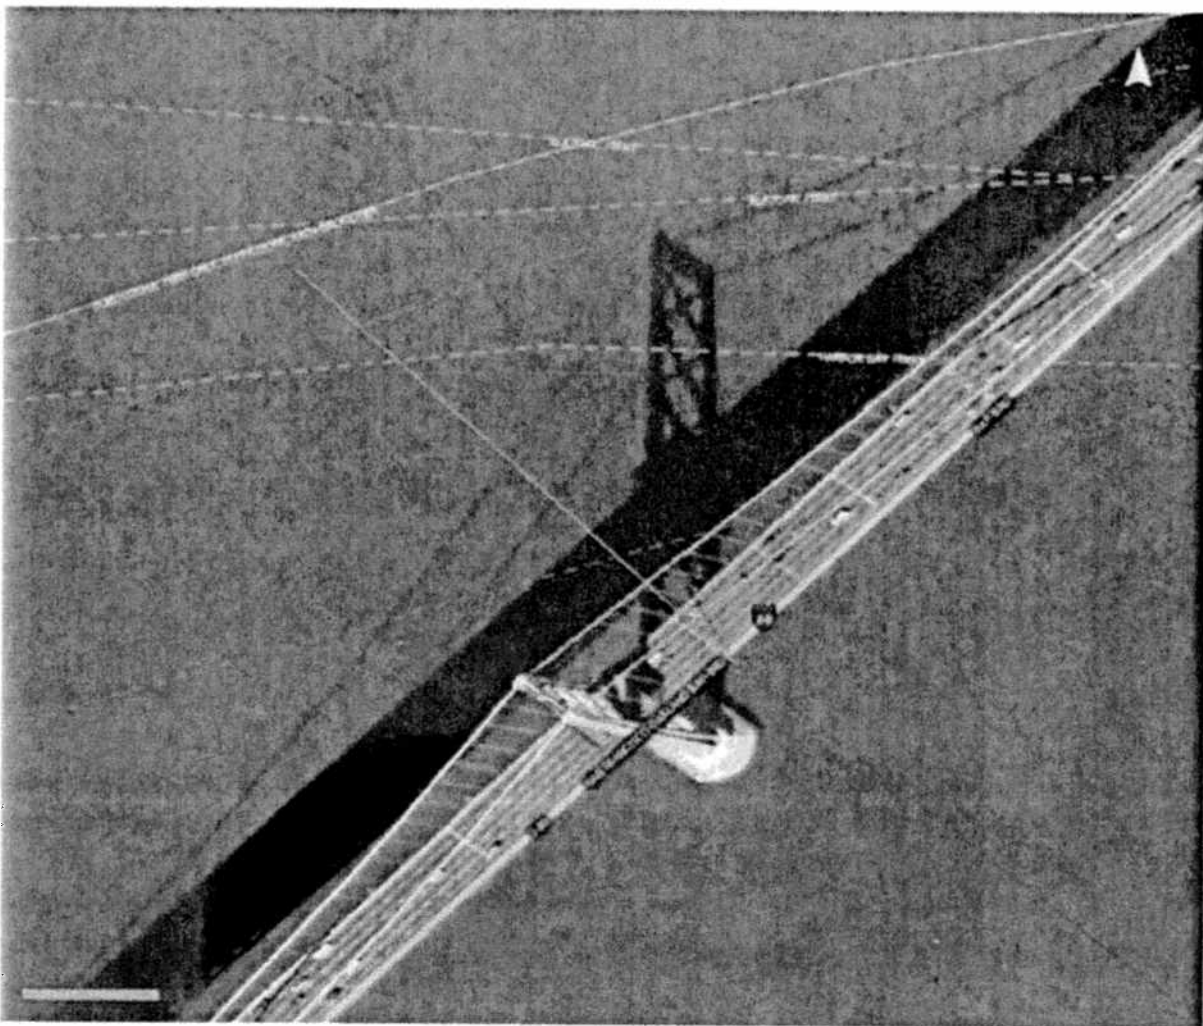
Figure 6. Aerial view of the Bay Bridge (Delta Tower) with the AIS trackline of the M/V COSCO BUSAN in blue.
