**RTI Group, LLC**  
910 Bestgate Road, Suite E  
Annapolis, MD 21401  
ofc: +1 410 571 0712 | fax: +1 410 571 0713  
www.rtiForensics.com

**DOT Requested Analysis**  
**of**  
**Failed SCUBA Cylinder/Valve Assembly**

**Report Date**  
**August 29, 2012**

**RTI Matter**  
**No. 50151.ME002**

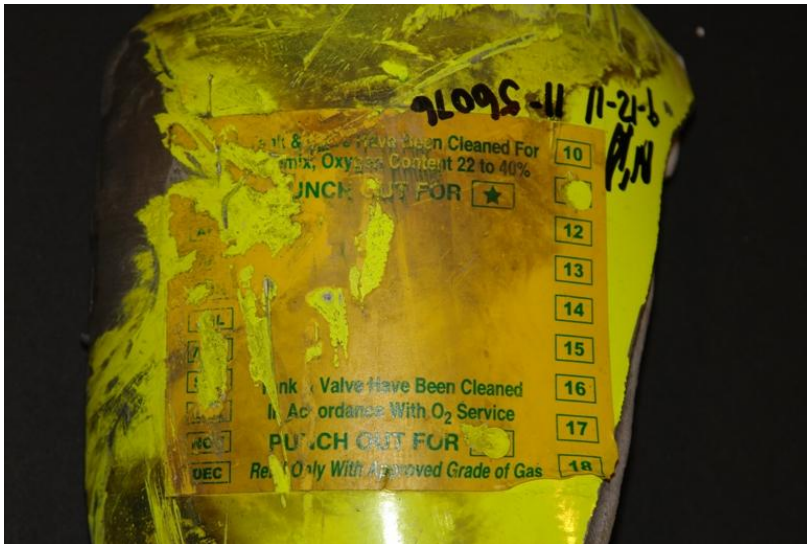
The cylinder fragment had on its exterior surface a full decal and part of another. The first decal, seen in **Figure 2**, appears like that used by the International Association of Nitrox and Technical Divers (IANTD), as seen in **Figure 3**, which states if the decaled cylinder has been cleaned for use with Nitrox<sup>1</sup> or Oxygen.

Figure 2. Label on smaller fragment.

In accordance with the federal regulations, the incident cylinder should have possessed a label indicating that the contents of the cylinder were compressed gas oxygen. The incident cylinder possessed two decals or labels. The first, shown in **Figure 2**, indicated that the cylinder had been cleaned in accordance with O<sub>2</sub> service. There is no indication as to who may have stamped and applied the decal, or as to what procedure was followed to certify the cylinder was properly cleaned. The failure to provide this information is counter to the suggestions of the Compressed Gas Association,<sup>12</sup> and a violation of the ASTM G 93 which states as follows:

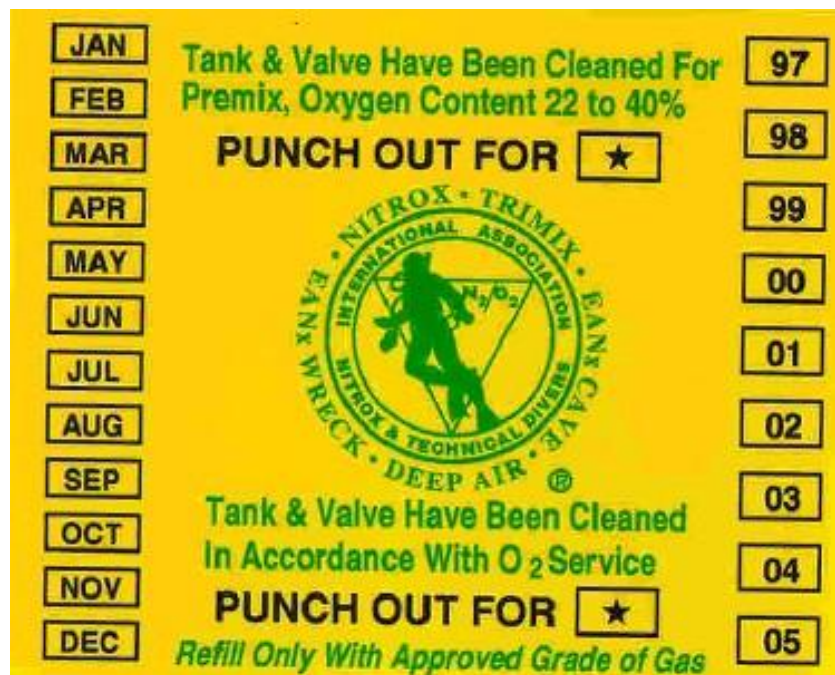
Figure 3. Decal label from International Association Nitrox and Technical Divers<sup>2</sup>

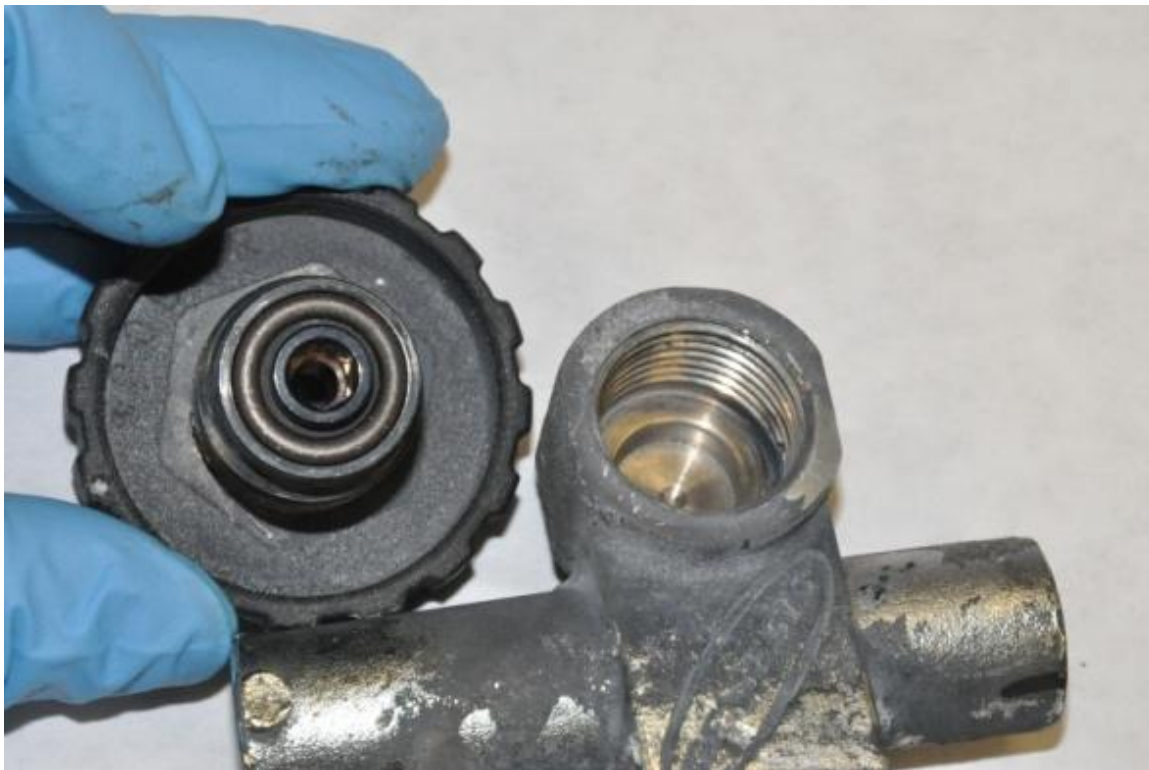
The valve side of the adapter fragment contained an intact O-ring and a fitting suitable for inserting a hex key. Visible on the handle was the raised text “300 BAR”, see **Figure 20**. Internal to the adapter is a metal air cup that serves as a filter between the cylinder valve and the

Figure 20. View of the incident valve and underside of the regulator adapter handle.

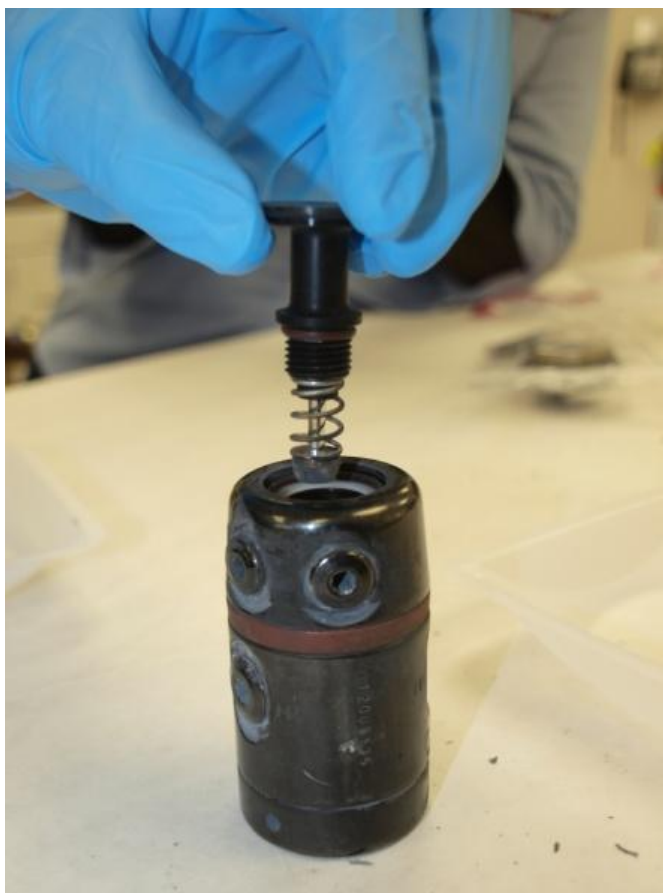
Next, the cap/spring/plunger assembly, that serves in conjunction with a diaphragm to meter the high pressure gas to the low pressure side of the regulator, was removed. An O-ring and a flat plastic washer were seated in the low pressure regulator barrel and subsequently removed. Minor sooting and particulate matter were visible inside the incident regulator, on the washer and O-ring, and at the interior plunger end. As much as possible of these particulates was captured for later chemical analysis. As is seen in **Figure 21** and **Figure 22**, these components appeared to be in an overall undamaged condition.

Figure 21. View of the incident regulator with the cap/spring/plunger assembly being removed.

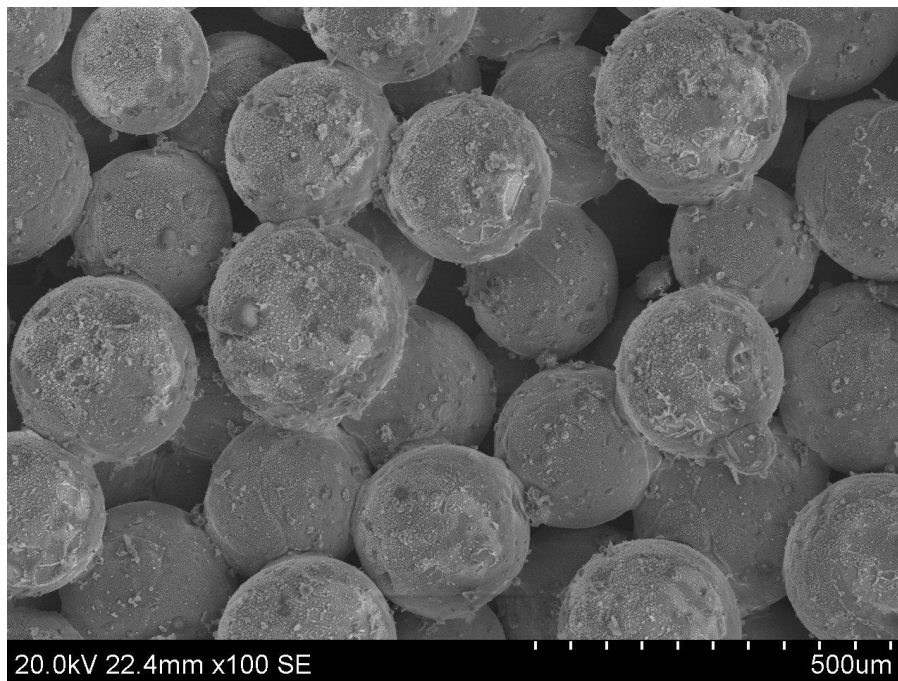
**Figure 25** shows the structure of the pressure regulator adapter air cup. It is composed of numerous metallic spheres approximately 250  $\mu\text{m}$ , or 0.250 mm, in size, bonded together in a process known as sintering. The random spacing between the spheres varies in size from a few microns to as much as 300 or 400 microns and acts as a filter for most particulates that might be present in the gas flow upstream of the regulator by creating a tortuous path. EDS of the air cup revealed metallic peaks of aluminum, nickel, copper, and zinc which are consistent with brass alloys.

Figure 25. SEM micrograph of incident air cup structure.

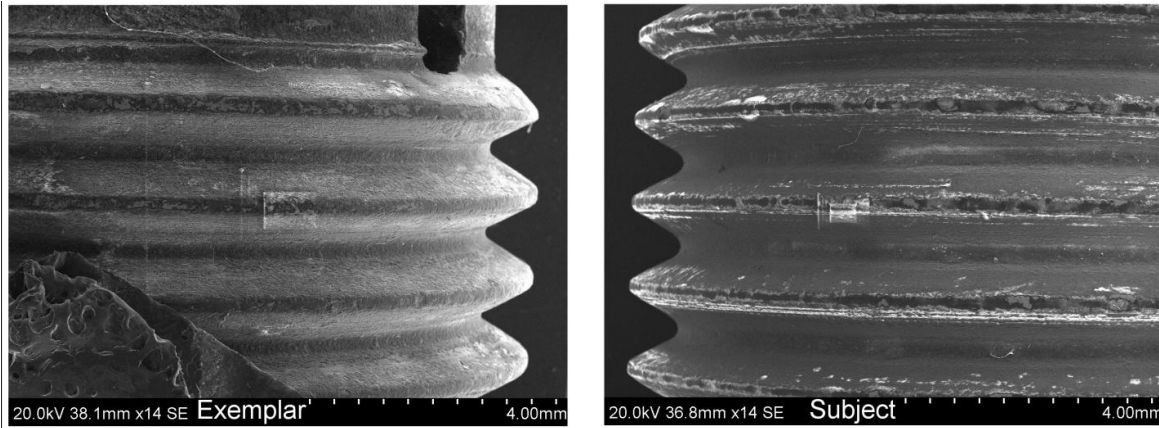
**Figure 26** and **Figure 27** show side by side comparison images of the exemplar and incident valve seat bodies in the threads and the smooth shaft, respectively. In **Figure 27** the extent of the coating is clearly visible on both bodies. EDS of both valve seat bodies in an uncoated area produced copper and zinc peaks indicative of brass alloys.

Figure 26. SEM micrographs comparing threaded portions of exemplar (left) and incident (right) valve seat bodies.

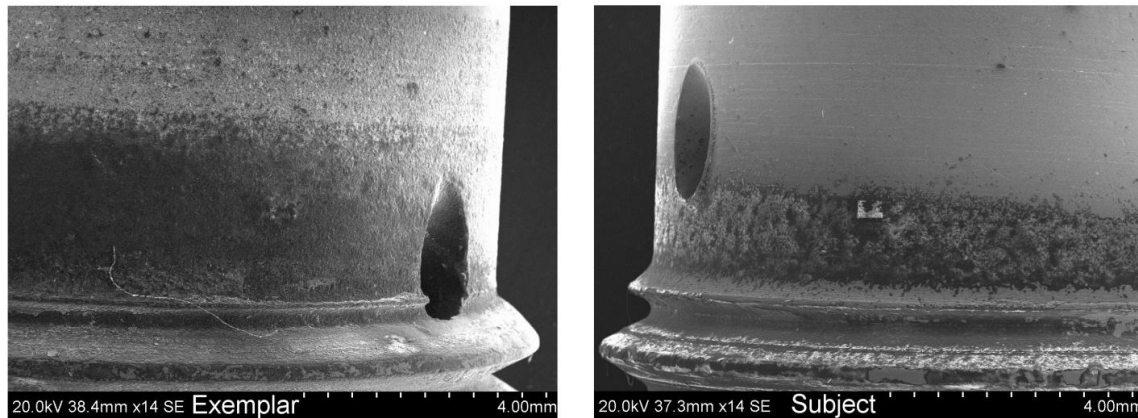
Figure 27. SEM micrographs comparing smooth portions of exemplar (left) and incident (right) valve seat bodies.

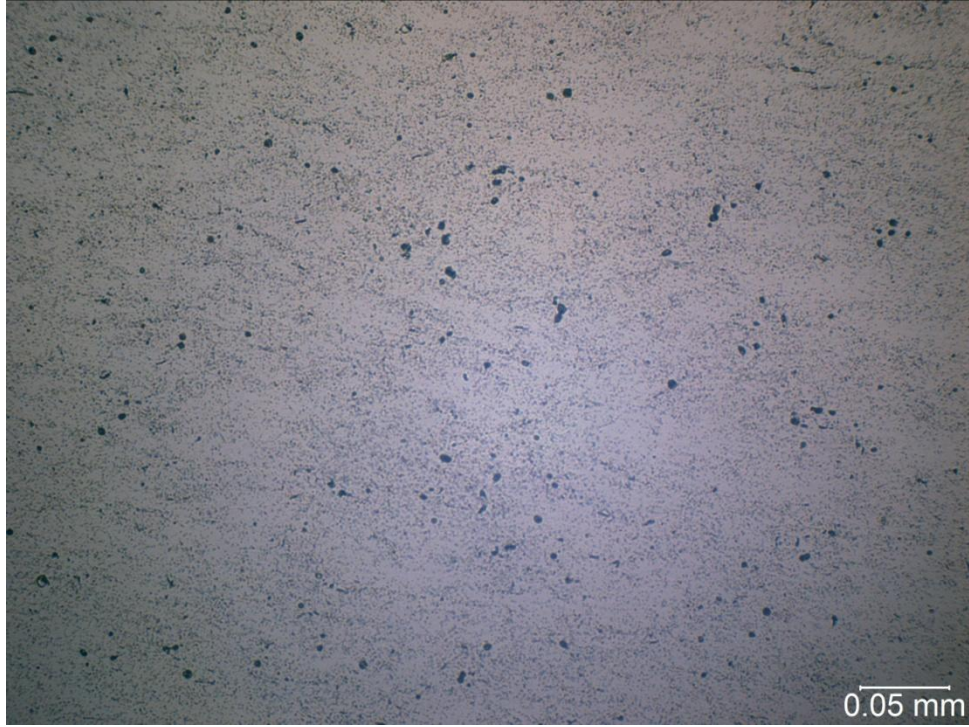
Samples A through D, as seen in **Figure 31**, were mounted and polished for metallographic examination. A weak hydrofluoric solution was used as an etchant to reveal the grain structure. The specimens were examined optically using a metallograph and images captured from various regions of all four samples. **Figure 32** and **Figure 33** show representative micrographs of samples A and D. Micrographs from all the samples were compared to a representative micrograph of 6061-T6 published in “Introduction to Aluminum Alloys and Tempers”.<sup>7</sup> The microstructures compare favorably, confirming that the incident cylinder was manufactured from 6061-T6.

Figure 32. Sample A center 200x

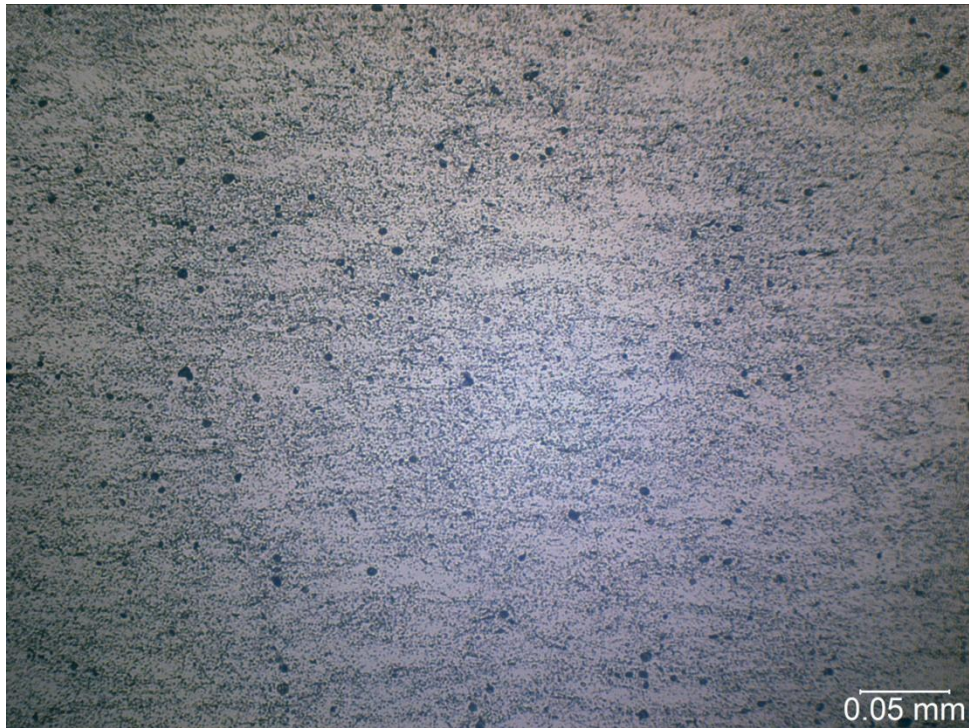
Figure 33. Sample D center 200x

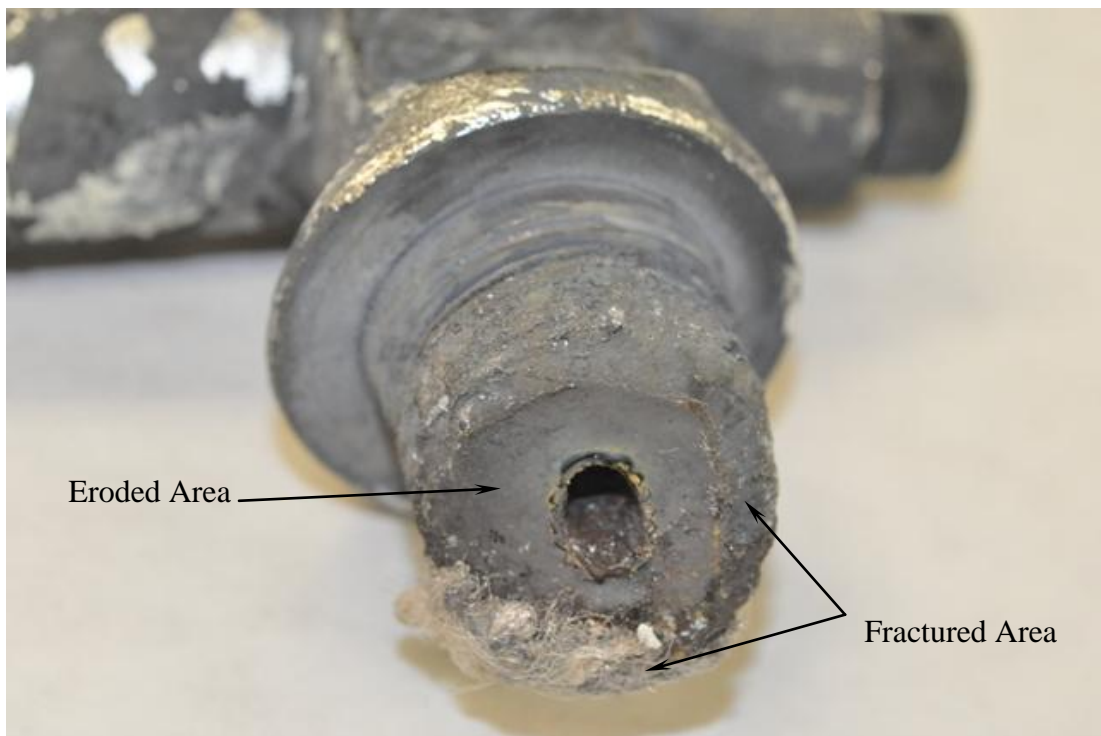
The cylinder valve base also exhibits a matching pattern of erosion consistent with combustion from ignited aluminum, and alloying<sup>8</sup> from flowing molten aluminum, all originating from the threaded region within the threaded neck cylinder opening, as seen in **Figure 36**. There is a region along the perimeter that exhibits fracture as well as melting and reaction. The gross erosion was angled to the axial normal, indicating that once ignited, the products of combustion were expelled downward into the cylinder. The damage pattern suggests the initial ignition and resultant kindling to promoted ignition occurred within the threads closest to the edge of where the threaded neck cylinder opening bottom and cylinder valve threads meet.

Figure 36. View of cylinder valve threaded area.

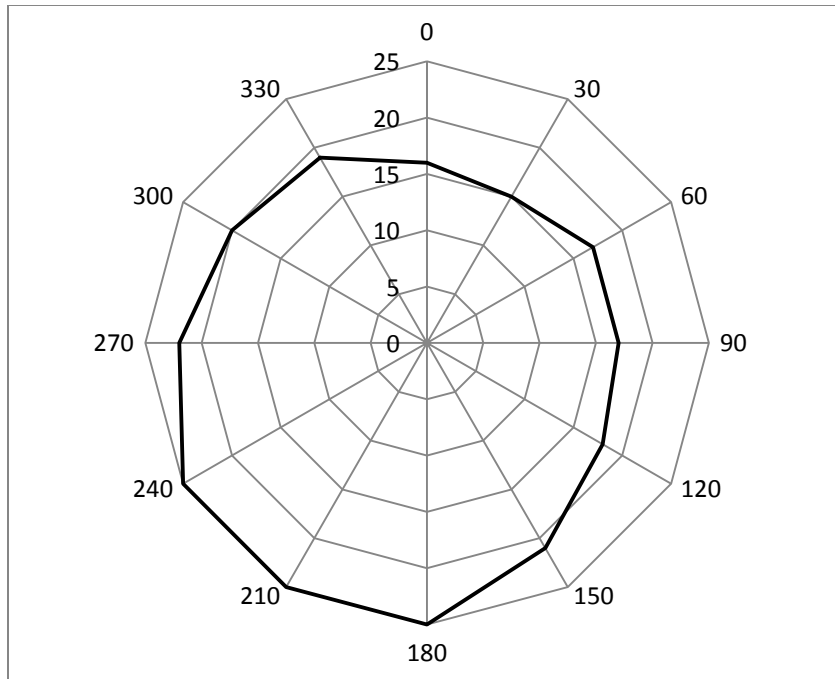
outlet centerline. As seen in **Figure 37**, the region with the greatest erosion was at 30°, with the least erosion at between 180° and 240°. Superimposing the radial plot with **Figure 35** and rotating the data -60° results in a near perfect overlay as seen in **Figure 38**. The closeness of fit supports the notion that the ignition point did occur within the threaded region. The exemplar cylinder valve threads extend 25 mm from the gasket lip to the flat bottom. The smallest depth of the valve threads measured 15 mm, indicating that perhaps 10 mm of material had eroded from the threads at that point.

Figure 37. Depth measurements of the valve threaded area, in mm.

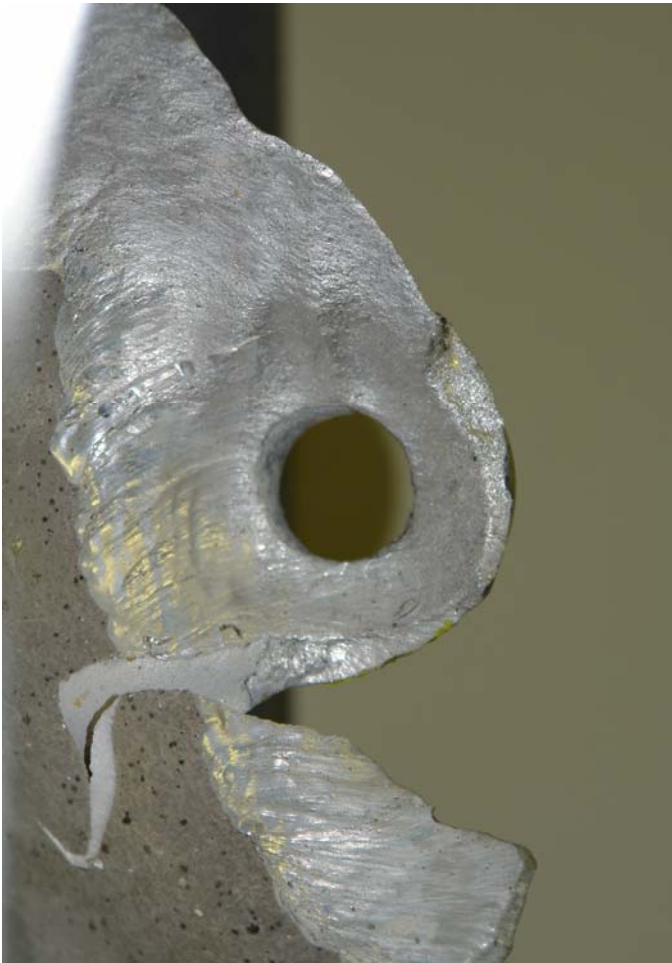
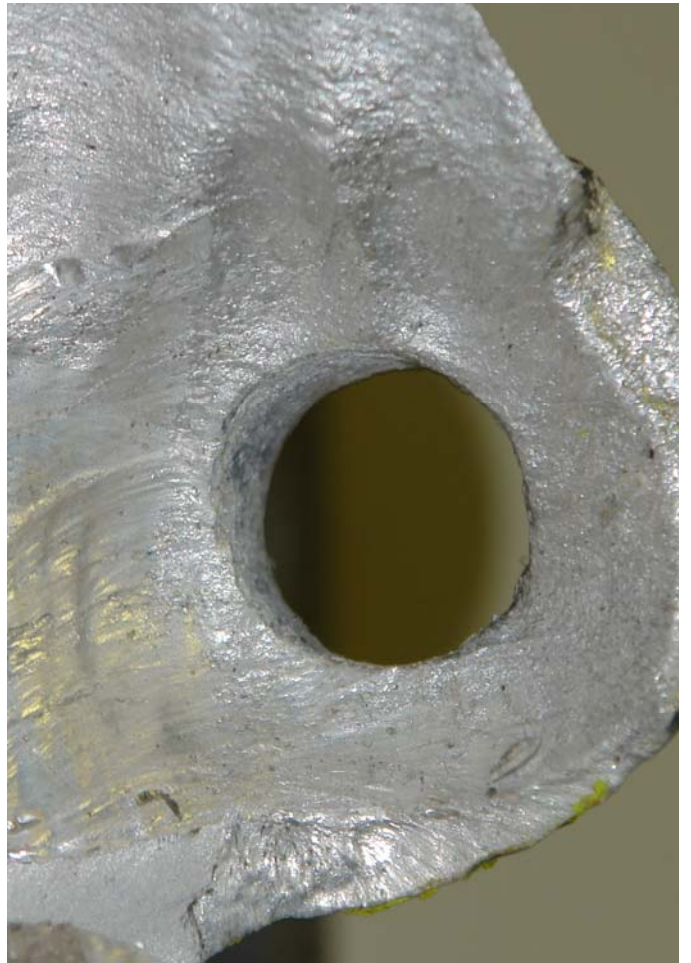
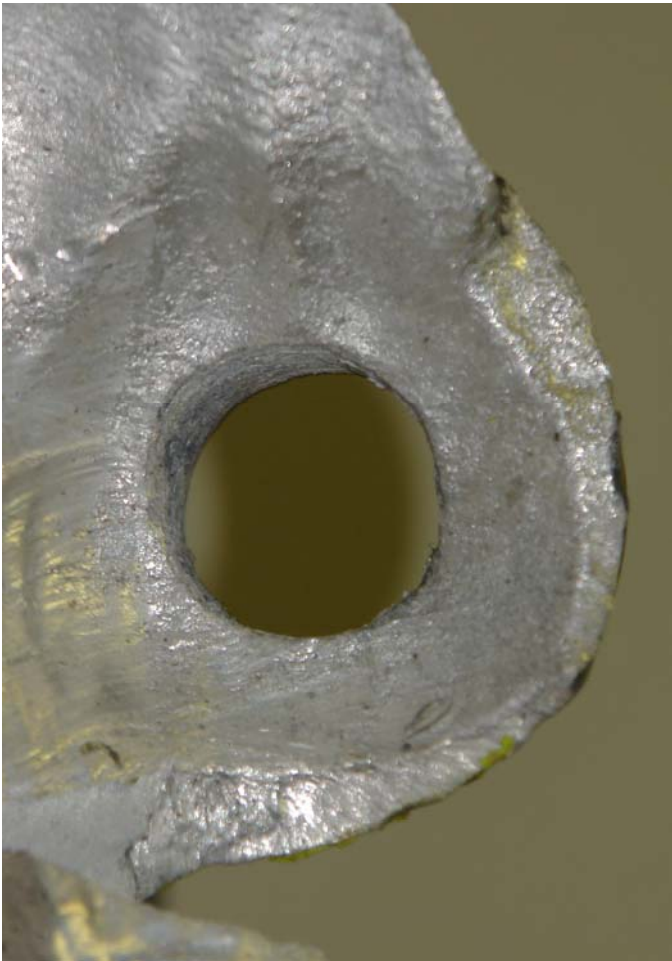
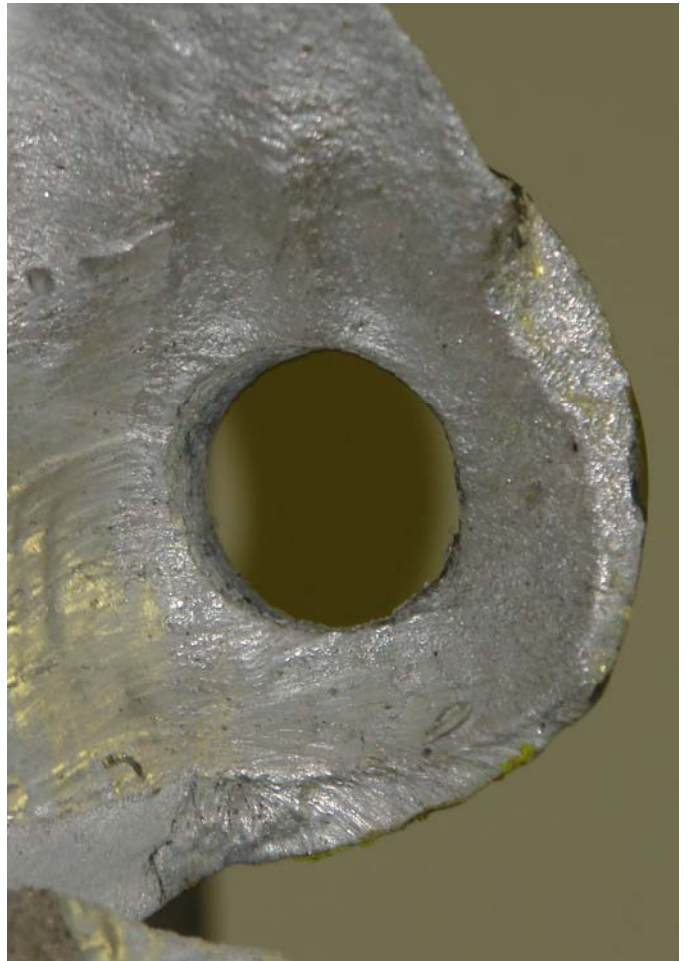
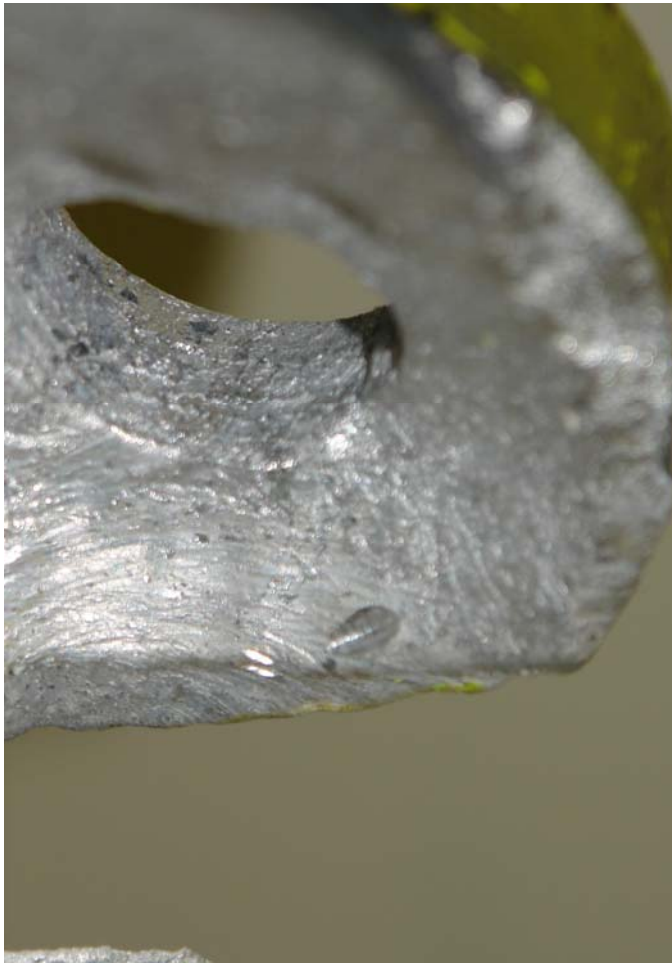
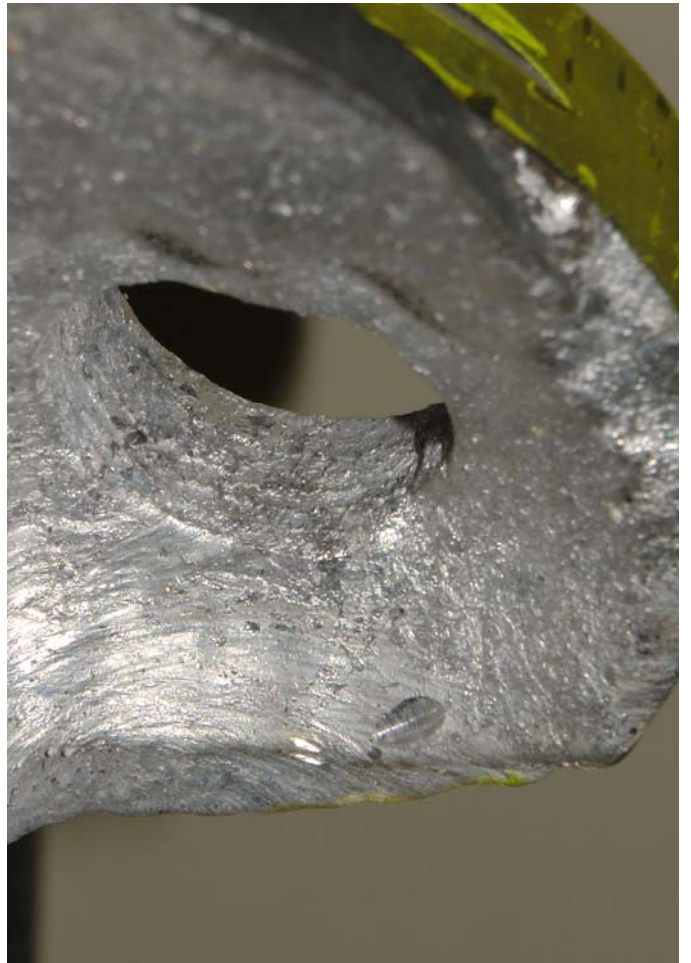
Inspection Photos of Jun. 8, 2012

Images of interior surface combustion area
