Inflight Cargo Fire
United Parcel Service Company Flight 1307
McDonnell Douglas DC-8-71F, N748UP,
Philadelphia, Pennsylvania
February 7, 2006

NTSB/AAR-07/07

Aircraft Accident Report

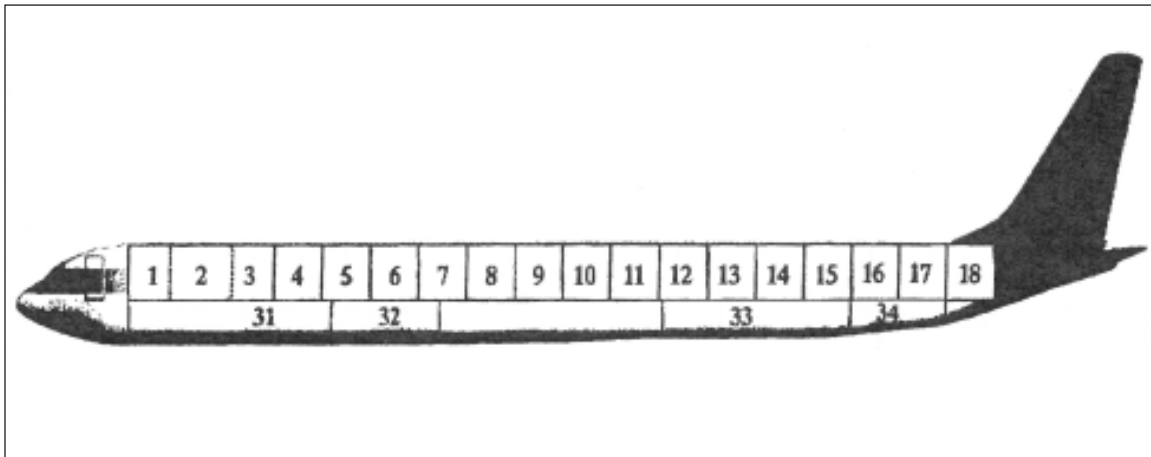
Figure 1. Diagram of the airplane's cargo configuration.

The main cargo compartment smoke detector system, which was installed at the time of the airplane's manufacture, comprised detectors located in the compartment ceiling that were designed to provide a smoke indication whenever the smoke around a detector reached a certain density (80 to 90 percent of normal light transmission). Five of the seven smoke detectors were mounted on the left side of the ceiling at locations corresponding to cargo containers 2, 5, 8, 11/12, and 14. The other two detectors were mounted next to each other near the ceiling centerline at locations corresponding to cargo containers 17 and 18. (See figure 1.)

had been consumed by fire, and the upper structure was sagging in several areas above containers 9, 10, and 11. None of the individual container floors or the main cargo compartment floor exhibited fire damage. (See figure 1.)
