SUBJECT: QUAD CITIES NUCLEAR POWER STATION  
NRC SPECIAL INSPECTION REPORT 50-254/02-03(DRS)

Report No: 50-254/02-03

Facility: Quad Cities Nuclear Power Station, Units 1 and 2

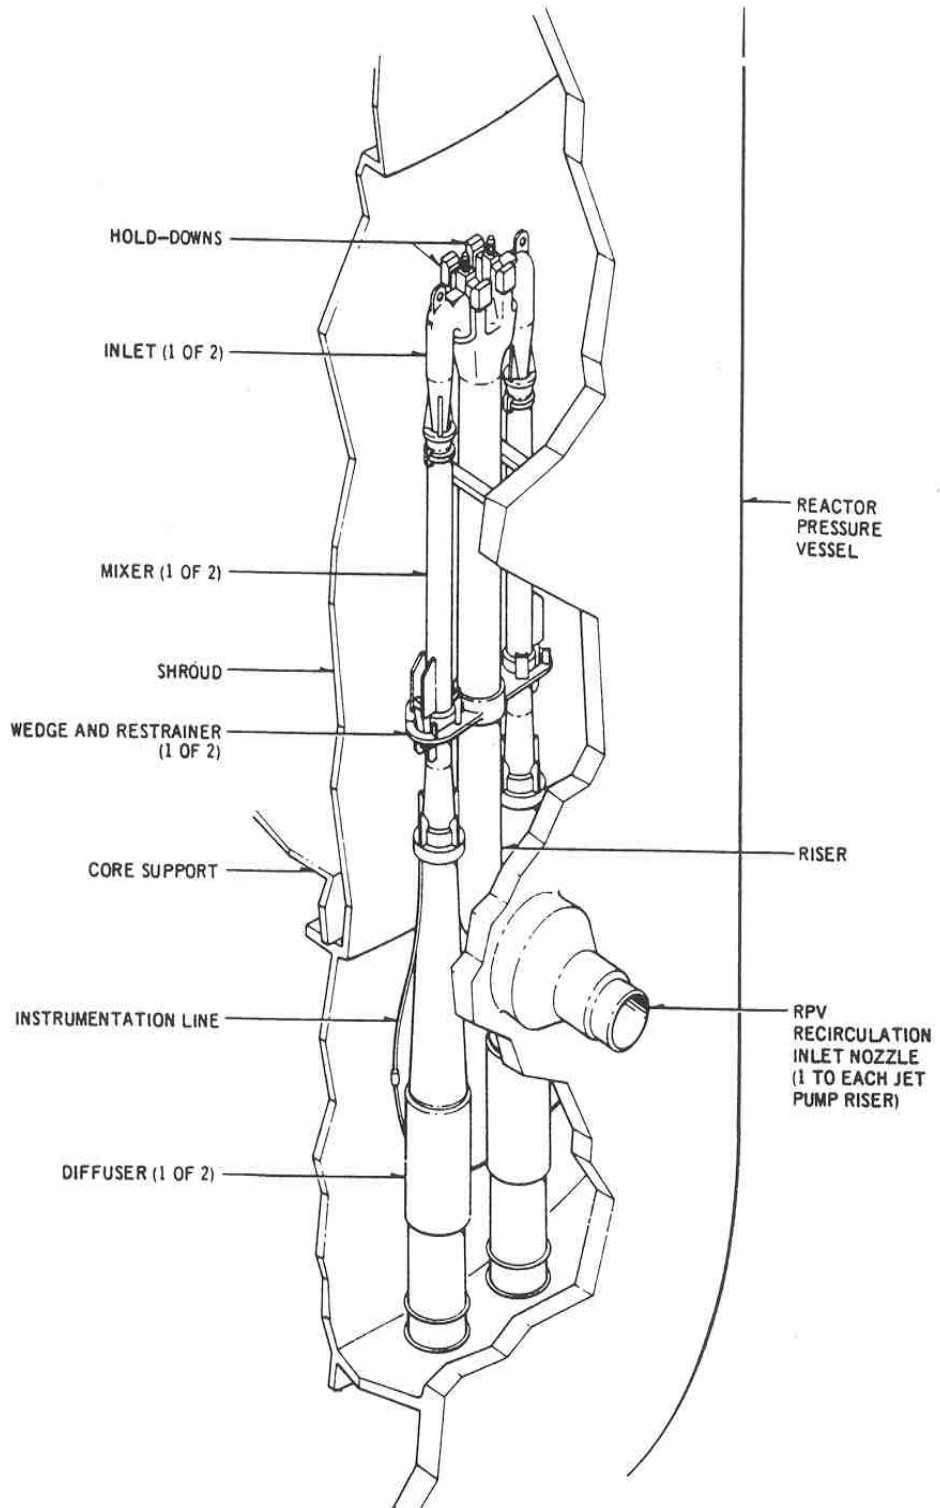
**JET PUMP BEAM No. 20**

On February 28, 2002, the NRC completed a Special Inspection at Quad Cities Unit 1 reactor facility regarding a failed Unit 1 jet pump hold-down beam (#20). The enclosed report documents the inspection findings which were discussed on February 28, 2002, and April 12, 2002, with Mr. Tulon and other members of your staff.

.3 Root Cause of Jet Pump Beam #20 failure

The inspectors reviewed the licensee's preliminary investigation and root cause documents.
