Loss of Control While Maneuvering
Pilatus PC-12/45, N128CM
Butte, Montana
March 22, 2009

NTSB/AAR-11/05
PB2011-910405

**LOSS OF CONTROL WHILE MANEUVERING
PILATUS PC-12/45, N128CM
BUTTE, MONTANA
MARCH 22, 2009**

NTSB/AAR-11/05
PB2011-910405
Notation 8102A
Adopted July 12, 2011

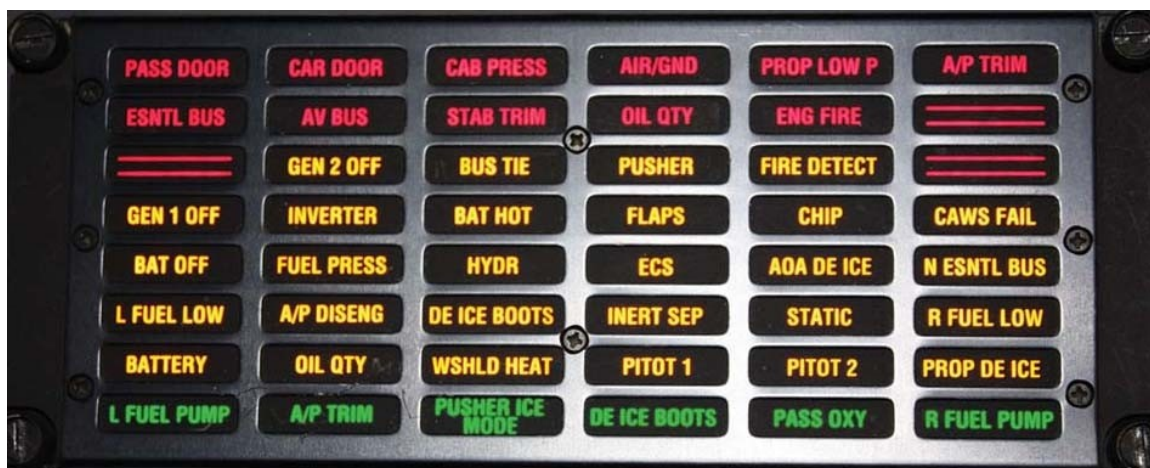
Figure 5. Central advisory and warning system display.

As shown in figure 5, among the CAWS indications were amber cautions for low fuel quantity (“L FUEL LOW” and “R FUEL LOW”) and low fuel pressure (“FUEL PRESS”) and green advisories for fuel boost pump operation (“L FUEL PUMP” and “R FUEL PUMP”). According to the PC-12 AFM, section 7, Airplane and Systems Description, dated February 28, 2005, a low fuel quantity occurs when the fuel level in a tank is less than 20 gallons (133 pounds), and low fuel pressure occurs when fuel system pressure is less than 2 psi. The “L FUEL PUMP” and “R FUEL PUMP” advisories showed that power was being relayed to the respective pump and was thus an indirect indication of boost pump operation. The CAWS was not configured with a direct indication of boost pump operation or output. As a result, pilots are required, as part of the AFM Before Starting Engine checklist, to manually activate each boost pump switch and audibly verify pump operation before each flight.
