Miami International Airport, Automated People Mover  
Train Collision with Passenger Terminal Wall  
Miami, Florida  
November 28, 2008

NTSB/RAR-11/01  
PB2011-916301

# Railroad Accident Report

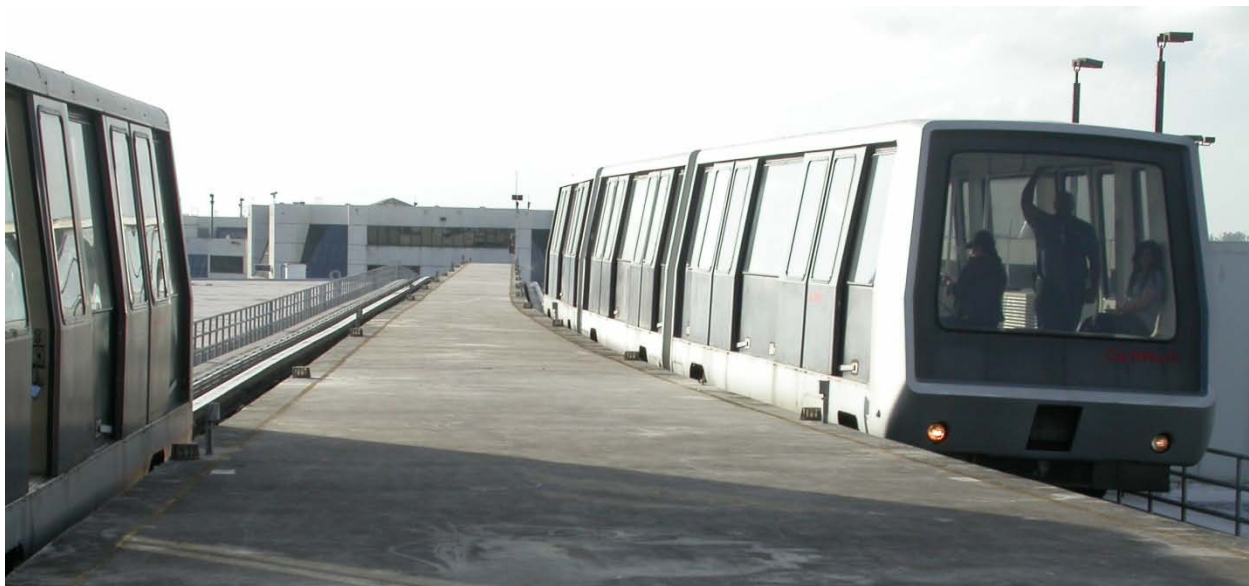
**Figure 2.** APM trains of the type involved in this accident. In this view, looking west toward Satellite E, the south train is on the left.

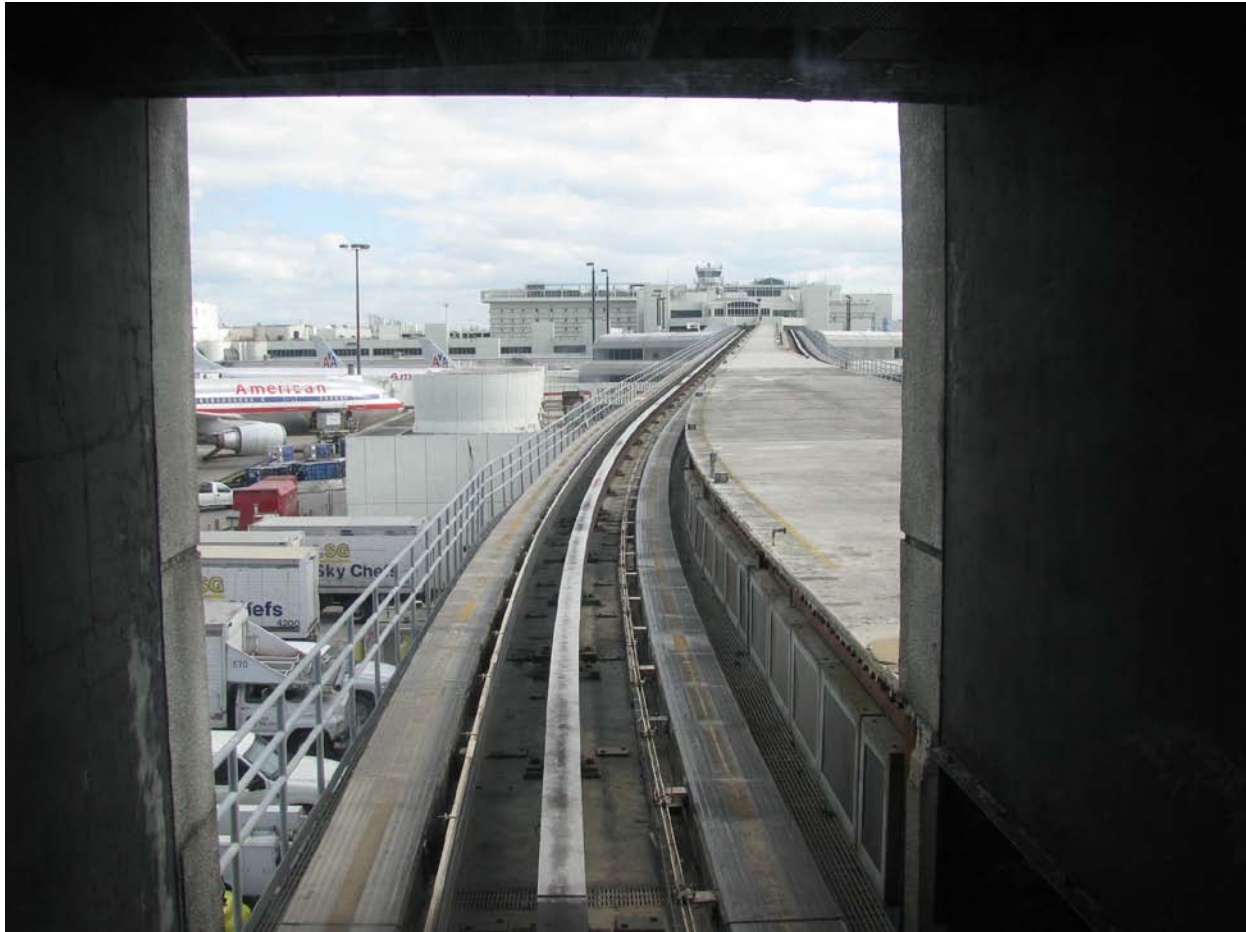
**Figure 3.** APM north train guideway looking toward the main terminal.
