Long-Term Performance of Corrosion Inhibitors Used in Repair of Reinforced Concrete Bridge Components

Publication No. FHWA-RD-01-097

U.S. Department of Transportation
Federal Highway Administration
Research and Development
6300 Georgetown Pike
McLean, VA 22101-2296

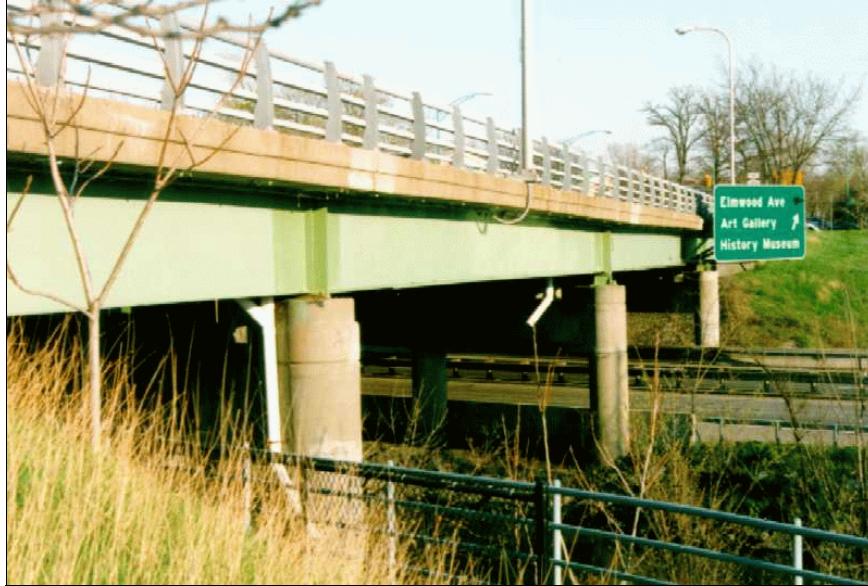
Figure 2-1. General view of the Elmwood Avenue bridge over NY Route 198, Buffalo, NY.

The Elmwood Avenue bridge over NY Route 198, Buffalo, NY, carries two northbound and two southbound lanes of traffic. The bridge has four spans and is supported by three piers with four circular columns each. Figure 2-1 shows a general view of the Elmwood Avenue bridge. Rehabilitation of the bridge (deck, approaches, sidewalks, piers, and abutments) started in March 1992, and was completed in October 1992. The substructure repair work was performed in stages between these dates as weather permitted.

Visual surveys were conducted during all three visits. In October 1994, approximately 2 years after the repair of the piers, the west section of the south face of all three pier caps appeared sound and no spalls were observed. The patched areas, particularly those with inhibitor treatments, were severely cracked. The observed cracking pattern was mud-flat cracking, typical of drying shrinkage cracks. During the second and third visits (May 1997, and June 1998, respectively), the drying shrinkage cracks appeared to be about the same. However, minor spalling was observed in the three piers.

Delamination surveys were conducted during the first and third visits; results are presented in table 2-1. The first evaluation (October 1994) revealed hollow-sounding areas in patches of all three south face sections and in the original concrete within the south face sections of the control and Cortec-treated pier cap faces. It was not determined whether the hollow-sounding areas were the result of continued corrosion, drying shrinkage cracking, or disbondment of the patch material. It was noted in the SHRP C-103 Field Validation report (Publication No. SHRP-S-658) that difficulties were encountered in bonding the cast-in-place patch concrete to the original concrete. Researchers detected hollow-sounding areas in patch concrete within weeks after the repairs were completed. The researchers did not survey all of the patch areas and did not verify that all hollow-sounding areas were repaired.

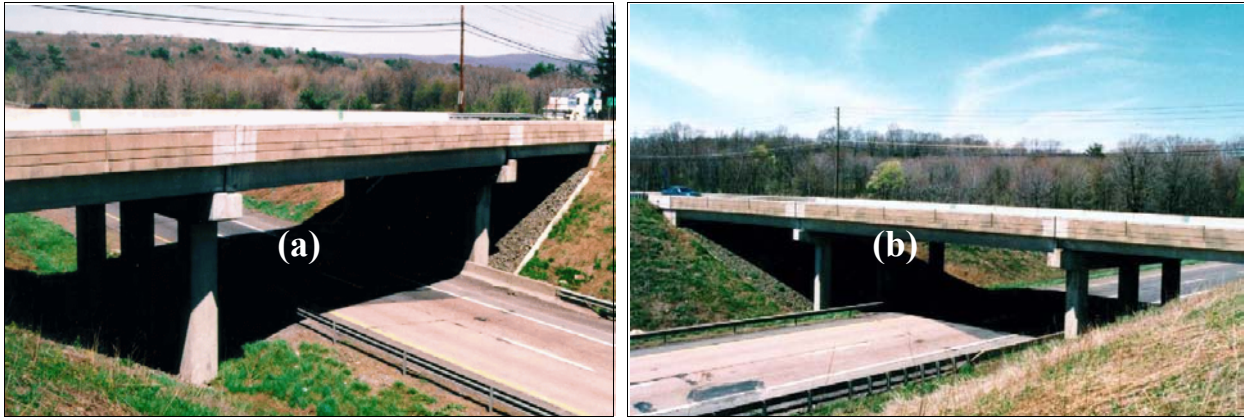
**Figure 3-1. General views of the SR 2042 bridge structures over I-81:
(a) west bridge and (b) east bridge.**

The Pennsylvania State Road (SR) 2042 bridge consists of two three-span structures and carries traffic in an east-west direction over the north and southbound lanes of I-81. The west bridge carries SR 2042 traffic over southbound I-81, and the east bridge carries SR 2042 traffic over northbound I-81. Each bridge is approximately 43 m long and 12 m wide, consisting of two 3.66-m-wide traffic lanes and two 2.44-m-wide breakdown lanes. Piers are numbered 1 through 4 from east to west. Piers 1 and 2 are on the east bridge, and piers 3 and 4 are on the west bridge. Figures 3-1 (a) and (b) show general views of the west bridge and the east bridge, respectively.

Piers 1, 2, and 3 were selected for SHRP C-103 field trial installation of shotcrete/corrosion-inhibitor repair systems. Areas of unsound concrete were delineated and removed to a depth of 19 millimeters (mm) below the reinforcing steel level with pneumatic hammers before repairs were begun. The exposed steel was sandblasted to near-white metal prior to application of the shotcrete and inhibitor treatment. In all patch repair areas, a wire mesh was tied to the reinforcing steel mat.

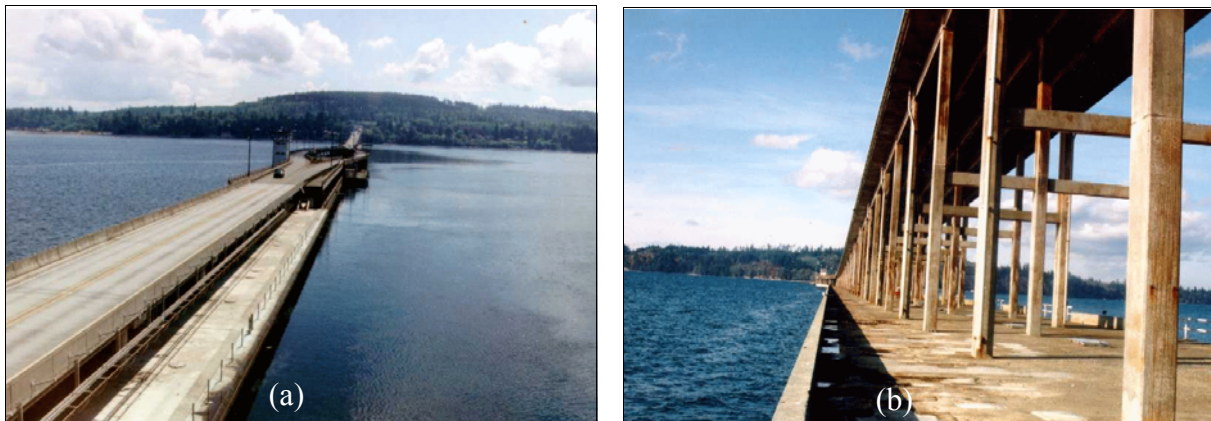
Figure 4-1. General views of the Hood Canal bridge.

The floating bridge was constructed in 1961. In 1979, the western half of the bridge sank in a storm and was subsequently replaced. Corrosion of the concrete reinforcing steel in the pontoon decks and substructure members is evident throughout the older eastern half of the floating bridge. Previous repairs to the eastern half of the bridge included patching of the pontoon decks, columns, and crossbeams, and the coating of these surfaces with epoxy. Even though the pontoon decks are about 1.5 m above high tide, they are constantly exposed to wind-blown brackish water mist, especially on the southern side of the decks. Water tends to pond on the deck surface. As a result, corrosion has continued unabated in the original and repaired concrete areas.

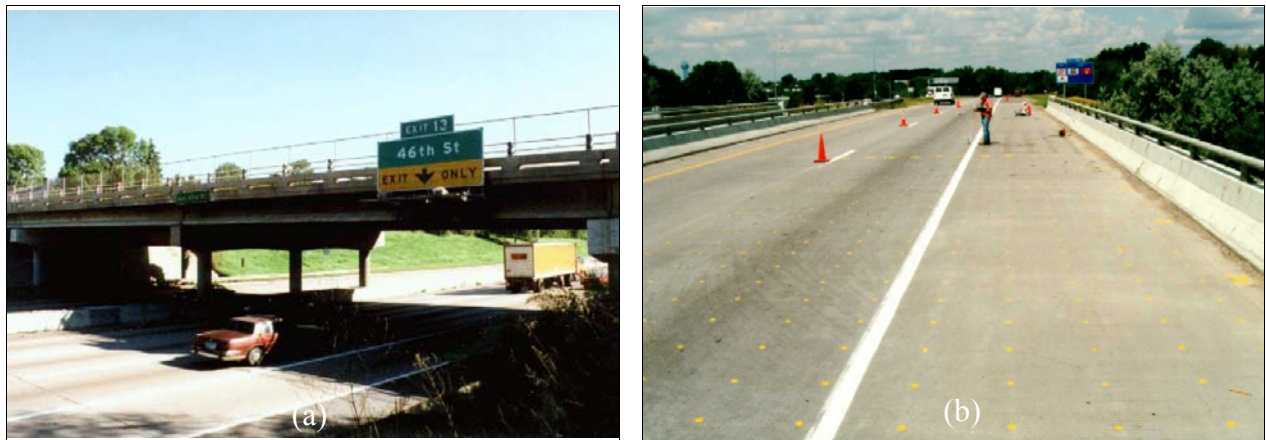
Figure 5-1. TH-3 over the Southview Boulevard bridge: (a) structure and (b) deck.

The TH-3 bridge over Southview Boulevard is located in south St. Paul, MN. TH-3 (recently renamed TH-52) is a main northbound arterial carrying southern traffic into St. Paul. The bridge was built in 1973 and is approximately 50 m long and 14 m wide, with one breakdown lane and two traffic lanes. The breakdown and right traffic lanes are approximately 3.35 m and 3.65 m wide, respectively. There is also a 0.92-m-wide shoulder adjoining the left traffic lane. Spans 1, 2, and 3 are 13.5 m, 23.0 m, and 12.5 m long, respectively. The deck, parapets, and substructure are cast-in-place reinforced concrete. The superstructure consists of precast, prestressed I-beams. Figures 5-1 (a) and (b) show general views of the structure and deck, respectively.

The deck was rehabilitated and overlaid with a 5.08-cm Low-Slump Dense Concrete (LSDC) mix in May-June 1992. About 3.81 cm of the original chloride-contaminated concrete was milled off to the top layer of reinforcing steel and unsound areas were removed with a pneumatic hammer. The entire deck surface was sandblasted to remove laitances prior to placement of the overlay.
