BIENNIAL REPORT 111th CONGRESS

AMERICANS WITH DISABILITIES ACT INSPECTIONS RELATING TO PUBLIC SERVICES AND ACCOMODATIONS

**Office of Compliance
August 2012**

Accessibility in the Legislative Branch – Report on Americans with Disabilities Act Inspections Relating to Public Services and Accommodations during the 111th Congress

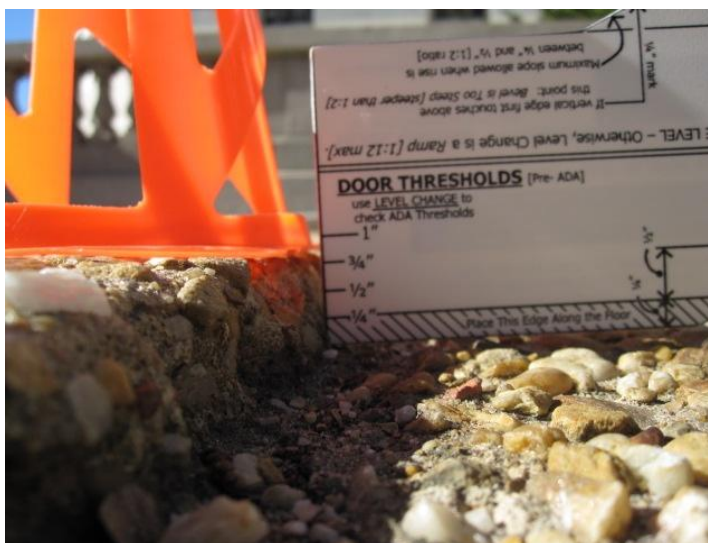
Example of Barrier Created by Level Change

Both the 1991 and 2010 Standards require that changes in level in excess of 1/2 inch be ramped. Under both the 1991 and 2010 Standards, changes in level up to 1/4 inch are allowed without modification, but level changes between 1/4 inch and 1/2 inch must be beveled at a 1:2 slope.¹¹
