Pacific Gas and Electric Company  
Natural Gas Transmission Pipeline Rupture and Fire  
San Bruno, California  
September 9, 2010

NTSB/PAR-11/01  
PB2011-916501

NTSB/PAR-11/01  
PB2011-916501  
Notation 8275C  
Adopted August 30, 2011

# Pipeline Accident Report

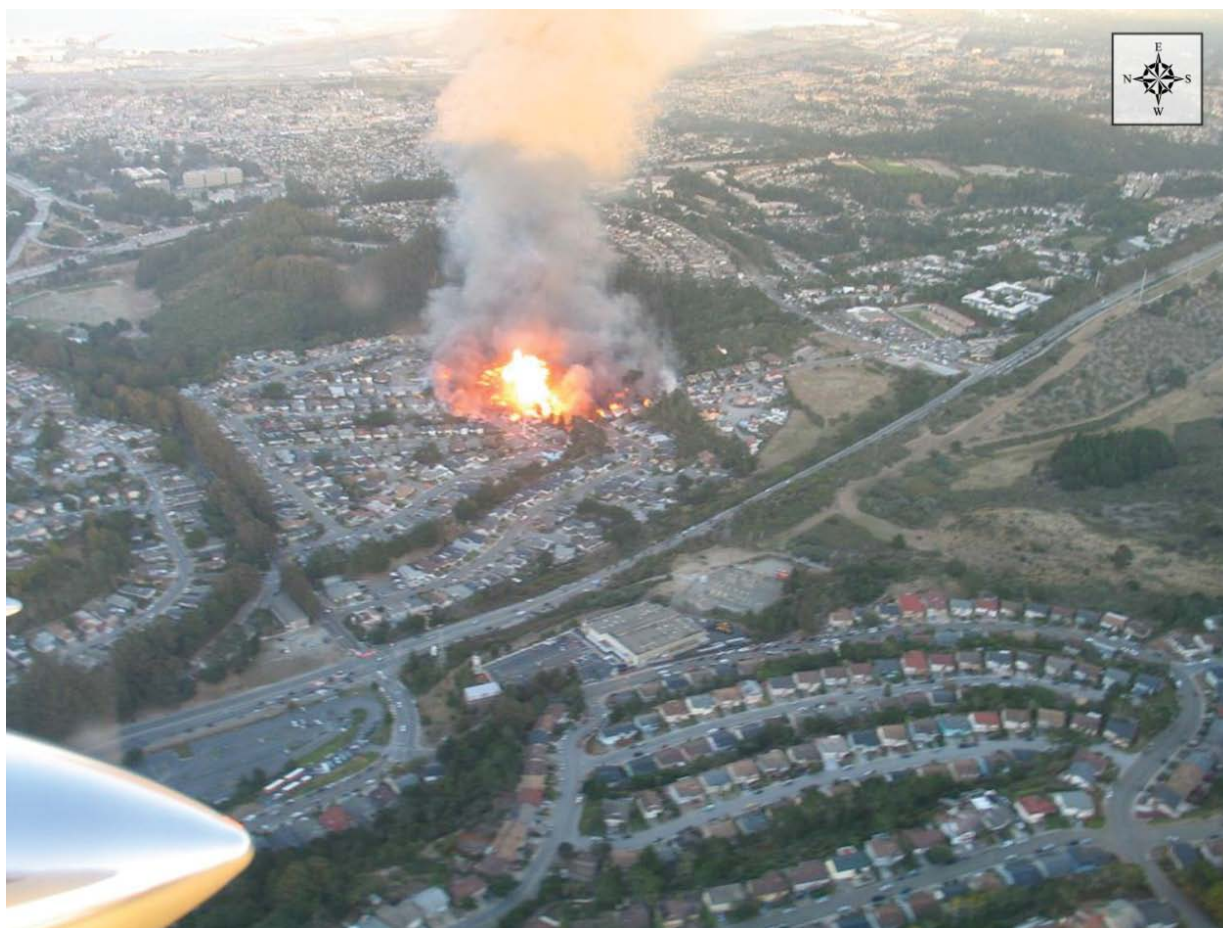
**Figure 3.** Aerial view of fire.

On September 9, 2010, about 6:11 p.m. Pacific daylight time,<sup>1</sup> a 30-inch-diameter segment of an intrastate natural gas transmission<sup>2</sup> pipeline known as Line 132, owned and operated by the Pacific Gas and Electric Company (PG&E), ruptured in a residential area in San Bruno, California. The rupture occurred at mile point (MP) 39.28 of Line 132,<sup>3</sup> at the intersection of Earl Avenue and Glenview Drive. The rupture produced a crater about 72 feet long by 26 feet wide. (See figure 1.) The section of pipe that ruptured, which was about 28 feet long, and weighed about 3,000 pounds, was found 100 feet south of the crater. (See figure 2.) PG&E estimated that 47.6 million standard cubic feet of natural gas was released. The released natural gas ignited, resulting in a fire that destroyed 38 homes and damaged 70. (See figure 3.) Eight people were killed, many were injured, and many more were evacuated from the area.

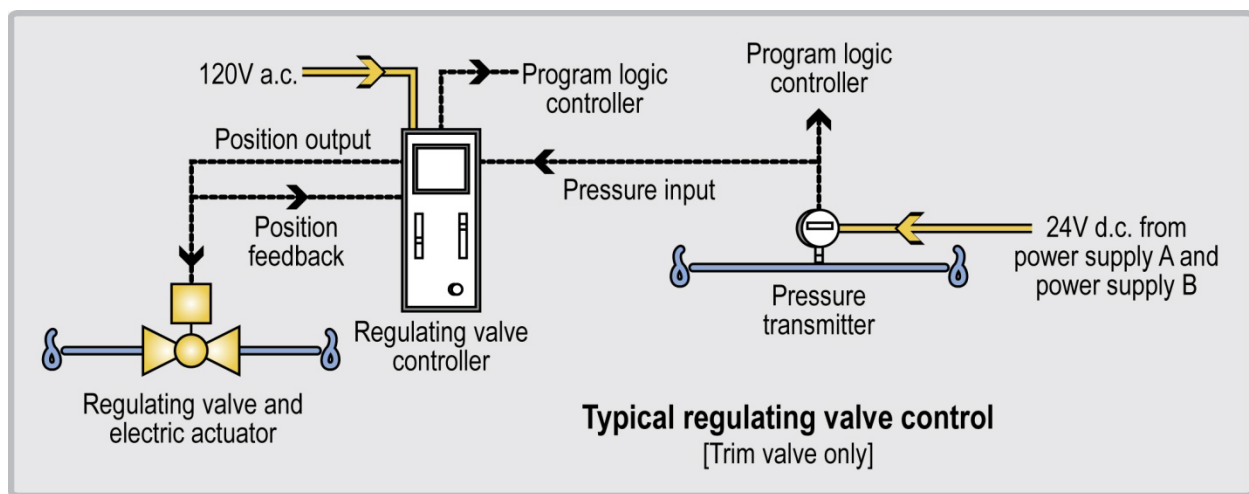
Figure 7. Schematic showing regulating valve control.

erratic voltages to pressure transmitters resulted in an erroneous low pressure signal to regulating valve controllers, causing them to command the regulating valves to a fully open position. (See figure 7.) Until then, the regulating valves on all incoming lines except Line 300B had been closed. When the valves opened fully, the monitor valves, whose purpose is to protect against accidental overpressure, became the only means of pressure control. The erratic voltages from the 24-volt power supplies also affected valve position sensors, generating erroneous signals to the SCADA center.

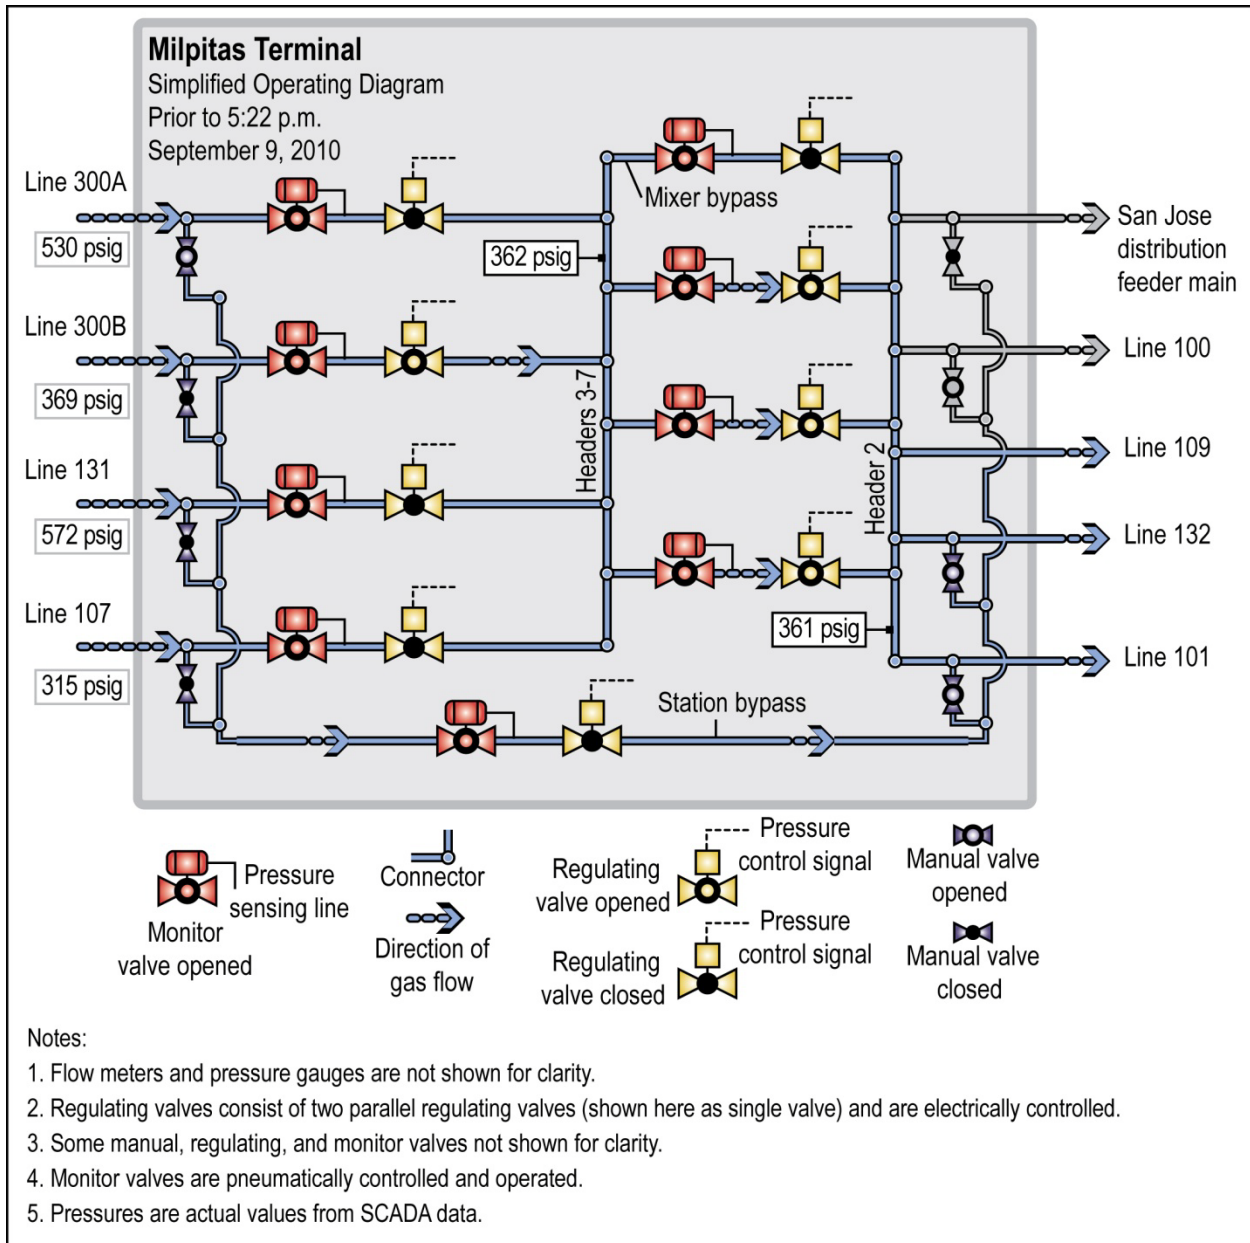
**Figure 8a.** Valve configuration at the Milpitas Terminal prior to 5:22 p.m.

At 5:22 p.m., as a result of regulating valves fully opening and the erroneous signals caused by the erratic voltages, the SCADA center alarm console displayed over 60 alarms within a few seconds, including controller error alarms and high differential pressure and backflow alarms from the Milpitas Terminal. (See figure 8a.) These alarms were followed by high and high-high pressure alarms<sup>13</sup> on several lines leaving the Milpitas Terminal, including Line 132. At 5:25 p.m., SCADA operator C called the Milpitas technician to report the high pressure alarms, stating that they “look real.” During this conversation, the Milpitas technician realized that the pressure and regulating valve controller displays on the local control panel had lost all data. At the same time, the SCADA consoles displayed constant pressures<sup>14</sup> on the downstream lines and showed all regulating and a majority of monitor and incoming line valves<sup>15</sup> at the Milpitas Terminal as not open.<sup>16</sup> (See figure 8b.)

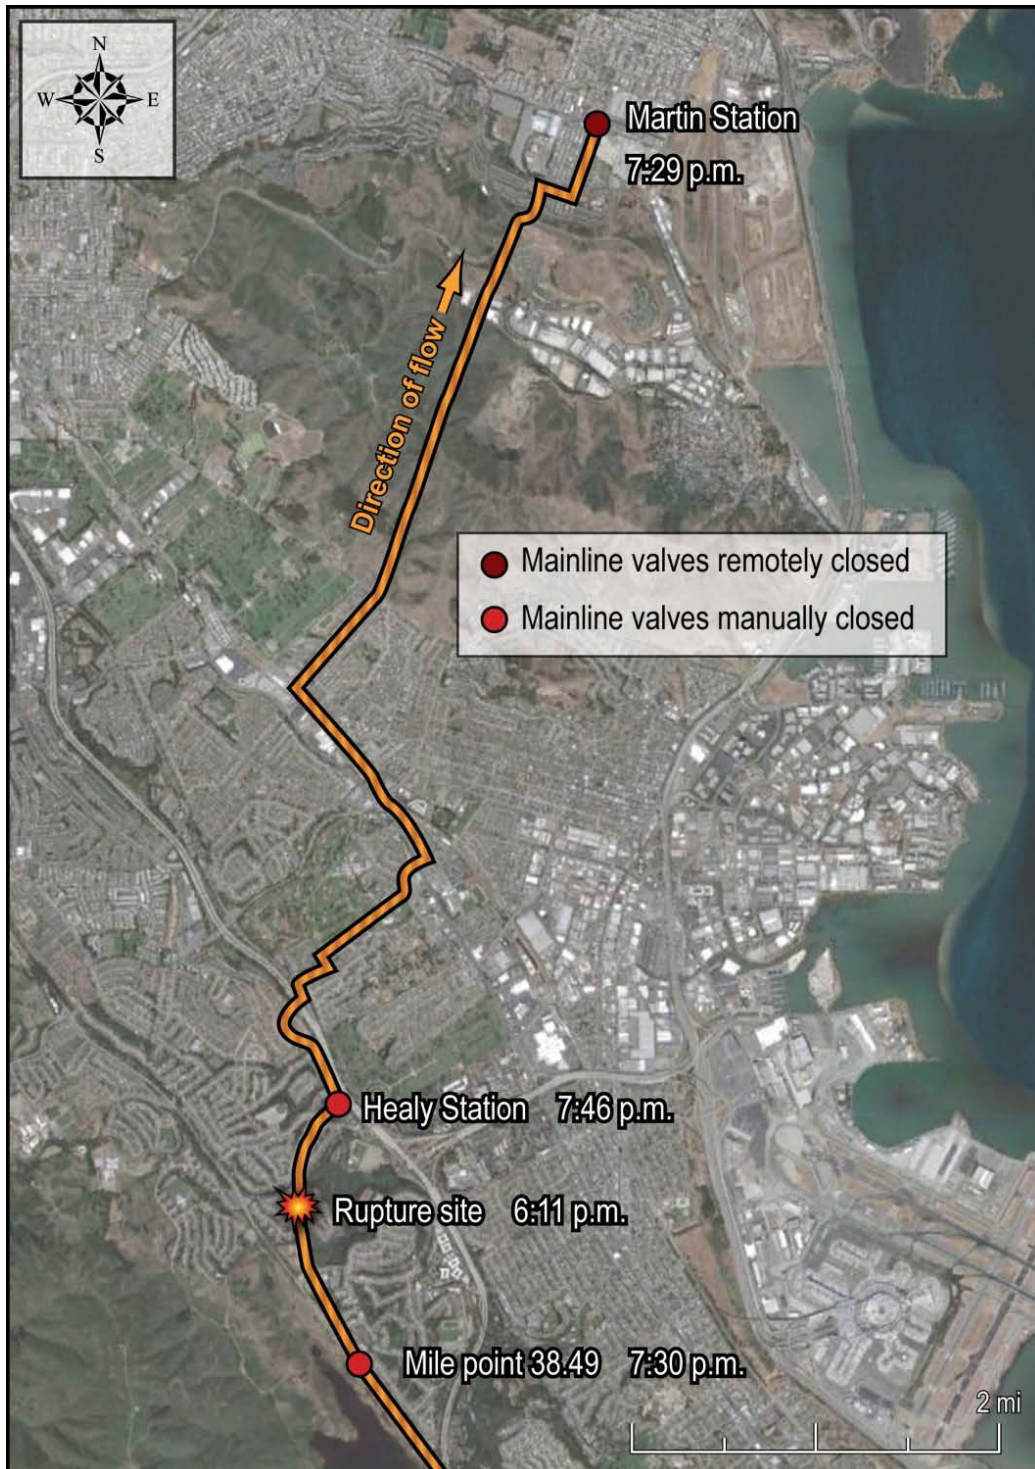
**Figure 10.** Location of valve closures.

At 7:27 p.m., supervisor 6, who was with the two mechanics, requested that the SCADA center close two valves at the Martin Station. SCADA operator D remotely closed the valves downstream of the rupture by 7:29 p.m., which stopped the gas flow from north to south. (See figure 10.)

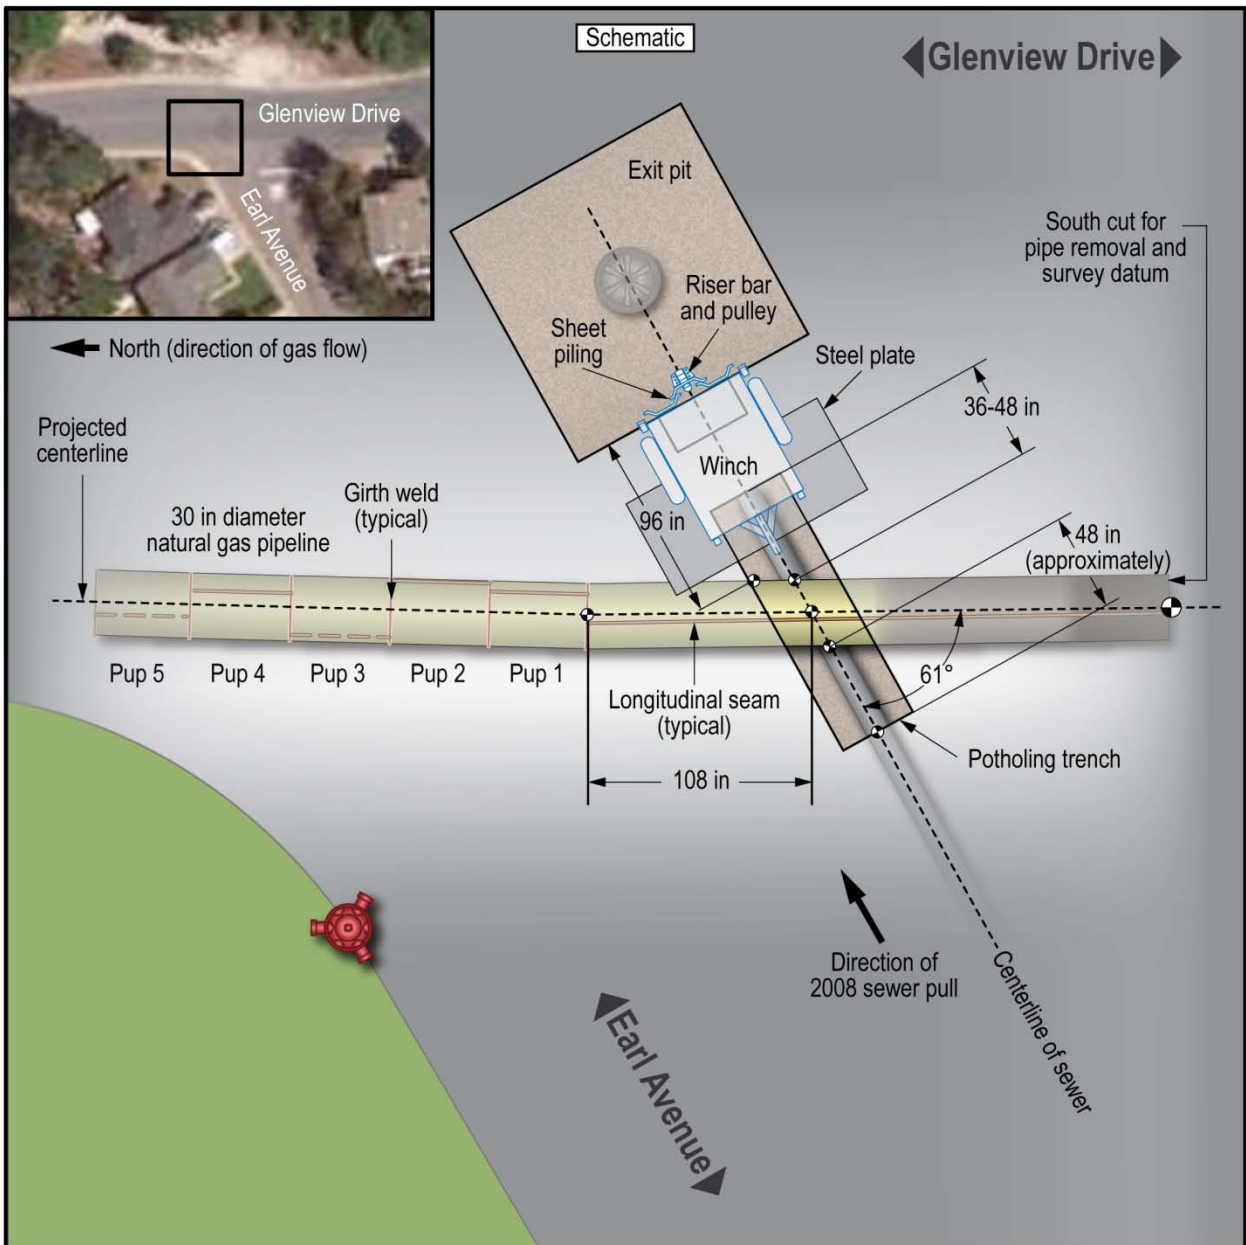
**Figure 17.** Diagram of excavations relative to Segment 180.

The pipe bursting began at the entry pit 290 feet to the west on Earl Avenue. A video of the project recorded the sound of the pneumatic bursting and showed the movement of the replacement pipe at the exit pit and the movement of the cable at the winch. Based on the recording, the pneumatic bursting rate was 214 strokes per minute. Based on the video, the replacement pipe pull rate ranged from 0.1–0.2 inches per second. According to the contractor, the maximum load on the winch was 14,000 pounds and the diameter of the cable was 0.562 inch. As the bursting head approached the potholing trench, the pneumatic device was turned off. From there, the replacement sewer pipe was pulled through the potholing trench, underneath Line 132, and up to the exit pit. (See figure 17.)

According to postaccident interviews, a PG&E gas mechanic was on site while part of the potholing trench was hand dug and after the polyethylene sewer pipeline had been pulled into the exit pit. The gas mechanic measured the vertical clearance between the bottom of Line 132 and the top of the new sewer pipeline, and determined that there was about 9 inches of clearance between the two. He also inspected the gas pipeline for damage and was satisfied with the work; he did not mention any problems or express any concern to the contractor foreman. The contractor proceeded to backfill the trench. The backfilling was neither witnessed nor inspected by the PG&E gas mechanic.

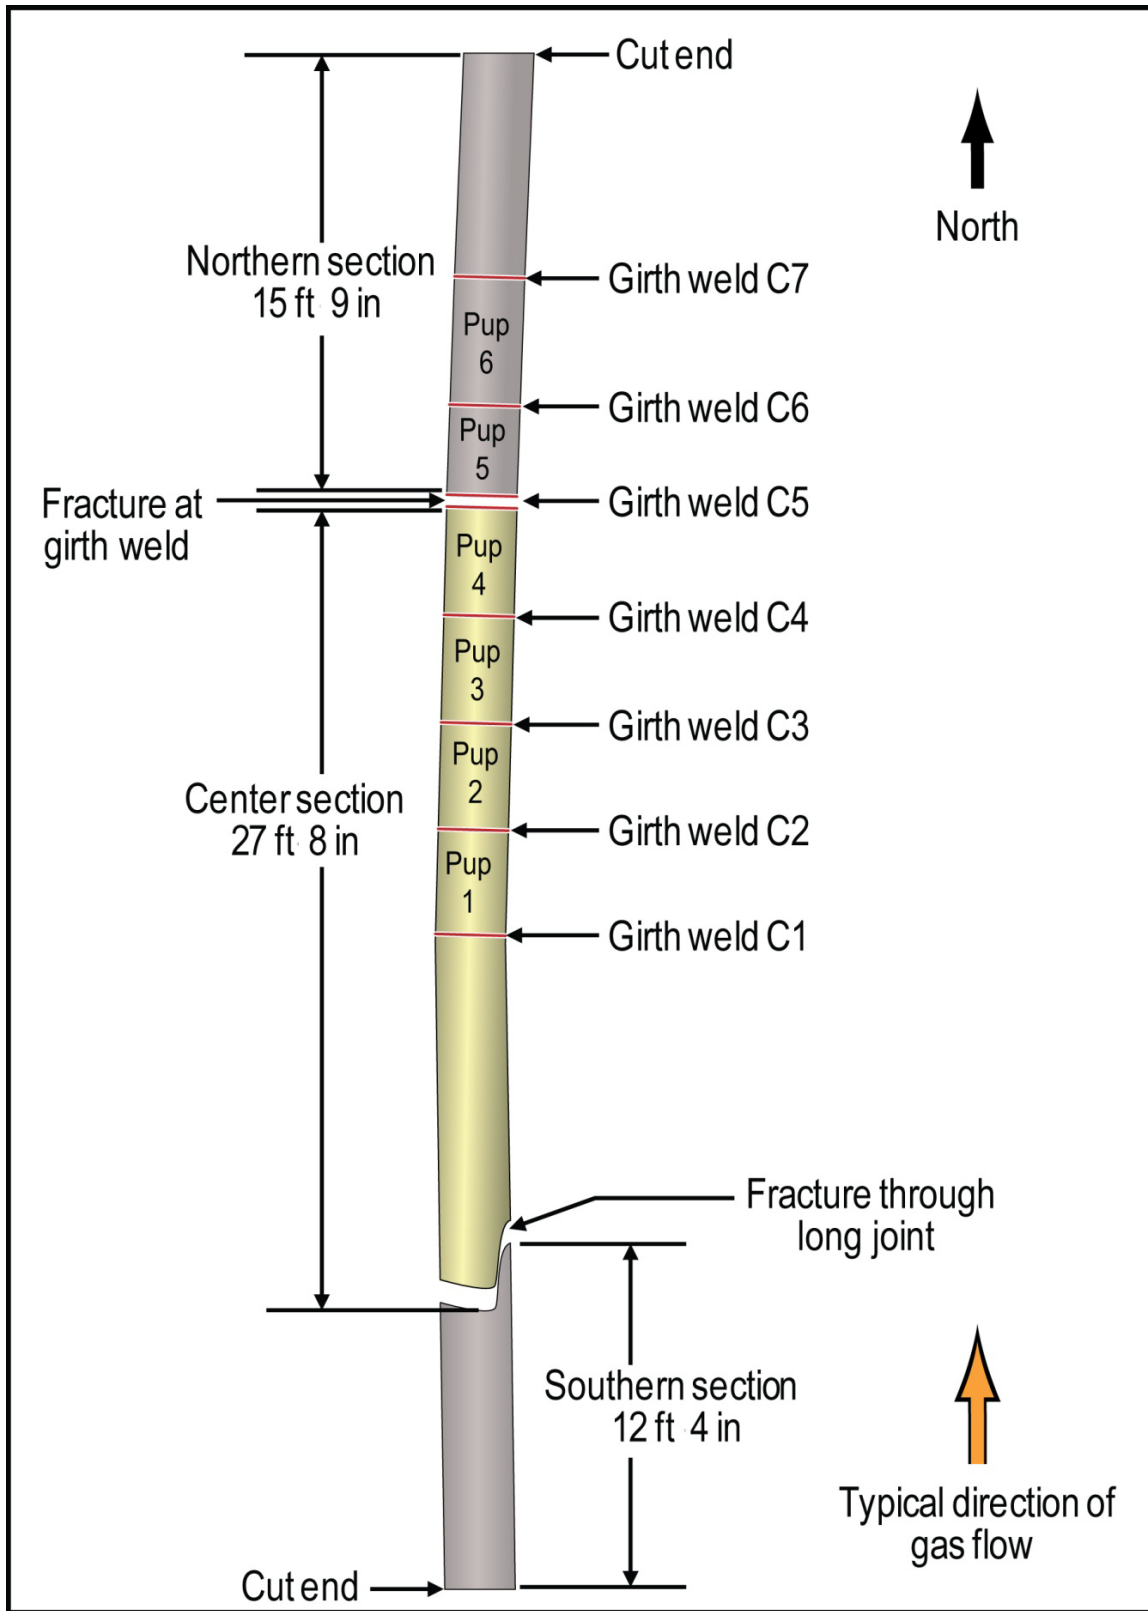
Figure 18. Schematic of accident pipe.

The ruptured section of pipe and two cutout sections of pipe, immediately south and north of the ruptured section, as illustrated in the figure 18 schematic, were examined at the NTSB Materials Laboratory. The southern<sup>63</sup> section of pipe consisted of a single portion of pipe (commonly referred to as a joint).<sup>64</sup> The center section (the ruptured section found about 100 feet from the crater) was fractured at both ends and comprised a continuation of the same long joint from the southern section as well as four shorter lengths of pipe (pups). The northern section of pipe comprised two more pups and a portion of another long joint. For convenience, the pups were numbered 1–6 in the south-to-north direction. The girth welds that joined the pups were numbered sequentially from south to north as C1, C2, and so on through C7.

The length of pups 1–5 varied from 43.00–46.75 inches, and pup 6 measured 54.25 inches. All six pups were nominal 0.375-inch wall thickness pipe, as was the south long joint. However, the north long joint was nominal 0.312-inch wall thickness pipe. The pipe material codes on documents associated with the 1956 relocation project specified 0.375-inch wall thickness pipe. The circumference of each length of pipe was consistent with nominal 30-inch-diameter pipe.

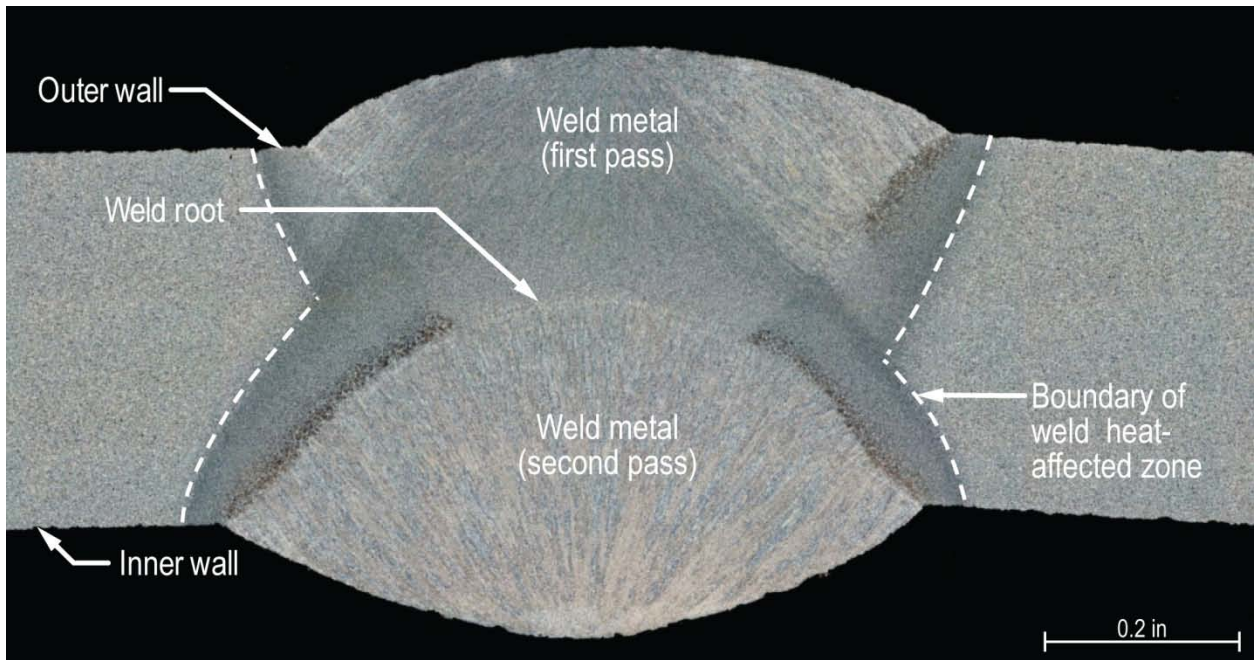
**Figure 19b.** Picture showing cross section of longitudinal seam in typical DSAW pipe.

The longitudinal seam welds on pups 1–3 were fabricated using a fusion welding process that deposited weld metal along the outer portion of the seam, but left an unwelded region along the inner portion of the seam. (See figure 19a.) The weld reinforcement, as well as part of the pipe body for pup 1, had been removed by grinding. The unwelded region persisted along the entire length of each seam. The size of the unwelded region, combined with the grinding of the weld reinforcements (and the pipe body for pup 1), resulted in net intact seam thicknesses of 0.162, 0.195, and 0.162 inch for pups 1, 2, and 3, respectively. The unwelded region defect was observed during a visual weld inspection of each pup. As shown in figure 19a, there was a 15° difference in the orientation of the inner surface of the pipe across the pup 1 longitudinal seam (an angular misalignment). For pup 2, the difference was 0°; and for pup 3, the difference was between 7–10°.

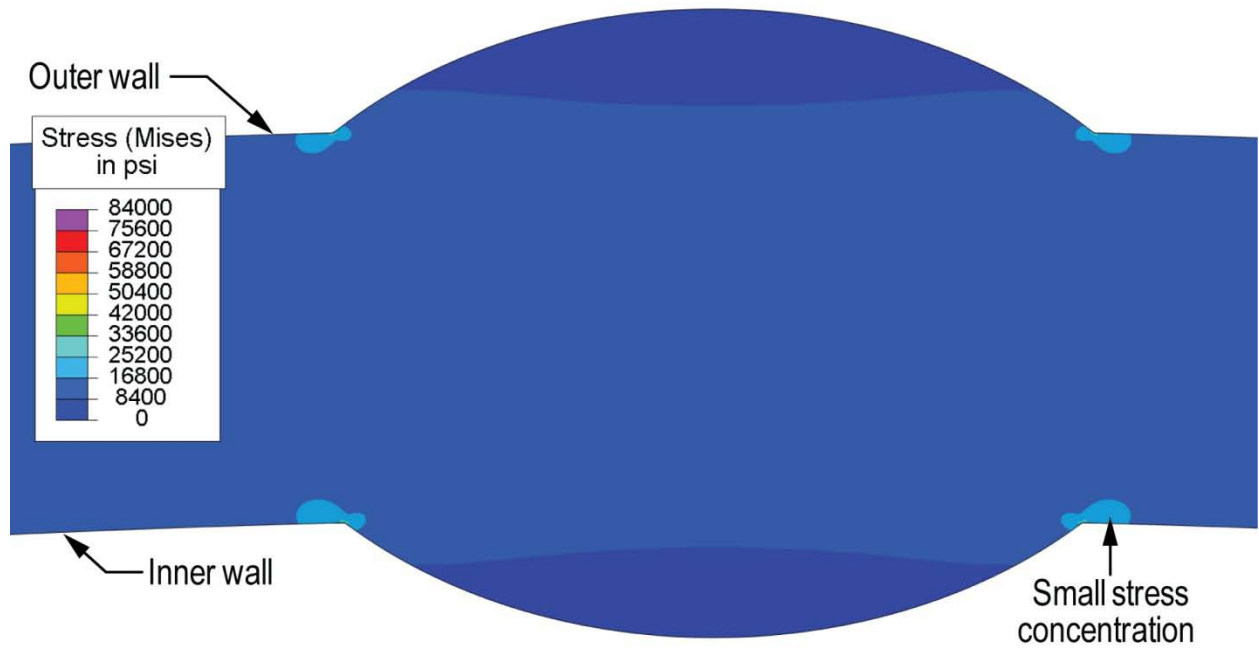
**Figure 22b.** Stress contours at an internal pressure of 375 psig for the finite element model of a DSAW seam. Contour values are the same as in figure 22a.

The model with the DSAW seam had small stress concentrations at the corners where the weld reinforcement intersected the wall of the pipe (on the order of 2 percent of the pipe wall thickness in size), but the stress in the model did not reach the yield stress. The unwelded region and angular misalignment in the model based on the pup 1 seam created a crack-like geometry (that is, notch) leading to a severe stress and strain concentration.<sup>85</sup> In that model, at 375 psig, the zone of material beyond the yield stress was on the order of half the pipe wall thickness in size. (See figures 22a and 22b.) The plastic strains<sup>86</sup> at the pup 1 notch tip were more than 100 percent greater than those of the pipe with the similarly sized weld defect but no angular misalignment. The plastic strains were also as much as 40 percent greater than those for the pup 3 weld geometry.
