Pilot/Race 177, *The Galloping Ghost*  
North American P-51D, N79111  
Reno, Nevada  
September 16, 2011

NTSB/AAB-12/01  
PB2012-102899

# Aircraft Accident Brief

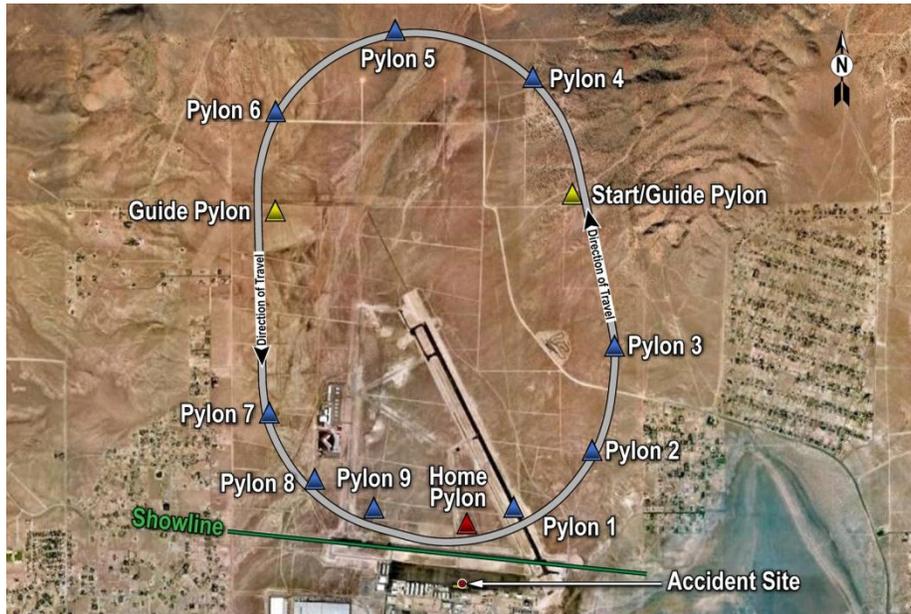
The accident airplane was in third place during the third lap of the six-lap race, trailing the second-place airplane (*Voodoo*, another experimental P-51D) by about 4.5 seconds and the lead airplane (*Strega*, also an experimental P-51D) by about 8.8 seconds. The accident airplane was traveling about 445 knots as it passed pylon 8 (see figure 1) and experienced a left roll upset

**Figure 1.** Diagram of the NCAR unlimited class race course at RTS, showing relative locations of pylons and the accident site.

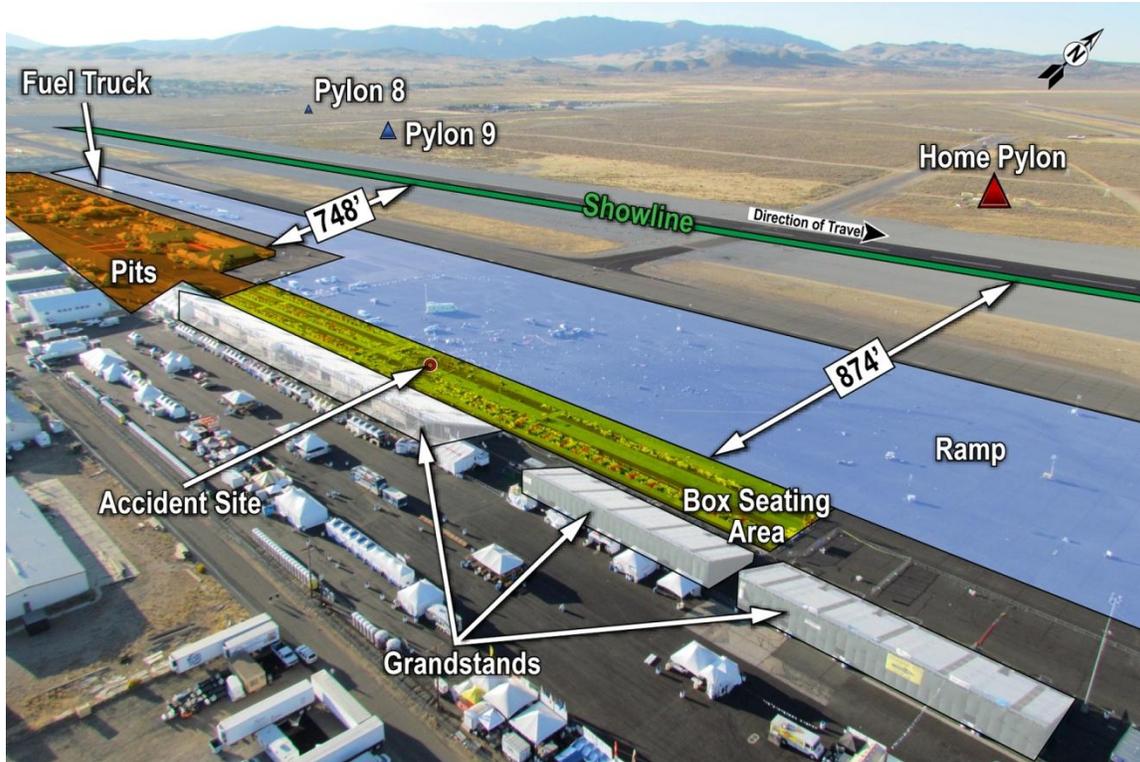
Ten people on the ground were fatally injured and dozens of others sustained minor to serious injuries when the airplane collided with the airport ramp in the spectator box seating area and scattered wreckage debris in the box seating area, ramp, and grandstands. The edge of the box seating area was 874 feet south of the showline, the edge of the pit area (where many other spectators were located) was 748 feet south of the showline, and a fuel truck was parked on the ramp near the pits (see figure 3). Racing airplanes were expected to fly parallel to the showline on the north side.

**Figure 3.** NCAR ramp area layout with accident site depicted.
