Collision of the Tankship *Elka Apollon*
With the Containership *MSC Nederland*
Houston Ship Channel, Upper Galveston Bay, Texas
October 29, 2011

NTSB/MAR-12/02
PB2012-916402

Marine Accident Report

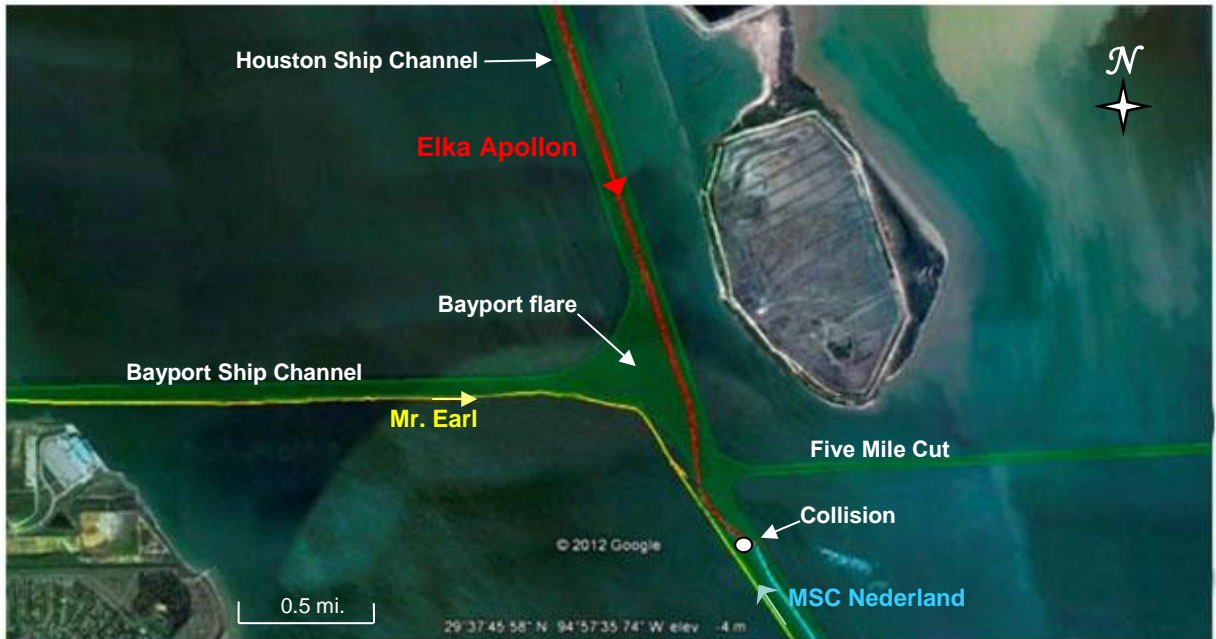
Channel. Also shown are the locations of the *Elka Apollon*, the *MSC Nederland*, and the *Mr. Earl* and their tracklines leading up to the collision. Characteristics of the Houston Ship Channel are described in greater detail in section 1.9, including a specific discussion of Houston pilotage requirements and oversight in section 1.9.3.

Figure 4. Aerial view of the accident area indicating the vessels' movements up to and following the collision. The *Elka Apollon's* trackline is labeled in red, the *MSC Nederland* is in light blue, and the *Mr. Earl's* is in yellow. (Image created by overlaying electronically captured position data on Google Earth image.)

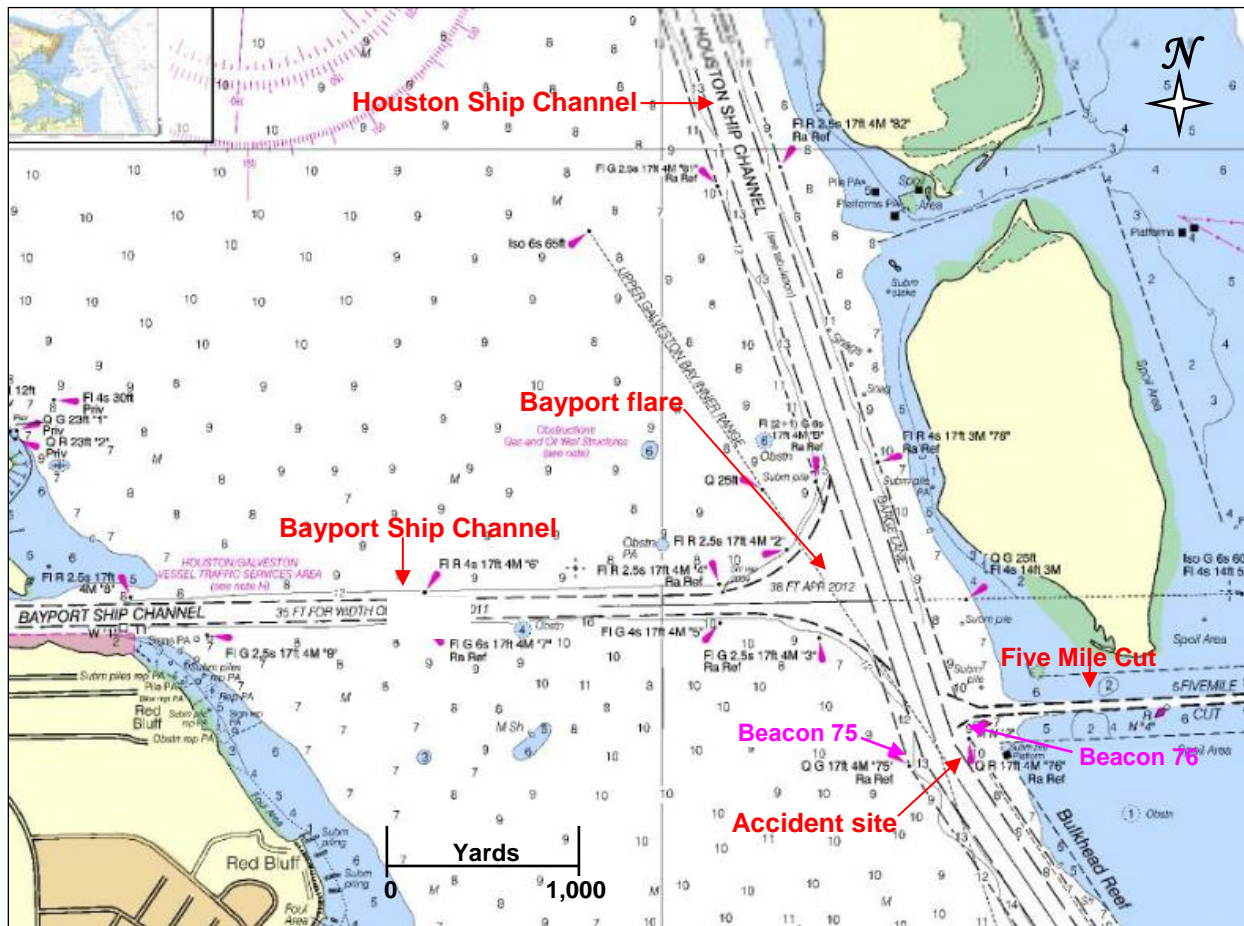
In the vicinity where the accident occurred, the Houston channel makes a 15-degree bend, changing from a course of 161 degrees to 146 degrees (see figure 9). This turn is located at navigation beacons 75 and 76, slightly south of Five Mile Cut. Five Mile Cut allows smaller vessels with a draft of 6 feet or less to transit between the Houston Ship Channel and the shallower portion of Galveston Bay located to the east.

Figure 9. Houston Ship Channel and Bayport flare, as shown in an excerpt from National Oceanic and Atmospheric Administration (NOAA) nautical chart 11327. Along each side of the main Houston channel are the barge lanes, indicated by dashed lines.

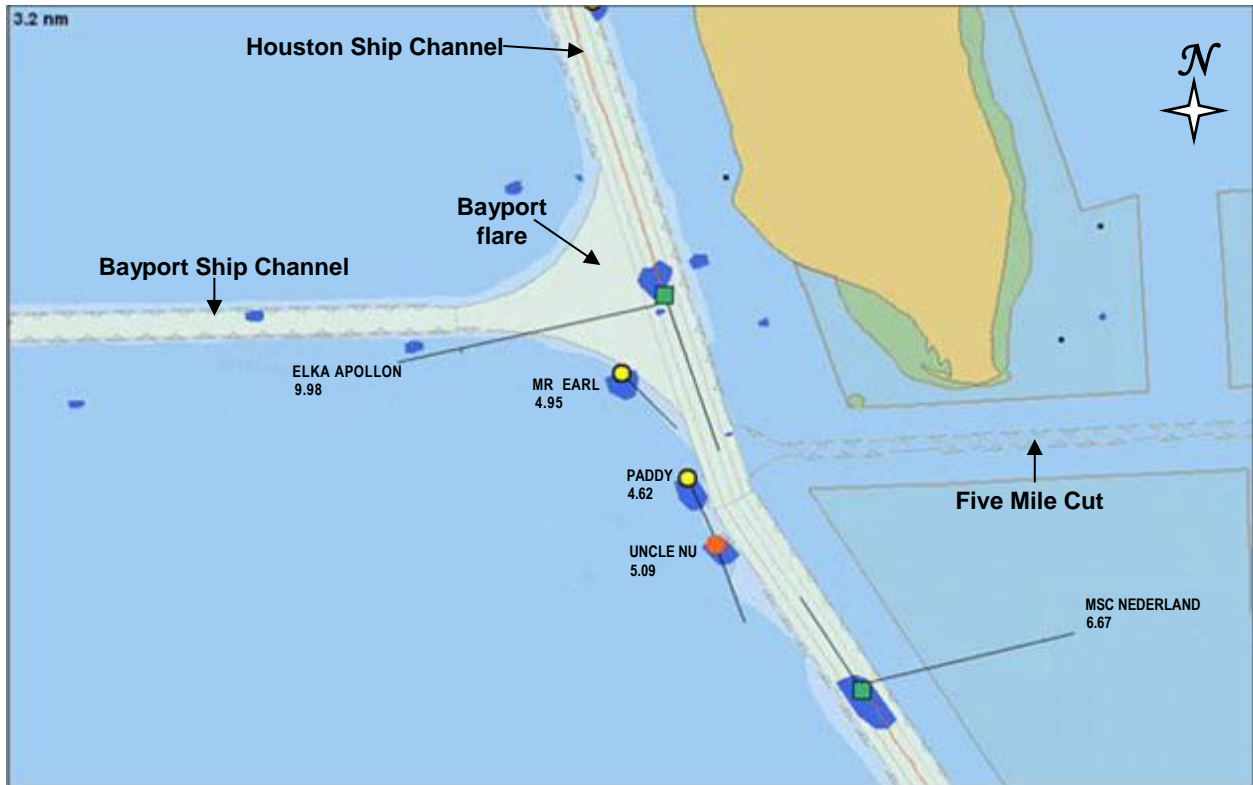
With the rudder still at port 20, at 0903:14, the conning pilot on the *Elka Apollon* communicated on VHF radio with two towboats pushing barges ahead in the channel and south of his position. These towboats were traveling in the channel’s barge lanes, outside the main channel. The conning pilot asked for a two-whistle³⁶ passing arrangement with both tows. This radio call from the pilot on the *Elka Apollon* to the tows lasted about 17 seconds. At the same time, the *MSC Nederland* was proceeding dead slow ahead at about 5.9 knots about 0.4 nm south of the bend in the channel at beacons 75 and 76 (figure 9 in section 1.9 indicates the location of beacons 75 and 76). The two tows on the radio call from the pilot on the *Elka Apollon* were in the outbound barge lane outside the main channel and between the two deep-draft ships (see figure 10).

Figure 10. Portion of VTS AIS display at 0902 on October 29, 2011, showing the *Elka Apollon* outbound and the *MSC Nederland* inbound (green squares near center and bottom right of screen, respectively) as they approach each other near the slight bend in the Houston Ship Channel and Five Mile Cut. The *Mr. Earl* is indicated by the uppermost yellow circle. The two other tows in the barge lane are labeled *Paddy* (yellow circle) and *Uncle Nu* (orange circle). Below the vessel name is its speed in knots. The dark blue areas near the vessel locations are radar images. (Original AIS vessel labels have been simplified for readability.)
