***Performance Evaluation of New Orleans and Southeast  
Louisiana Hurricane Protection System***

***Floodwall and Levee Performance  
Analysis***

***Interagency Performance Evaluation  
Task Force (IPET)***

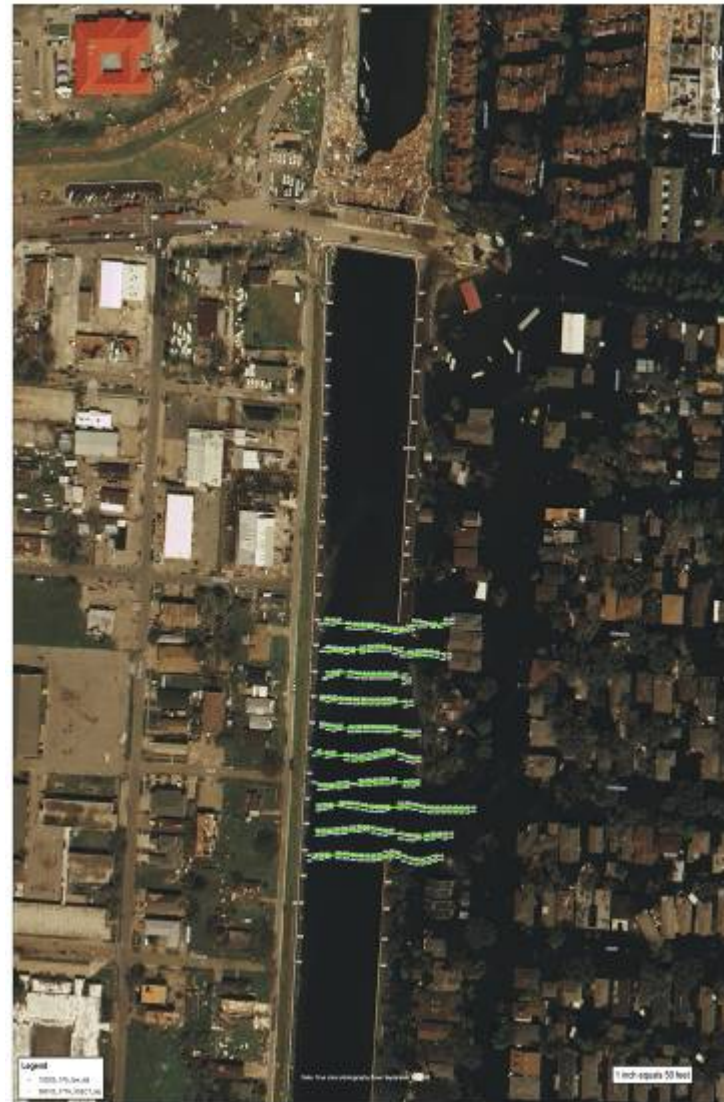
# 17<sup>th</sup> Street Canal Breach

- **Primary Factors Leading to the 17th Street Canal Breach:**
  - **Development of a gap between the wall and the levee fill on the canal side of the wall**
  - **Variation in foundation clay shear strength from levee crest to landside toe**
- **Except for the outfall canals, all other damage to the floodwalls and levees has been due to overtopping**

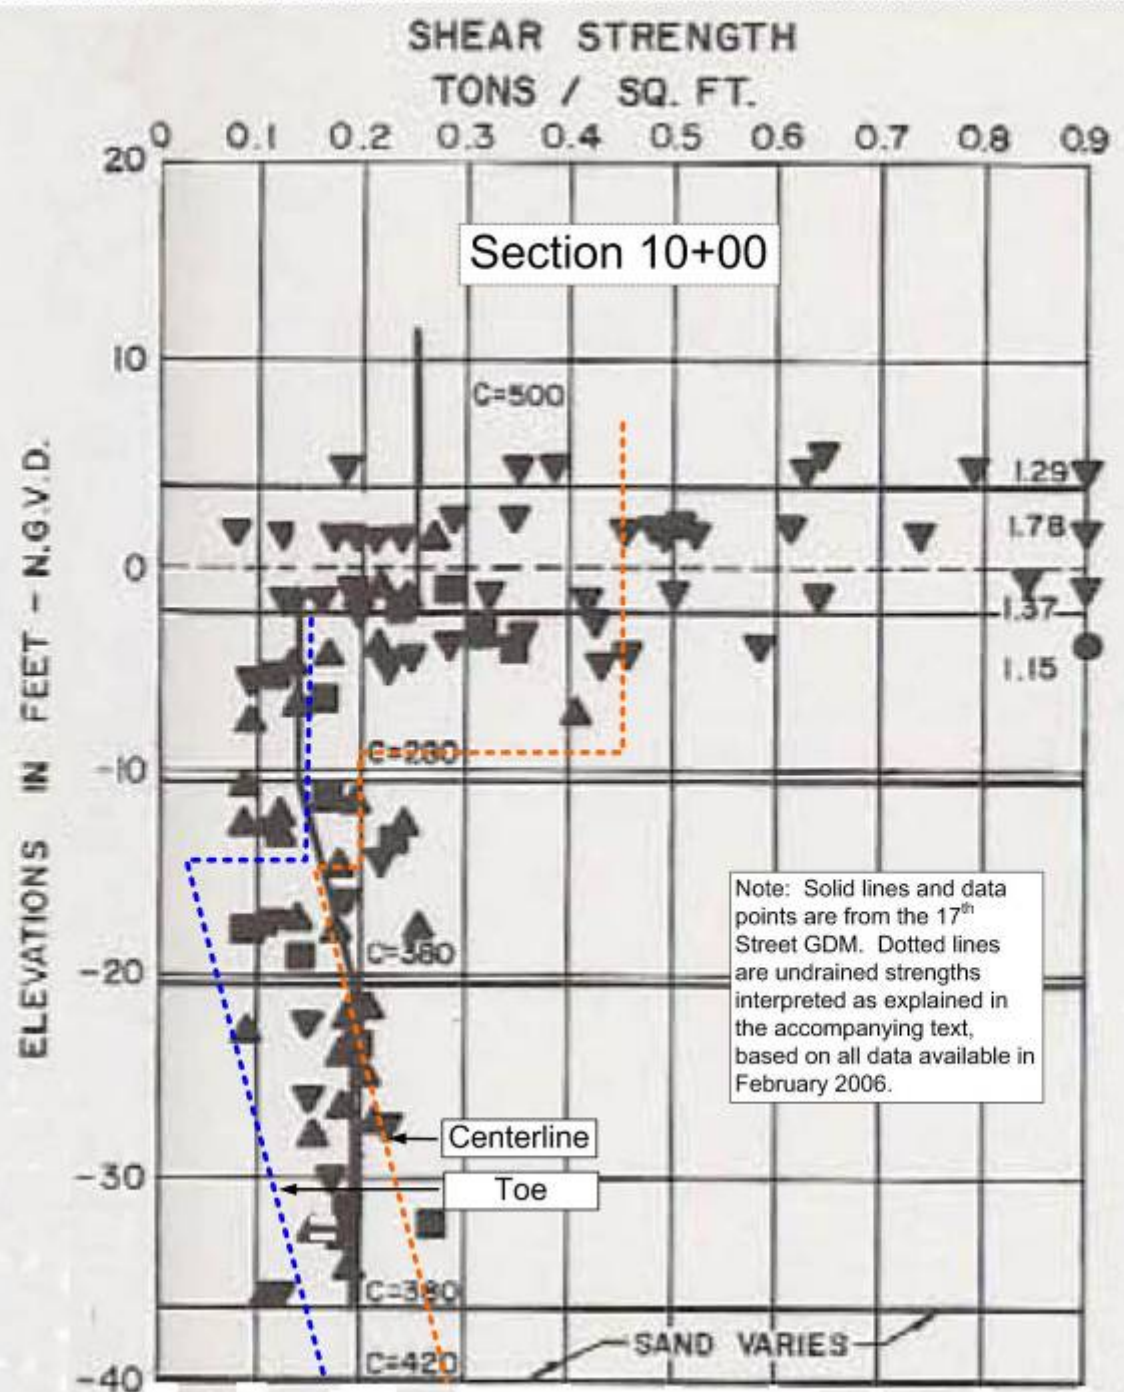
# Comparison of IPET shear strength model with design shear strengths

- **Strengths are lower beneath levee slope and beyond toe than beneath crest**
- **GDM 20 strengths were the same beneath the levee crest, slope and beyond the toe**
- **Strengths are about 20% higher to the south of the breach and 30% higher to the north**
- **Factor of safety are about 15% higher for adjacent areas than for the breach area**

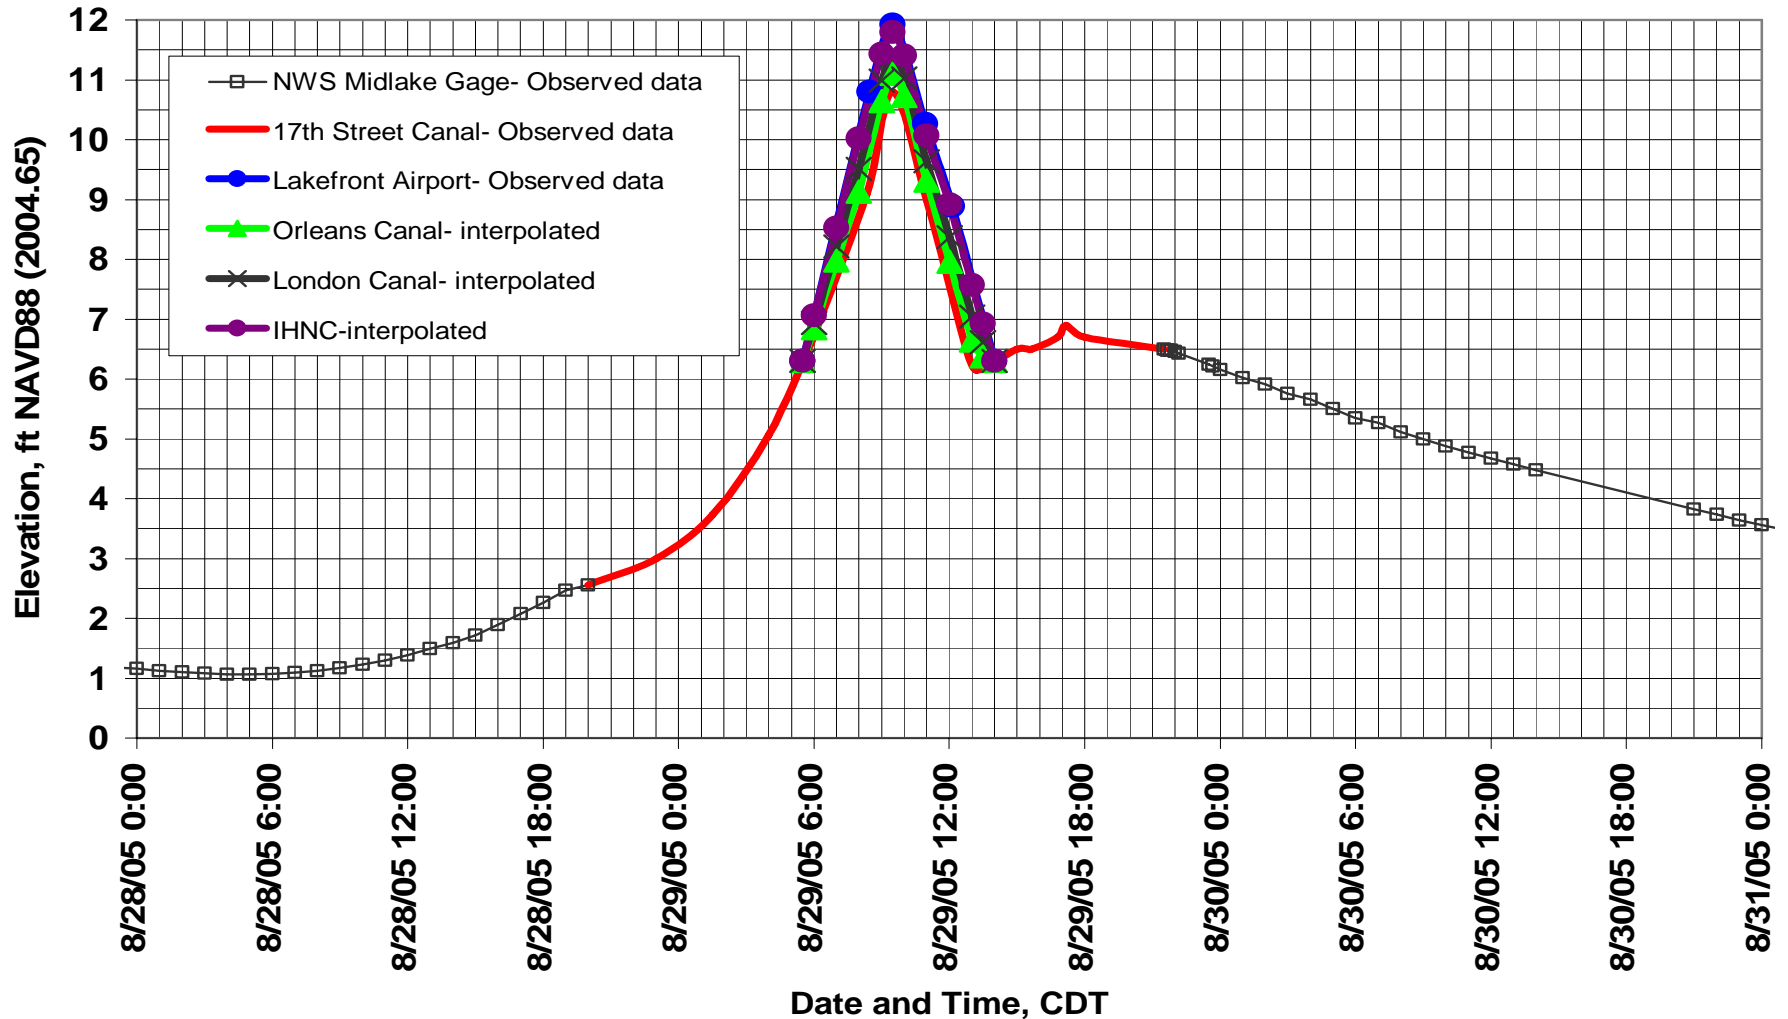
# 17<sup>th</sup> Street Canal Hydrograph

- **W. L. = 11.3 ft, with crack,  $F = 1.00$**
- **W. L. was 7.5 ft to 9.5 ft, plus wave effects, at time of failure**
- **Wave effects may be + 1.0 ft**
- **W. L. for  $F = 1.0$  is one to two feet higher than estimated effective water level at time of failure**

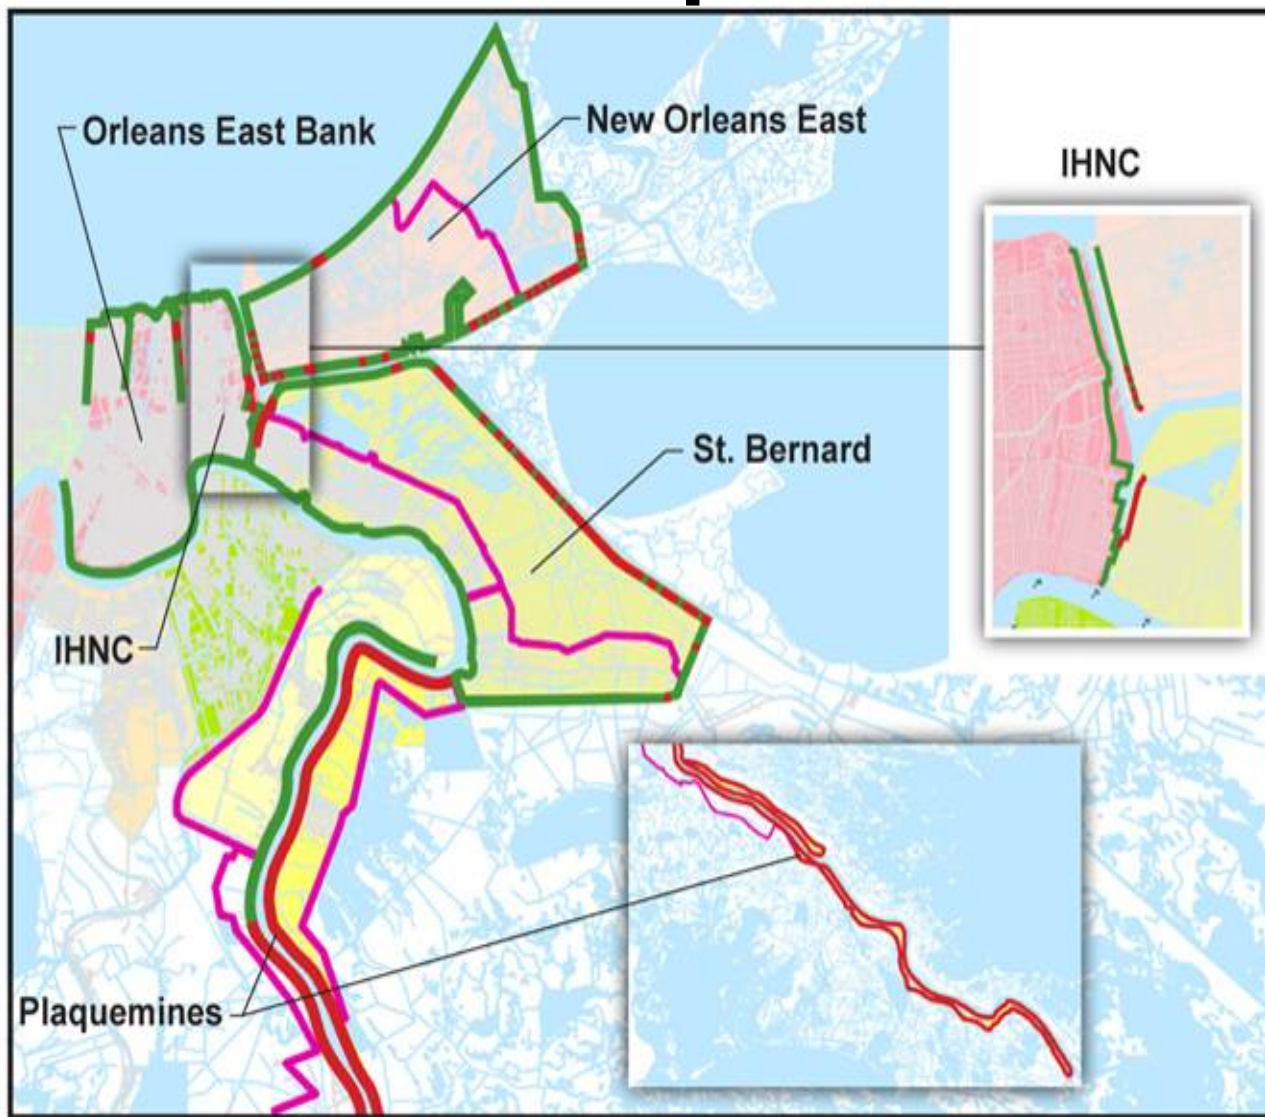
# Impacted Area

- 284 miles: Federal levees/floodwalls
- 71 pump stations

- 169 miles: Federal levees/floodwalls
- 34 pump stations

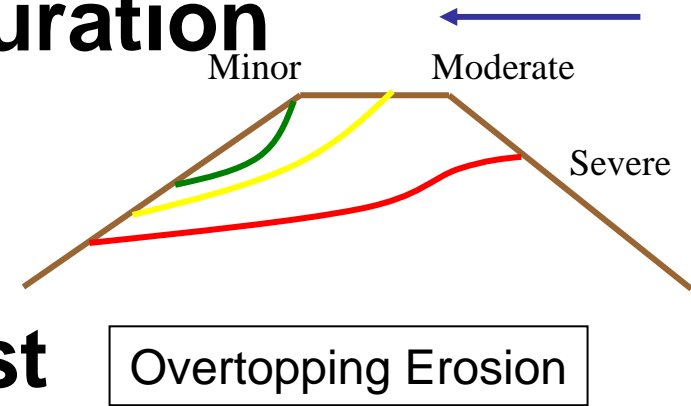
# Erosion Assessment

- **Pre-Katrina and post-Katrina LIDAR surveys**
  - Determine depth and surface area of erosion
  - Categorize the severity of the erosion
- **Storm surge height and duration**
- **Wave height and duration**
- **Levee surface soil type**
- **Elevation of the levee crest**
