# Appendix 1

## Hydrograph and High Water Mark Analysis

### Introduction

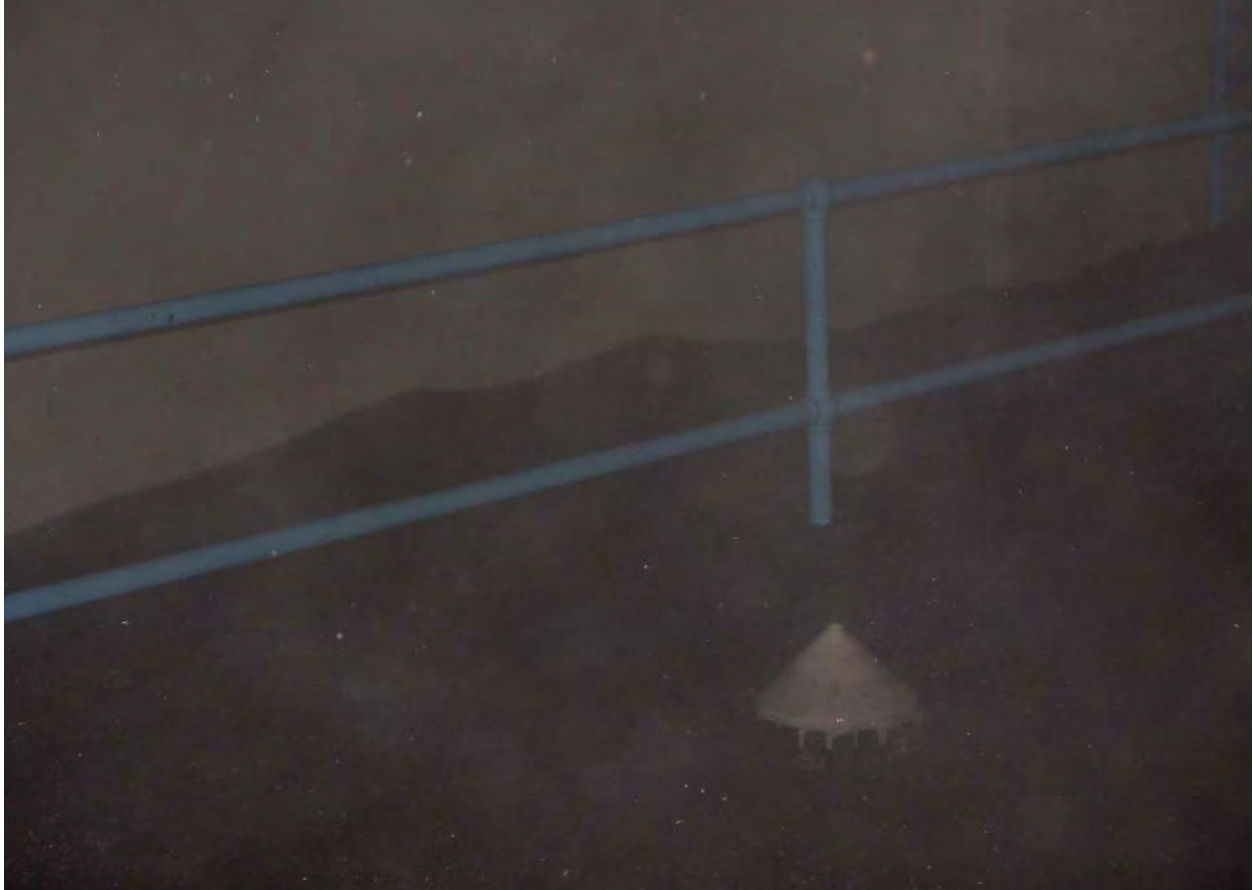
- a. 0552 (CDT) on 8/29/05, elevation 6.6 ft: Figures 1-9 and 1-10 show pictures taken of the blue rail at 0552 (CDT). By knowing the distance between the top and bottom rails and the elevation of both rails, the distance from the bottom rail to the water surface can be determined using the ratio of distances in the photograph. In Figure 1-9 the water level is 1.0 ft below the lower rail. In Figure 1-10, the water levels at the 3 vertical posts are 0.2, 0.6, and 0.7 ft below the lower rail. The differences in distance below the lower rail is the result of wave action that has a wave height (trough to crest) of at least 0.8 ft based on these two pictures. By averaging the distances, the wave effects are reduced but not eliminated. Averaging all 4 yields an average distance below the lower rail of 0.6 ft for a water surface elevation of  $7.2 - 0.6 = 6.6$  ft.

Figure 1-9. Picture DSC02231.JPG taken at 0552:00 CDT on 8/29/05, elevation 6.6 ft. Looking southwest. Water level is 1.0 ft below lower rail.

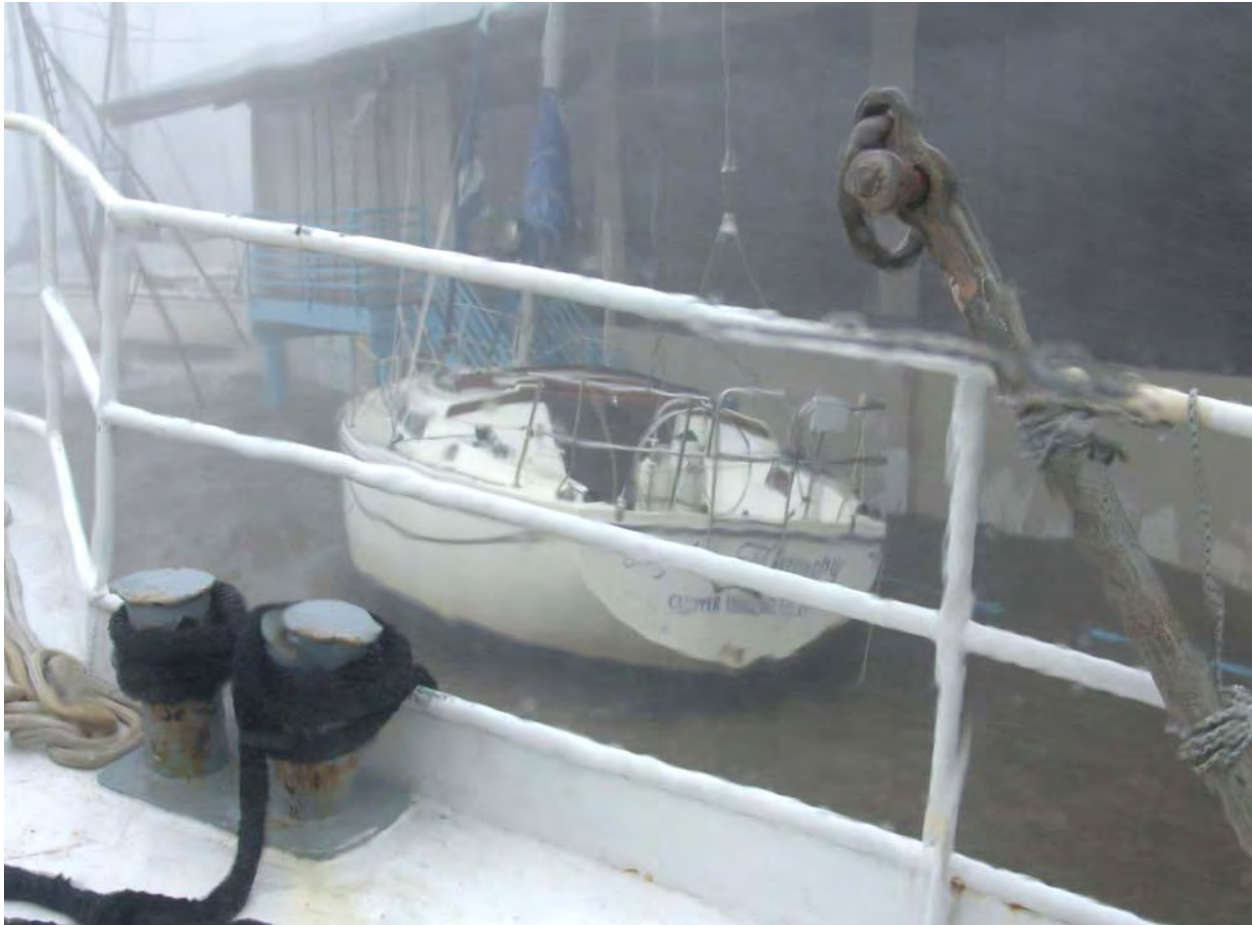
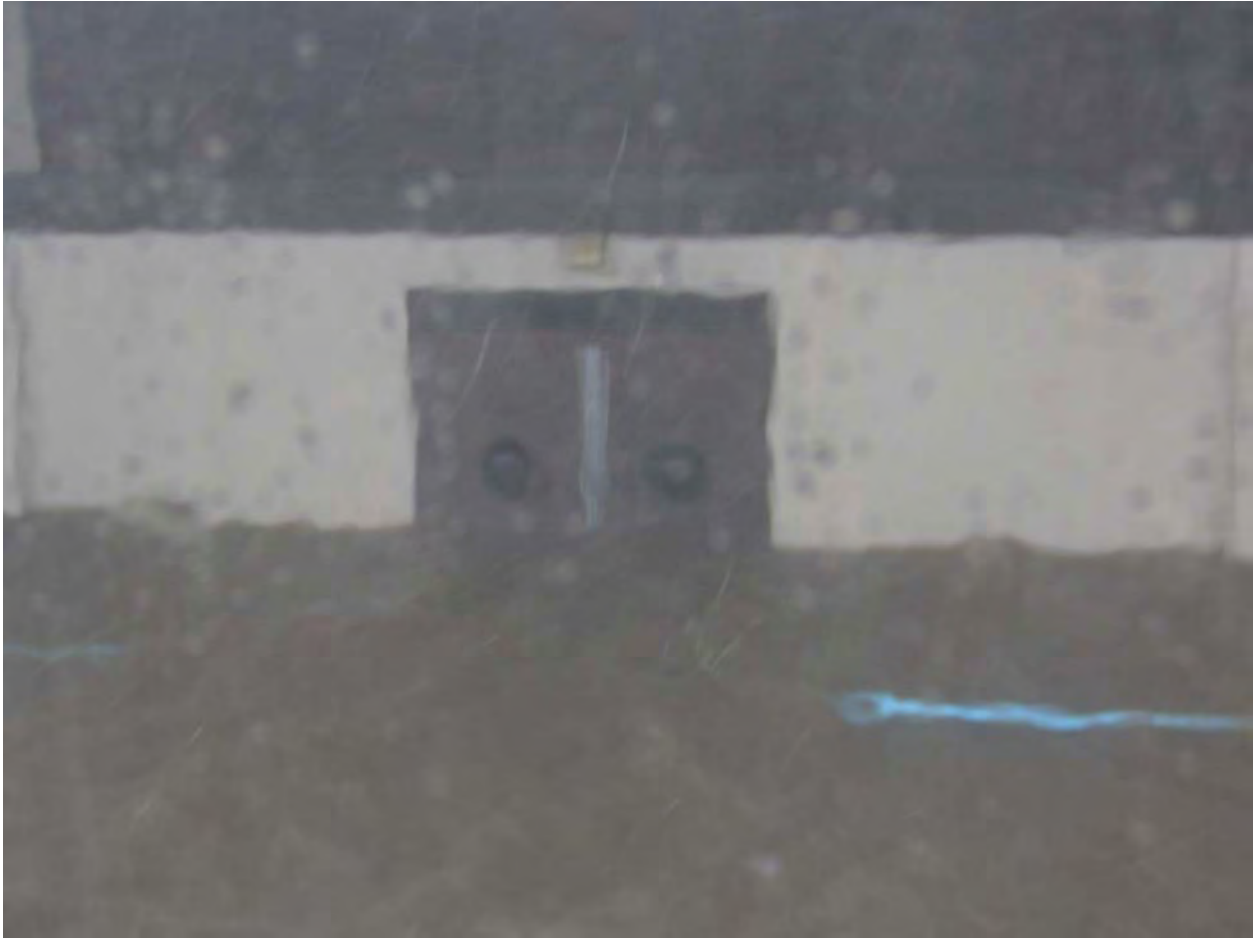
- b. 0814 (CDT) on 8/29/05: Pictures DSC02233-DSC02236 show the harbor with no tops of piling visible but no elevations can be determined.
- c. 0816 (CDT) – 0826 (CDT) on 8/29/05, elevation 9.1 ft: Figures 1-11 to 1-15 (pictures DSC02237-DSC02241) show the water level at the top rail in all available pictures. Figure 1-14 shows the double door in the middle of the north wall of the MYH building. The boat owner said the double door was knocked down sometime on the 8/29/05. Elevation of the top rail is 9.1 ft.

Figure 1-11. Picture DSC02237.JPG taken at 0816:22 (CDT) on 8/29/05, elevation 9.1 ft. Looking southeast. Water level at upper rail. Brightness and contrast adjusted.

Figure 1-12. Picture DSC02238.JPG taken at 0816:28 (CDT) on 8/29/05, elevation 9.1 ft. Looking southeast. Water level at upper rail. Brightness and contrast adjusted

Figure 1-13. Picture DSC02239.JPG taken at 0816:52 (CDT) on 8/29/05, elevation 9.1 ft. Looking southeast. Water level at upper rail. Brightness and contrast adjusted.

Figure1-14. Picture DSC02240.JPG taken at 0826:32 (CDT) on 8/29/05, elevation 9.1 ft. Looking south. Water level at upper rail.

Figure 1-15. Picture DSC02241.JPG taken at 0826:36 (CDT) on 8/29/05, elevation 9.1 ft. Looking south. Water level at upper rail. Brightness and contrast adjusted.

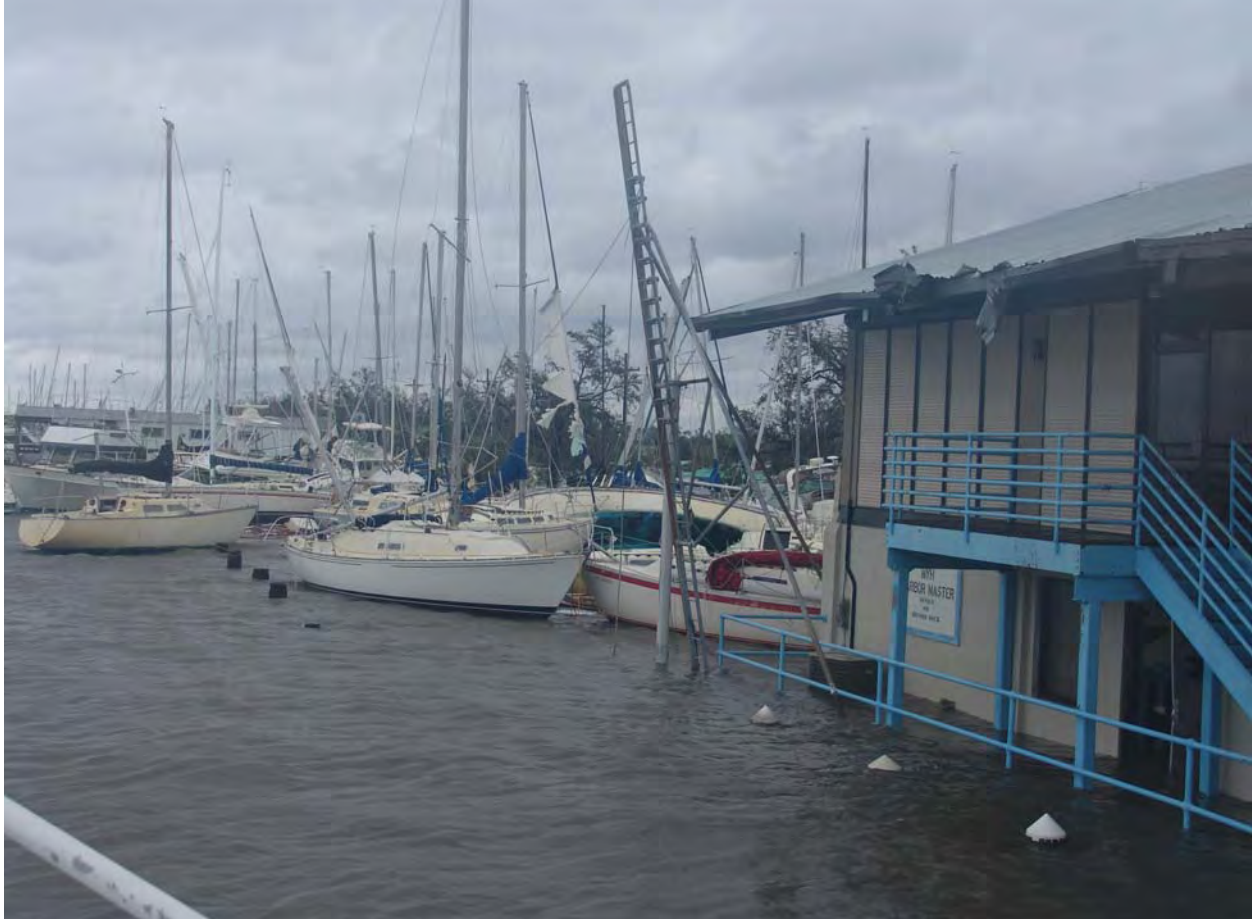
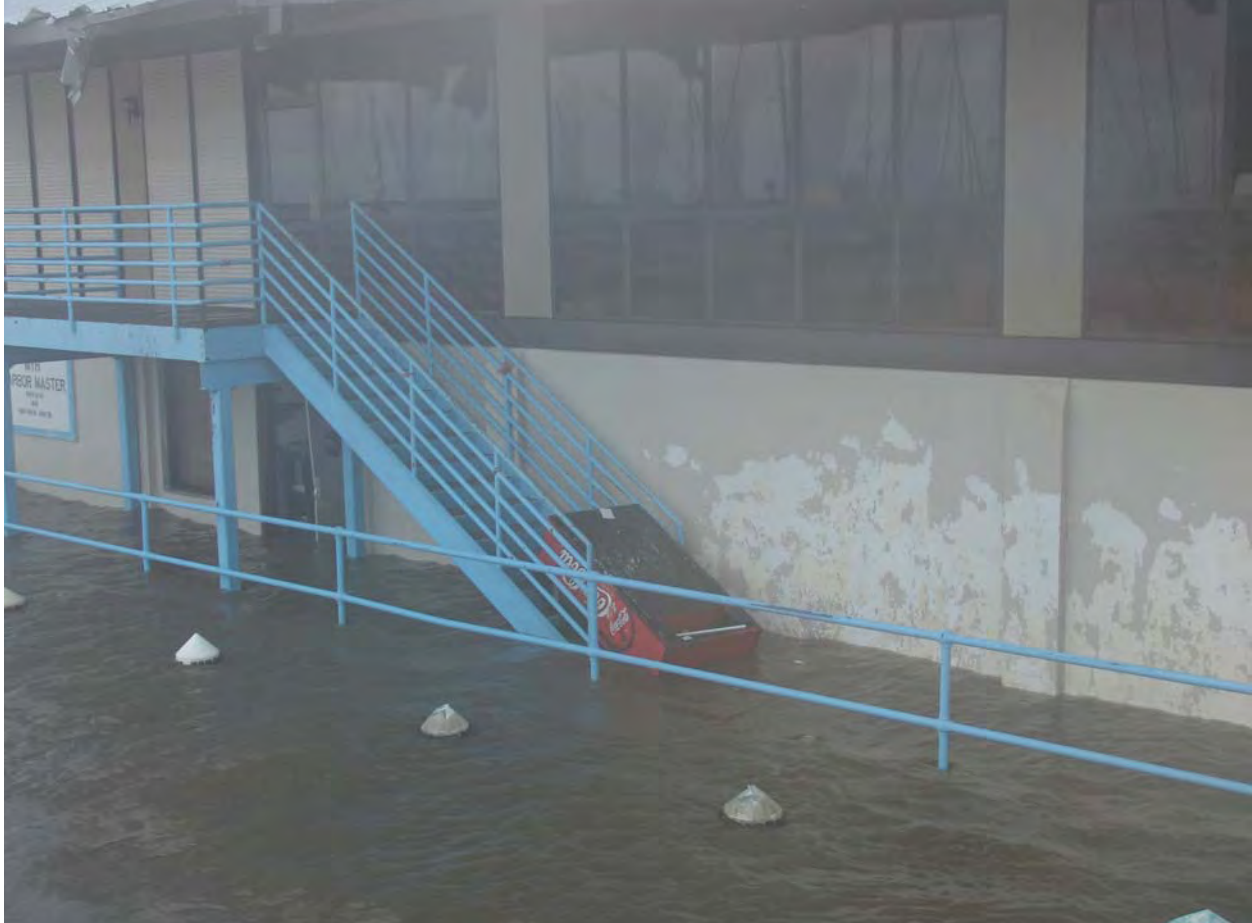
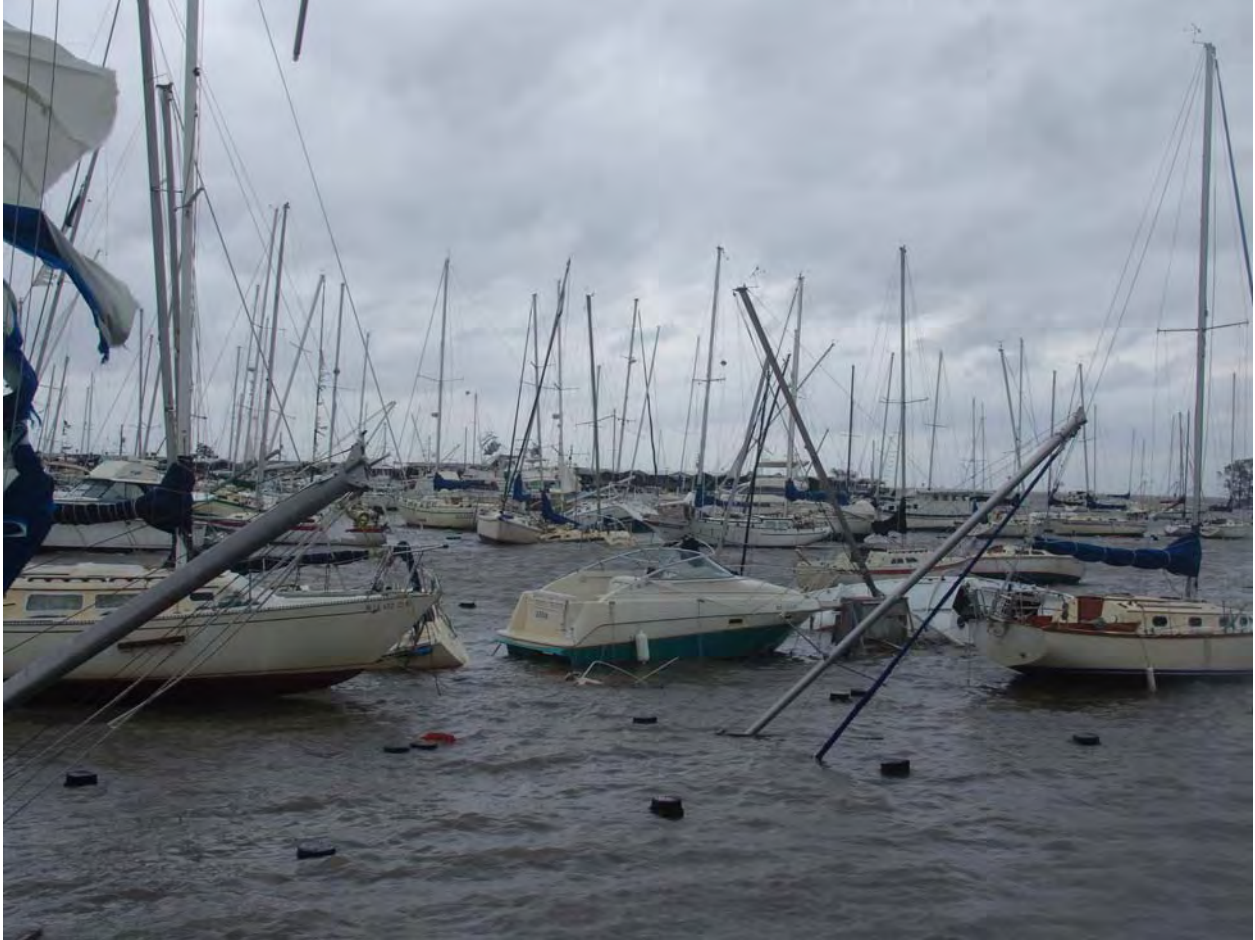
- g. 1537 (CDT) – 1543 (CDT) on 8/29/05, elevation 6.5 ft: Numerous pictures provide rail evidence and top of piling evidence. Figure 1-17 (DSC02262- 1538:44) shows the water level at 5 vertical posts at 0.7, 0.8, 0.8, 0.7, and 0.6 ft below the lower rail that averages 0.7 ft. Figure 1-18 (DSC02263- 1538:54) show the water level at 4 vertical posts at 0.5, 0.7, 0.7, and 0.9 ft below the lower rail that averages 0.7 ft below the lower rail that gives an elevation of  $7.2 - 0.7 = 6.5$  ft. Figures 1-19 (DSC02267- 1539:34) and 1-20 (DSC02269- 1539:56) show the double piling with the orange cushion. Based on the photographs, the water level is about 0.1 ft below the top of piling giving an elevation of 6.5 ft.

Figure 1-17. Picture DSC02262.JPG taken at 1538:44 (CDT) on 8/29/05, elevation 6.5 ft. Looking east-southeast. From left to right vertical posts, water level is 0.7, 0.8, 0.8, 0.7, and 0.6 ft below the center of the lower rail.

Figure 1-18. Picture DSC02263.JPG taken at 1538:54 (CDT) on 8/29/05, elevation 6.5 ft. Looking southeast. From left to right, water level is 0.5, 0.7, 0.7, and 0.9 ft below the center of the lower rail.

Figure 1-19. Picture DSC02267.JPG taken at 1539:34 (CDT) on 8/29/05 elevation 6.5 ft. Looking northeast.

Figure 1-20. Picture DSC02269.JPG taken at 1539:56 (CDT) on 8/29/05, elevation 6.5 ft. Looking northeast.

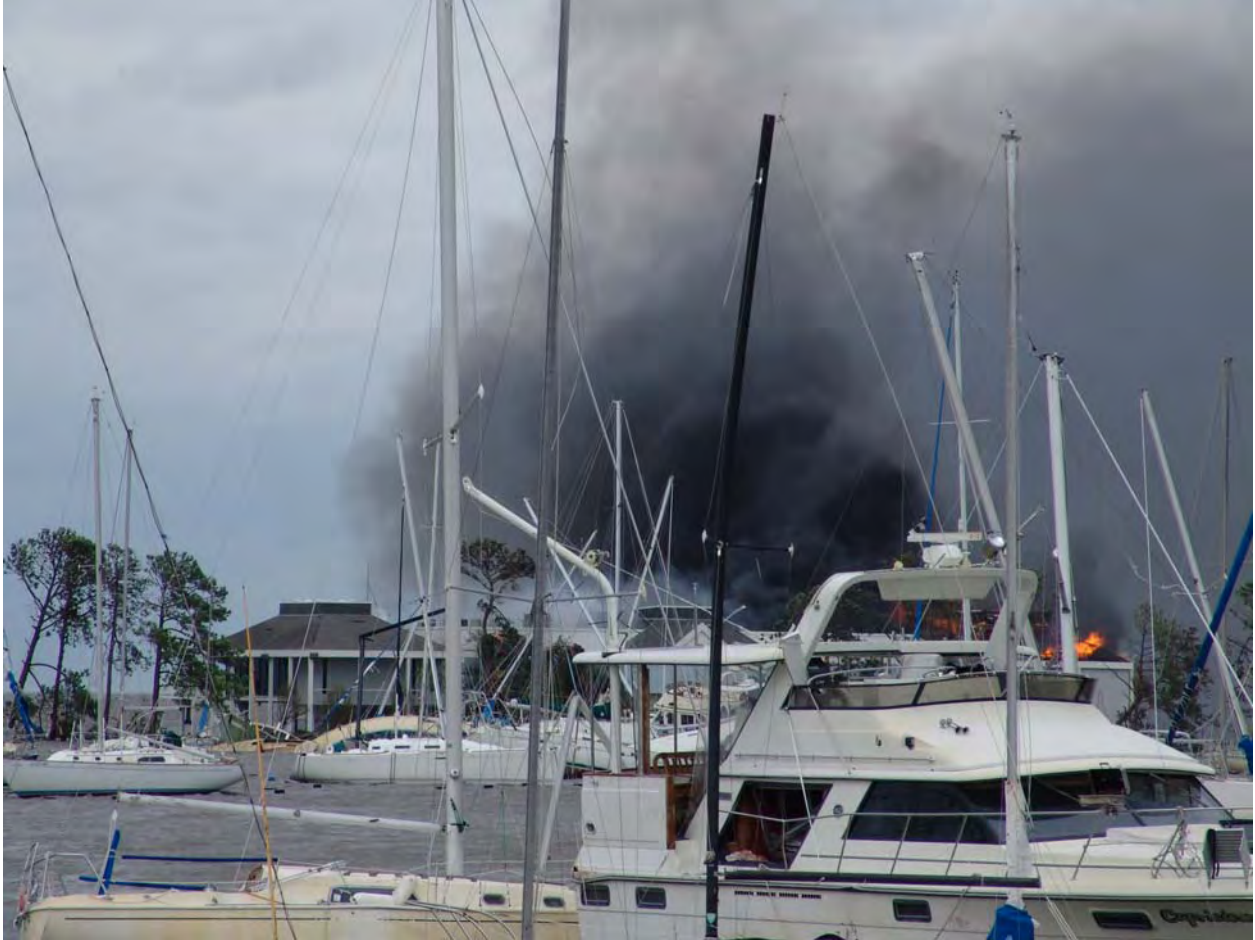
- h. 1648 (CDT) – 1650 (CDT) on 8/29/05, elevation 6.7 ft: Numerous pictures (DSC02280- DSC02296) of fire in background and top of piles both close to the boat and far away. Figure 1-21 (DSC02287) shows a typical picture of top of piling relative to water level. Average distance of water level below tops of piling was about 0.1-0.3 ft. Based on surveyed average top of piling, average elevation was 6.7 ft.

Figure 1-21. Picture DSC02287.JPG taken at 1649 (CDT) on 8/29/05, elevation 6.7 ft. Looking northeast.

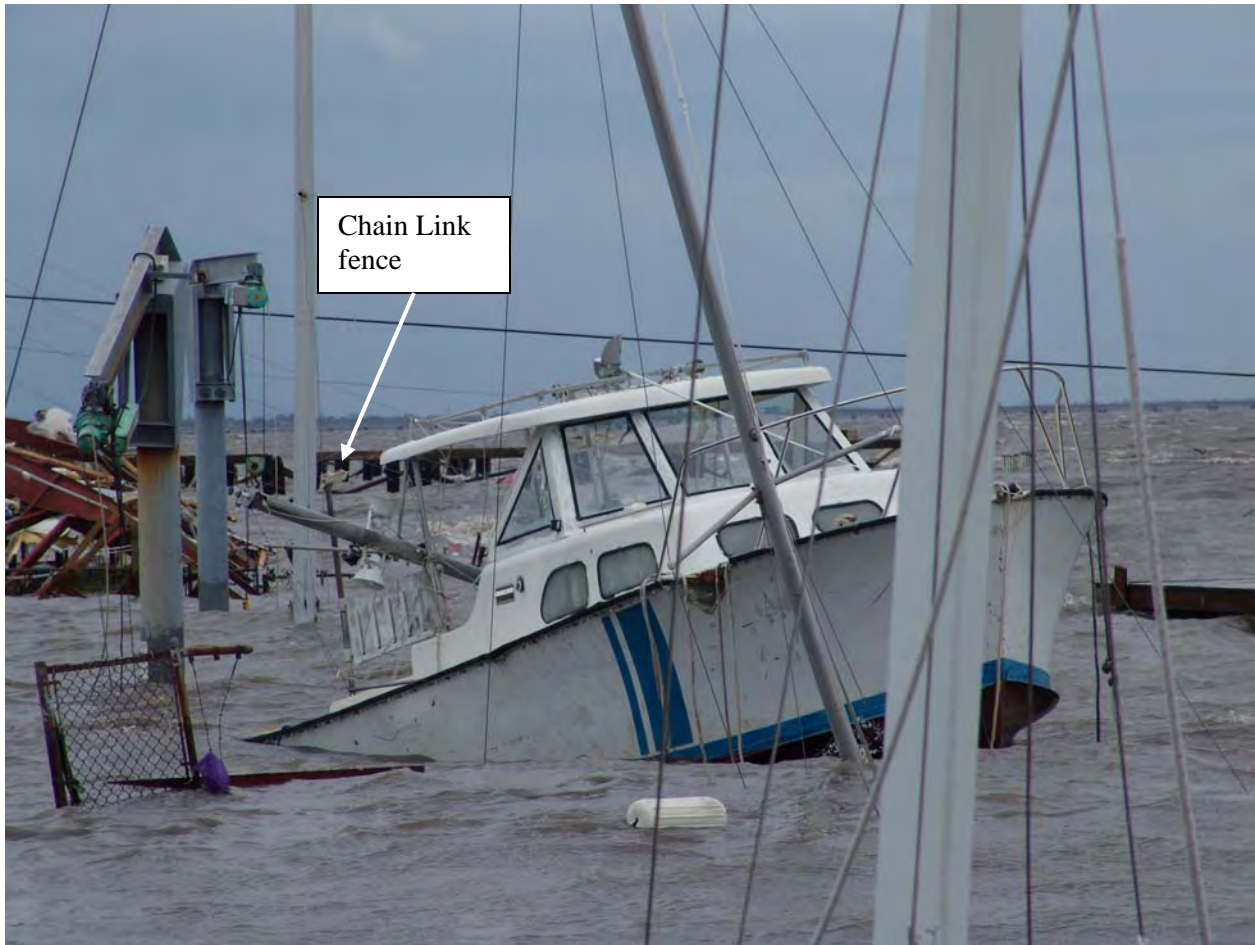
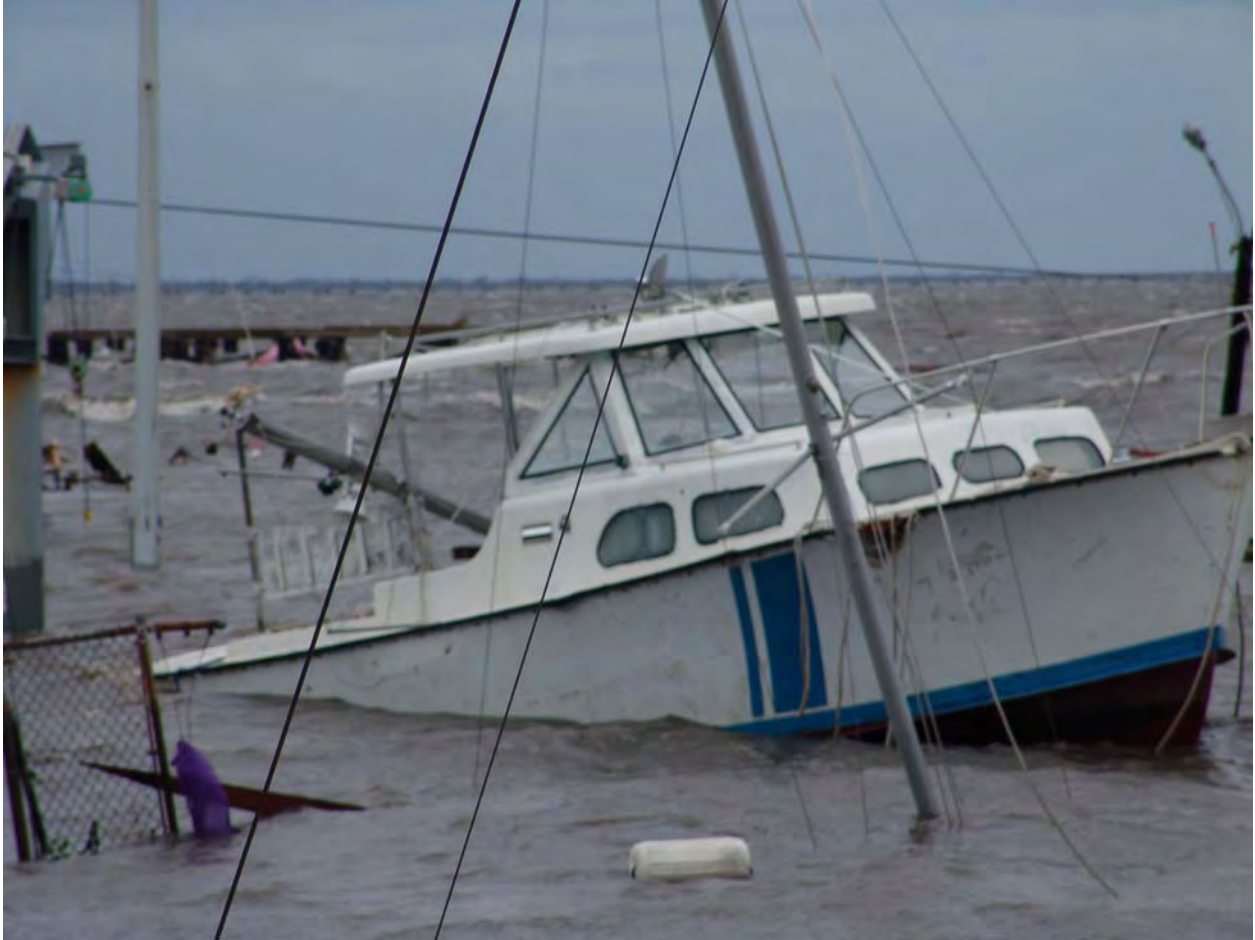
- i. 1710 (CDT) – 1724 (CDT) on 8/29/05, elevation 6.9 ft: Pictures DSC02297 – DSC02327 show distance of water level below tops of highest pilings of about 0.1 ft or an elevation of 6.8 ft. Figures 1-22 (DSC02305- 1711:04) and 1-23 (DSC02306- 1711:14) show the chain link fence section west of the moored boat. The water level position on the fence

Figure 1-22. Picture DSC02305.JPG taken at 1711:04 (CDT) on 8/29/05, elevation 7.5 ft. Looking west

Figure 1-23. Picture DSC02306.JPG taken at 1711:14 (CDT) on 8/29/05, elevation 6.5 ft. Looking west.

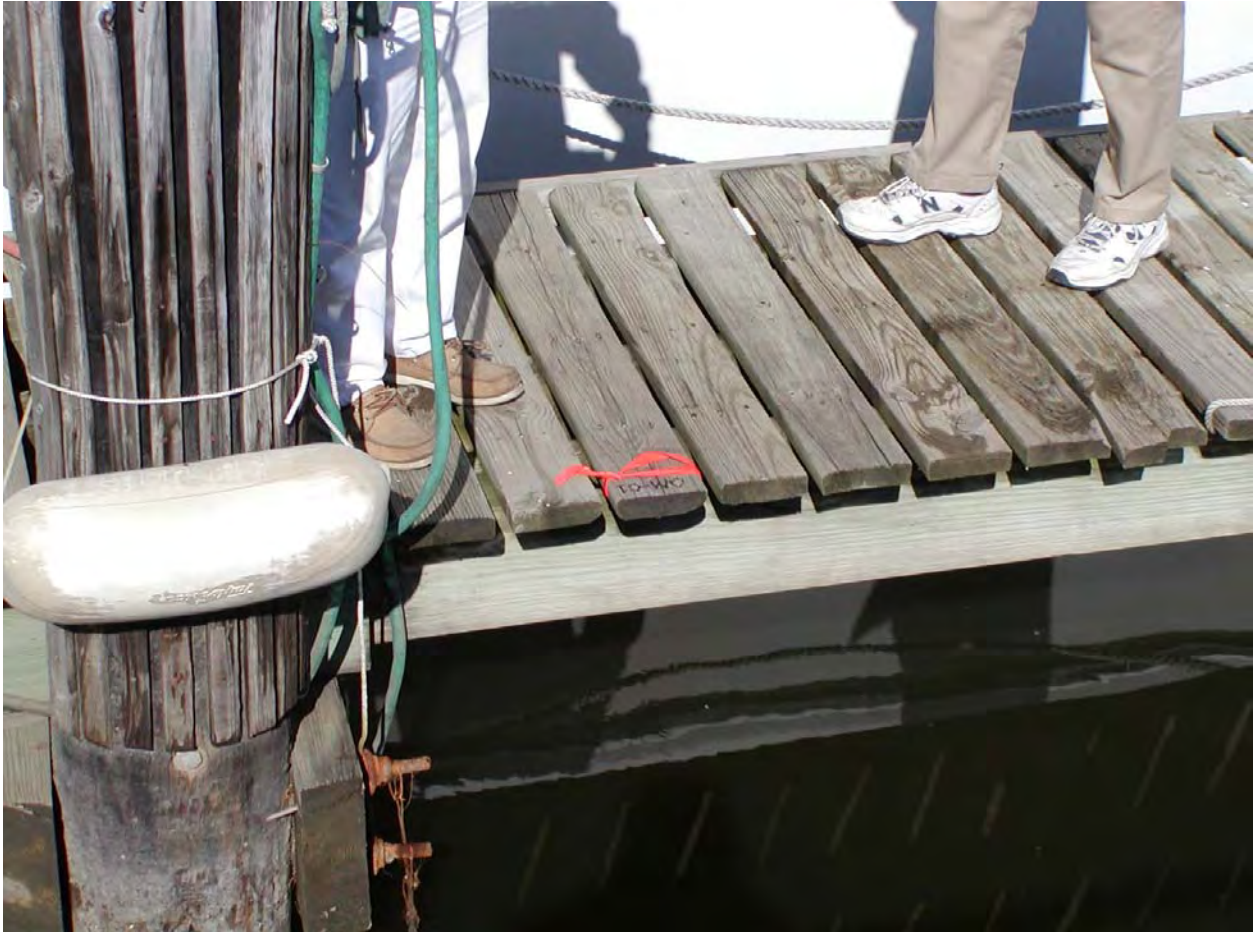
- a. Sunday 8/28/05, 16:00 hrs: Water level 1 ft above normal. No mark will be surveyed because uncertain how to quantify “normal.”
- b. Sunday 8/28/05. 23:00 hrs, elevation 3.0 ft: Water level at bottom side of the 2X6’s covering the deck of the finger pier. Survey point OM-01, Figure 1-26.
- c. Monday 8/29/05,01:30, elevation 3.7 ft: Water level at top of 1<sup>st</sup> step up from finger pier. Survey point OM-02, Figure 1-27.
- d. Monday 8/29/05,04:00, elevation 5.1 ft: Water level at top of concrete pile cap. Survey point OM-03, Figure 1-28.
- e. Monday 8/29/05,06:00, elevation 5.6 ft: Water level at top of steps equal to top of main concrete dock in Figure 1-28. Survey point OM-04.
- f. Monday 8/29/05,06:15, elevation 7.0 ft: Water level at 1<sup>st</sup> rail. Survey point OM-05, Figure 1-29.

Figure 1-26. Time 23:00 on 8/28/05, elevation 3.0 ft. Bottom of 2X6 deck board

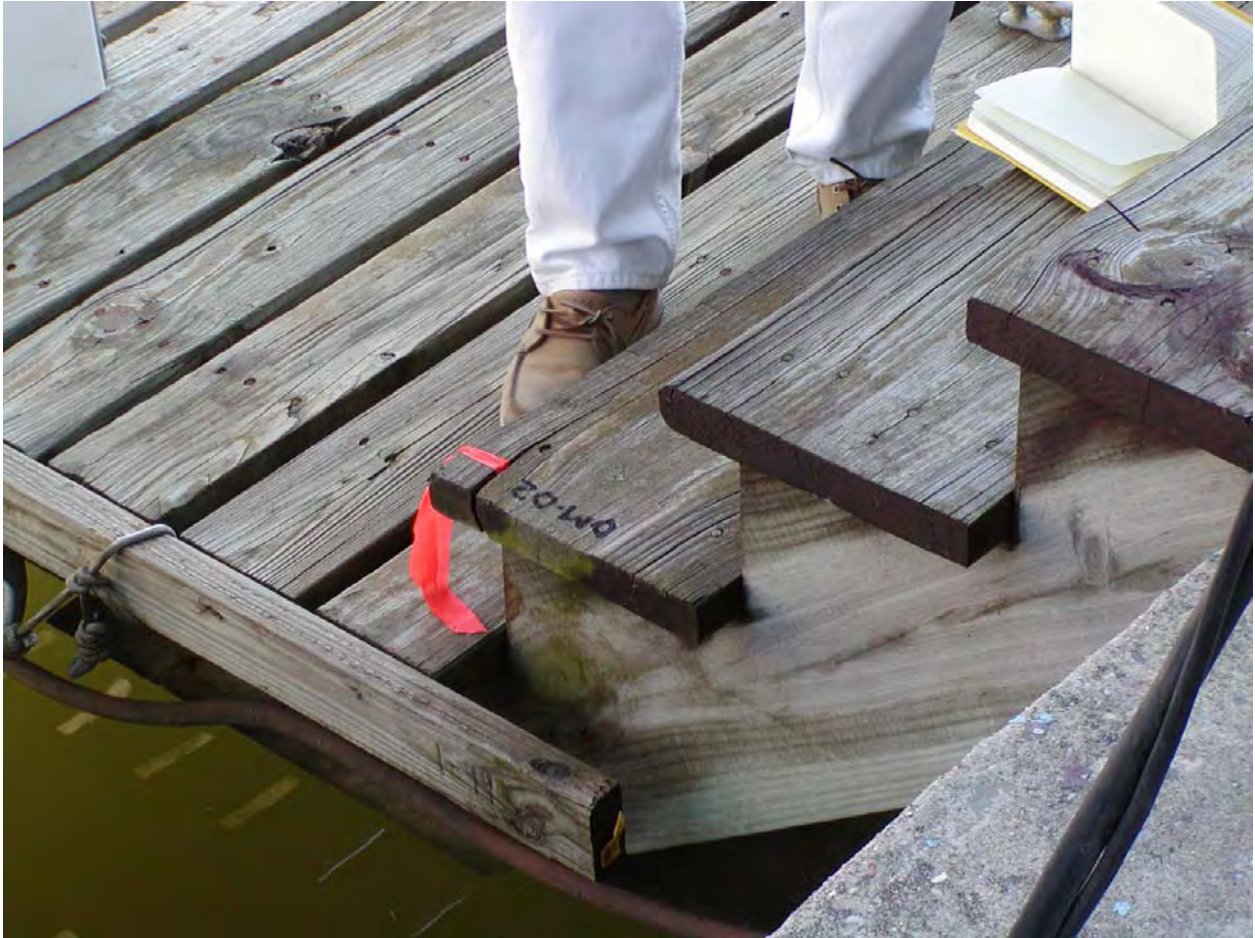
Figure 1-27. Time 1:30 on 8/29/05, elevation 3.7 ft. Top of first step on finger dock

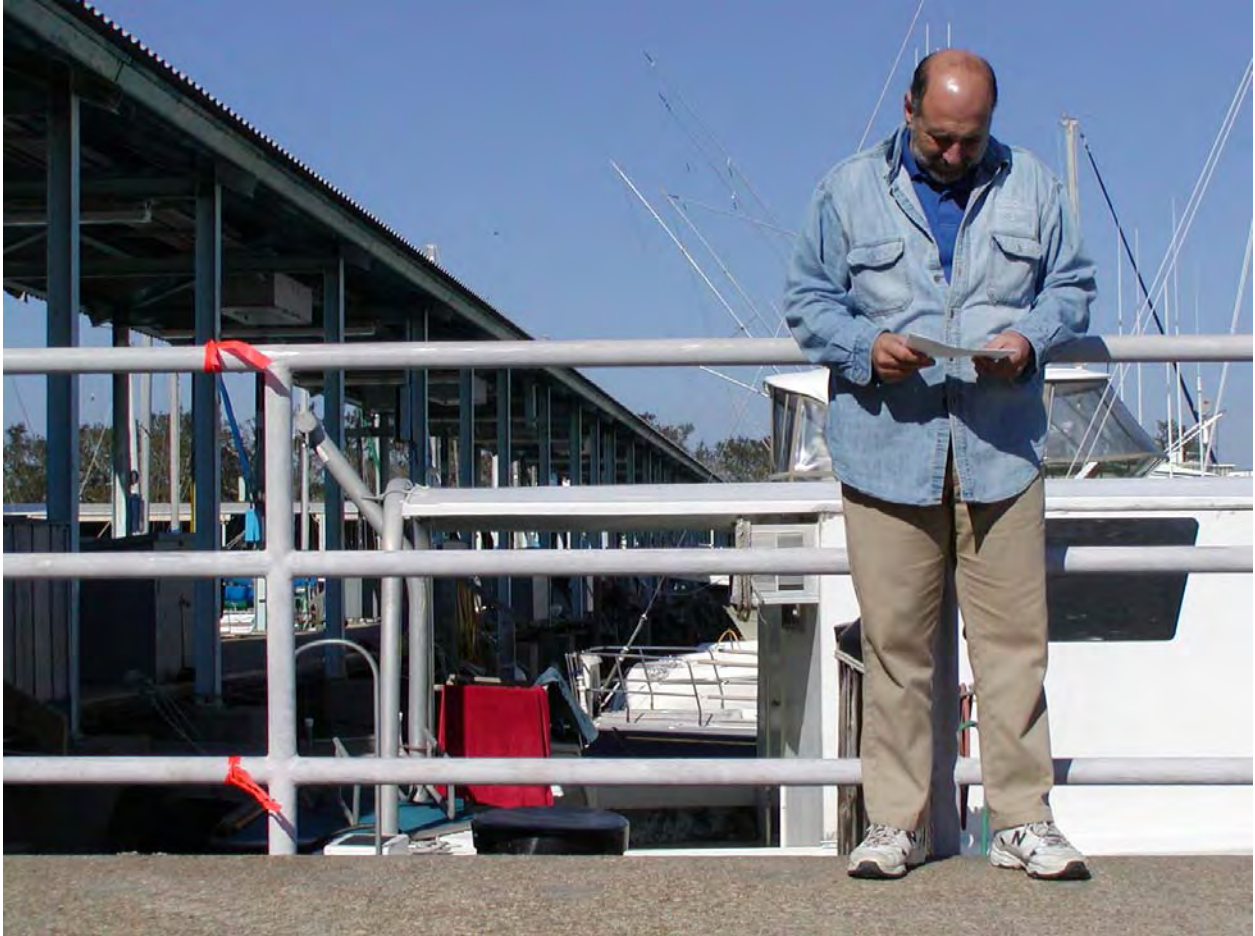
- i. Monday 8/29/05, from 12:45 to 15:00, elevation 6.5 ft: Water level at top of main walkway that supports metal railing. Elevation scaled from Figure 1-31 as 6.5 ft.

Figure 1-31. Main walkway of Orleans Marina. Boat is just behind individual on the walkway.

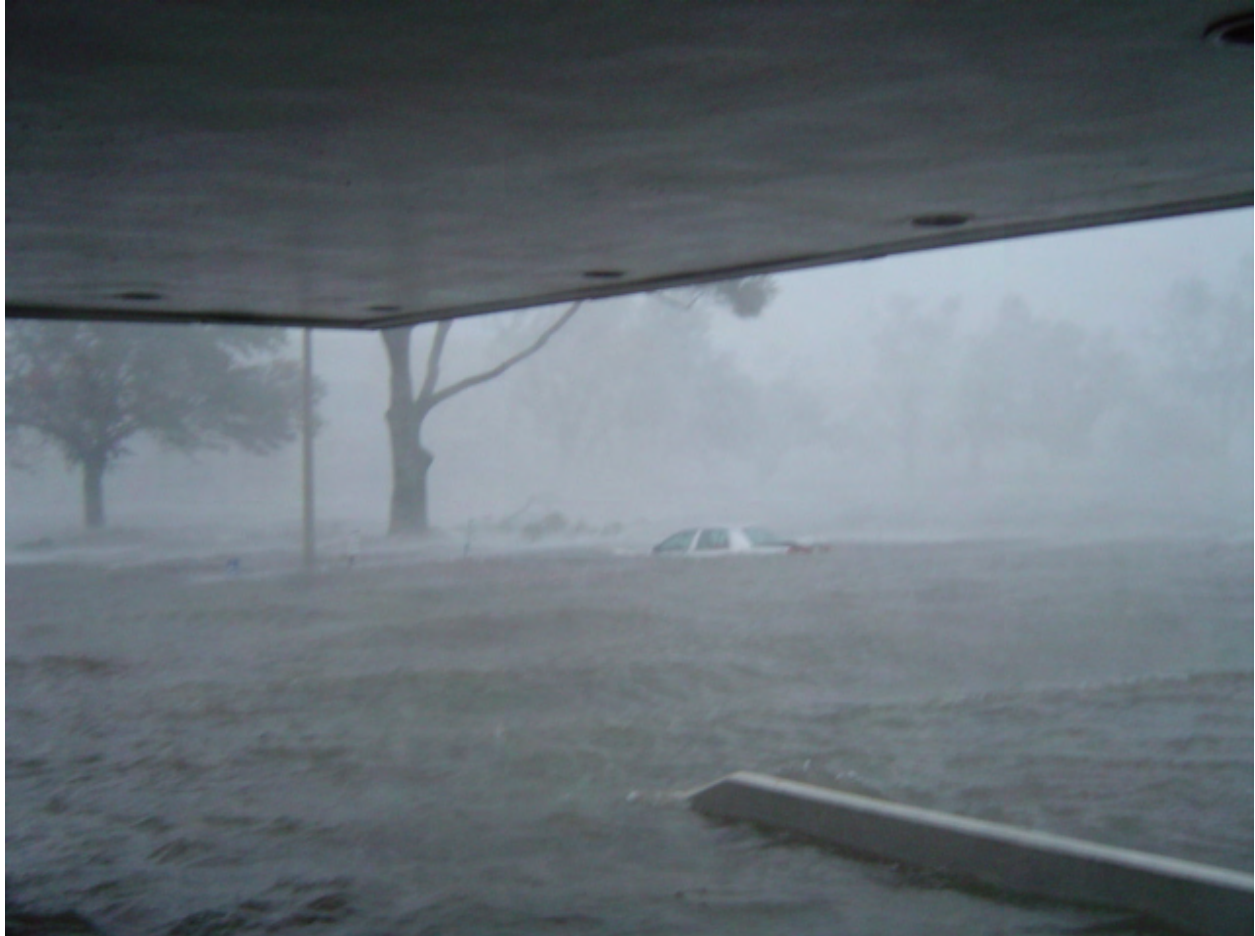
Figure 1-34. Time 7:29 AM, APH-01.

- a. Time 7:29, Airport high water mark (APH)-01, elevation 6.7, Figure 1-34. Located south of terminal building on sloping wall. APH-01 is the earliest photograph providing stage data at the airport. Being on the south side of the terminal building, this mark is protected from direct wave activity from Lake Pontchartrain. Low wave action is evident.

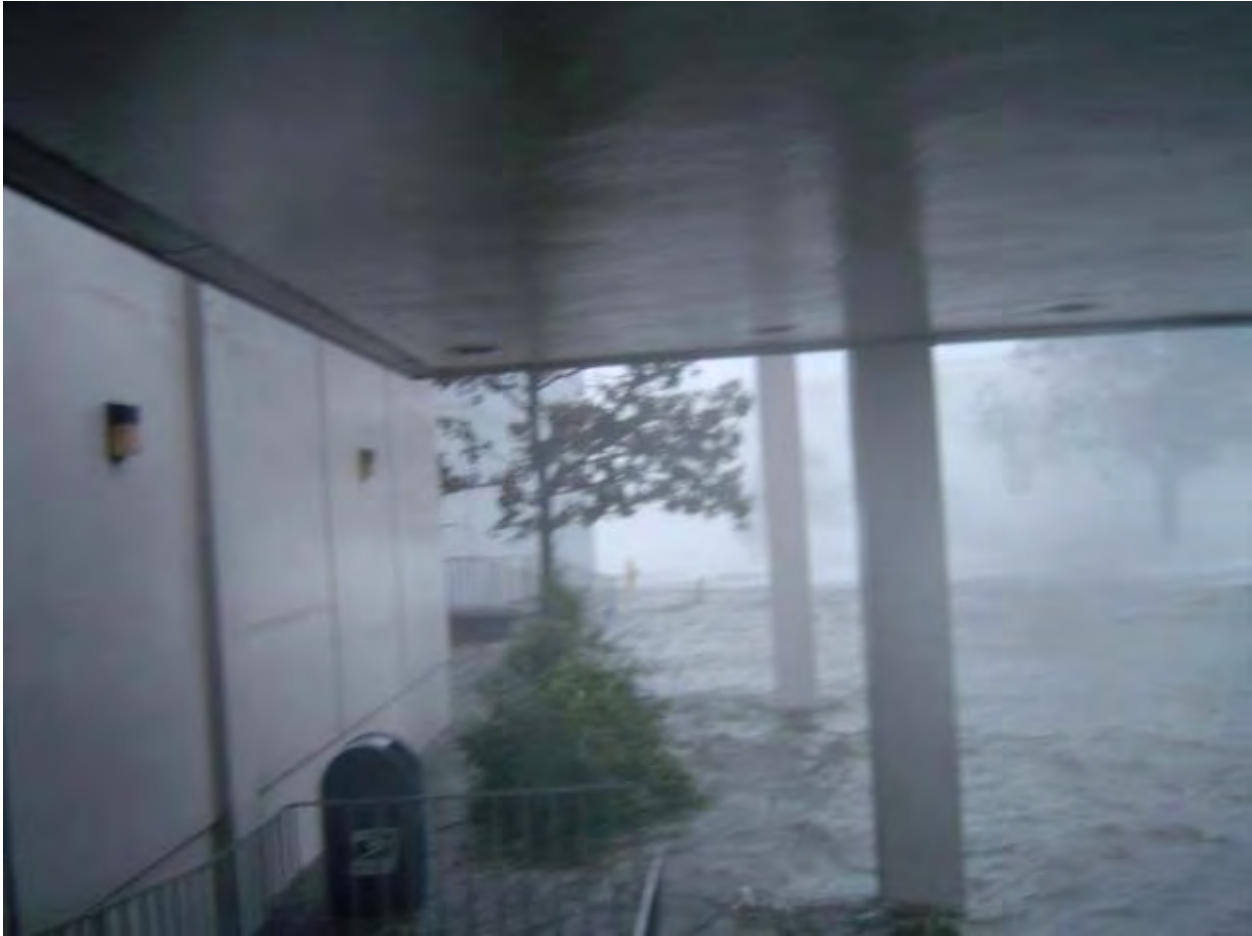
- b. Time 7:29 AM, APH-22, elevation 6.6, Figure 1-35. On south wall of terminal building near east walkway. Horizontal joint in wall is 0.3 ft above floor of terminal which is at elevation 8.45 ft. Distance from bottom of light to joint was 6.3 ft. Scaled distance from joint to water surface was 2.2 ft. The influence of the surrounding bathymetry on water levels raises significant doubt about points APH-01 and APH-22.

Figure 1-35. Time = 7:29, APH-22. Wall on south side of terminal building, east walkway

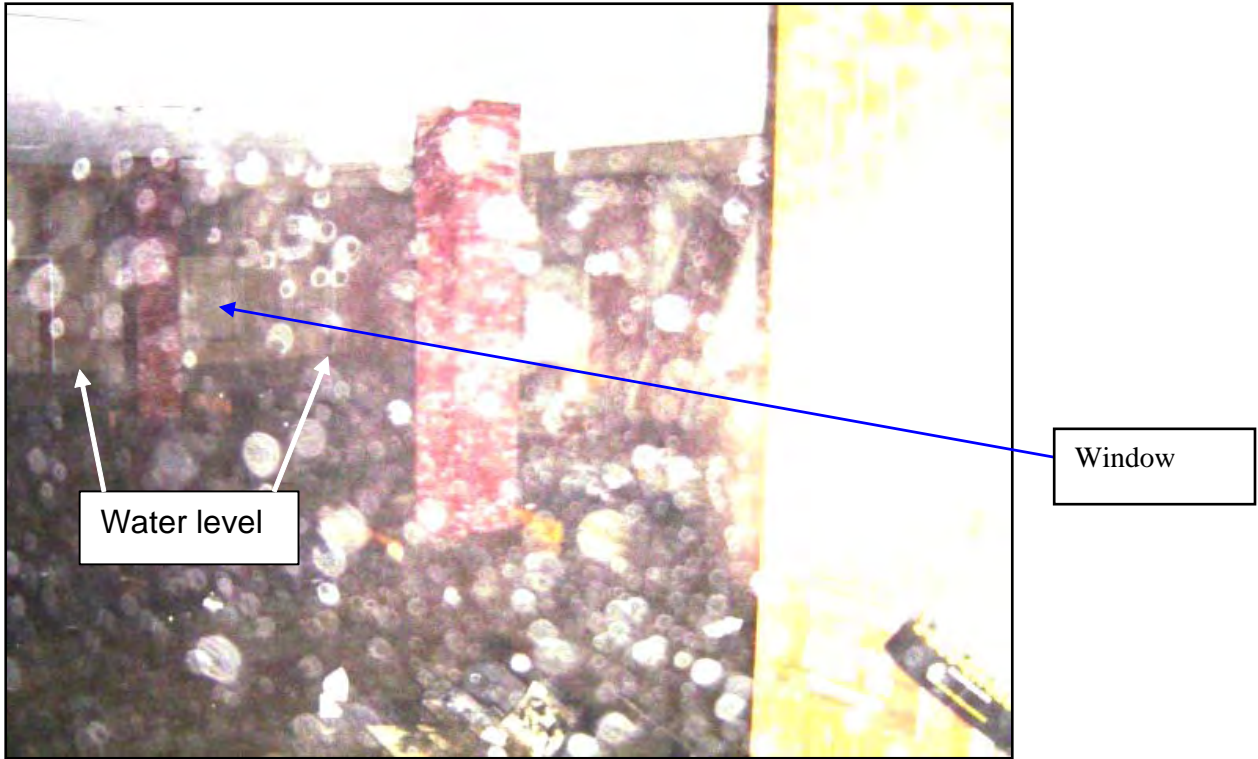
Figure 1-36. Time 8:27 AM, APH-21.

- c. Time 8:27 AM, APH-21, elevation 10.8, Figure 1-36. Picture inside terminal lobby in which brightness and contrast have been adjusted to show water level. The window height was measured at 4.5 ft and the distance from the bottom of the window to the floor was 3.5 ft. Based on scaling the photograph, the distance from the bottom of the window to the water surface was 1.2 ft resulting in a 2.3 ft depth above the floor. The floor of the terminal is at elevation 8.45 giving a water level of 10.8.

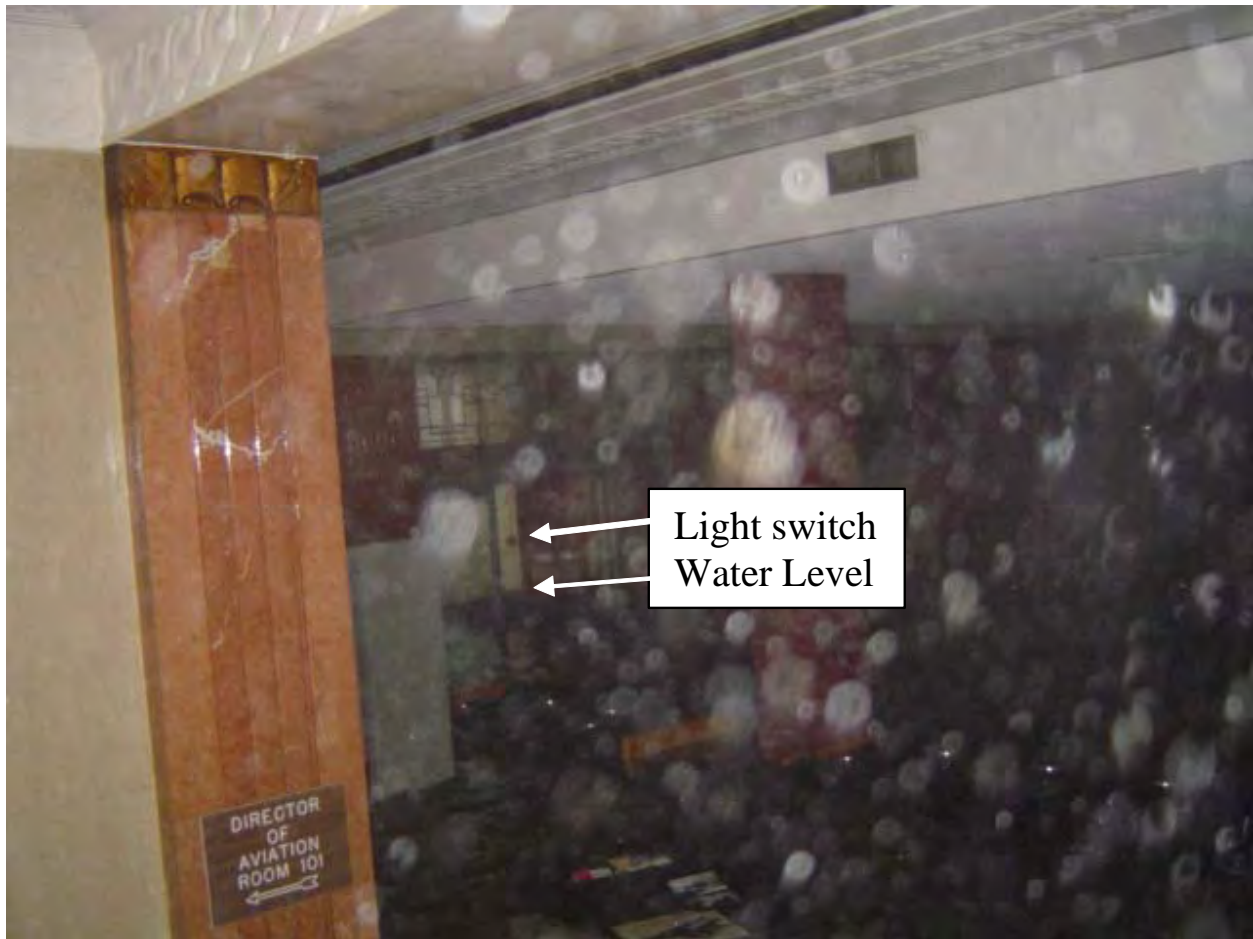
- d. Time 8:28 AM, APH-15, elevation 10.8, Figure 1-37. Inside terminal on wall near south door in Figure 1-37. The distance on the wall above the bottom of the light switch was measured at 2.7 ft and the bottom of the light switch to floor was 4.2 ft. Based on scaling the photograph, the distance to the water surface was 1.9 ft below the bottom of the switch giving a depth above floor of 2.3 ft. Based on a terminal floor elevation of 8.45 ft, water level was 10.8 ft. Note that the column in the figure is brown whereas the same column in subsequent figures is white. According to Orleans Levee District personnel, the picture in Figure 1-37 was taken just before the fake marble covering fell off the column. The inside terminal elevation marks should have low wave activity and low uncertainty. The agreement of APH-15 and APH-21 elevations adds to the confidence in water level at this time in the hydrograph but some low wave activity can be seen inside the terminal in Figure 1-36.

Figure 1-37. Time = 8:28 AM, APH-15. Door at south side of terminal building lobby

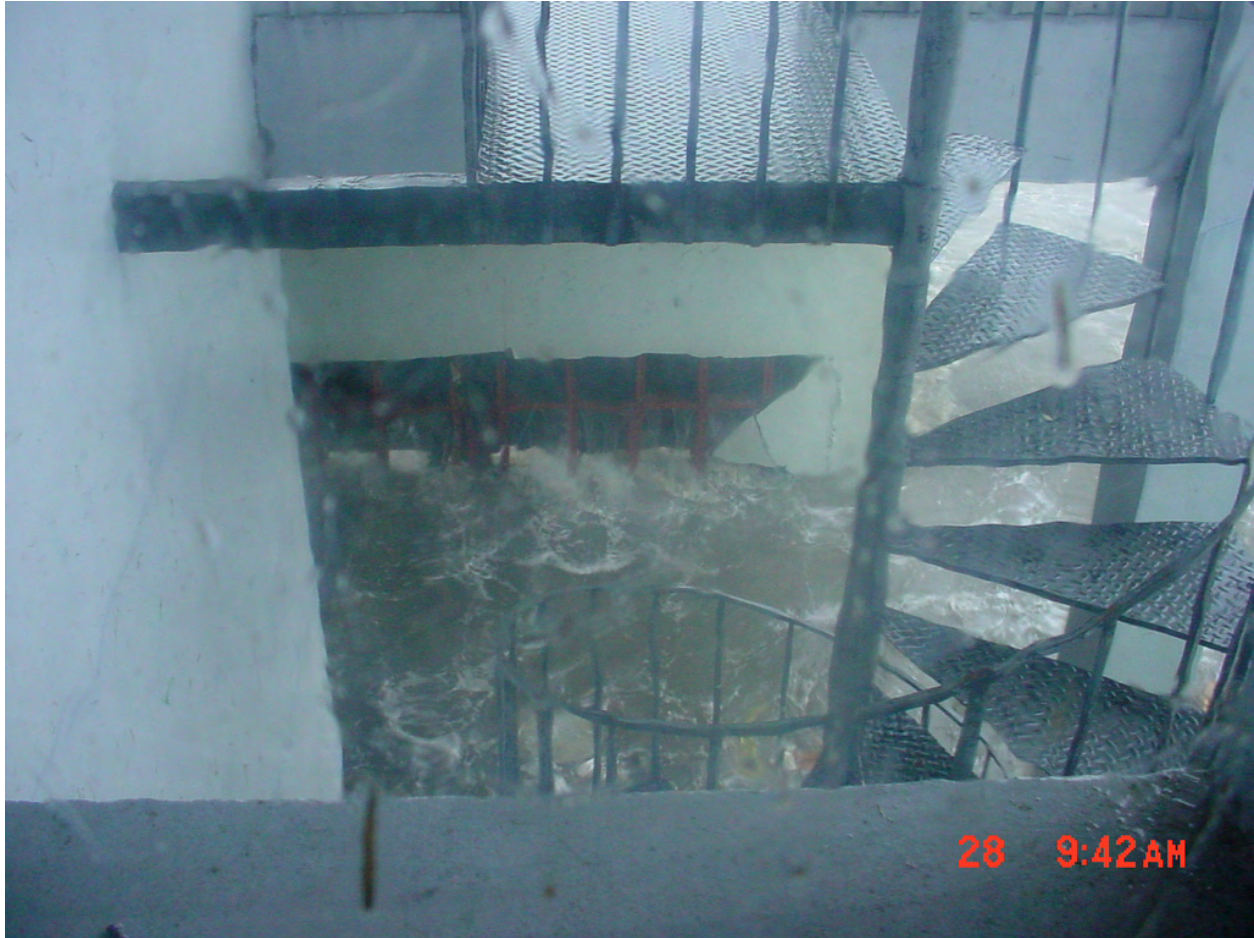
- f.* Time = 9:42 AM, APH-03, elevation 10.6 ft, Figure 1-39. On outside wall north of east spiral staircase where plaster is broken. The elevation of this mark has significant uncertainty because it is exposed to high wave activity.

Figure 1-39. Time = 9:42 AM, APH-03. Wall north of east spiral staircase.
