# Appendix 1

## Hydrograph and High Water Mark Analysis

### Introduction

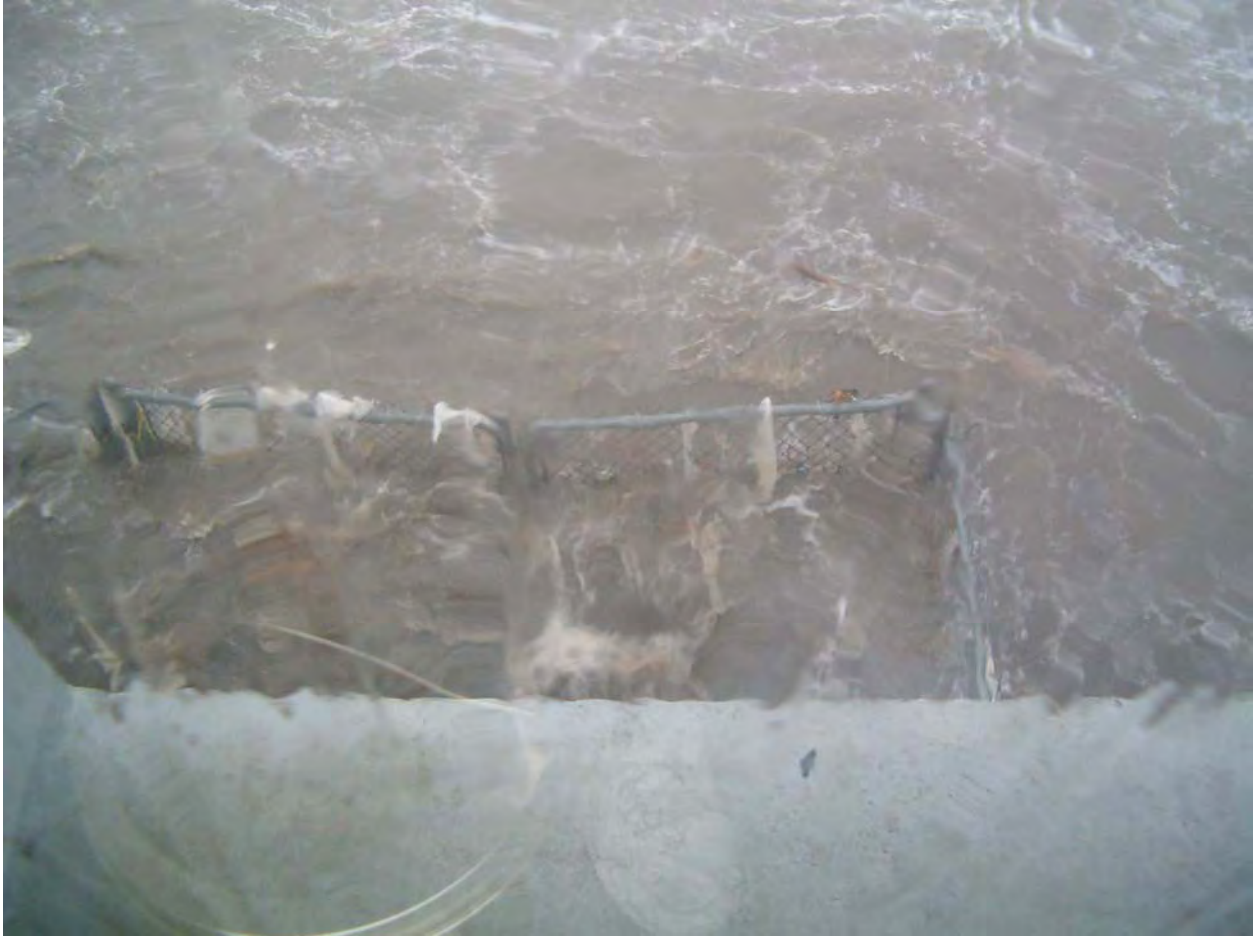
- g.* Time = 9:55 AM, APH-05, elevation 11.3 ft, Figure 1-40. Mark is located on the chain link fence. This mark is exposed to high wave activity. The number of openings in the chain link fence between the top bar of the fence and the water surface were counted from the photograph. The same number was used in the field to determine the position to be surveyed.

Figure 1-40. Time = 9:55 AM, APH-05. Chain link fence, north side of building, east of lobby.

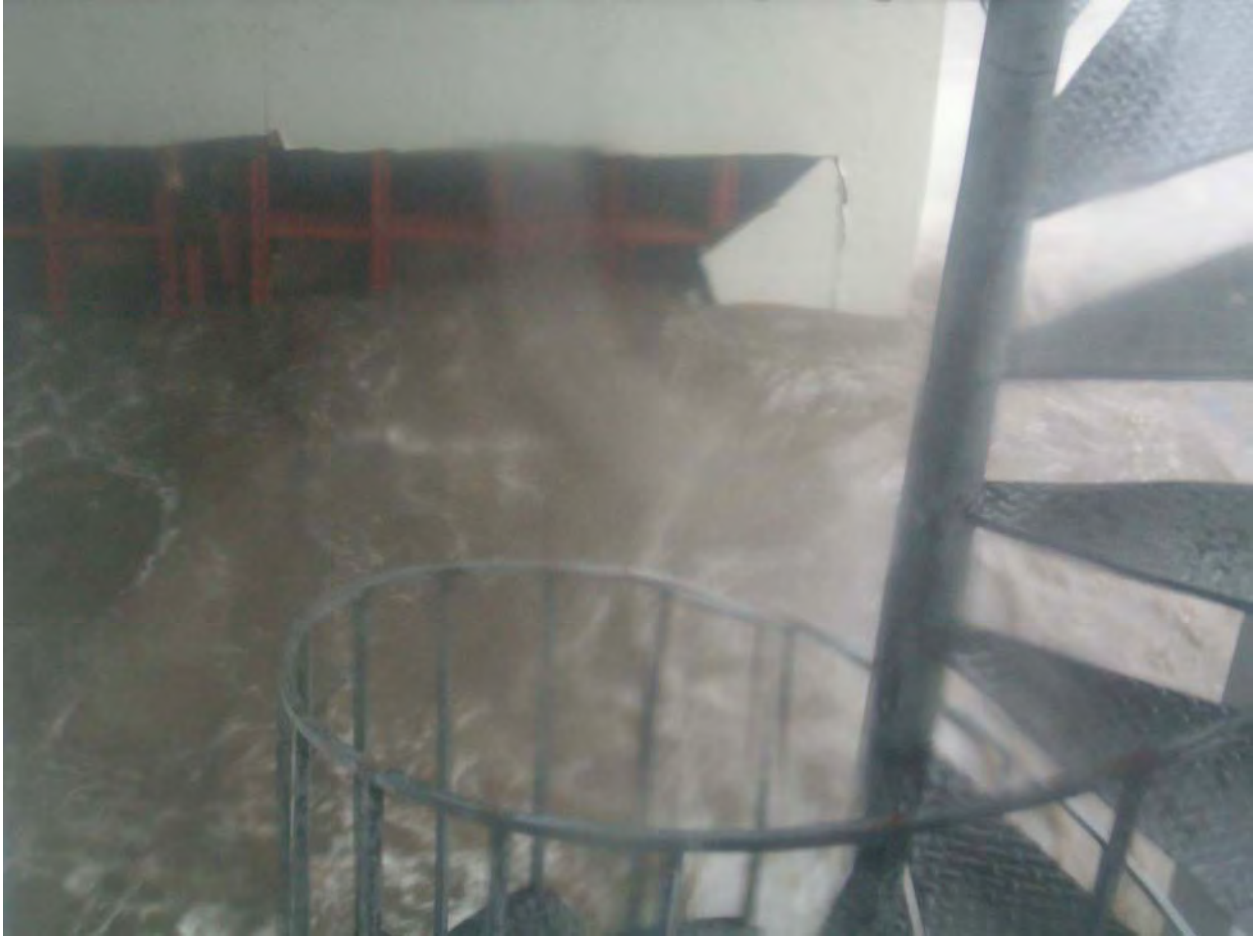
- h.* Time = 9:56 AM, APH-16, elevation = 10.9 ft, Figure 1-41. Located on the outside wall north of east spiral staircase where plaster is broken. This mark is exposed to high wave activity.

Figure 1-41. Time = 9:56 AM, APH-16. Wall north of east spiral staircase.

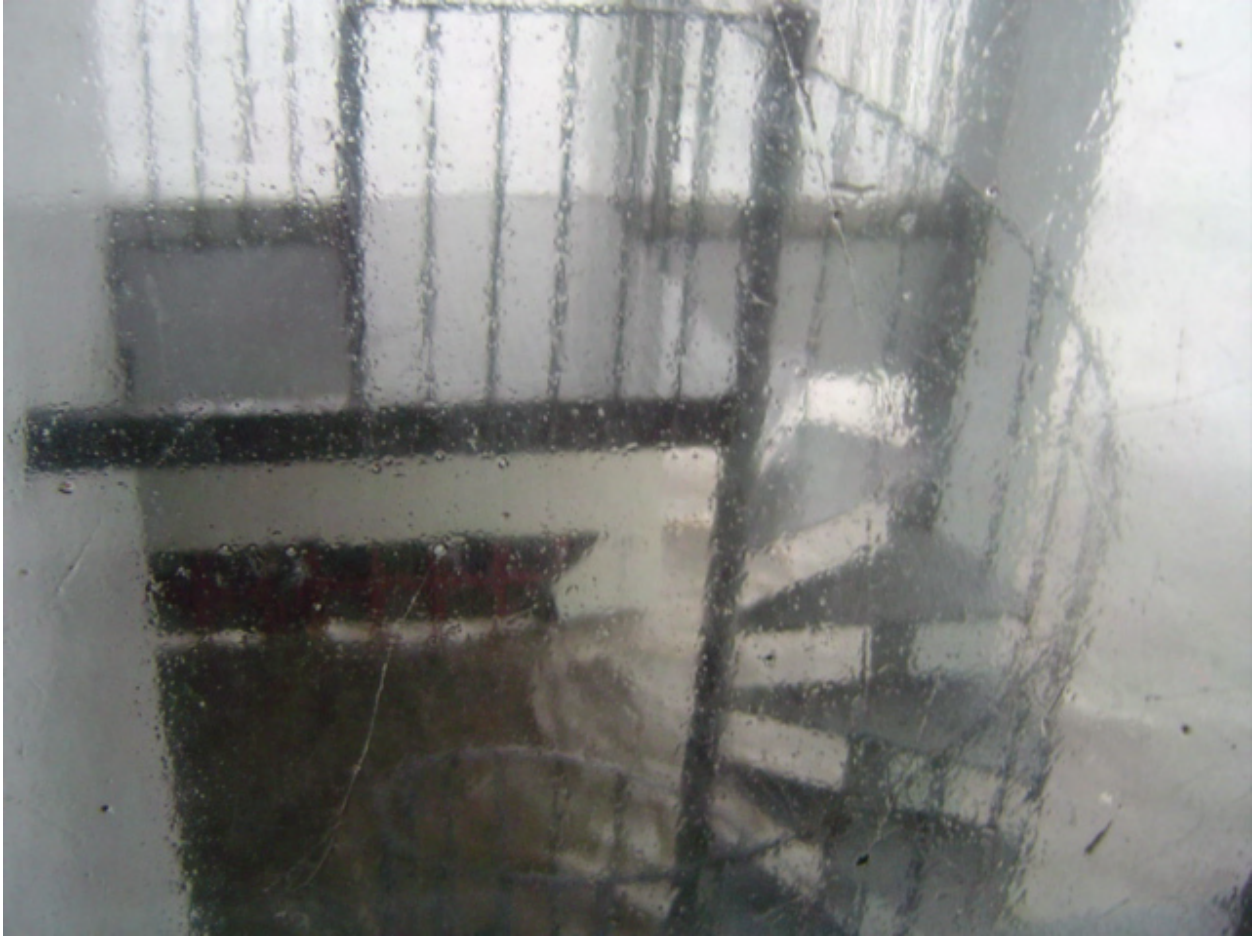
- i.* Time = 10:30 AM, APH-17, elevation = 10.6 ft, Figure 1-42. On outside wall north of east spiral staircase where plaster is broken. This mark is exposed to high wave activity.

Figure 1-42. Time = 10:30 AM, APH-17. Wall north of east spiral staircase.

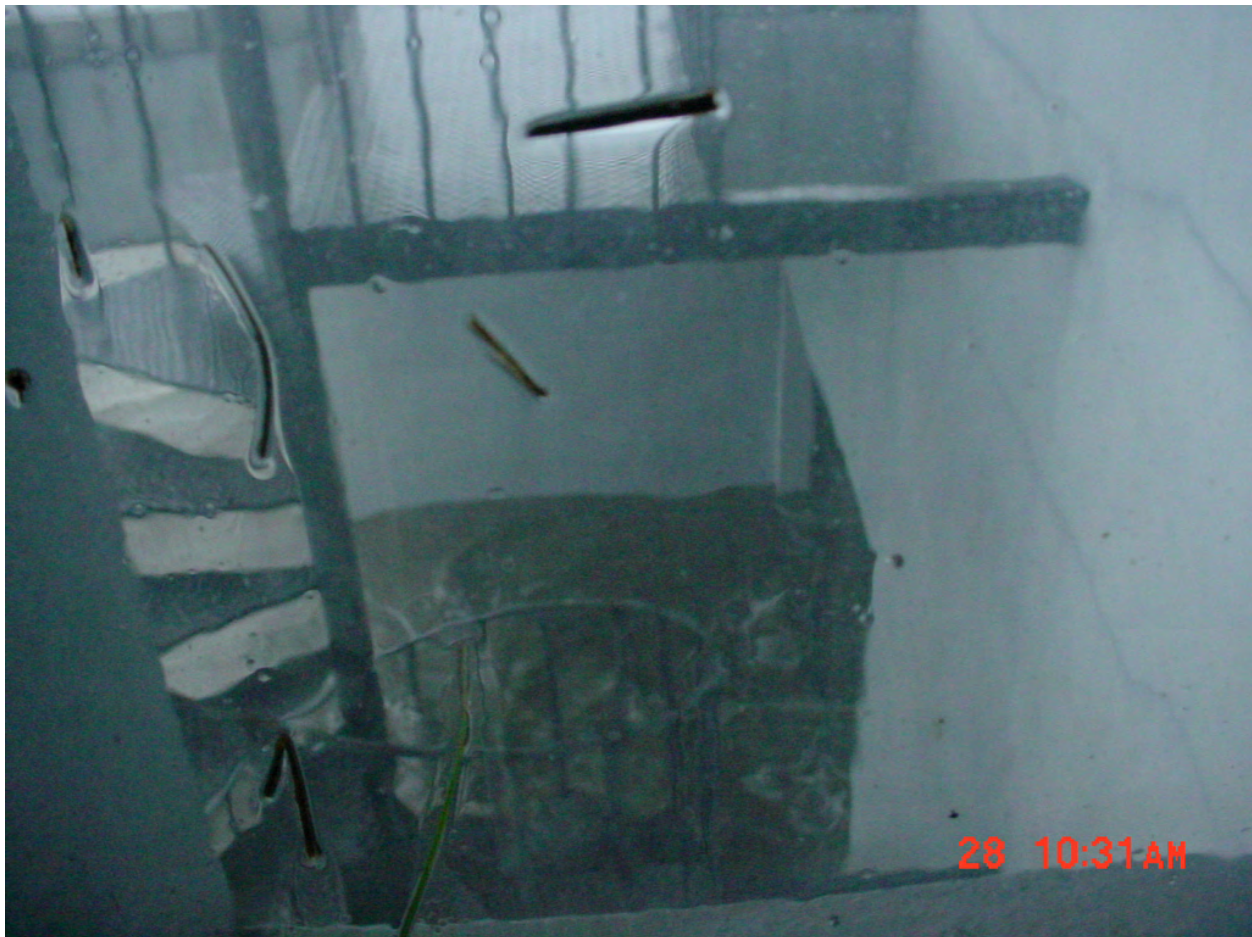
- j.* Time = 10:31 AM, APH-02, elevation 9.5 ft, Figure 1-43. On outside wall north of west spiral staircase. This mark is exposed to high wave activity. This mark was difficult to locate because the wall had no defined points to relate to the water level. One IPET member positioned himself in the window where the picture was taken and another IPET member placed his hand on the wall until his hand in the actual viewing and the water level in the photograph were at the same vertical position on the wall. This mark has significant uncertainty because of the method just described and the high waves present.

Figure 1-43. Time = 10:31 AM, APH-02. Wall north of west spiral staircase.

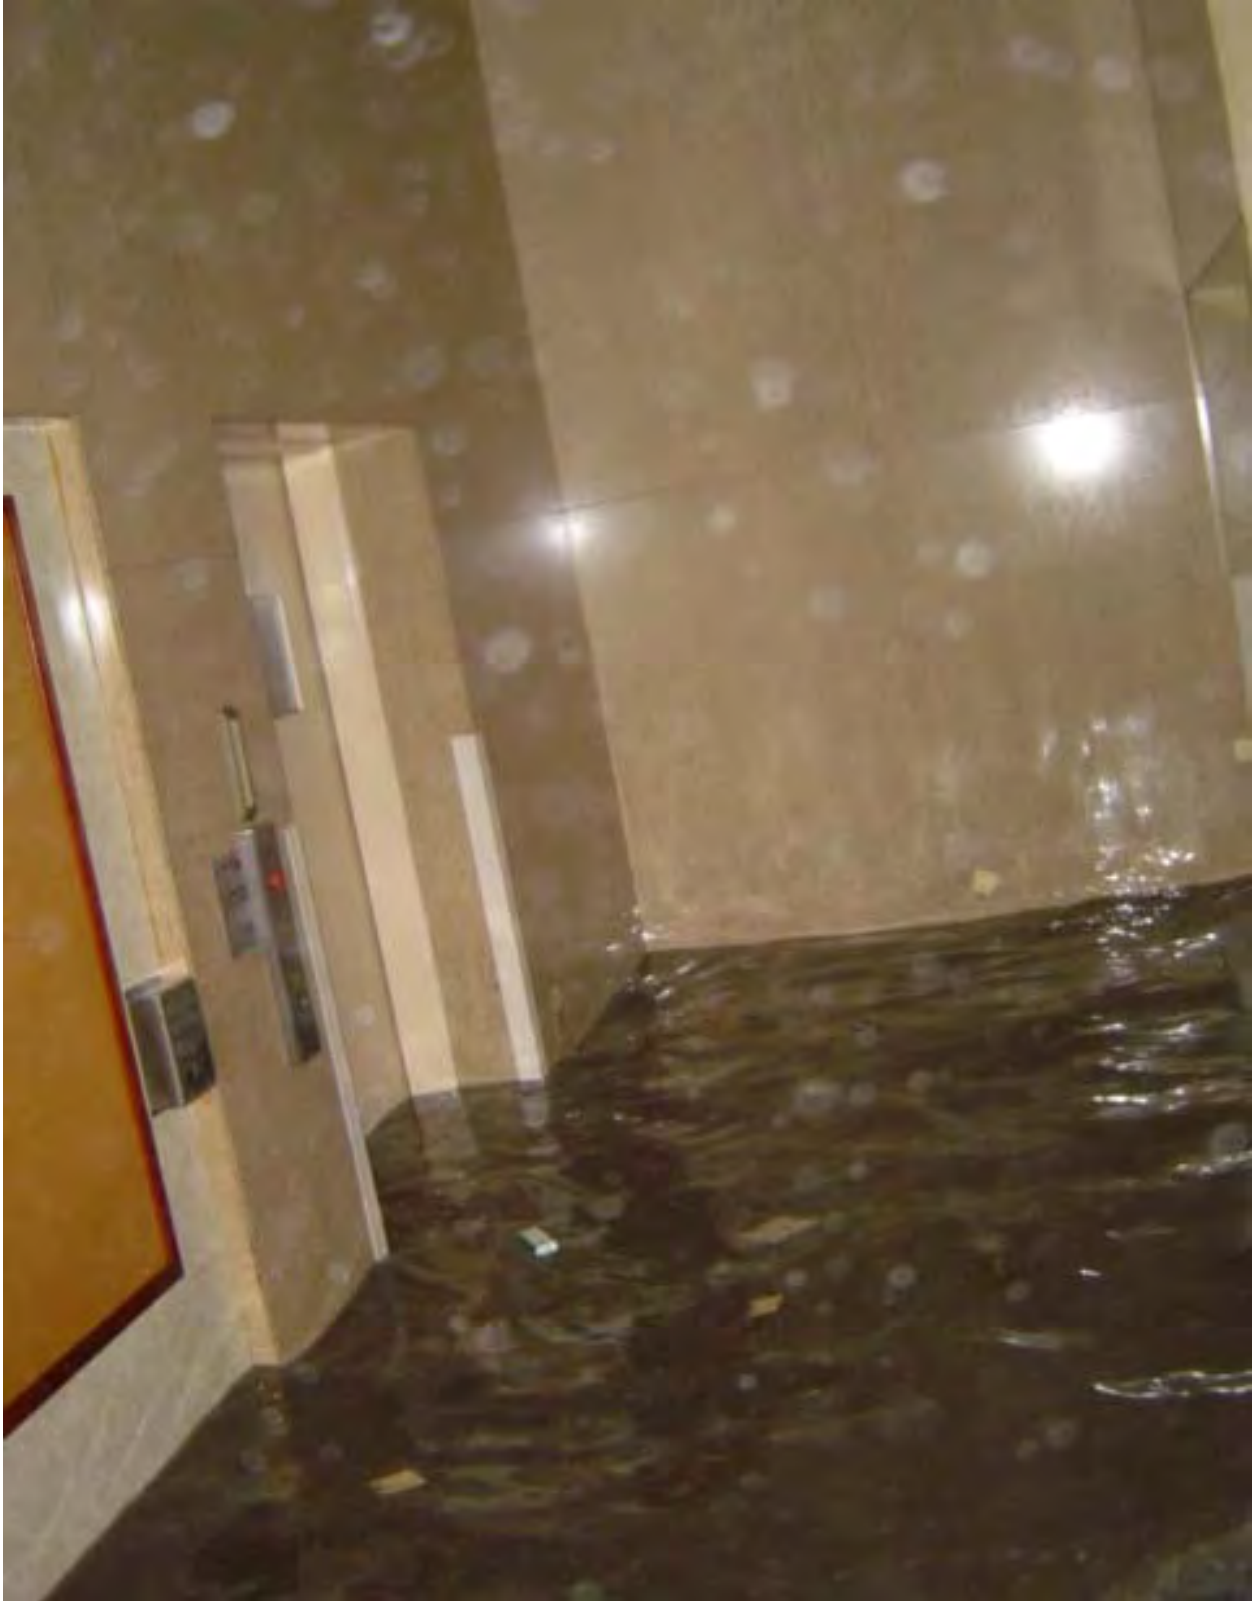
- l.* Time = 10:56 AM, APH-10, elevation 10.3 ft, Figure 1-45. Mark was determined by scaling from the photograph the distance from the top of the white strip on the elevator door facing to the top of the elevator door opening and the distance from the top of the white strip to the water surface. The distance from the top of the white strip to the top of the elevator door opening was measured at the airport and the ratio of the photograph measurements were used to position the mark. The elevator is in a side hallway off the main lobby of the terminal building and should have little wave activity. The agreement of this mark and APH-08 is strong evidence supporting these two marks.

Figure 1-45. Time = 10:56 AM, APH-10, elevator east of lobby.

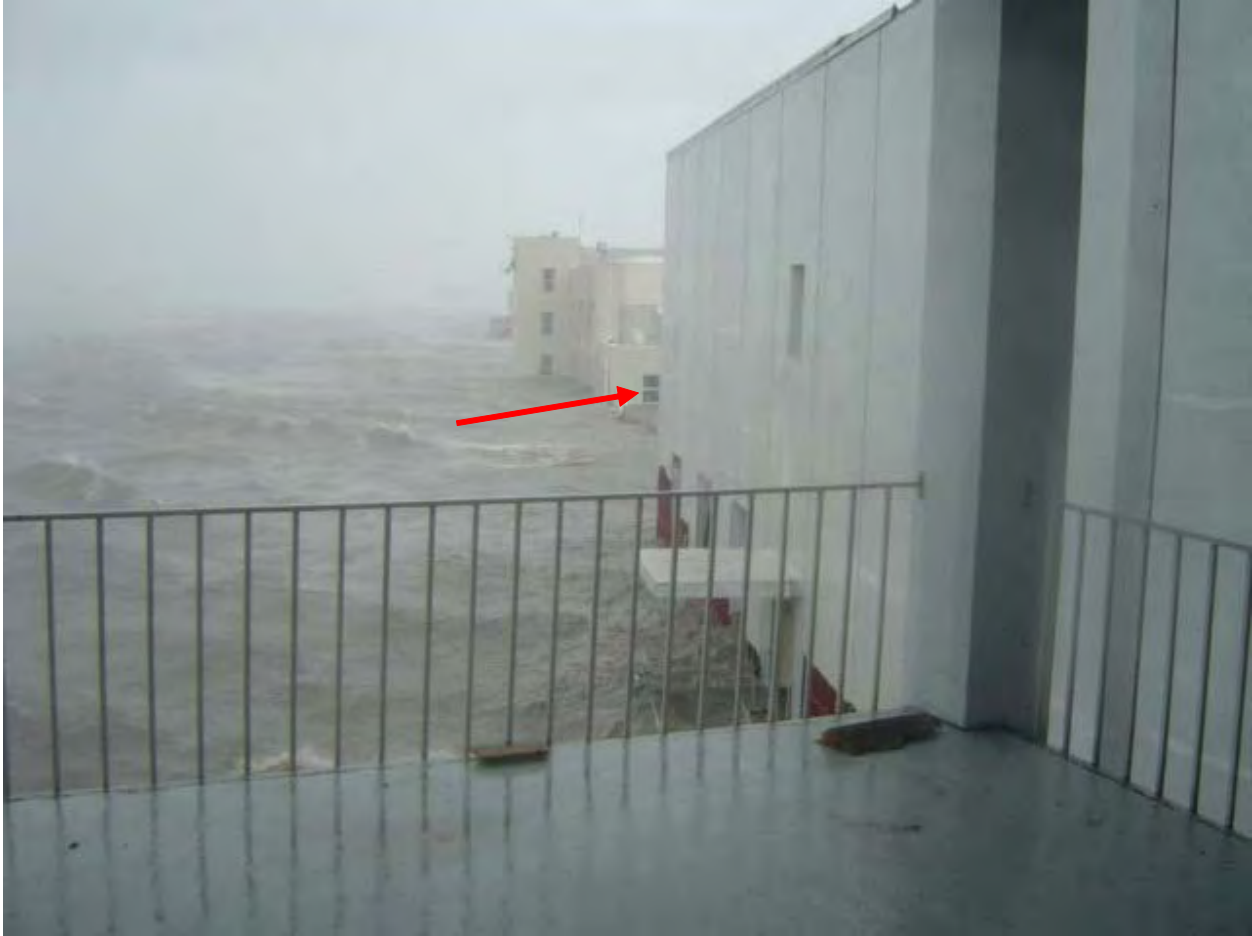
- m.* Time = 11:48 AM, APH-18, elevation 10.3 ft, Figure 1-46. On the west side of the building east of the terminal building, the water level is at the top of the lowest window.

Figure 1-46. Time = 11:48 AM, APH-18. Top of lowest window on building east of terminal building.

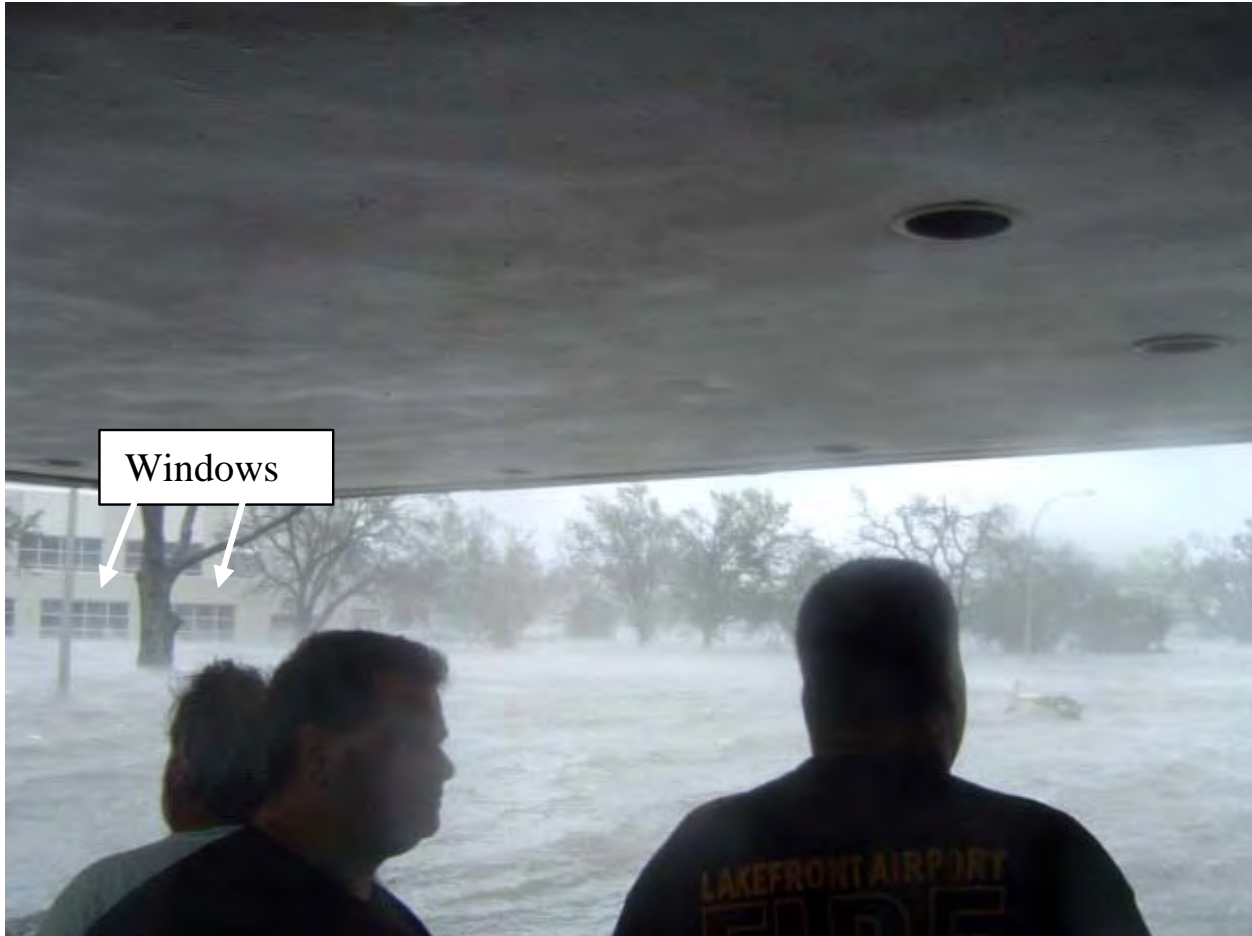
- p.* Time = 12:31, APH-19, elevation 8.8 ft, Figure 1-49. The left side of the photograph was zoomed to the windows on the building east of the airport. Mark to be surveyed was determined by scaling from the photograph the height of the window and the distance from the top of the lowest window to the water surface. The height of the window (2.5 ft) was measured at the airport and the ratio of the photograph measurements were used to position the mark. The size of the windows and the haziness in the photograph along with the wave activity cause significant uncertainty in this mark.

Figure 1-49. Time = 12:31 PM, APH-19. Windows on building just east of terminal building.

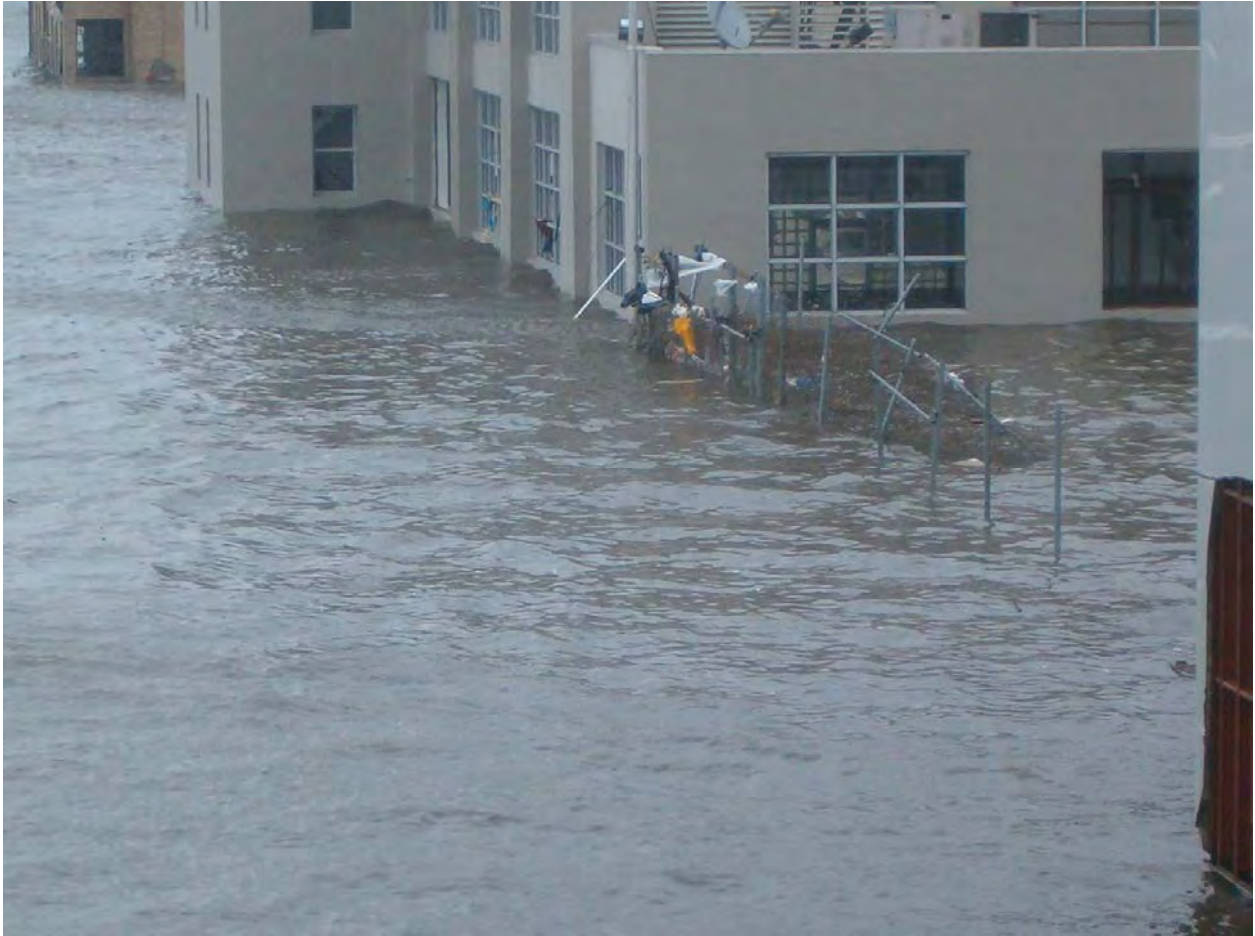
- r.* Time = 2:46 PM, APH-12, elevation 7.1 ft, Figure 1-51. Mark is below the windows on the building east of the terminal building. The mark to be surveyed was determined by scaling from the photograph the height of the window and the distance from the bottom of the lowest window to the water surface. The height of the window (2.5 ft) was measured at the airport and the ratio of the photograph measurements were used to position the mark which was 0.5 ft below the bottom of the lowest window. This is the first photograph where the water is calmed significantly which makes this a mark with little uncertainty.

Figure 1-51. Time = 2:46 PM, APH-12. Below windows on building east of terminal building.

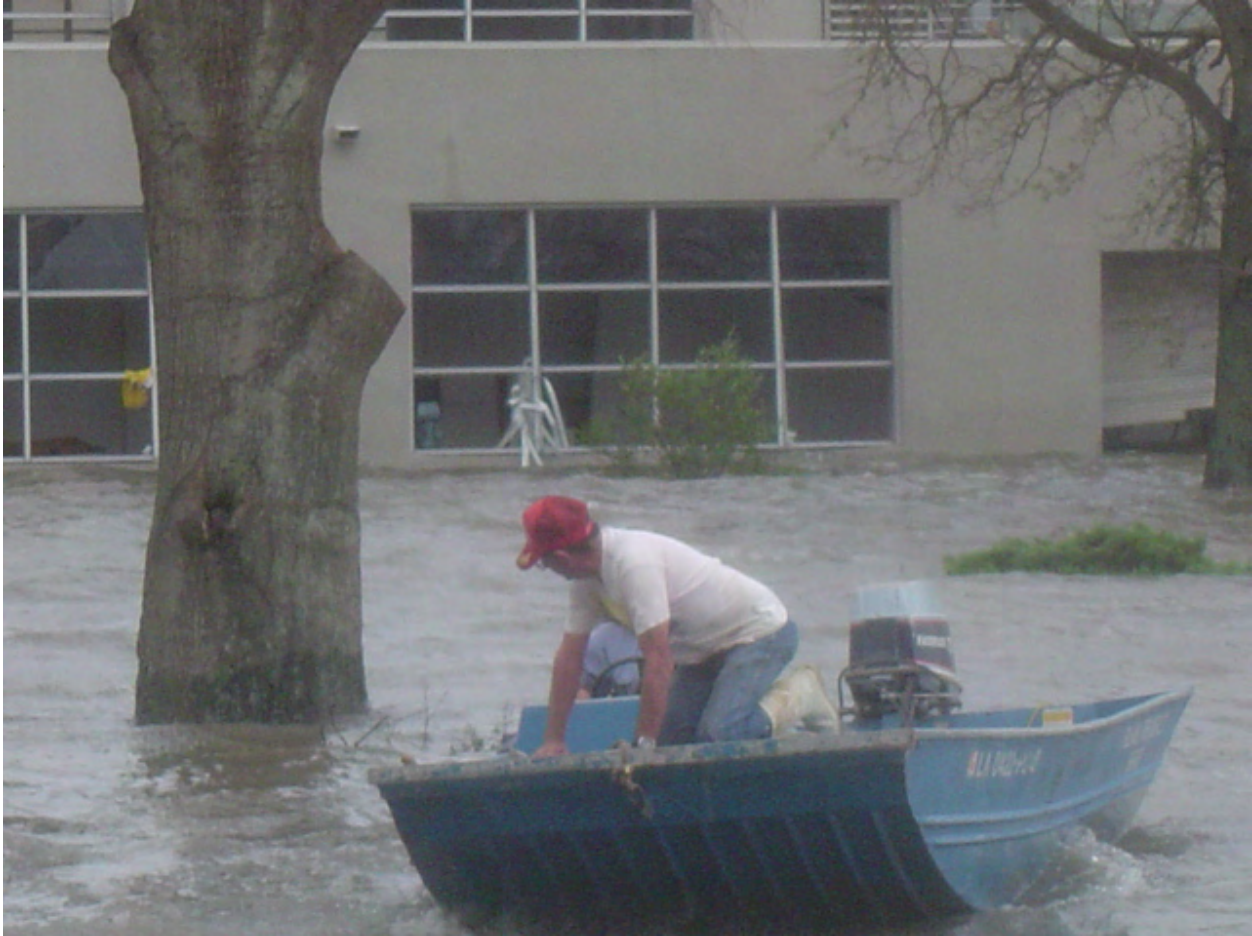
- s. Time = 5:14 PM, APH-20, elevation 7.3, Figure 1-52. Mark is below the windows on the building east of the terminal building. The mark to be surveyed was determined by scaling from the photograph the height of the window and the distance from the bottom of the lowest window to the water surface. The height of the window (2.5 ft) was measured at the airport and the ratio of the photograph measurements were used to position the mark which was 0.0 to 0.3 ft below the bottom of the window.

Figure 1-52. Time = 5:14 PM, APH-20. Below windows on building east of terminal building.

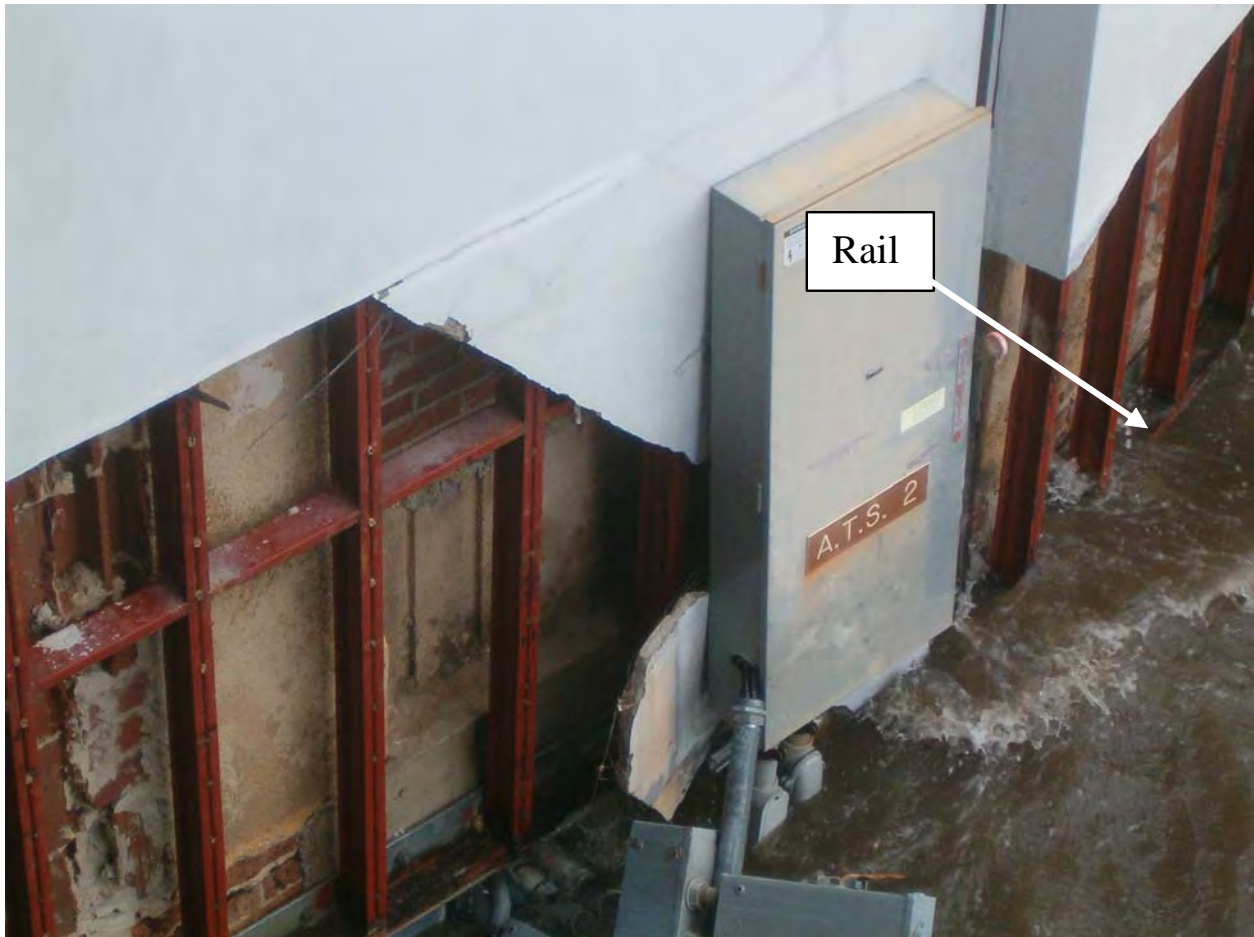
- t. Time = 5:30 PM, APH-11, elevation 7.4 ft, Figure 1-53. Located on north side of terminal building, west of lobby. Water level is at horizontal framework just to the west or right of the electrical panel box. Wave activity was low.

Figure 1-53. Time = 5:30 PM, APH-11. Bottom of horizontal rail to right of electrical panel box on north side of terminal building, east of lobby.

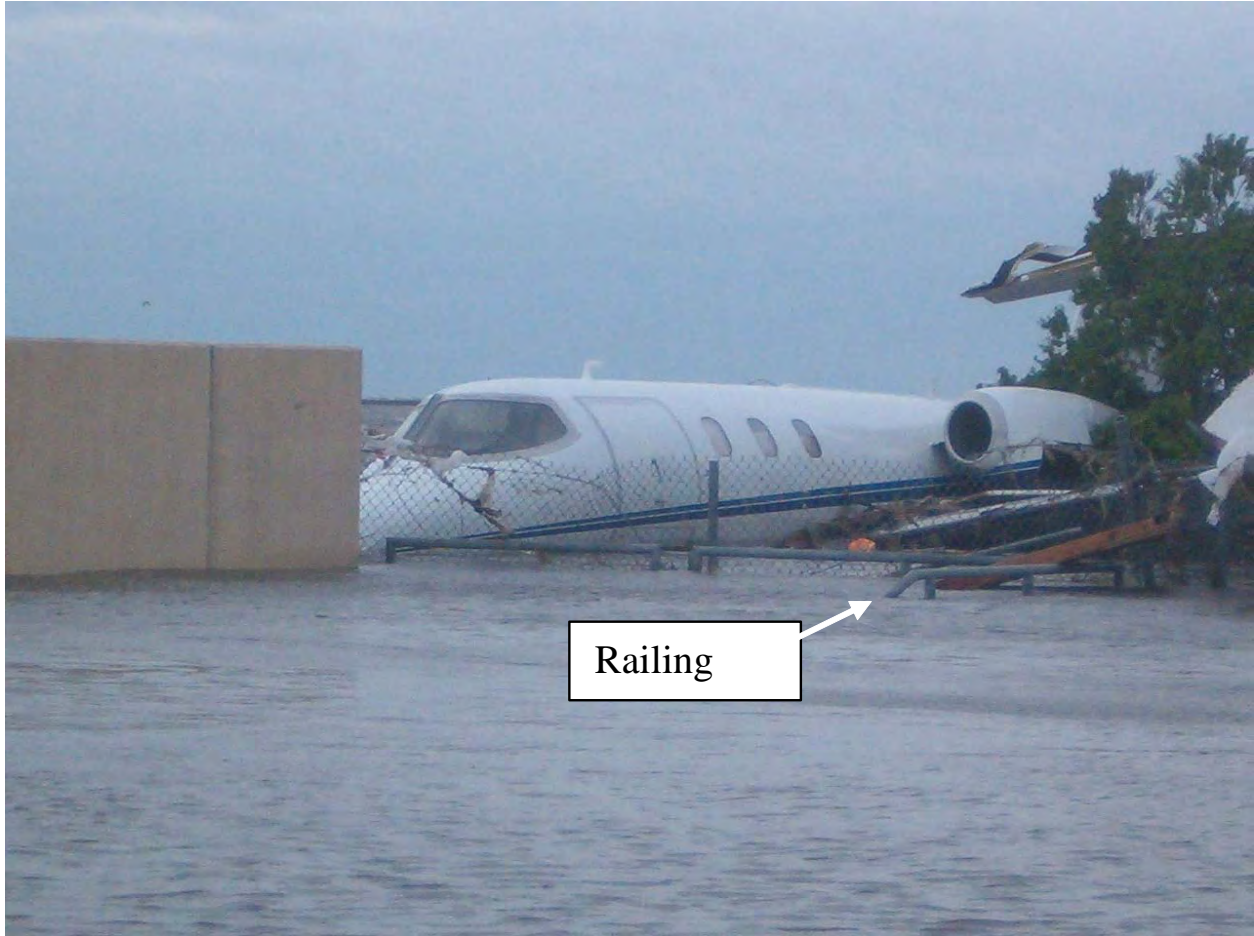
- u. Time = 6:30 PM, APH-14, elevation 7.0 ft, Figure 1-54. Located southwest of terminal building near floodwall opening. Mark to be surveyed was on sloping handrail that is below and slightly to the left of the jet engine. The absence of wave activity makes this a mark with little uncertainty.

Figure 1-54. Time = 6:30 PM, APH-14. On slanted railing just below jet engine.

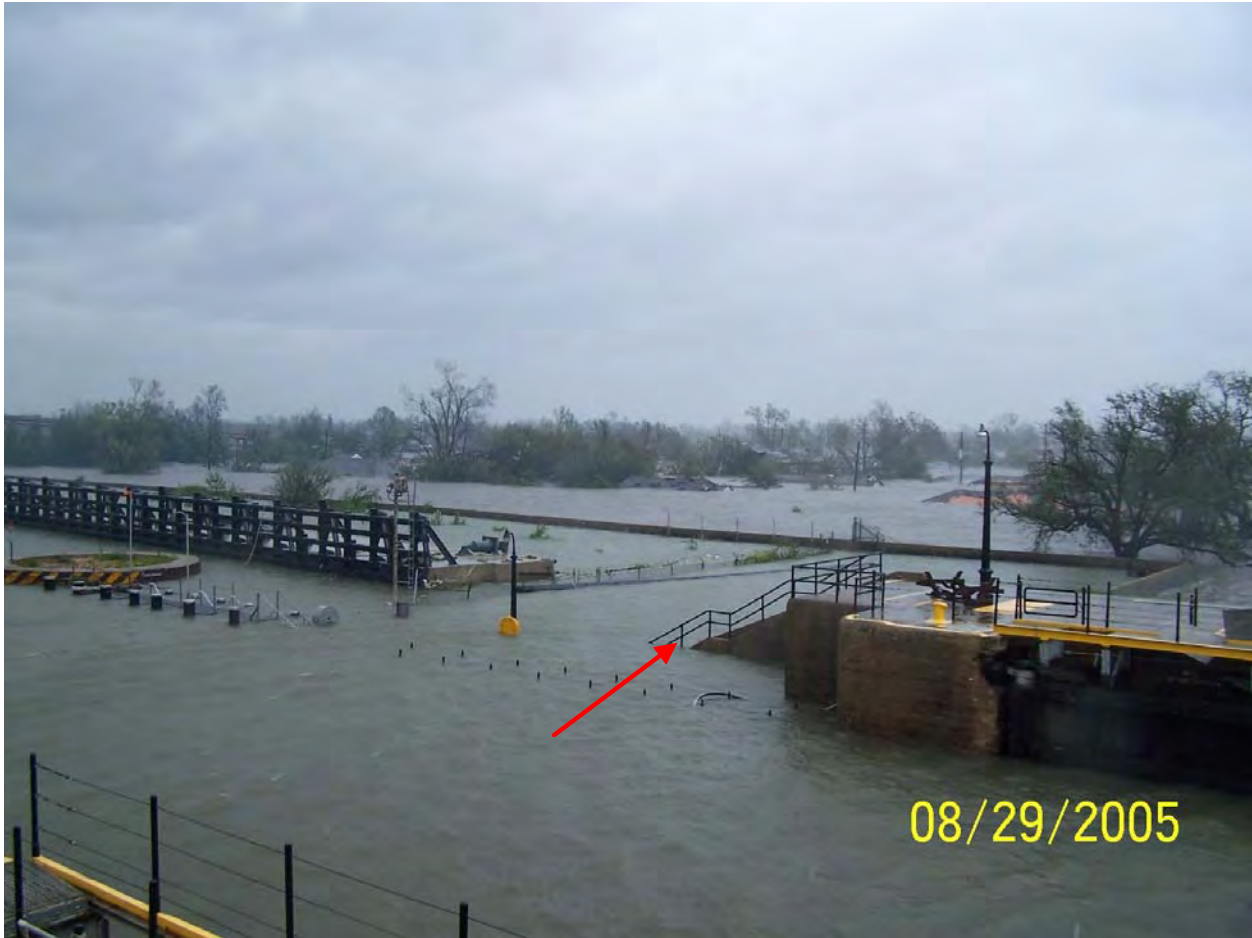
- b.* File time 11:47 AM, Picture 100\_0502, Figure 1-60, looking east-northeast into Lower Ninth Ward. Water level at location of sloping handrail. Elevation = 11.5 ft.

Figure 1-60. Time 11:47, picture 100\_0502. Red arrow shows location surveyed. Looking east-northeast into Lower Ninth Ward.

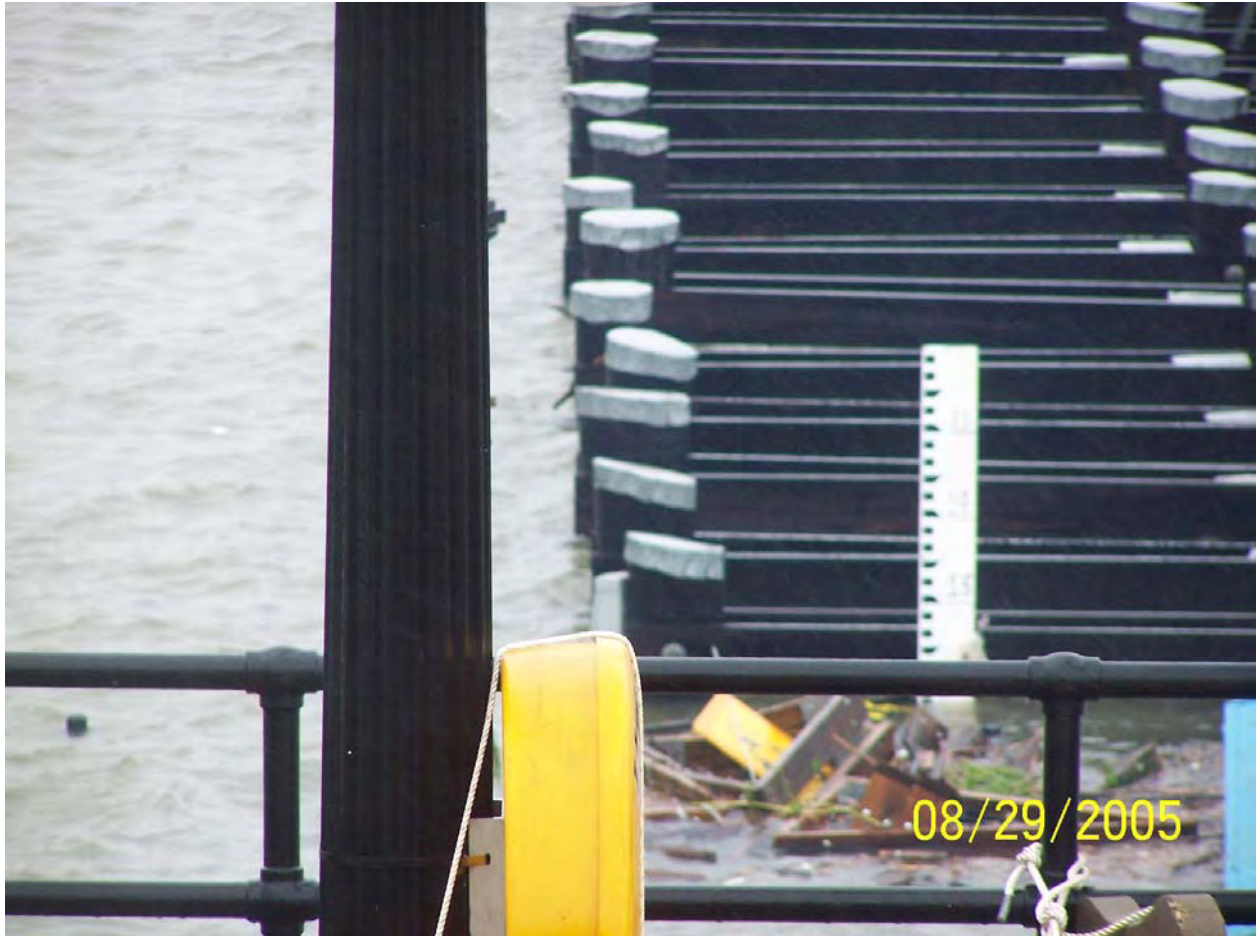
- c.* File time 11:50 AM, picture 100\_0507, Figure 1-61, looking north. Shows staff gage where water level is almost hidden by handrail. Using other objects in the picture such as tops of handrails, the staff gage reading is 11.8 ft, that is an elevation of 11.1 ft.

Figure 1-61. Time 11:50, picture 100\_0507, looking north.

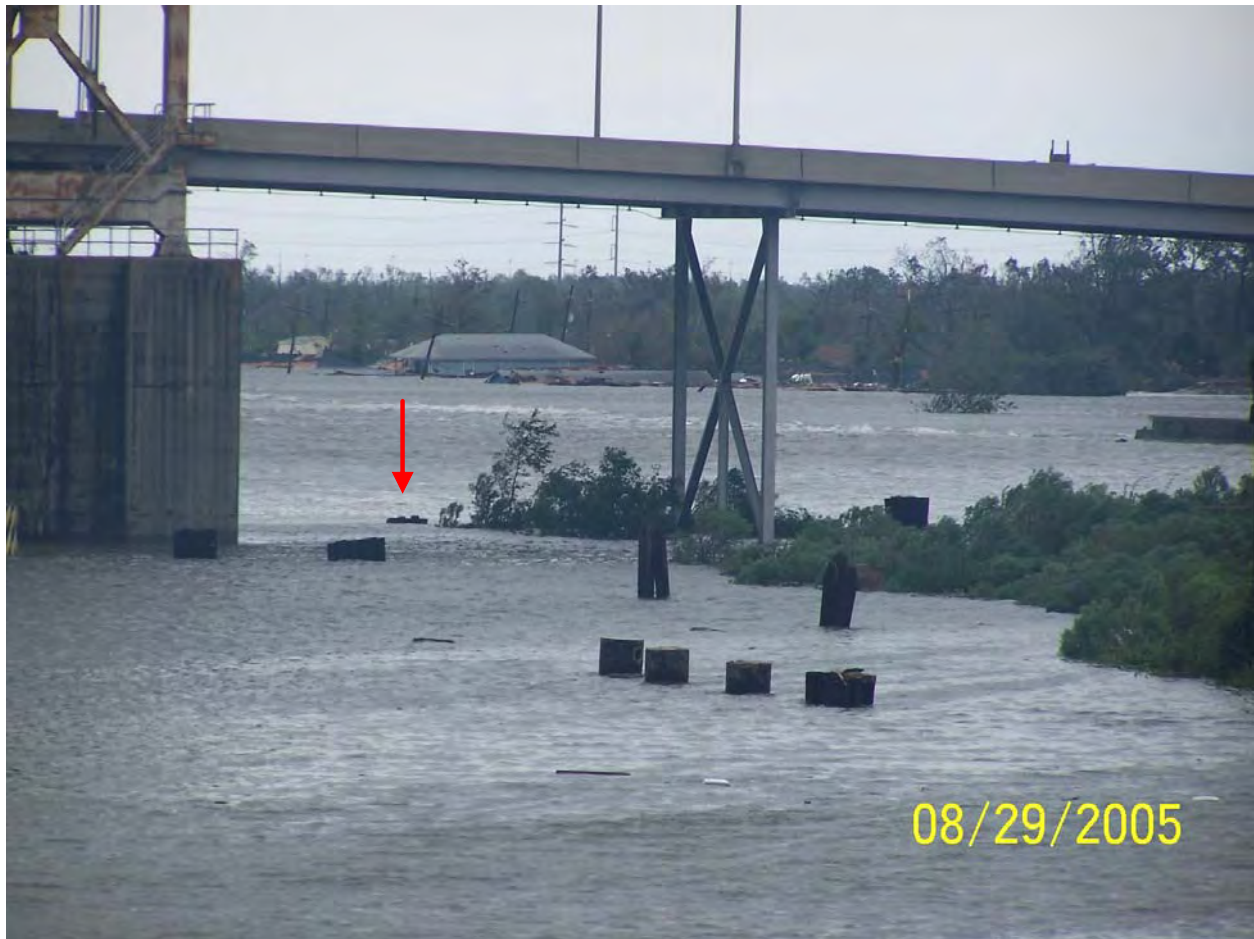
- d.* File time 3:03 PM, Picture 100\_0508, Figure 1-62, looking northeast into Lower Ninth Ward. Top of highest pile in cluster under arrow is at elevation 8.7 ft. Based on width of pile cluster of 4.8 ft, water level is 0.8 ft below top of highest pile for an elevation of 7.9 ft.

Figure 1-62. Time 3:03 PM, picture 100\_0508. Breach on east side of IHNC in background. Looking northeast into Lower Ninth Ward.

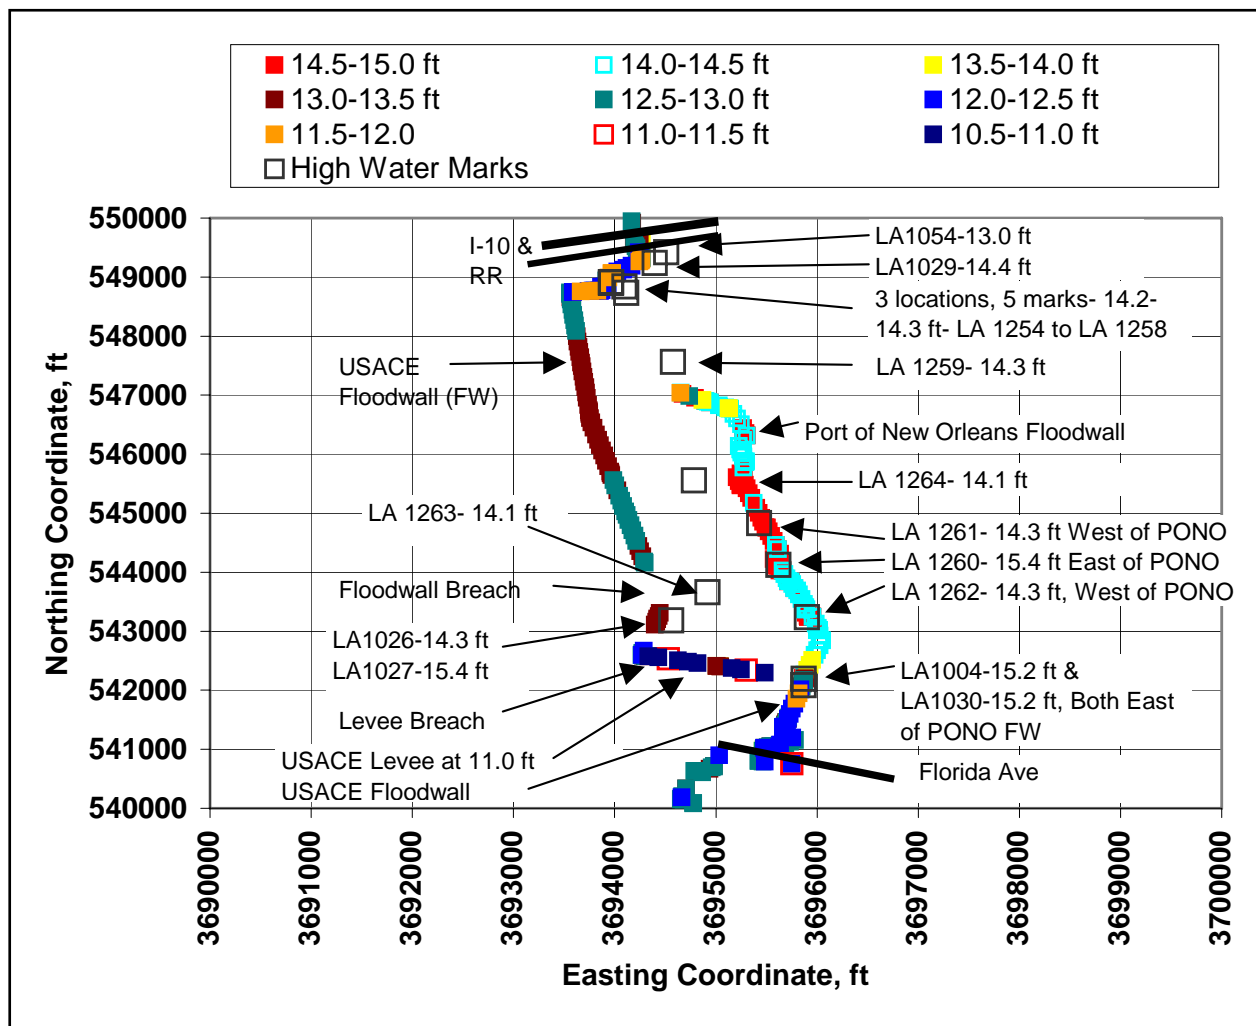
Figures 1-65, 1-66 and 1-67 show high water marks and a layout of the USACE protection along the west side of the IHNC. Figure 1-66 shows the layout of the PONO floodwall. On Figure 1-66 at the railroad south of I-10 on the west side is the floodwall opening that was

sandbagged prior to Katrina and failed sometime during Katrina. High water mark LA 1054 at 13.0 ft is close to this opening and may have been affected by the sandbag failure. The other marks in this area of 14.2-14.4 ft are believed to better represent water levels immediately south of the railroad bridge just south of the I-10 bridge. The railroad bridge was in the down position during Katrina. High water marks on the north and south sides of the railroad bridge show about a 1.5 ft drop in water level across the bridge. Evidence on the ground (Figure 1-68) showed vegetation laid down indicating high velocity through the I-10/railroad area of the IHNC.

Figure 1-66. Floodwall layout, wall elevations, and high water marks along the west side of IHNC, I-10 to Florida Avenue railroad bridge.

One location west of the PONO floodwall has a single high water mark (LA 1027) that does not agree with the other high water mark data (See Figure 1-66). Mark LA 1027 is also shown on Figure 1-70 at latitude 29.987. Mark LA 1027 at elevation 15.4 ft is located in the same building as LA1026 at elevation 14.3 ft. Neither mark is a well-defined seed/debris line as are the other

marks in this area. Both marks are based on debris in the rafters of a heavily damaged building that is close to the floodwall and levee breach on the west side of the IHNC. Both LA 1026 and LA 1027 were described as possibly low. Subsequent visits to this building by other IPET members has not resolved the peak water level in this building. The agreement of LA 1026 at elevation 14.3 ft with 4 other marks west of the PONO is the reason LA 1027 is not accepted.

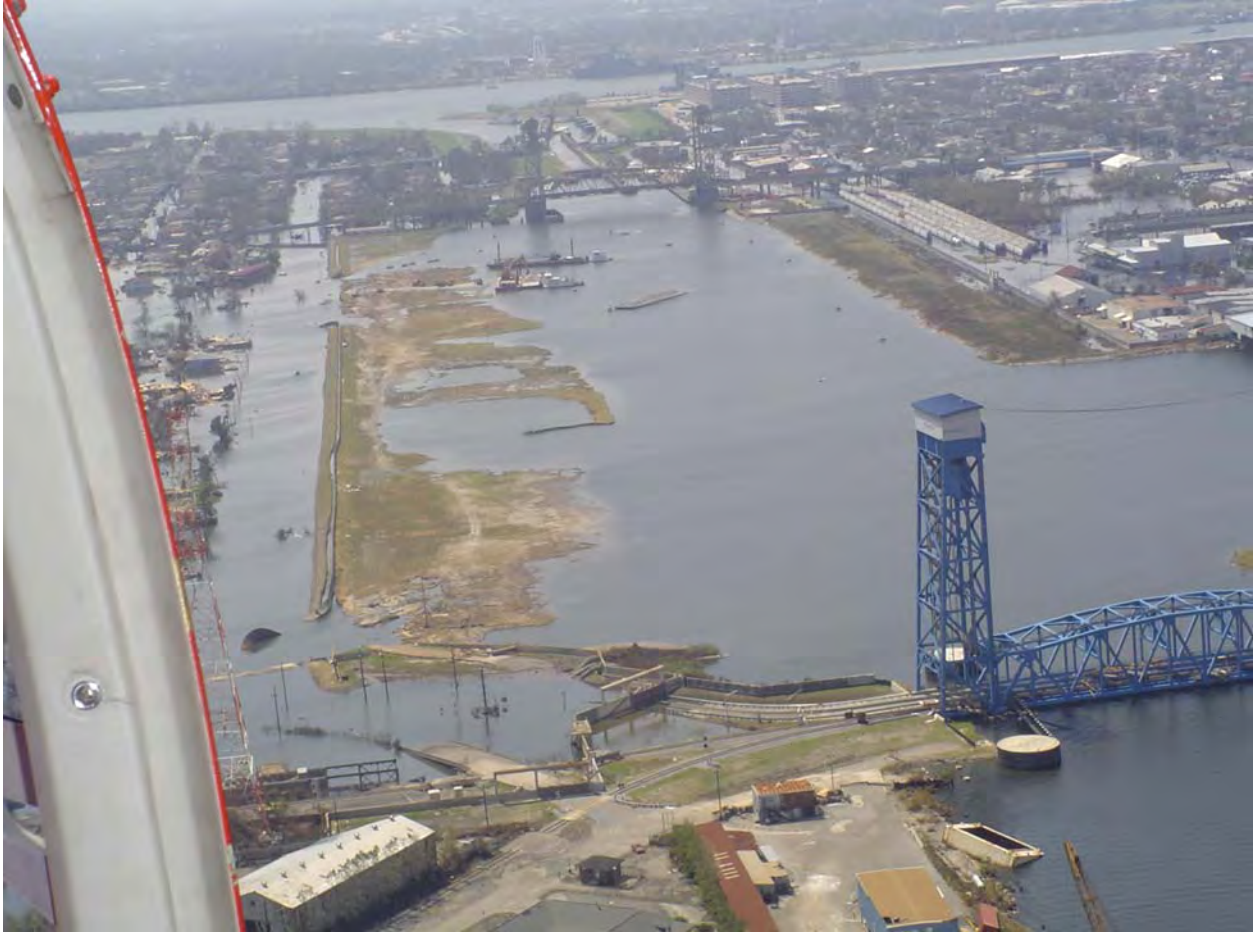
during the storm. Figure 1-69 shows the Florida Avenue Railroad bridge (blue bridge in foreground) in the down position on 7 Sept 05.

Figure 1-69. Florida Avenue railroad bridge (blue), two breaches on east side of IHNC into Lower 9<sup>th</sup> Ward, and IHNC lock at top of picture. Picture looking south-southwest. Note debris on railroad bridge.
