# Appendix 1

## Hydrograph and High Water Mark Analysis

### Introduction

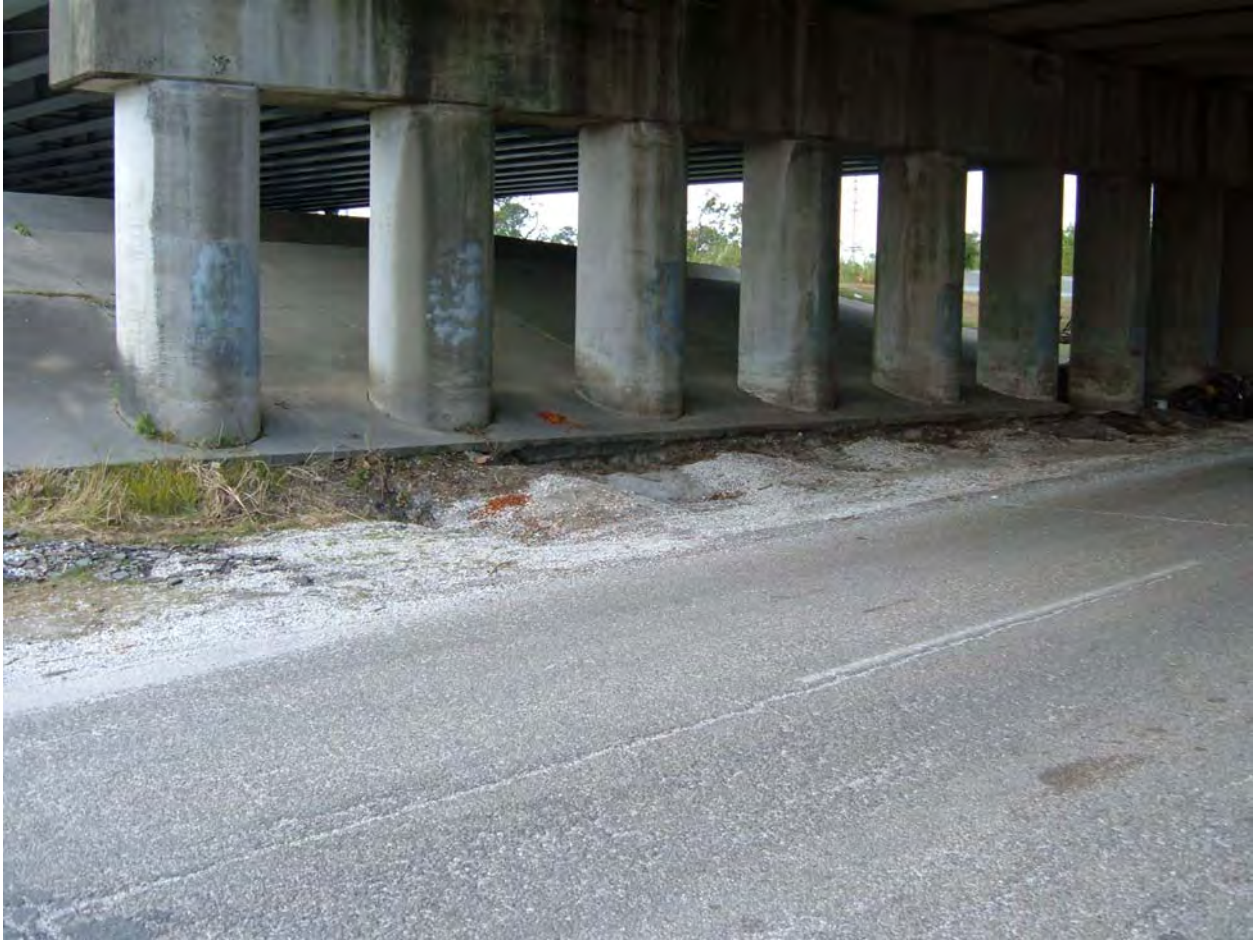
Another operator on another visit to OP#7 stated that the wall did not overtop. Water levels in Lake Pontchartrain, scour, and limited high water marks near the pump station show the wall did overtop. Although not easily seen in Figure 1-71, minor scour occurred below the low wall on the east side of the station. Note the rise of about 1 ft in the low wall in Figure 1-71 behind the individual in the picture. The walls adjacent to the low wall that are at elevation 10.8 ft on the east side and elevation 11.3 ft on the west side had no evidence of scour on the protected side of the wall supporting the first operator’s account of the maximum amount of flow over the wall being about 1 ft. Figure 1-75 shows scour between the columns that could only have come from flow down the concrete slope that is adjacent to the low wall on the east side of the channel. Figure 1-76 shows scour around a power pole below the earth levee on east side of Orleans Ave Canal. Figure 1-77 shows scour below the concrete apron that is below the low wall on the east side of the canal. Figure 1-78 shows greater scour behind the low wall on the west side of Orleans Canal. Note that the west low pump station wall has a larger fall to the ground that is important in determining the amount of scour. Figure 1-79 shows where the west low wall ties into the higher pump station wall. Based on debris trapped in the vegetation, flow overtopped this wall by about 6” that supports the pump station operator’s lower estimate of 6-12” of flow over the wall.

Figure 1-75. Scour between columns below low pump station wall at OP#7. Low wall is at top of slope behind concrete columns.

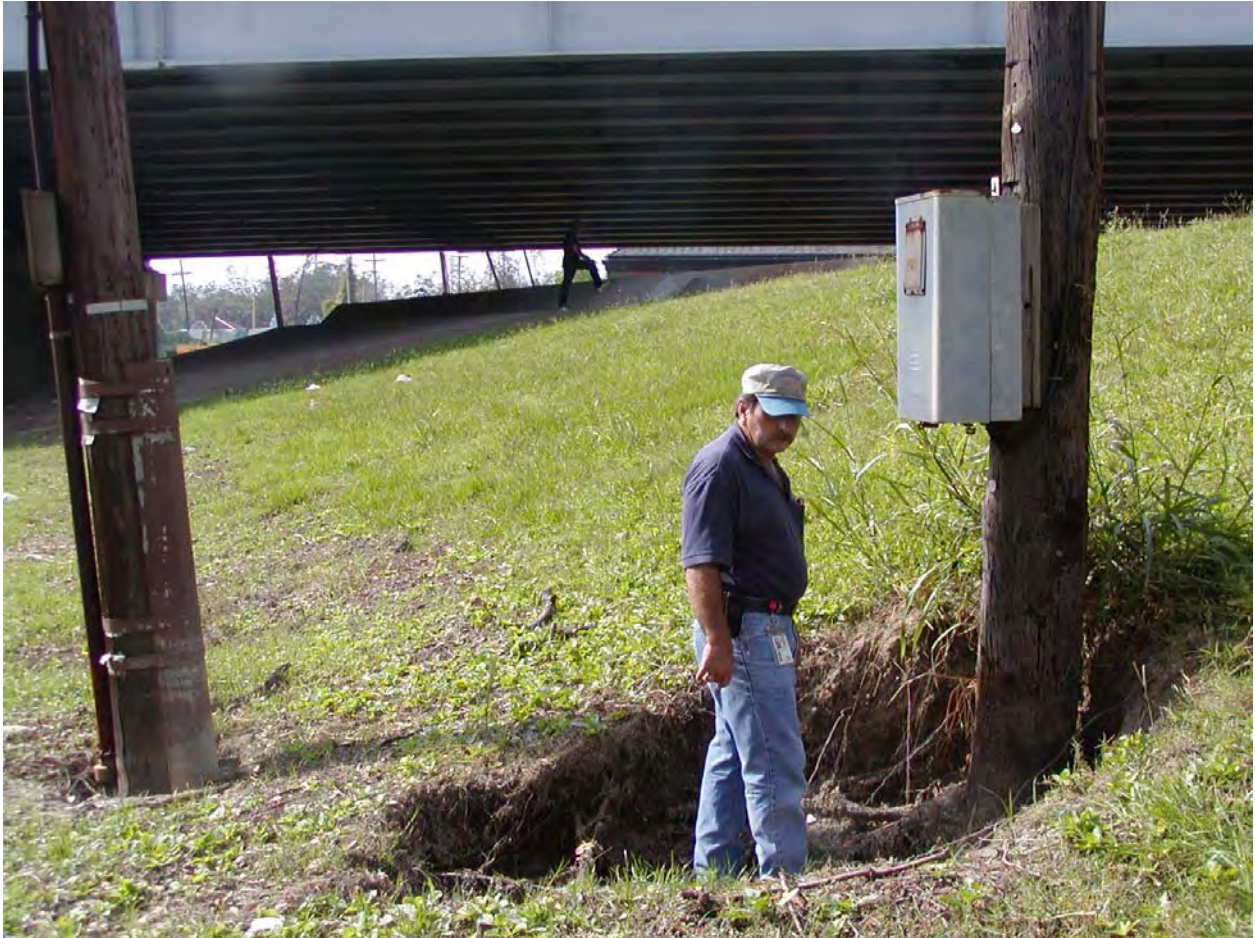
Figure 1-76. Scour around power pole below earth levee on east side of Orleans Ave Canal.

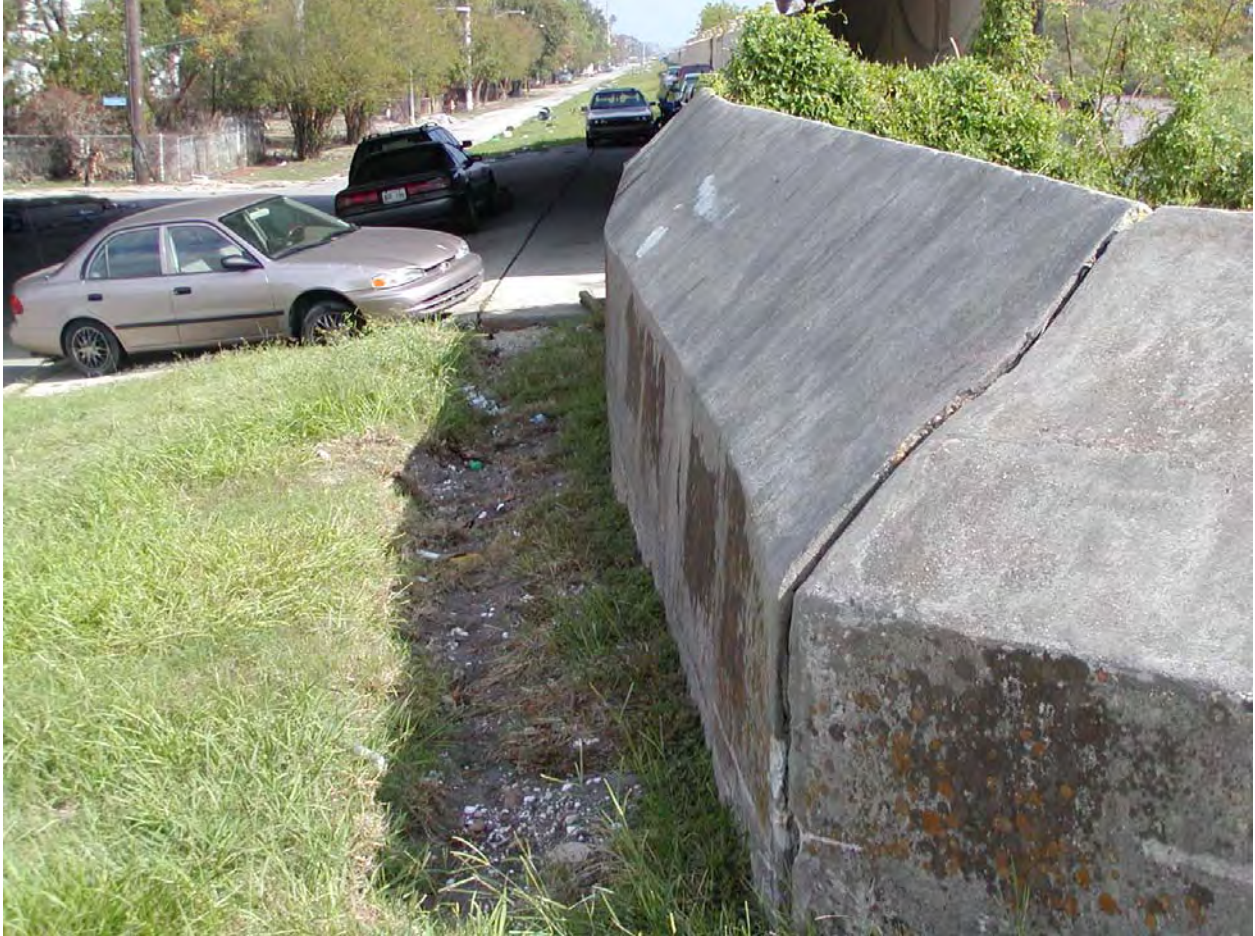
Figure 1-78. Scour below OP#7 low pump station wall on west side. Note that fall distance and scour is greater on this side than on the east side. Note floodwall in background that is about 4.3 ft higher.

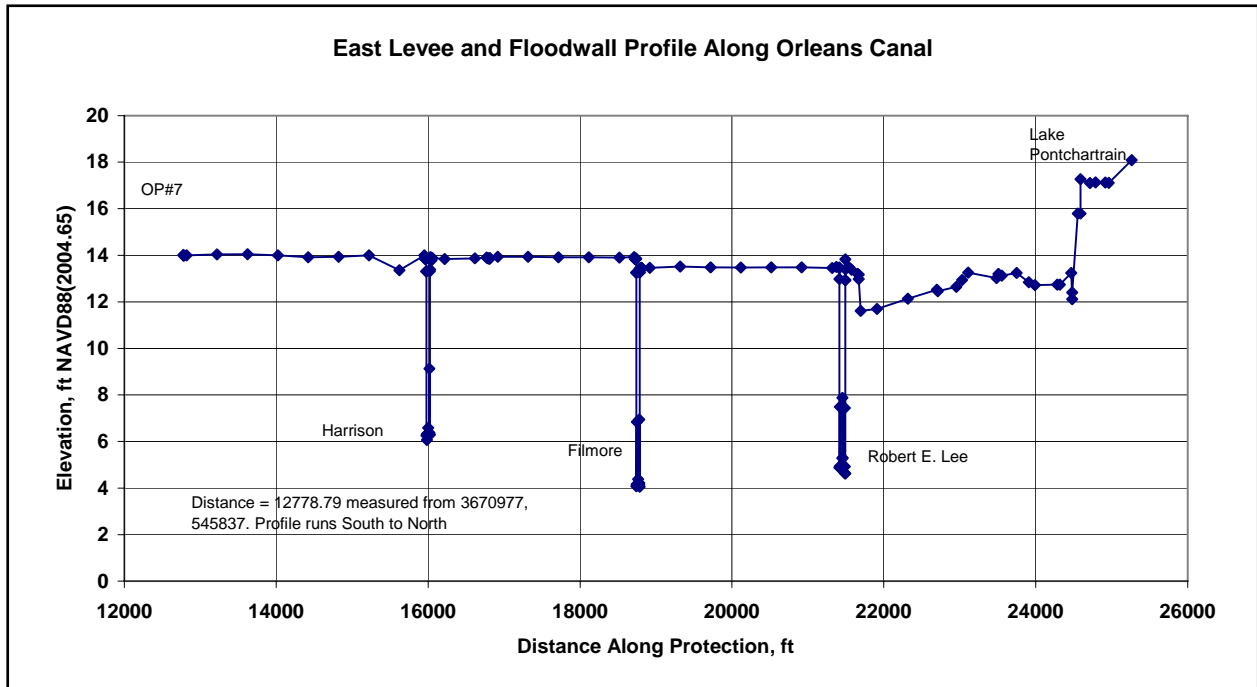
Figure 1-81. East Levee and Floodwall Profile for Orleans Avenue Canal. Note that low areas at bridges and pump stations are floodgate openings that were closed during the storm.

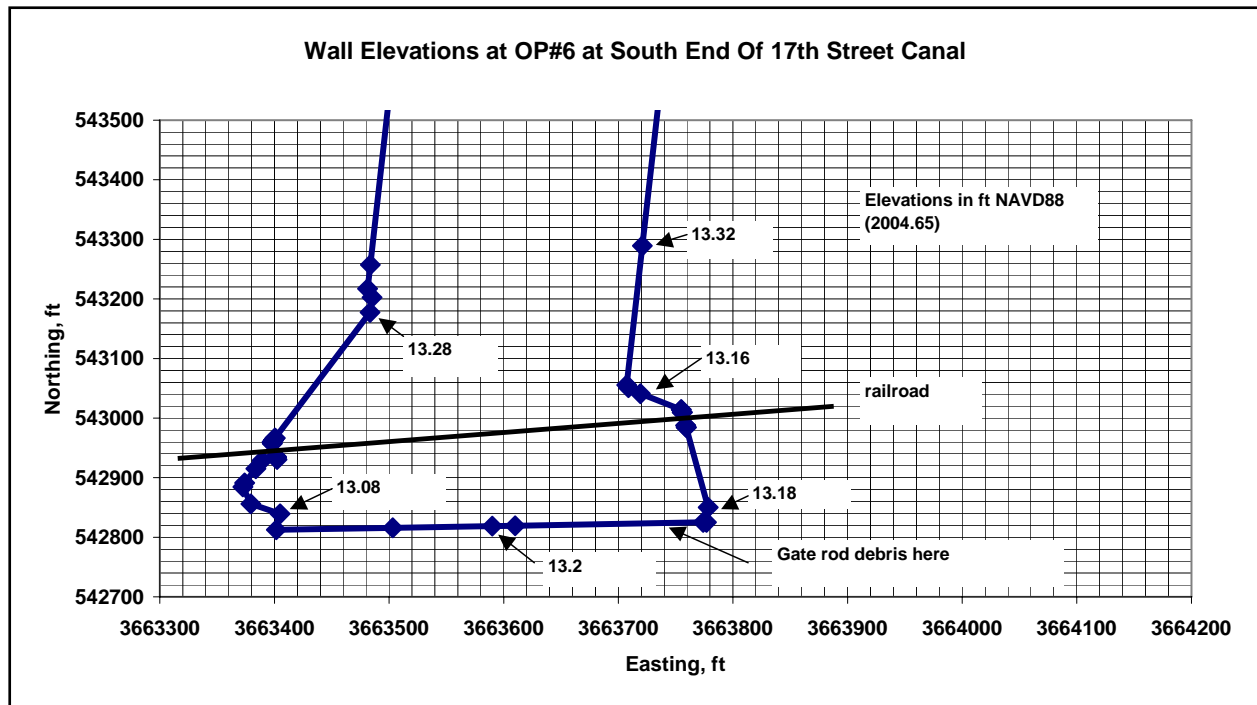
The floodwall and fronting protection walls at the pump station OP#6 are at about elevation 13-13.2 ft as shown in Figure 1-83. On 9/29/05, debris was observed at the top of the fronting protection wall as shown in Figure 1-84. This debris was only observed at the center portion of the fronting protection wall as shown on Figure 1-83, a location where waves coming down the canal would be largest. On 11/9/05, a debris HWM LA 1252 was found (Figure 1-85) around two gate rods, both at about 2.1 ft below the top of the floodwall for an elevation of about 11.1 ft. This type of mark is best described as “at least this high” because the debris can wrap around the gate rod at a higher water level and fall down when the stage drops/waves subside and settle on the gate rod support. The location of this HWM is 50-ft east of the point on the fronting protection wall that is inline with the east floodwall (Figure 1-83). This high water elevation was confirmed at another HWM LA 1251 found on 9/29/05 and located in an area on the west side of the discharge area where top of debris at a crack in the wall was found at 2.2 ft below top of floodwall (at the 13.08 ft point in Figure 1-83) for an elevation of 10.9 ft. Both marks, LA 1251 and 1252 were in areas exposed to some wave action. A picture (Figure 1-86) taken in 4/06/06 shows the location of LA 1251. In this picture the debris in the crack was no longer at the level of 2.2 ft below the top of the wall. A third HWM LA 1019 at this general location was levee debris at 9.0 ft. Levee debris high water marks have been inconsistent when compared to nearby marks inside structures.

Figure 1-83. Wall elevation at OP#6 at south end of 17th Street Canal.

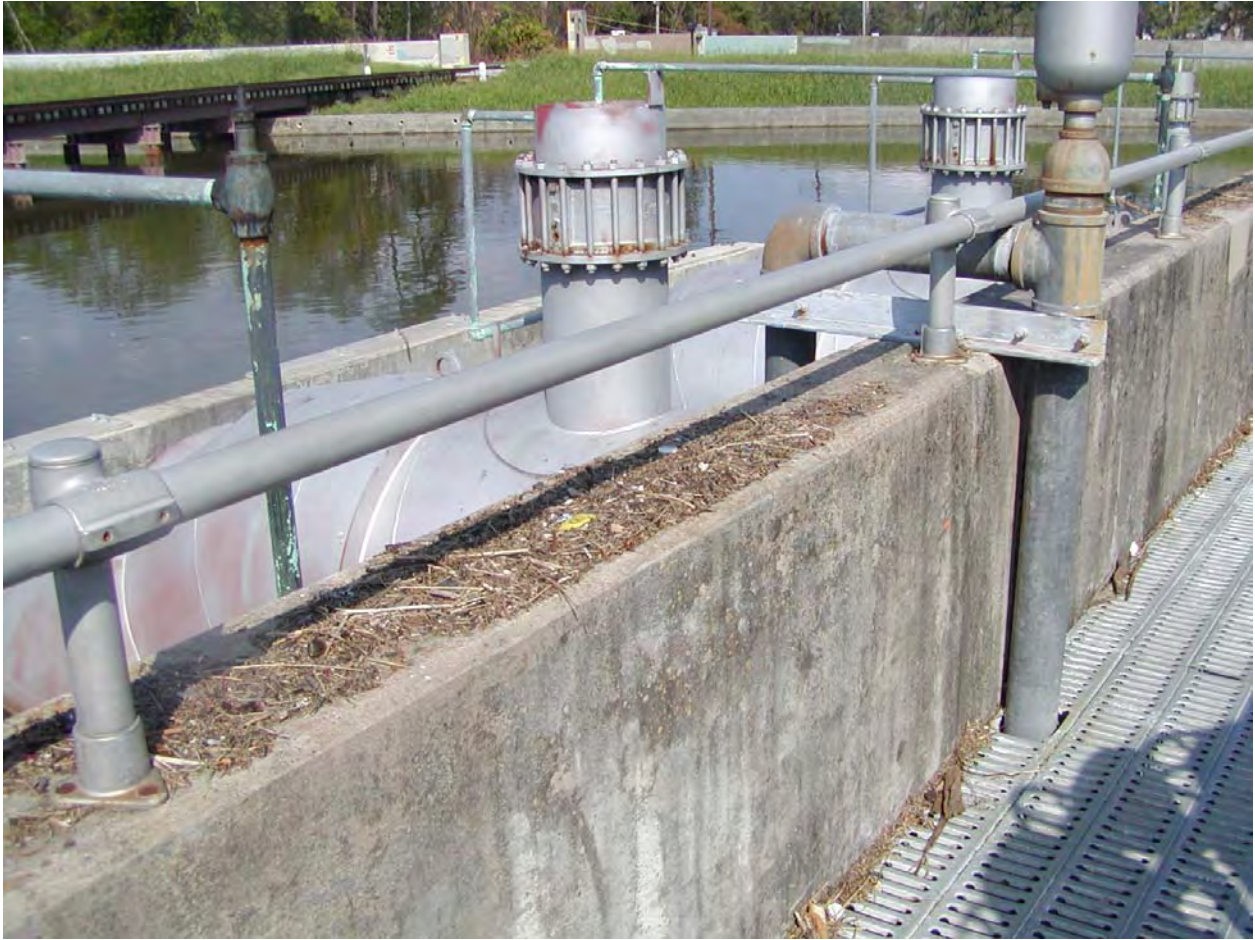
Figure 1-84. Debris on top of floodwall at OP#6 at 17th Street Canal.

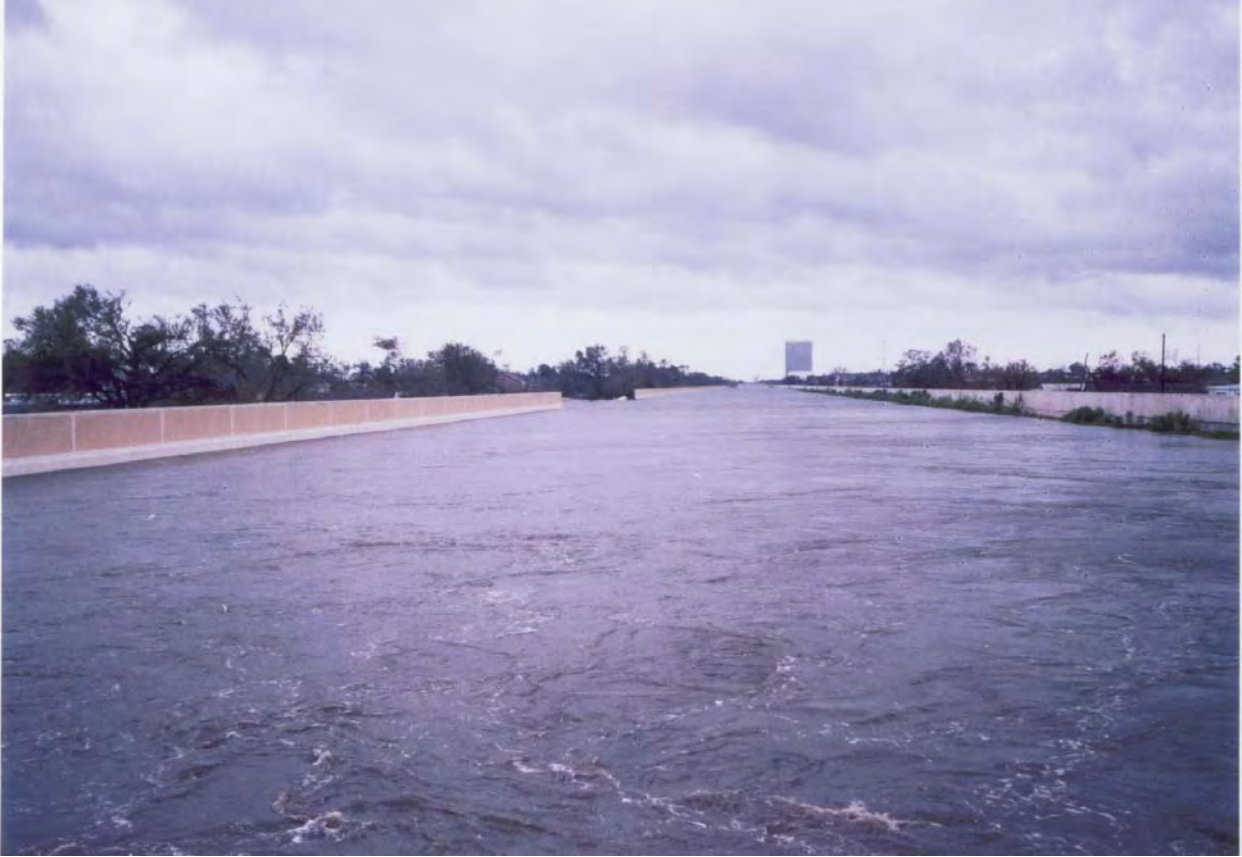
Figure 1-88. 17th Street Canal and breach at 2 pm on 8/29/05. Looking south.

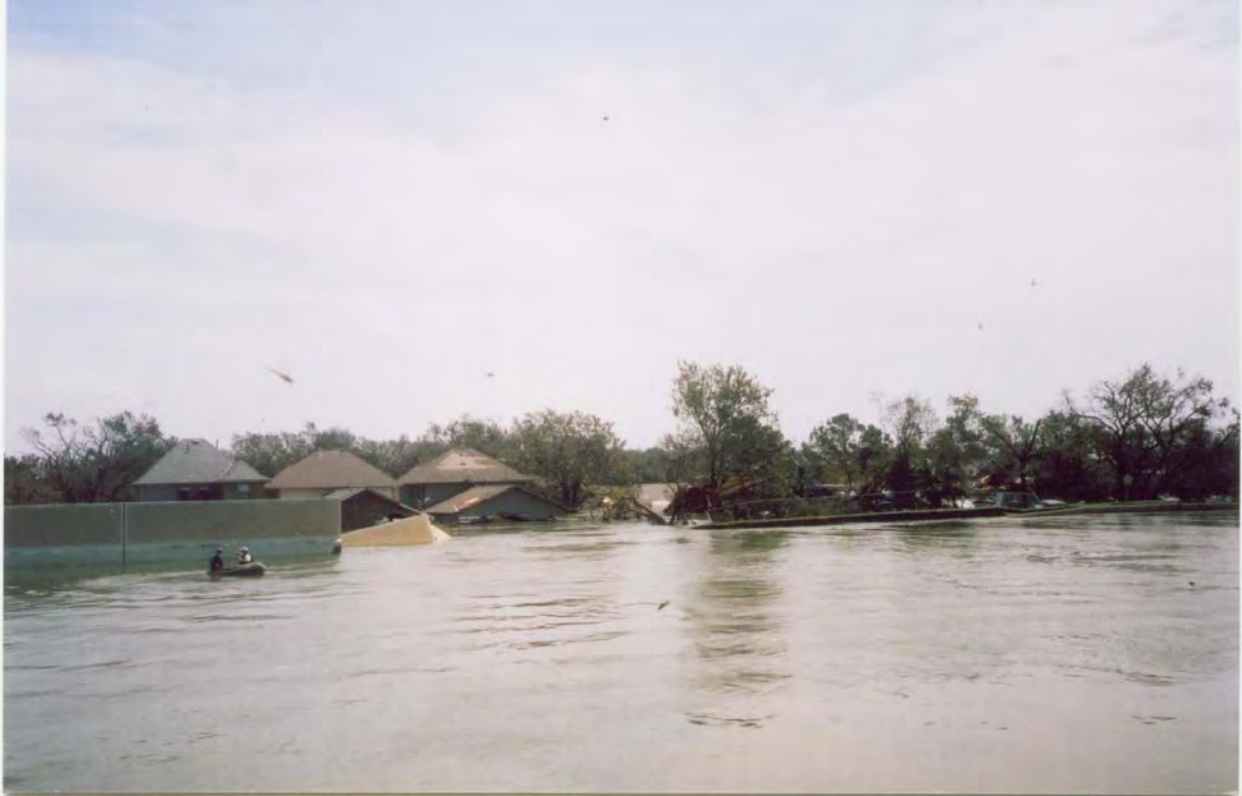
Figure 1-89. North end of 17th Street Canal breach at 3 PM on 8/29/05.

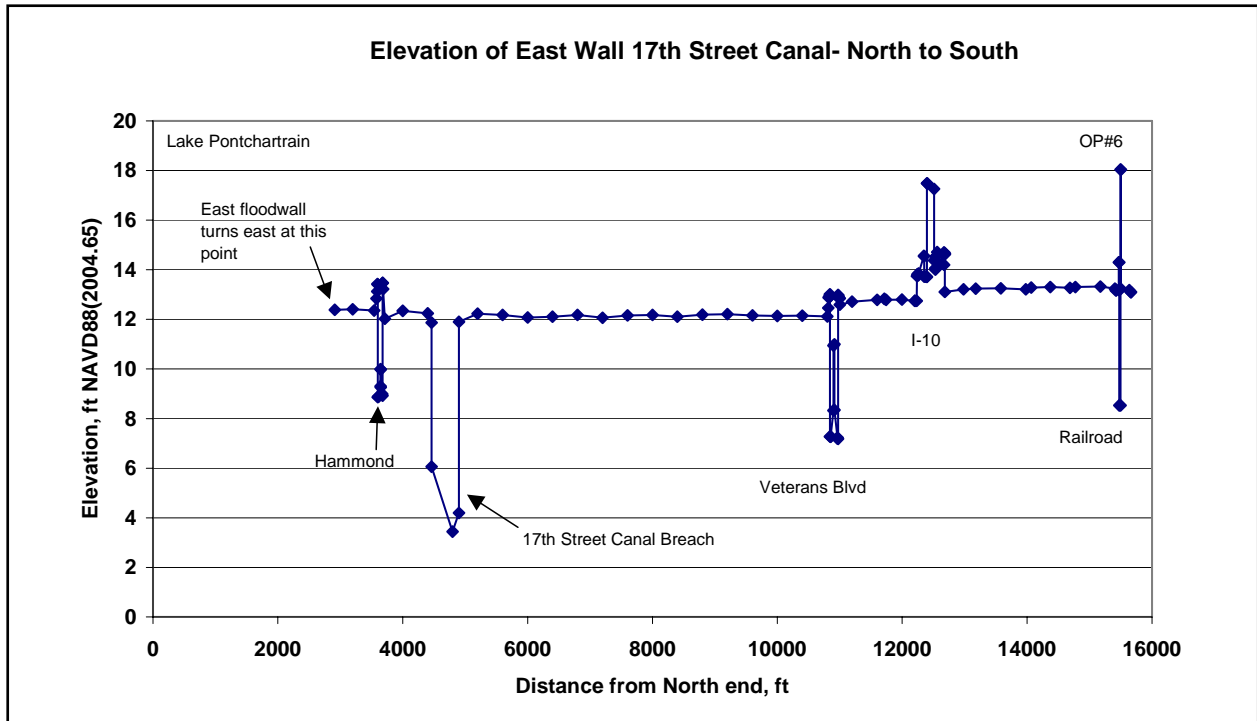
Figure 1-91. Floodwall profile along east side of 17th Street Canal. Note that low areas at bridges and pump stations are floodgate openings that were closed during the storm.

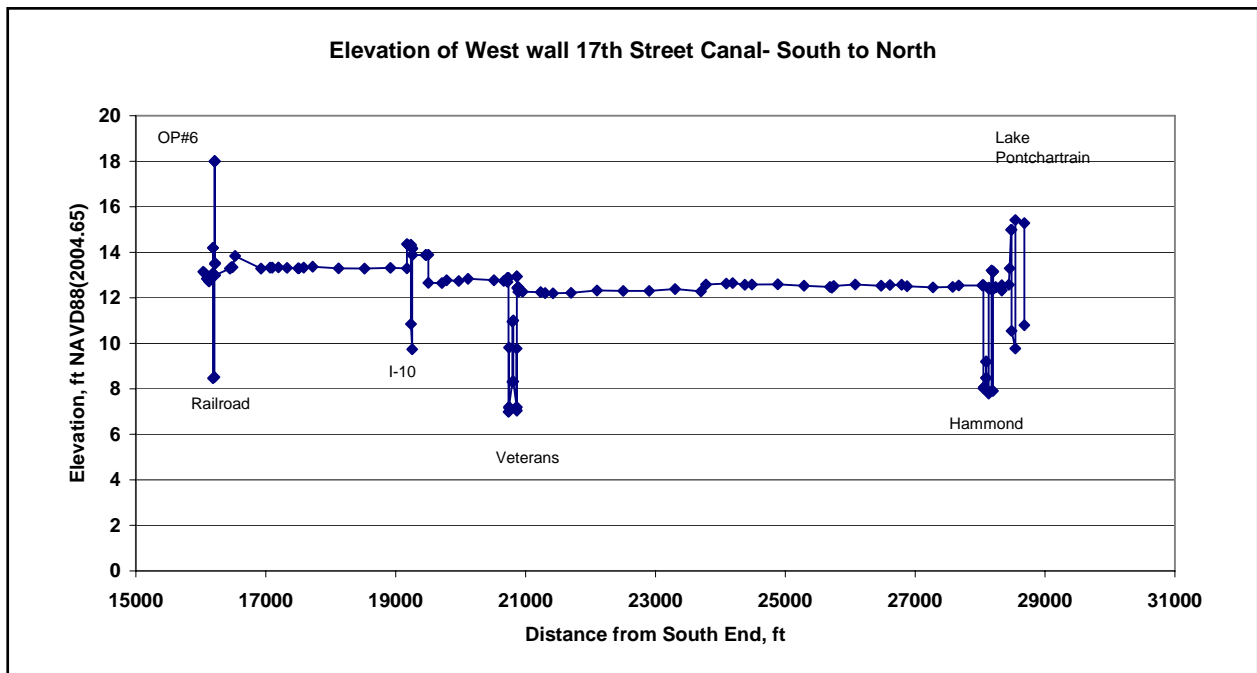
Figure 1-92. Floodwall and levee profile along west side of 17th Street Canal. Note that low areas at bridges and pump stations are floodgate openings that were closed during the storm.

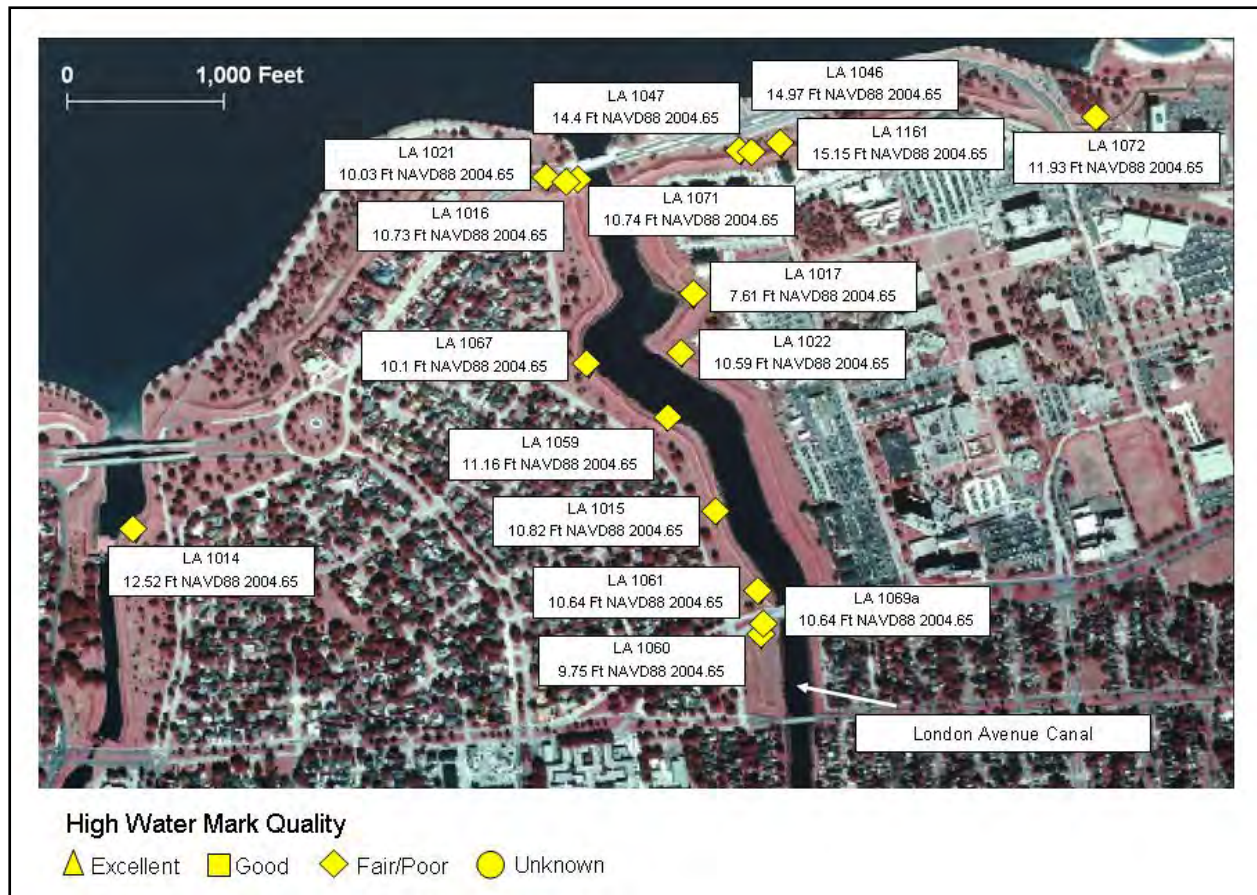
Various factors but particularly the timing of the breaches complicate high water marks within the London Avenue Canal. Both the north breach near Robert E. Lee and the south breach near Mirabeau may have occurred before the peak high water in the lake, which would influence high water marks inside the canals. Marks south of Lakeshore Drive will have wave influence and will be lowered by the entrance loss at the north end of London Avenue Canal as well as head loss across the Lakeshore Drive Bridge because of flow through the breaches. The locations of levee debris marks near the entrance of the London Canal are shown in Figure 1-93. Observed high water marks inside London Avenue Canal were as follows:

Figure 1-93. Location of high water marks near entrance of London Avenue Canal.

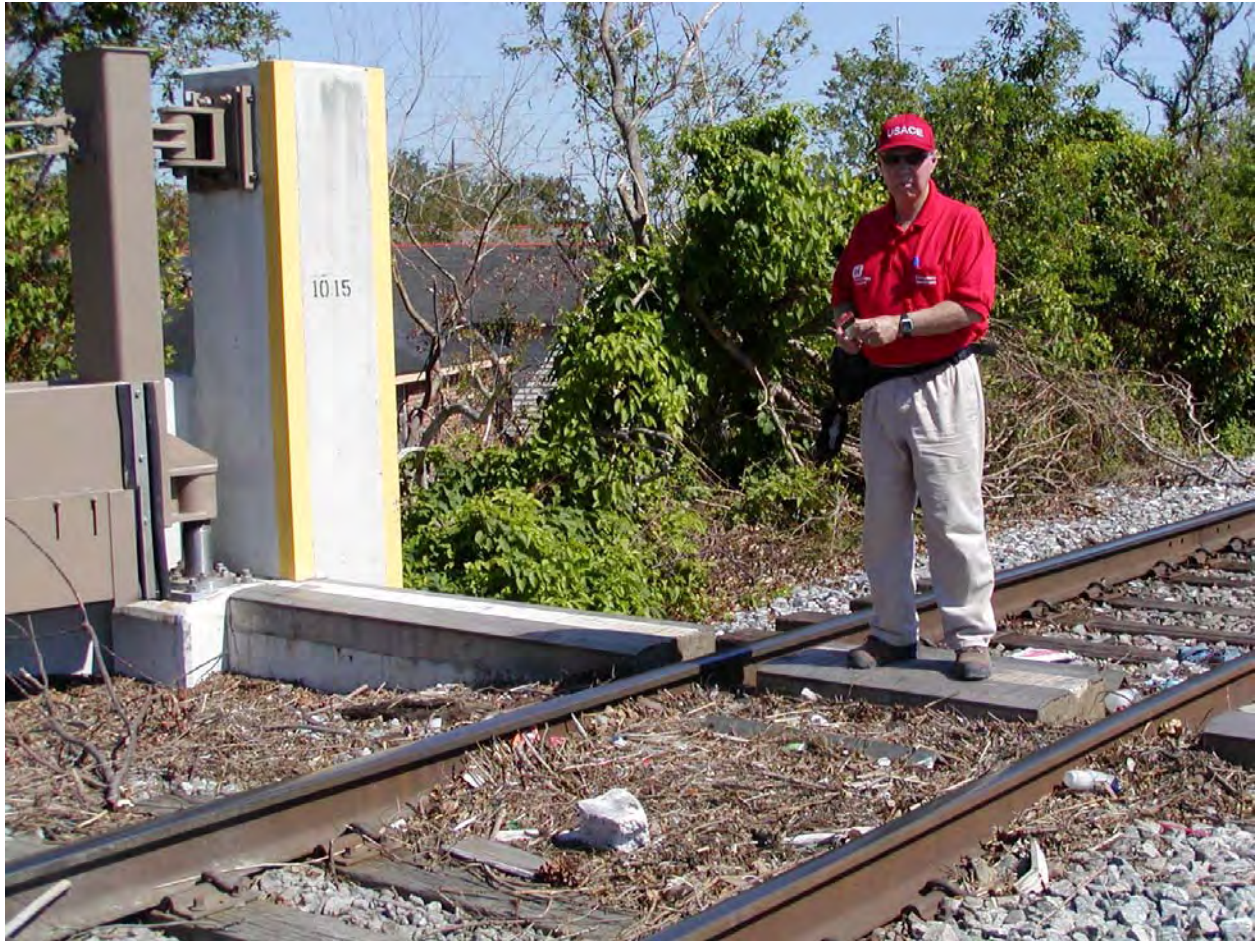
- h.* LA 1069- 10.6 ft- Debris on southwest side of Robert E. Lee Bridge.
- i.* LA 1227- 9.5 ft- revisit to site of LA 1018 at OP#3 on east side of discharge area. This is a difficult mark to assess because of the factors listed in the beginning of this section. Observers believe debris between railroad rails suggest the water level was at least as high as the railroad ties that was the elevation surveyed. Mark location shown in Figure 1-97.

Figure 1-97. East floodgate at OP#3 at south end of London Avenue Canal. High water mark LA 1227 at top of railroad ties.

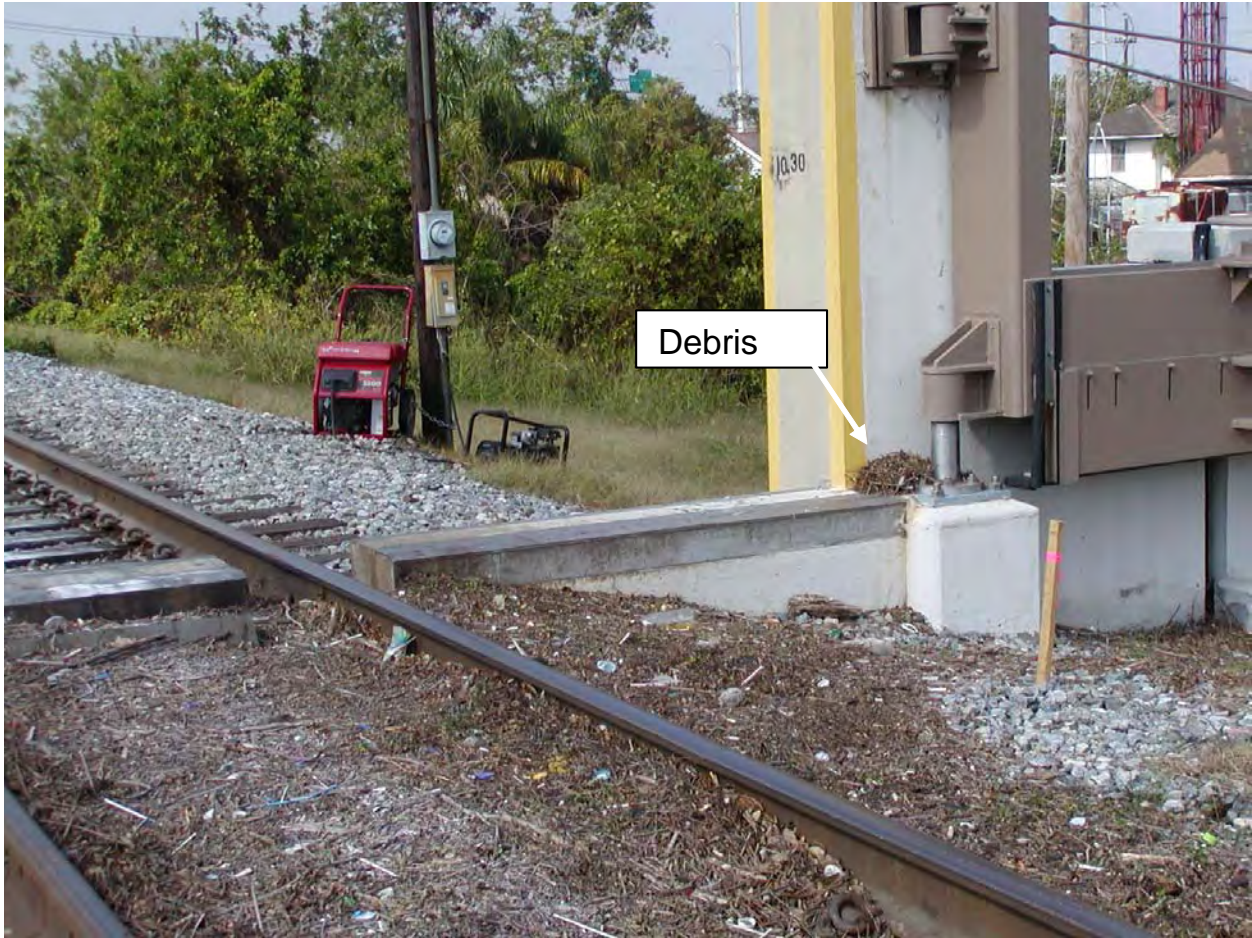
- j.* LA 1228- 10.0 ft- this mark is a debris mark on the west side of the discharge area. Debris is on a support for the floodgate and somewhat protected from any wave action in the canal as shown in Figure 1-98. The water level could have been higher as the debris may have been left behind as the water level dropped.

Figure 1-98. West floodgate at OP#3 at south end of London Avenue Canal. High water mark LA 1228 based on debris on top of sill at floodgate opening.

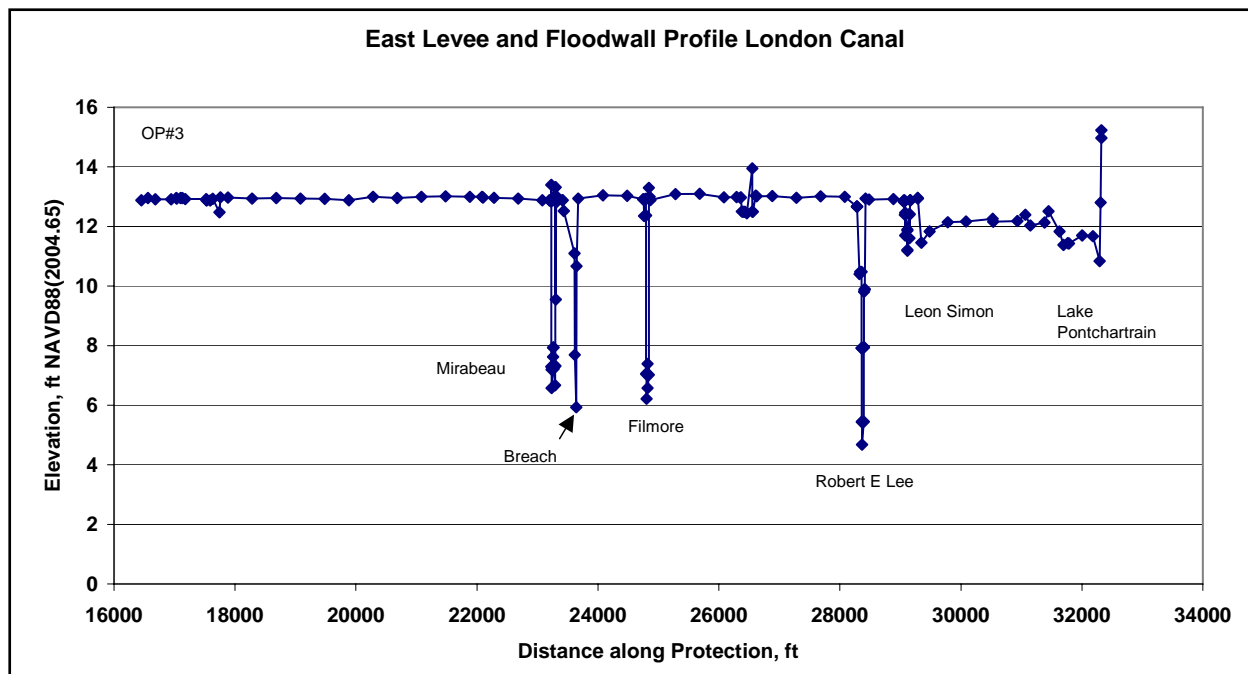
Figure 1-99. East levee and floodwall profile for London Avenue Canal. Note that low areas at bridges and pump stations are floodgate openings that were closed during the storm.

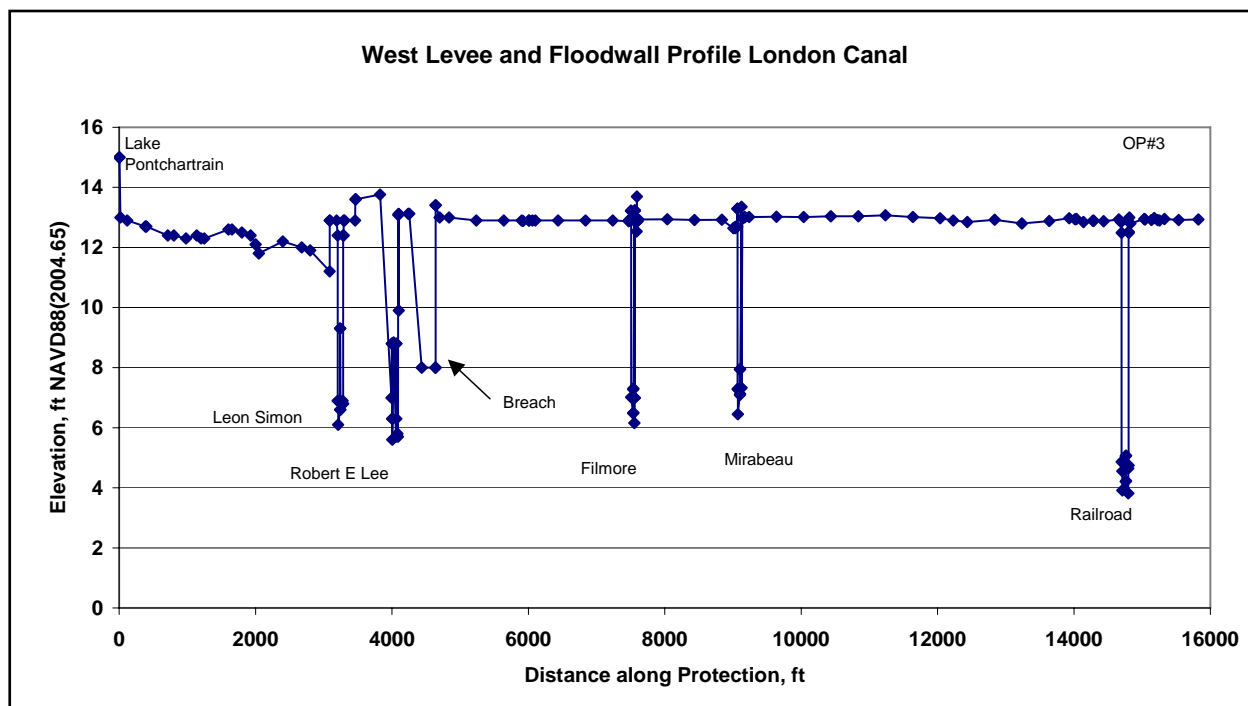
Figure 1-100. West levee and floodwall profile for London Avenue Canal. Note that low areas at bridges and pump stations are floodgate openings that were closed during the storm.

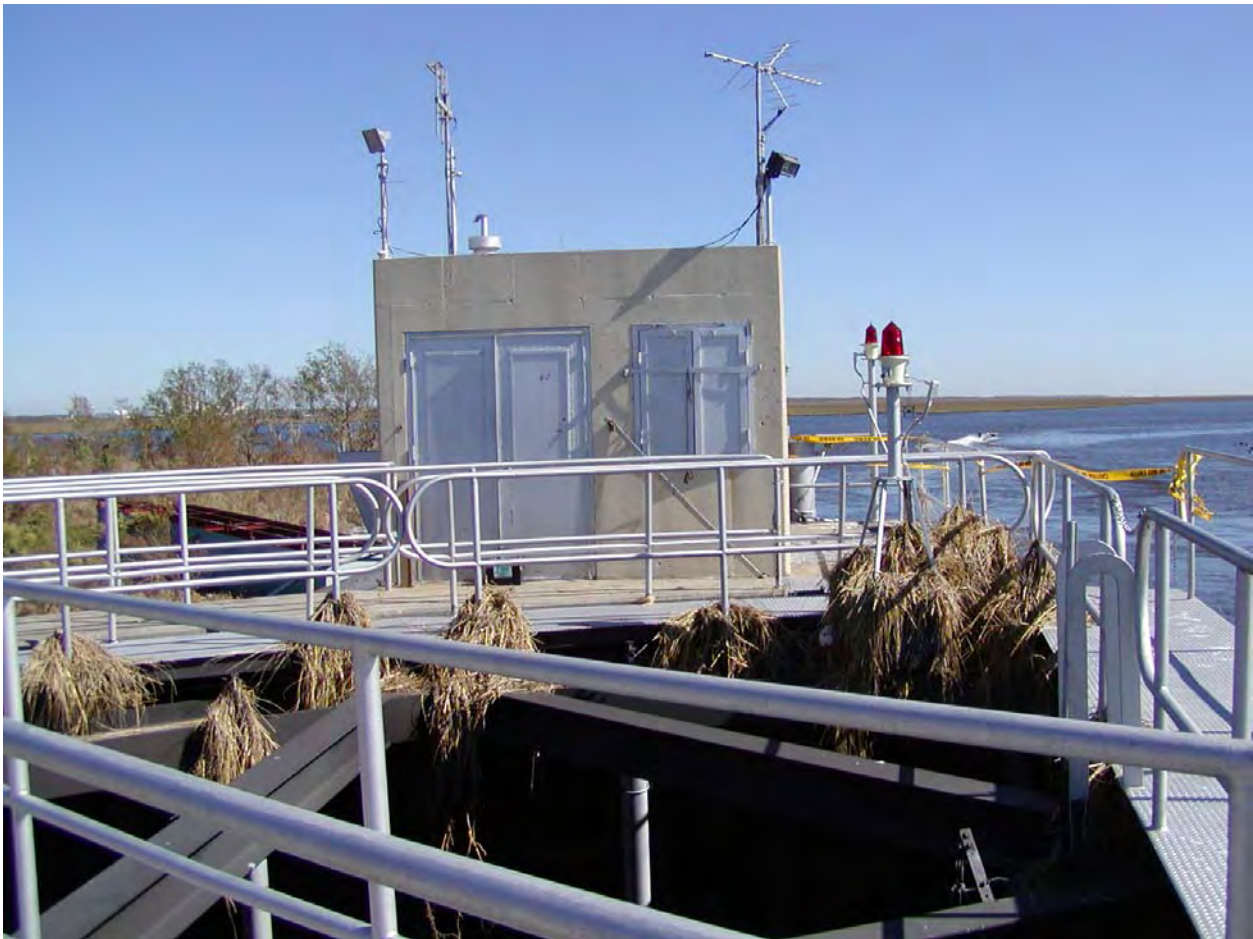
- g. LA 1043 (el 18.2 ft) - Located 1.1 mile southeast of the GIWW/ MRGO junction at the Bayou Bienvenue Structure. This mark is debris inside a radiator that is inside the gage house (Figure 1-101). The doors to this gage house were damaged by the storm surge and significant flow was passing through the gage house. The large amount of flow through the gage house and potential for wave effects within the gage house may cause this mark to be high.

Figure 1-101. Bayou Bienvenue Gage House.

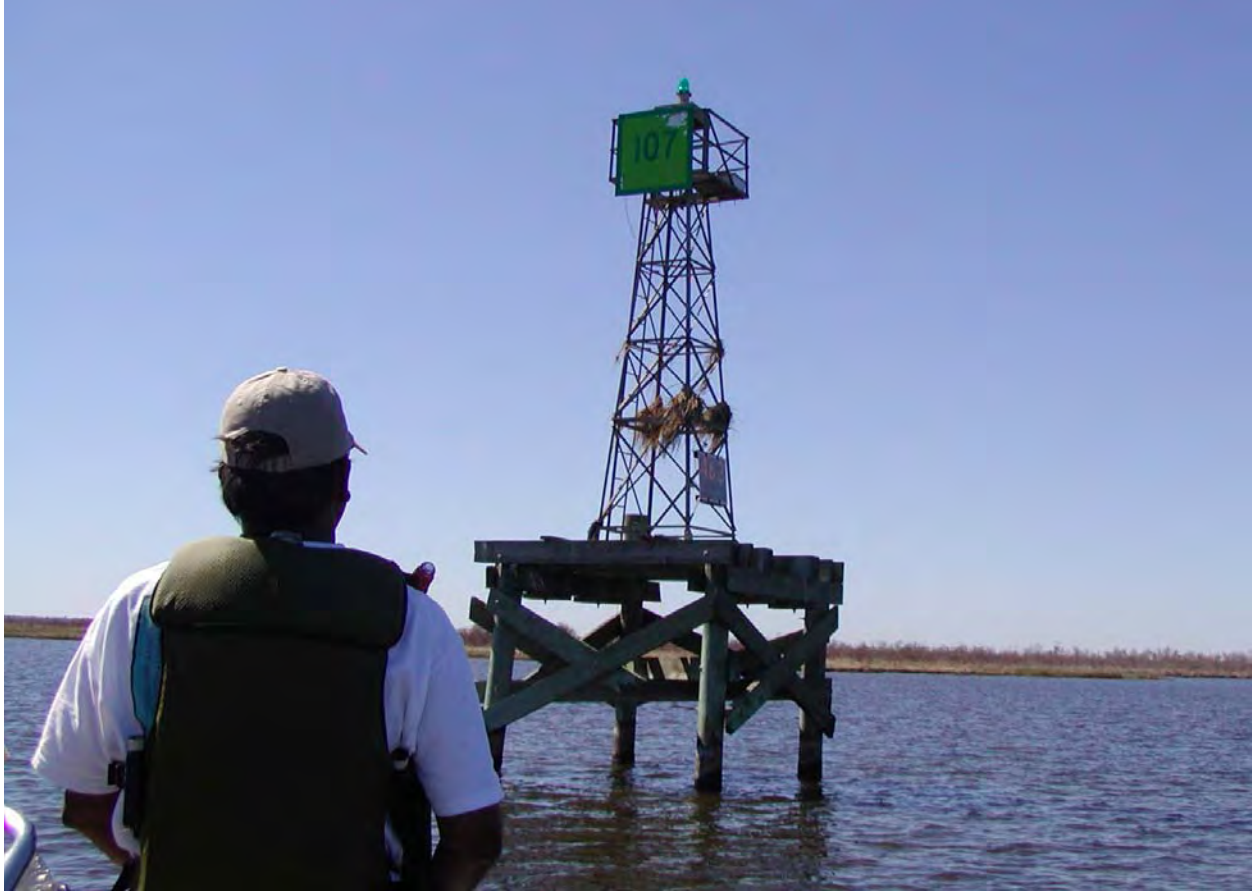
- n. LA 1155 - This mark was not surveyed and was only accessible by boat since it was on channel marker #107 (Figure 1-102). The marker is about 13.8 miles southeast of the GIWW/MRGO junction and about 0.7 miles southeast of where the levee protection leaves the MRGO. The debris on this tower was measured at 19.6 ft above the water level at 1345 hrs on 10/17/2005. The Bayou Dupre gage read about 1.8 ft on this same day giving an elevation of about 21.4 ft (relative to an uncertain datum). This debris elevation contains a large wave component. Water depth at the channel marker on the day of the inspection was about 12 ft.
- o. LA 1087 (el 18.1 ft) - Well-defined debris line inside bedroom of home (Figure 1-103) at Shell Beach that is about 19 miles southeast of the GIWW/MRGO junction. High water mark is 31" above second level floor.

Figure 1-102. LA 1155 on MRGO. Debris on tower.

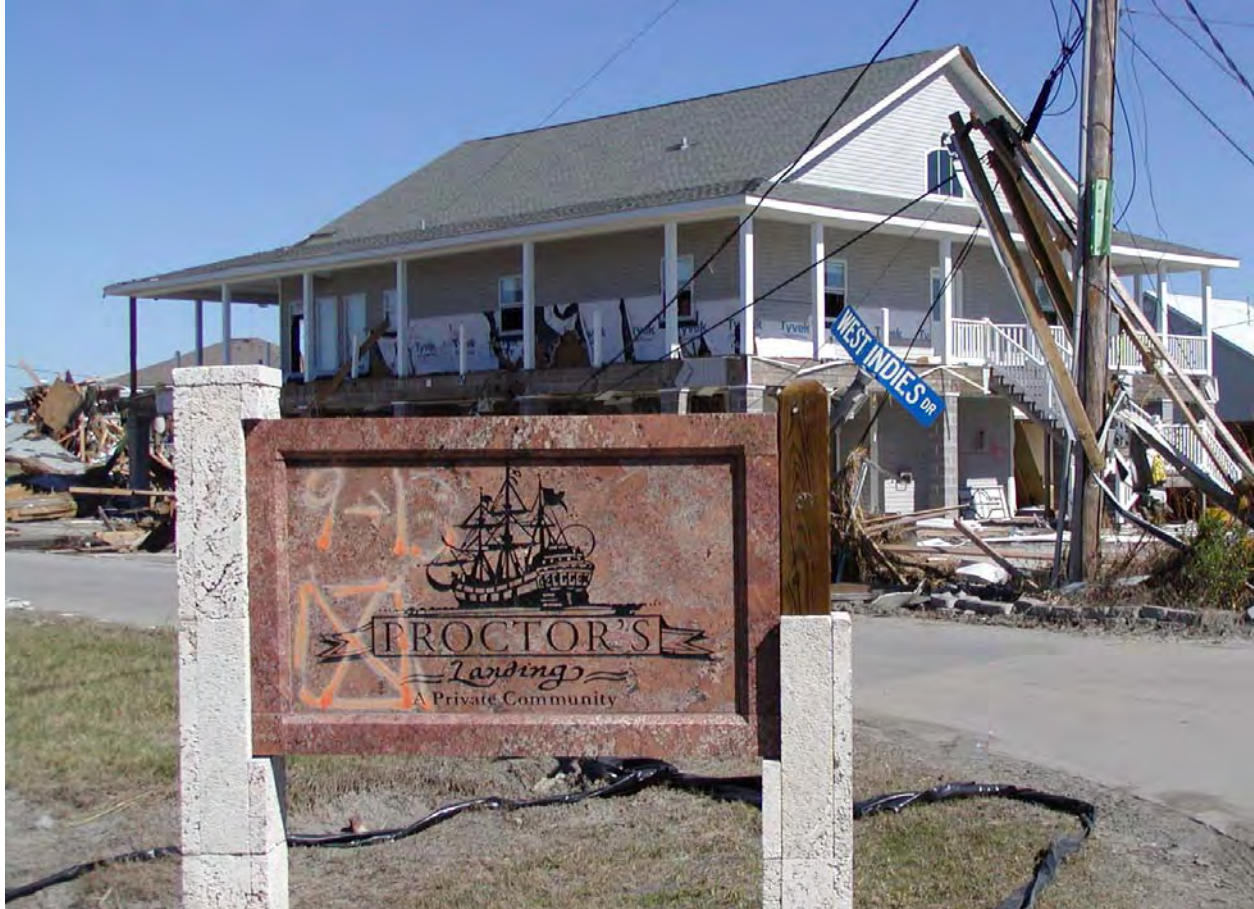
Figure 1-103. Home in Shell Beach containing high water mark LA 1087 at 31" above second level floor.

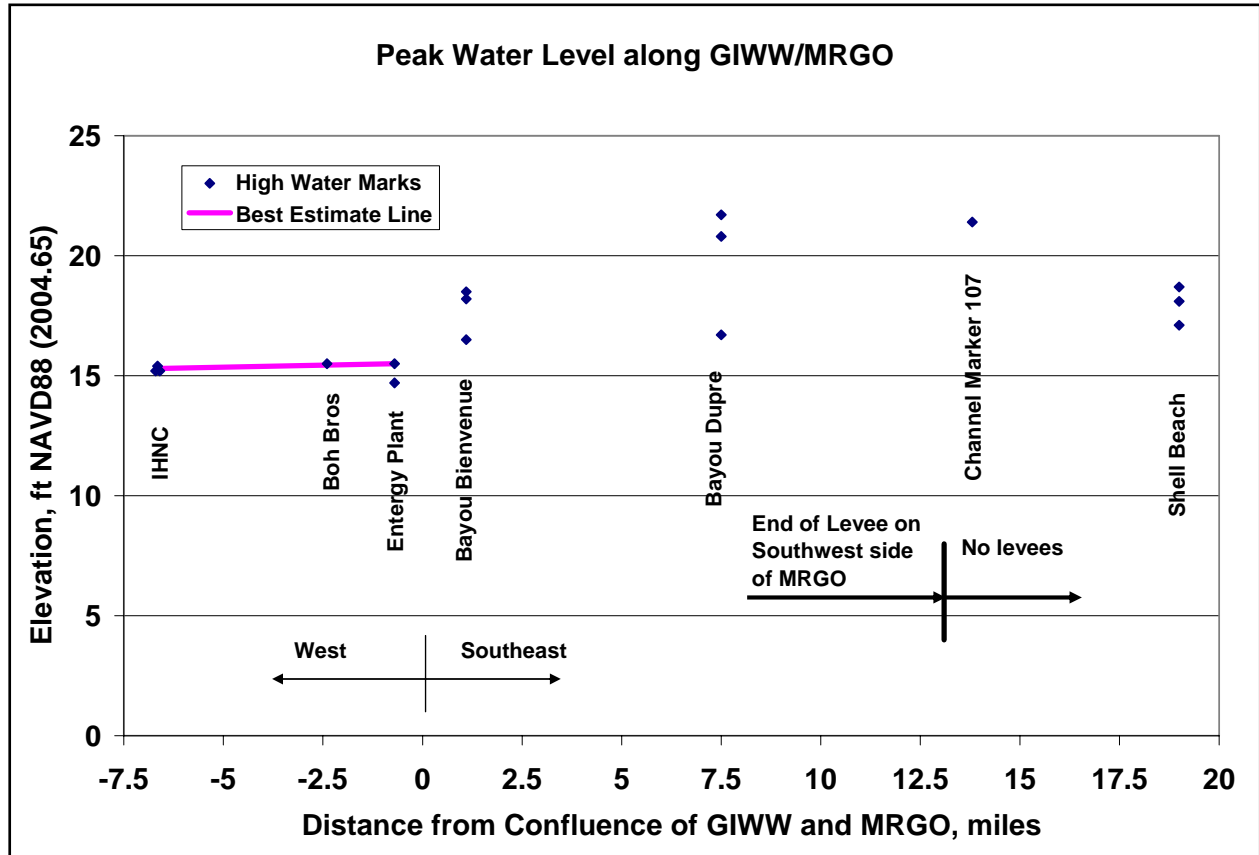
Figure 1-104 shows a plot of the high water mark data along the GIWW/MRGO along with a best estimate line. The best estimate line ends at the Entergy Plant because of uncertainty of high water marks at Bayou Bienvenue and Bayou Dupre, the large wave component at channel marker 107, and the fact that Shell Beach is beyond the levee protection. Of all the marks southeast of the GIWW/MRGO junction, the marks at Shell Beach are the most reliable estimates of the peak “still” water level.

Figure 1-104. Peak water level along GIWW and MRGO based on high water marks.
