# Appendix 1

## Hydrograph and High Water Mark Analysis

### Introduction

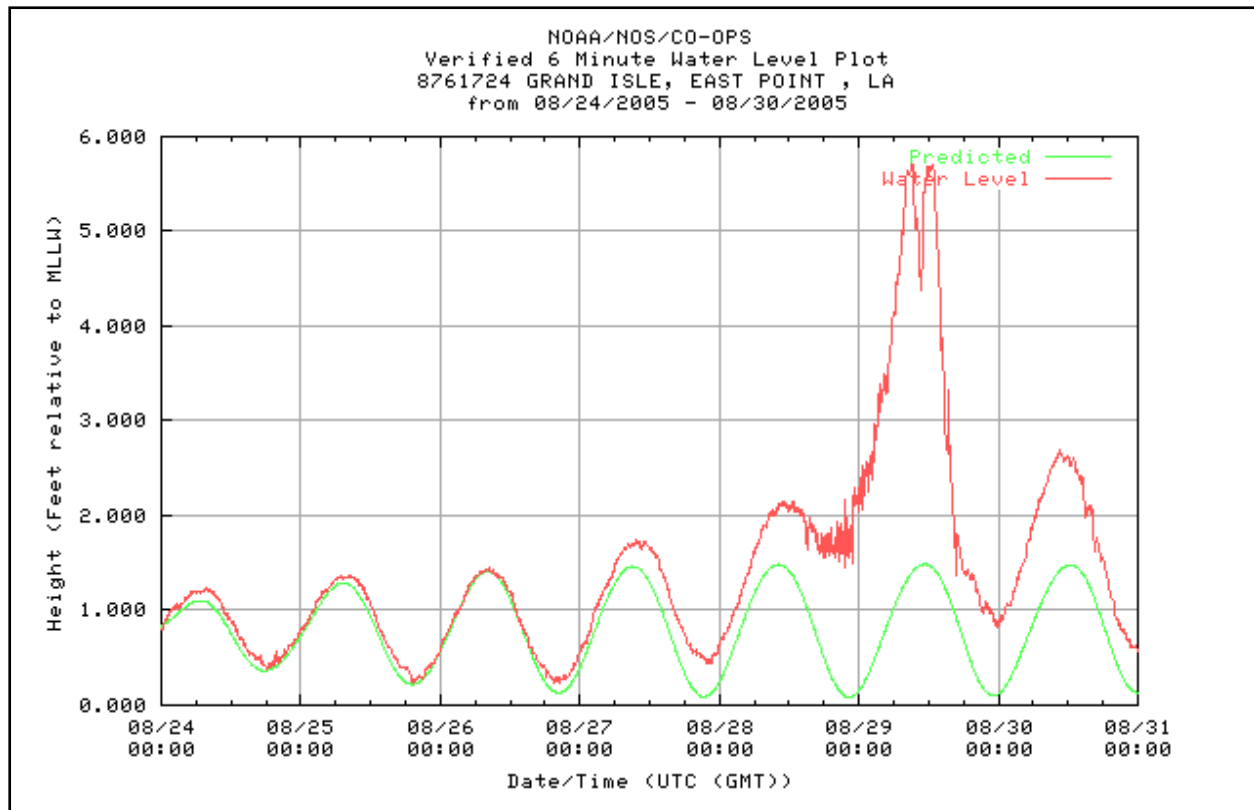
instruments at these stations are among the few that functioned throughout Katrina's passage and recorded peak water levels. The Grand Isle station recorded a peak water level of 5.70 ft above mean lower-low water (MLLW) at 09:06 UTC on 29 August 2005. The Southwest Pass station recorded a peak water level of 7.61 ft above MLLW at 09:30 UTC on 29 August 2005.

Figure 1-105. Hydrograph for NOAA National Ocean Service station at Grand Isle, Louisiana. Vertical datum relation between MLLW and NAVD88-2004.65 is uncertain.

Note the double peak in the Grand Isle hydrograph. There was initial concern that the double peak may have been caused by movement of the gage or supporting structure. Inspection of the station shortly after Katrina's passage showed the gage and supporting structure to be intact and the gage vertical datum was confirmed as correct. The simplest, most obvious meteorological explanation for the double peak is a sudden, temporary shift in the local winds, but this has not been verified at this time. The data of these hydrographs have been verified as conforming to NOS standards.

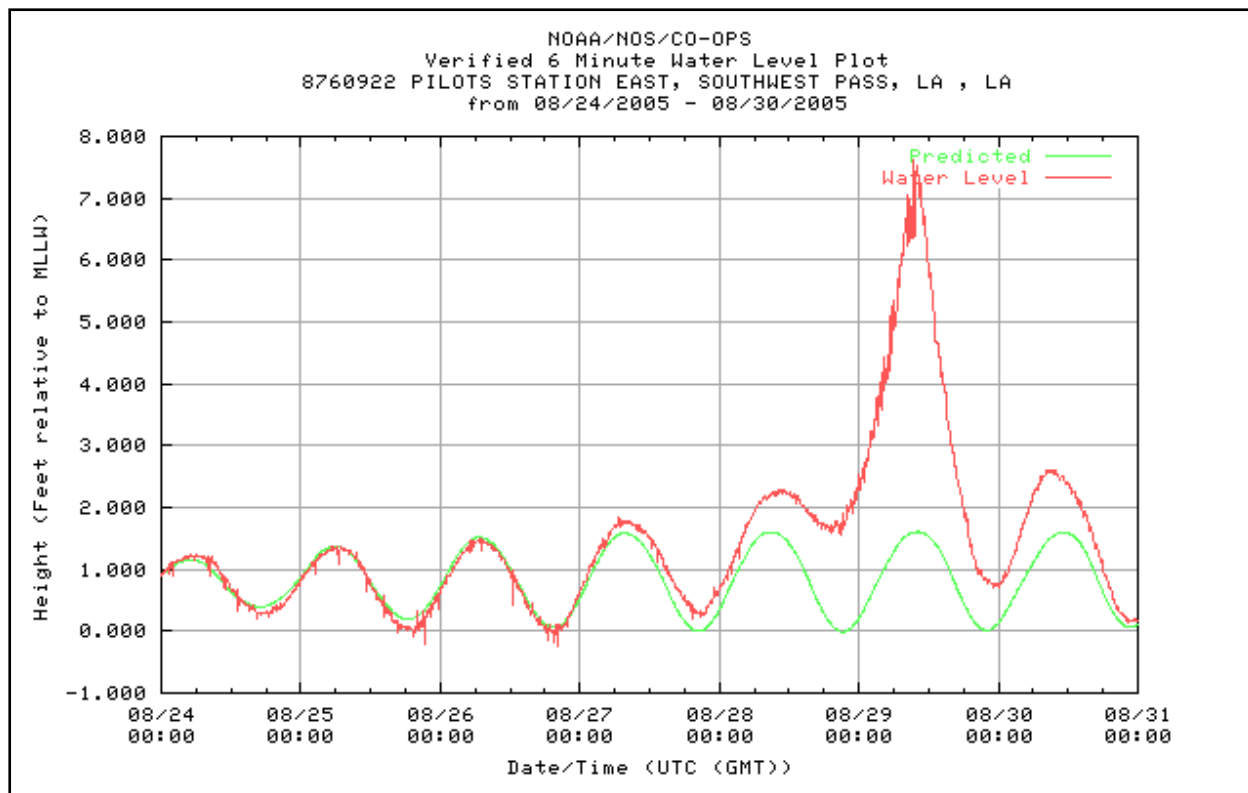
Figure 1-106. Hydrograph for NOAA National Ocean Service Station at Southwest Pass, Louisiana. Vertical datum relation between MLLW and NAVD88-2004.65 is unknown.

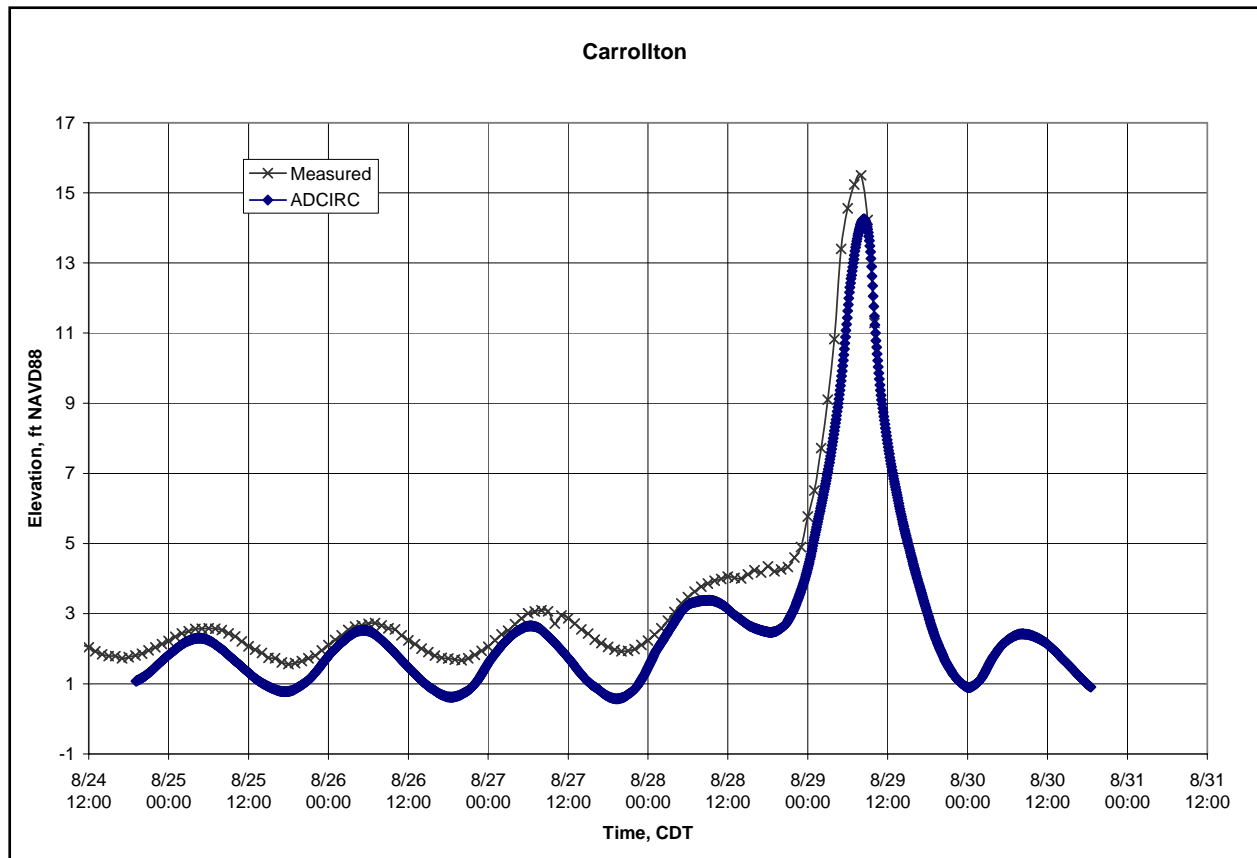
Time series of model response during Hurricane Katrina are compared to water level data at the tidal and river gauges. Hydrographs at 7 stations are plotted with the data records and model output in Figure 5-10. The model shows a very good match to both the tidal signal and the storm surge. Furthermore the datums appear to be well matched. The comparison at the mouth of the Mississippi River at South Pass indicates that the modeled tides are well represented in the region. The peak storm surge is under-predicted by about 1.8 ft. However nearby high water marks indicate that the observed peak value may somewhat under-represent the surge in the region. Specifically there are three nearby high water marks that indicate peak still water levels of 8.9, 8.6 and 8.5 ft. This more closely matches the ADCIRC predicted value. The gauge at Carrollton in the Mississippi River adjacent to New Orleans indicates that the model correctly captures the propagation of tides and surge up the Mississippi River. The tides are slightly under-damped; the computed peak water level is approximately 1.5 ft less than the measured value. It is noted that the recording station failed after the peak surge passed New Orleans. The

Figure 5-10b. Comparison of modeled versus measured storm surge hydrograph (ft NAVD88 2004.65) at the Carrollton gauge at New Orleans within the Mississippi River

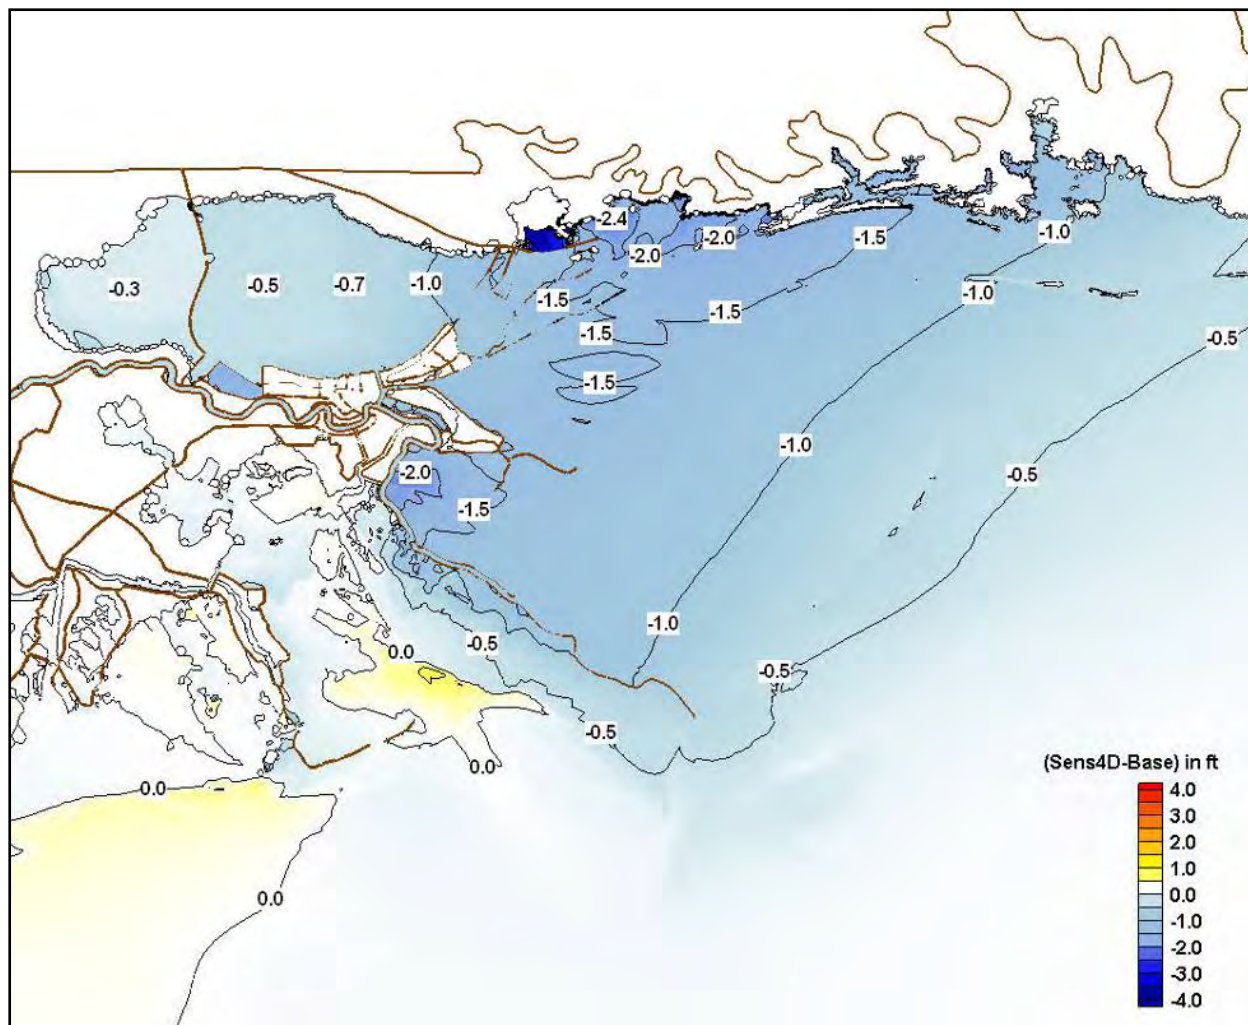
throughout the Hurricane Katrina impacted area (Figure 5-17). The greatest decreases in water level are along the Mississippi coast.

Figure 5-17. Difference in peak surge between sensitivity simulation with 5% decrease in wind speed and the base simulation

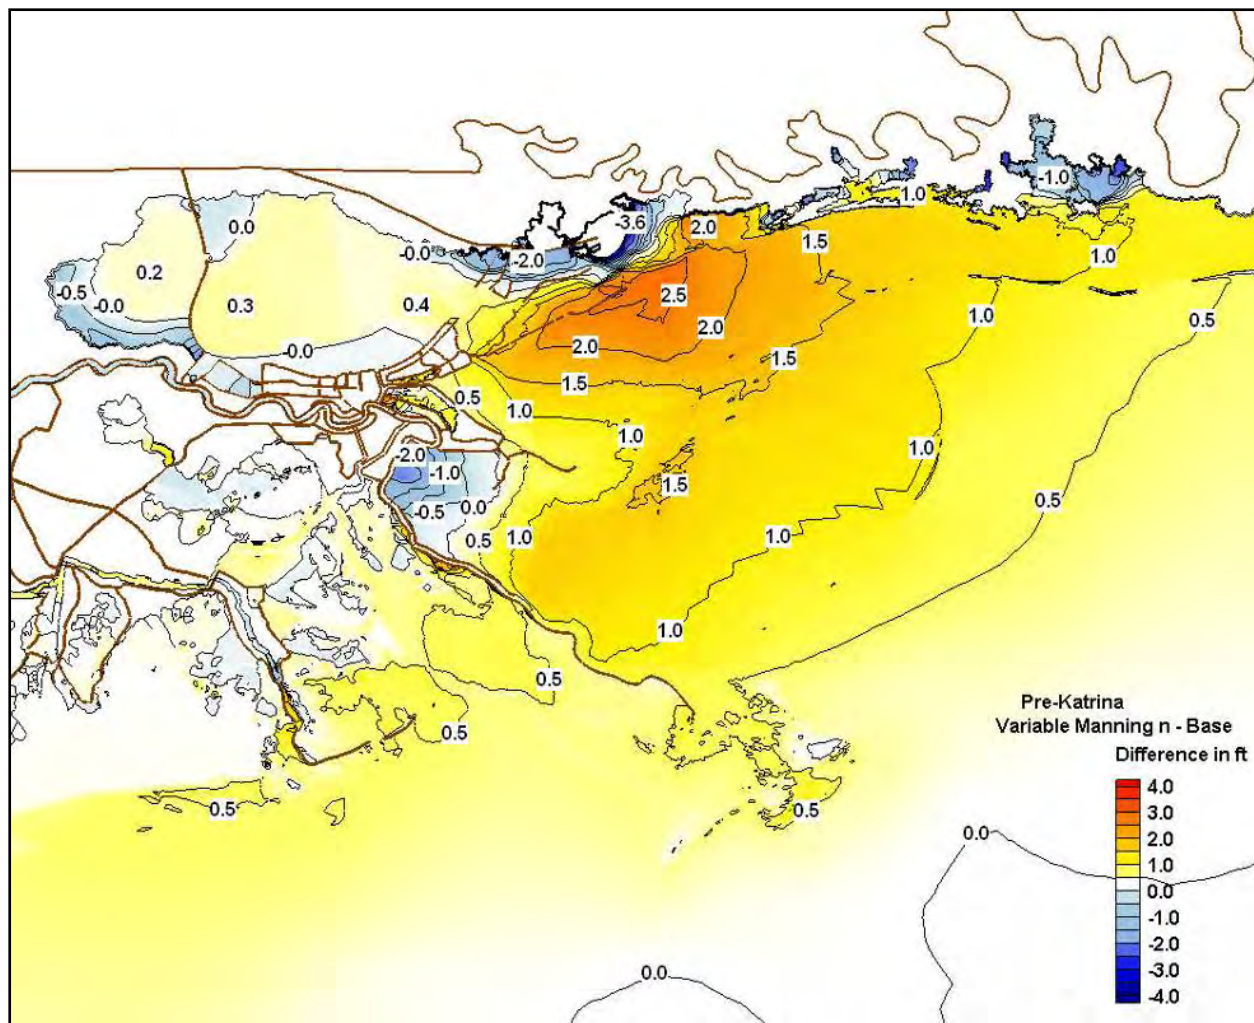
Figure 5-22. Difference in peak surge between sensitivity simulation with Pre-Katrina variable friction and the base simulation

Changing the Pre-Katrina friction formulation from a single value to a spatially-varying friction field to represent Pre-Katrina vegetation, results in an increase in peak water level in deeper water and a decrease in water level in the overland areas (Figure 5-22). This is related to the decrease in bottom friction in open waters with the Manning  $n$  specified equal to 0.020 there and the increase in frictional resistance in due to high Manning  $n$  values inland. Note that the extensive network of connecting channels that occur throughout the marshes, cyprus forests and other regions in Southern Louisiana were not considered in these simulations.

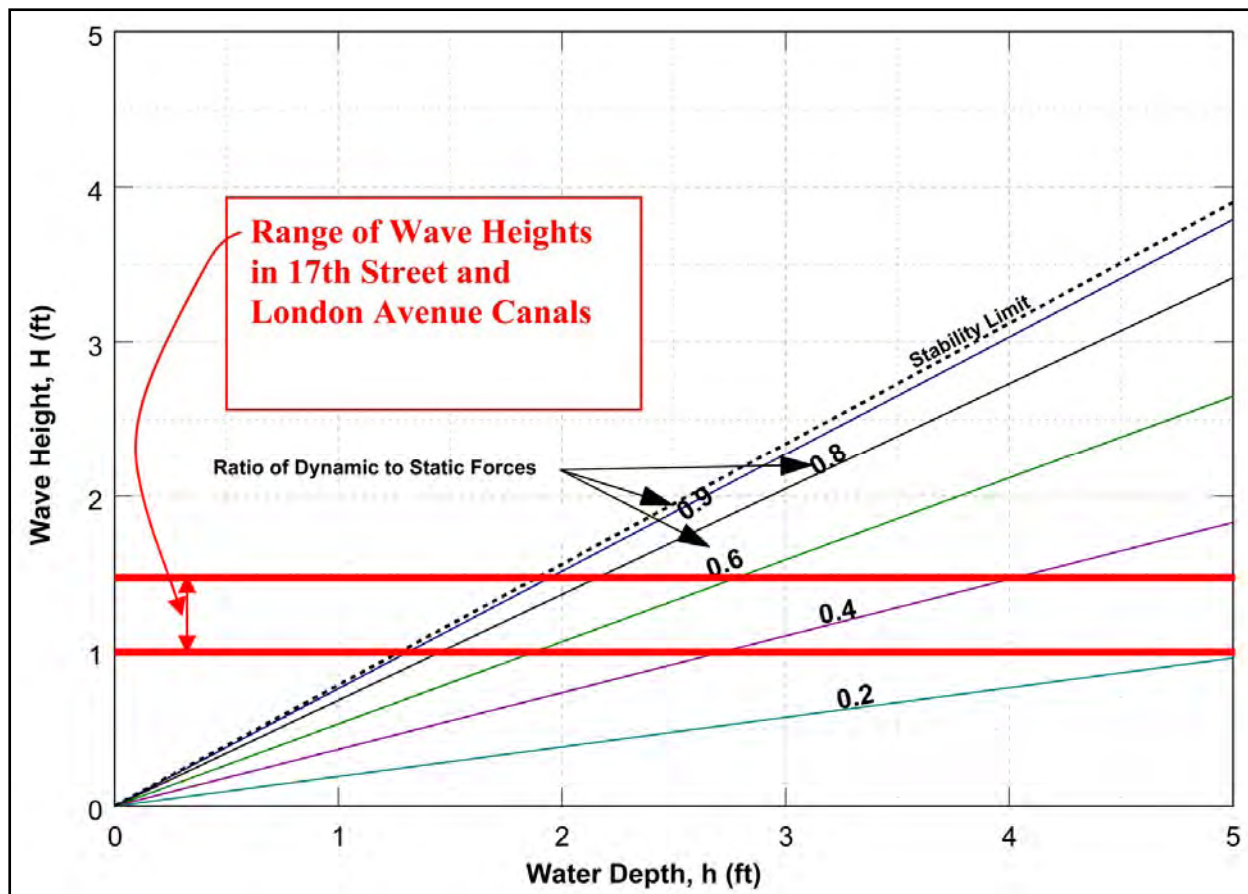
Figure 8-2. Isolines of Constant Values of the Ratio of Dynamic to Static Force Components,  $R_F$  versus water depth,  $h$ , and wave height,  $H$

Figure 8-2 presents the ratio of dynamic to static forces versus water depth and wave height. The stable shallow water wave height limit of  $H/h = 0.78$  is also shown. The range of wave heights from 1 ft to 1.5 ft is highlighted as the approximate wave height range determined to occur at the 17th Street and London Avenue floodwalls during Katrina. It is seen that for a water depth against the floodwall of, say, 4 ft, and a wave height of 1 ft to 1.5 ft, the *total force* ranges between approximately 128% and 140 % of the static force component.

The magnitudes of these ratios are such that the dynamic forces and moments associated with the presence of waves should be taken into account in floodwall design and analysis.

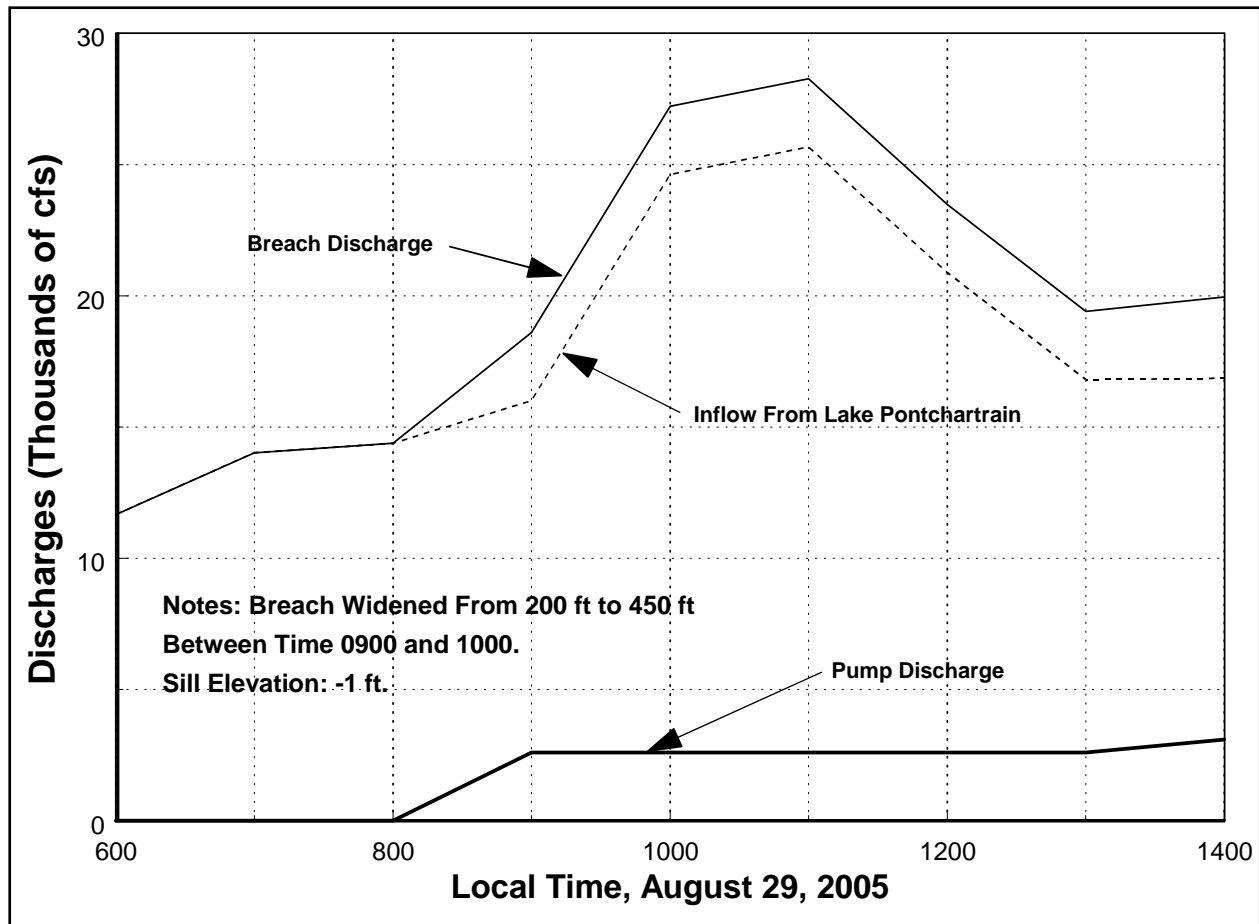
Figure 10-5 presents the breach discharge and the discharges from the lake and the pump for this case. It is seen that the peak breach discharge is slightly less than 29,000 cubic feet per second (cfs).

Figure 10-5. Time history for breach discharge. Scenario 1

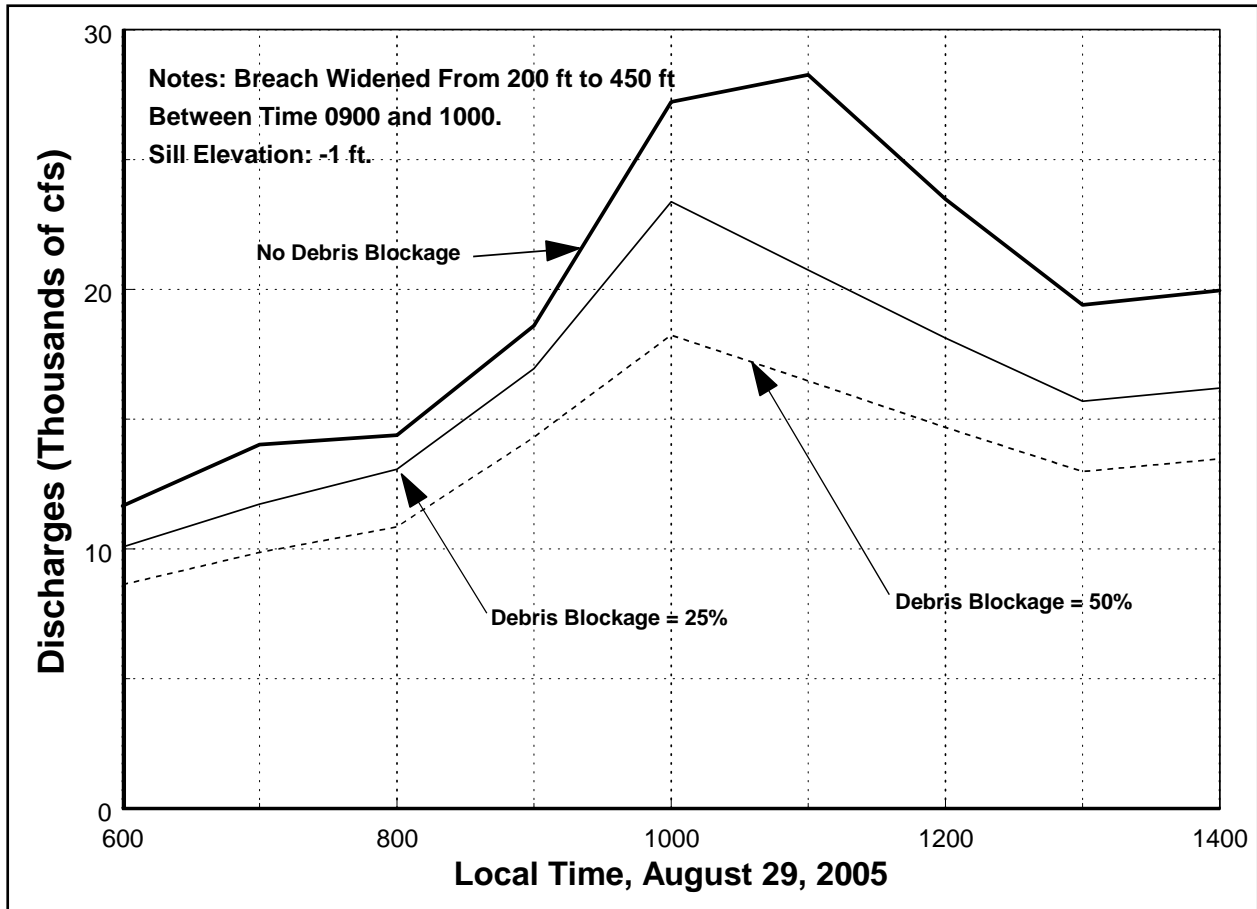
Figure 10-9. Breach discharges as a function of blockage of Hammond Street Bridge flow area

It was found that the breach discharges were relatively insensitive to the Weisbach-Darcy friction coefficients. However, blockage by debris of the flow area under the Hammond Highway Bridge caused both a substantial reduction in the breach discharges and the water surface profile elevations along the 17th Street Canal. For the range of conditions examined with and without the flow blockage, the peak breach discharge ranged from approximately 18,000 cfs to 29,000 cfs. The scenario of a breach of one floodwall panel length indicates that the water surface gradients in the canal are very small resulting in the water surface elevation at the breach being approximately the same as in Lake Pontchartrain.

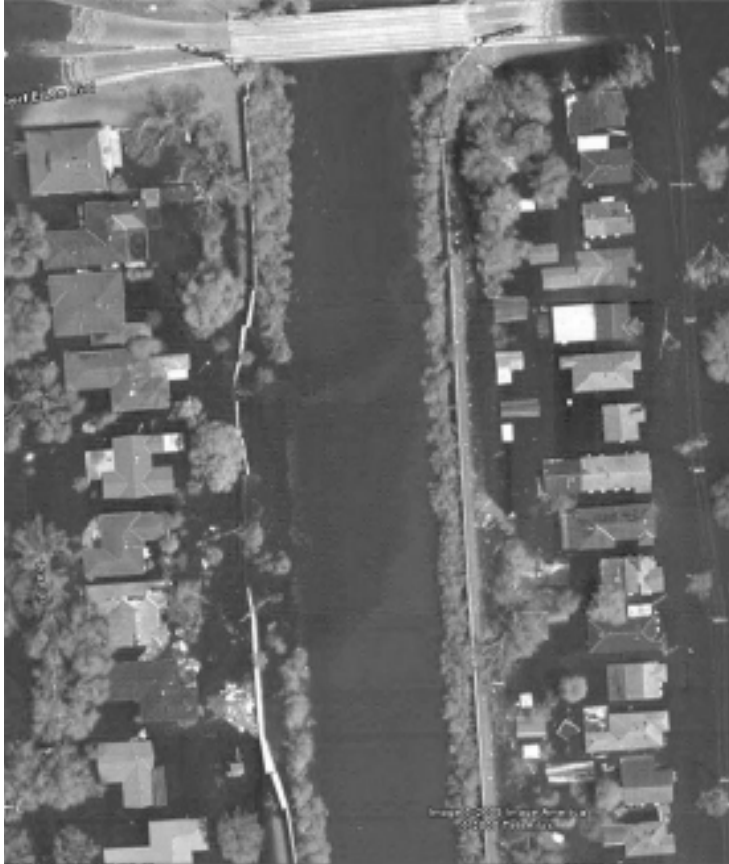
(a) North breach near Robert E. Lee Bridge  
 Figure 11-1. London Avenue Canal breaches

- Breach occurred between 0700 and 0800, August 29, 2005
- Breach “sill” unknown, but here estimated at - 1.0 ft.
- Breach Length = 80 ft.
- North end of breach = 8,380 ft. from Lake Pontchartrain.

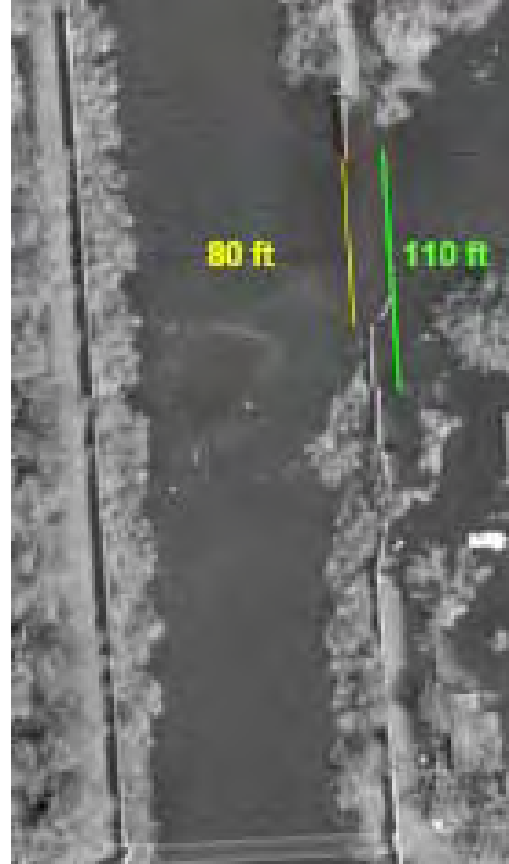
(b) South breach at Mirabeau Avenue

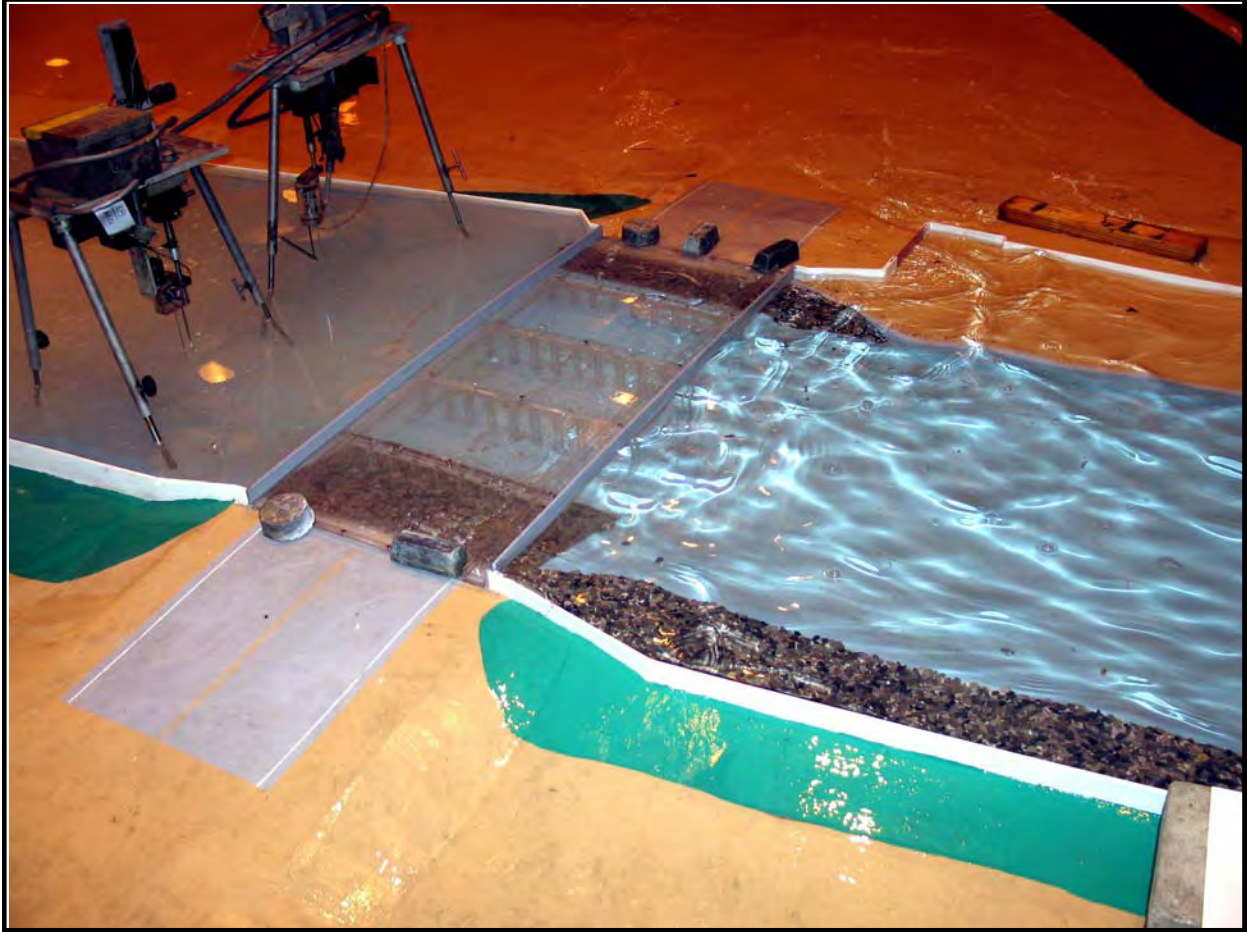
Figure 12-12 presents a photograph of the model in the region straddling the bridge. The rough water surface on the right-hand (north) side is indicative of reflected wave energy, whereas the left side is relatively quiescent. The results of reflection analyses, shown in Figure 12-13, indicate that as the hurricane surge rises, the reflection coefficient jumps from about 10 percent to nearly 35 percent. Figure 12-14 shows the change in wave behavior across the bridge as a function of time during the Katrina simulation.

Figure 12-12. Wave reflection at the Hammond Highway Bridge. Region to right of bridge is lake-side (north side)

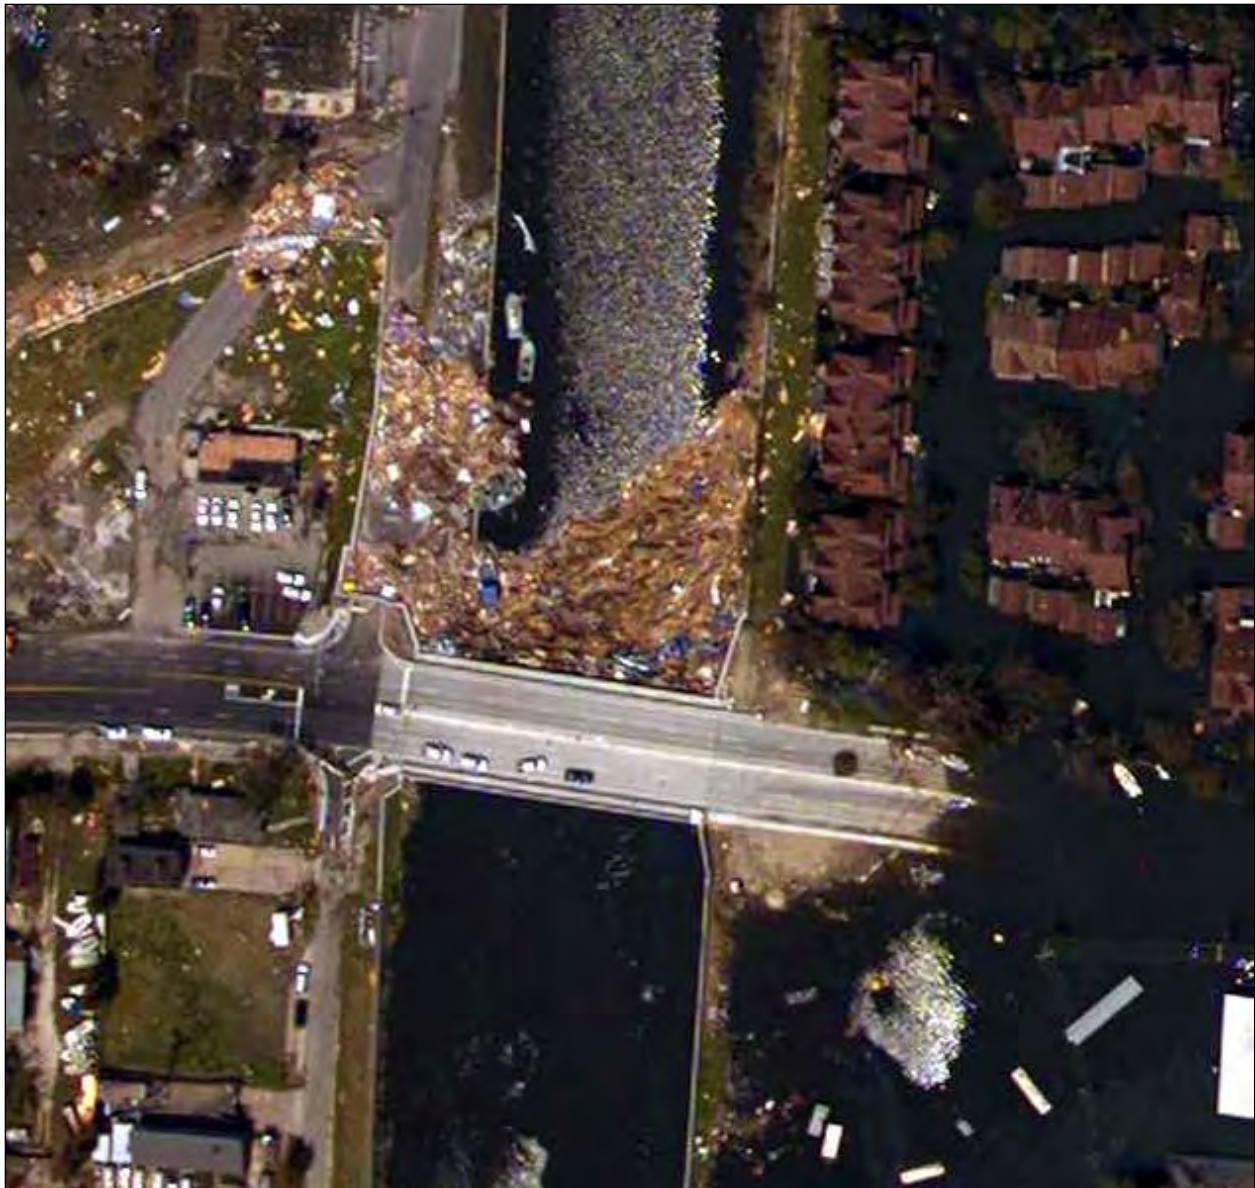
Post-storm aerial photos showed a large debris field jammed against the lake side of the Hammond Highway Bridge (see Figure 12-19). It reasonable to conclude that a major portion of the debris material was derived from structures that were on piles just north of the canal entrance, and that most likely debris started gathering at the bridge when flow through the breach was strong enough to draw water from Lake Pontchartrain. Initial tests of the physical model were conducted to determine the effect of the debris plug on wave transmission. Because it was unknown exactly when the material was deposited at the bridge, model data were collected from 0500 to 1100 hrs for two idealized debris conditions.

Figure 12-19. Post-storm debris at Hammond Highway Bridge. The triangular wedge is about 200 ft across at bridge

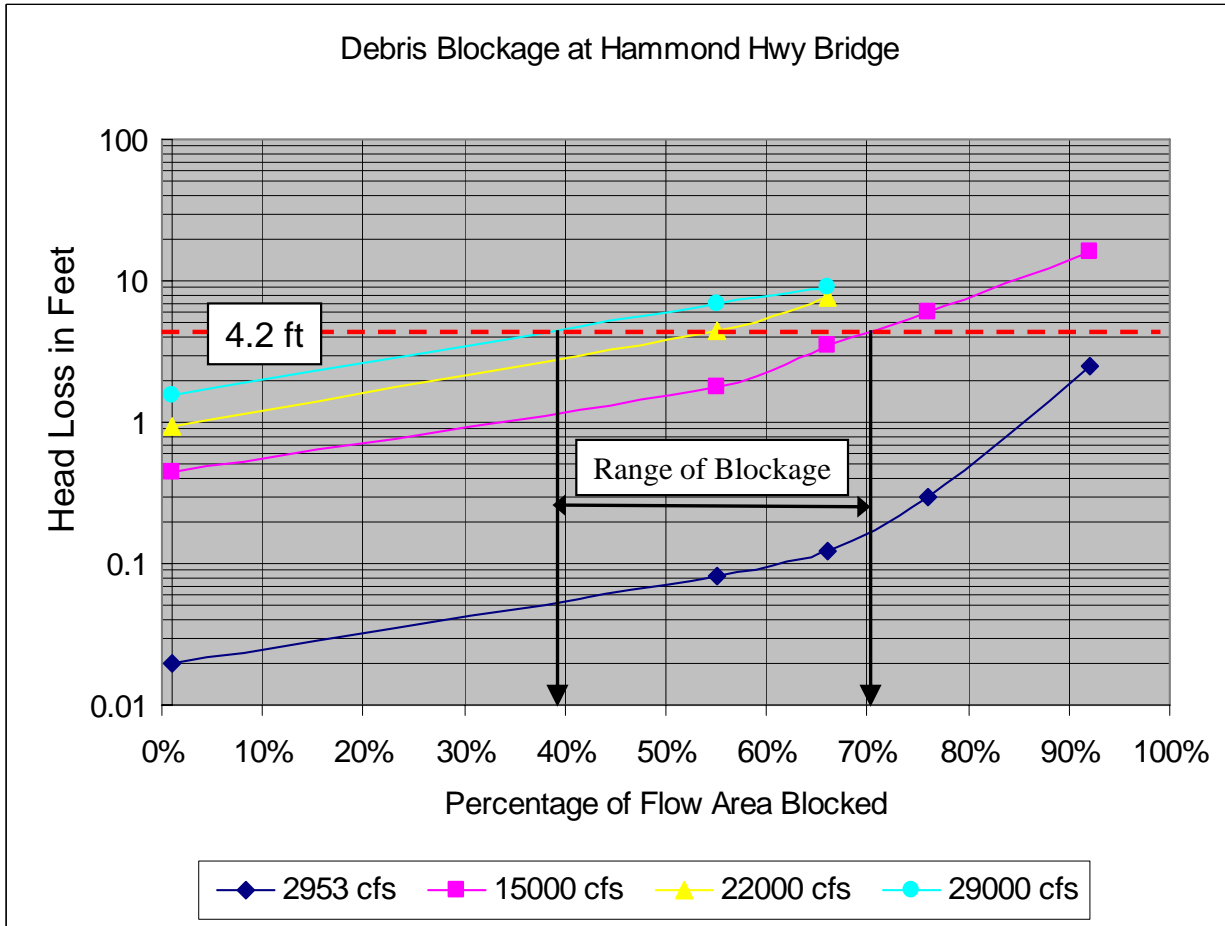
Based on a photograph taken at 1100 CDT looking through the actual breach into the canal, a graph may be created to estimate the blockage that occurred during the storm. From the photograph, the water elevation in the canal is estimated to be at approximately +3.0 ft. At 1100, Lake Pontchartrain was at elevation +7.2 ft, indicating a head difference of 4.2 ft. Re-plotting the data from Figure 12-26 in the manner shown in Figure 12-27, and assuming a flow range of 15,000 to 29,000 cfs through the breach (this range is representative of breach flow conditions based on analytical work performed in this task area and discussed in Appendix 10. Figure 12-27 shows the flow area blockage by the debris would be in the range of 40 to 70 percent.

Figure 12-27. Estimated blockage of 17th St Canal by debris at the Hammond Highway Bridge

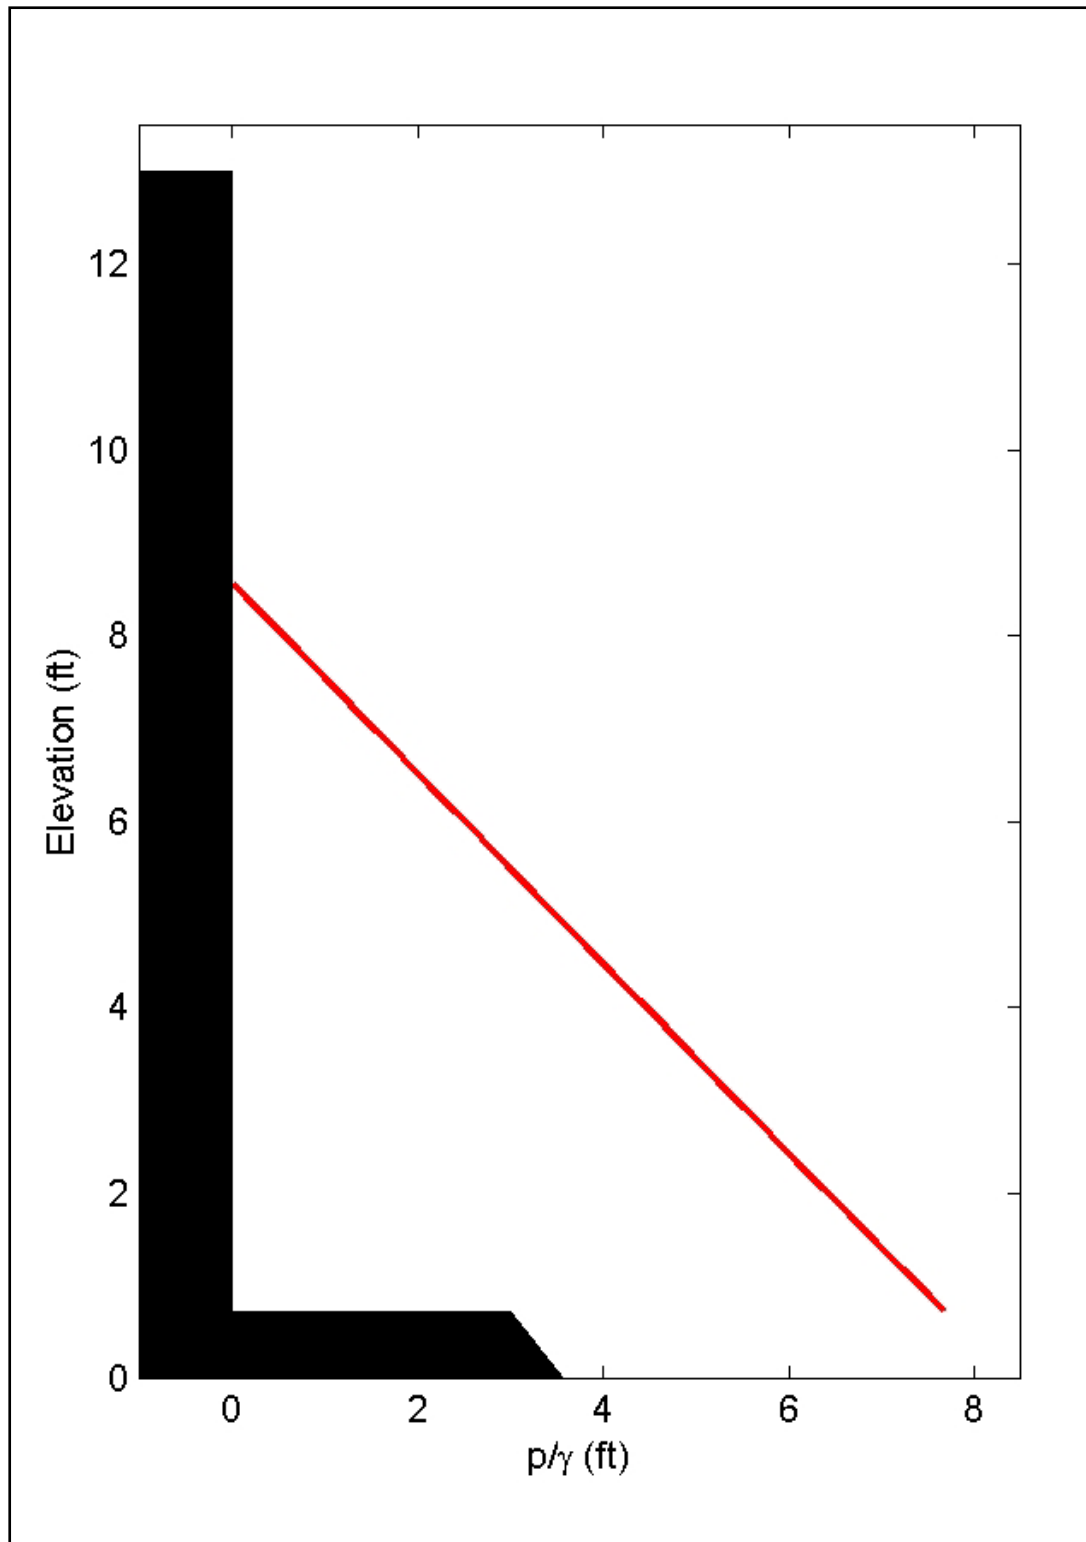
Figure 15-22. Example of numerically predicted vertical distribution of pressure under a wave crest near the London Avenue Canal failure location just south of Robert E. Lee Bridge at 1200 UTC. The black shape represents the floodwall and the red line is the distribution

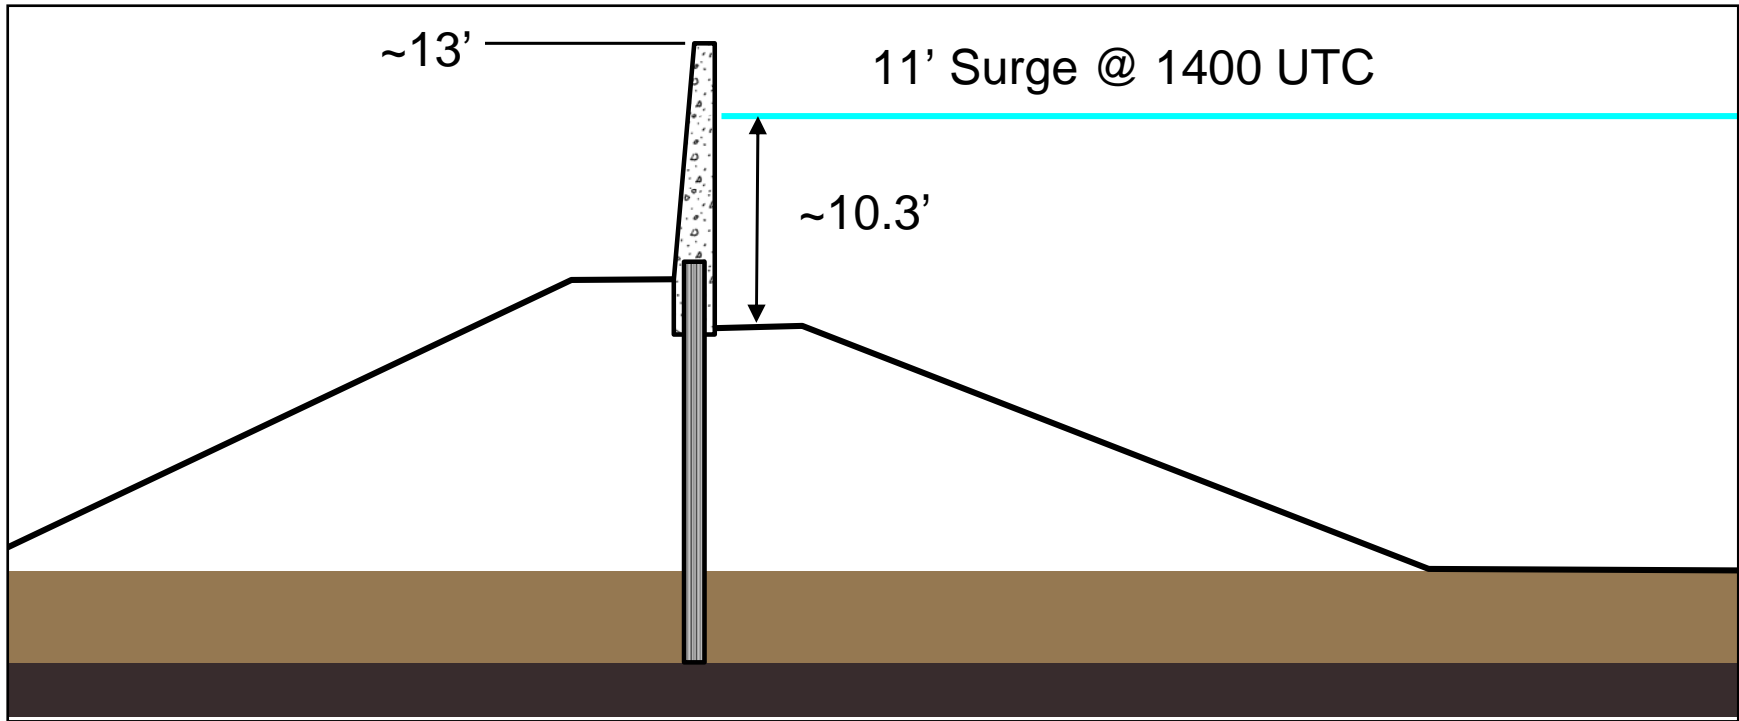
Figure 15-25. The location of the water force described here is immediately south of the Robert E Lee Bridge. Water forces and lines of action are summarized in the table below. In the table, the force,  $F_{nw}$ , is the force that would result from a static water column of height,  $h$ .

Time (UTC)	Surge (ft)	$h$ (ft)	$F_{nw}$ (lb/ft)	$z_r$ w/ $F_{nw}$ (ft)	$F_{2\%}$ (lb/ft)	$z_r$ w/ $F_{2\%}$ (ft)	$\Delta F$ (lb/ft)
1400	11	10.3	3,310	3.4	3964	3.8	422

Figure 15-25. Cross-sectional schematic for Orleans Avenue Canal south of the Robert E Lee Bridge

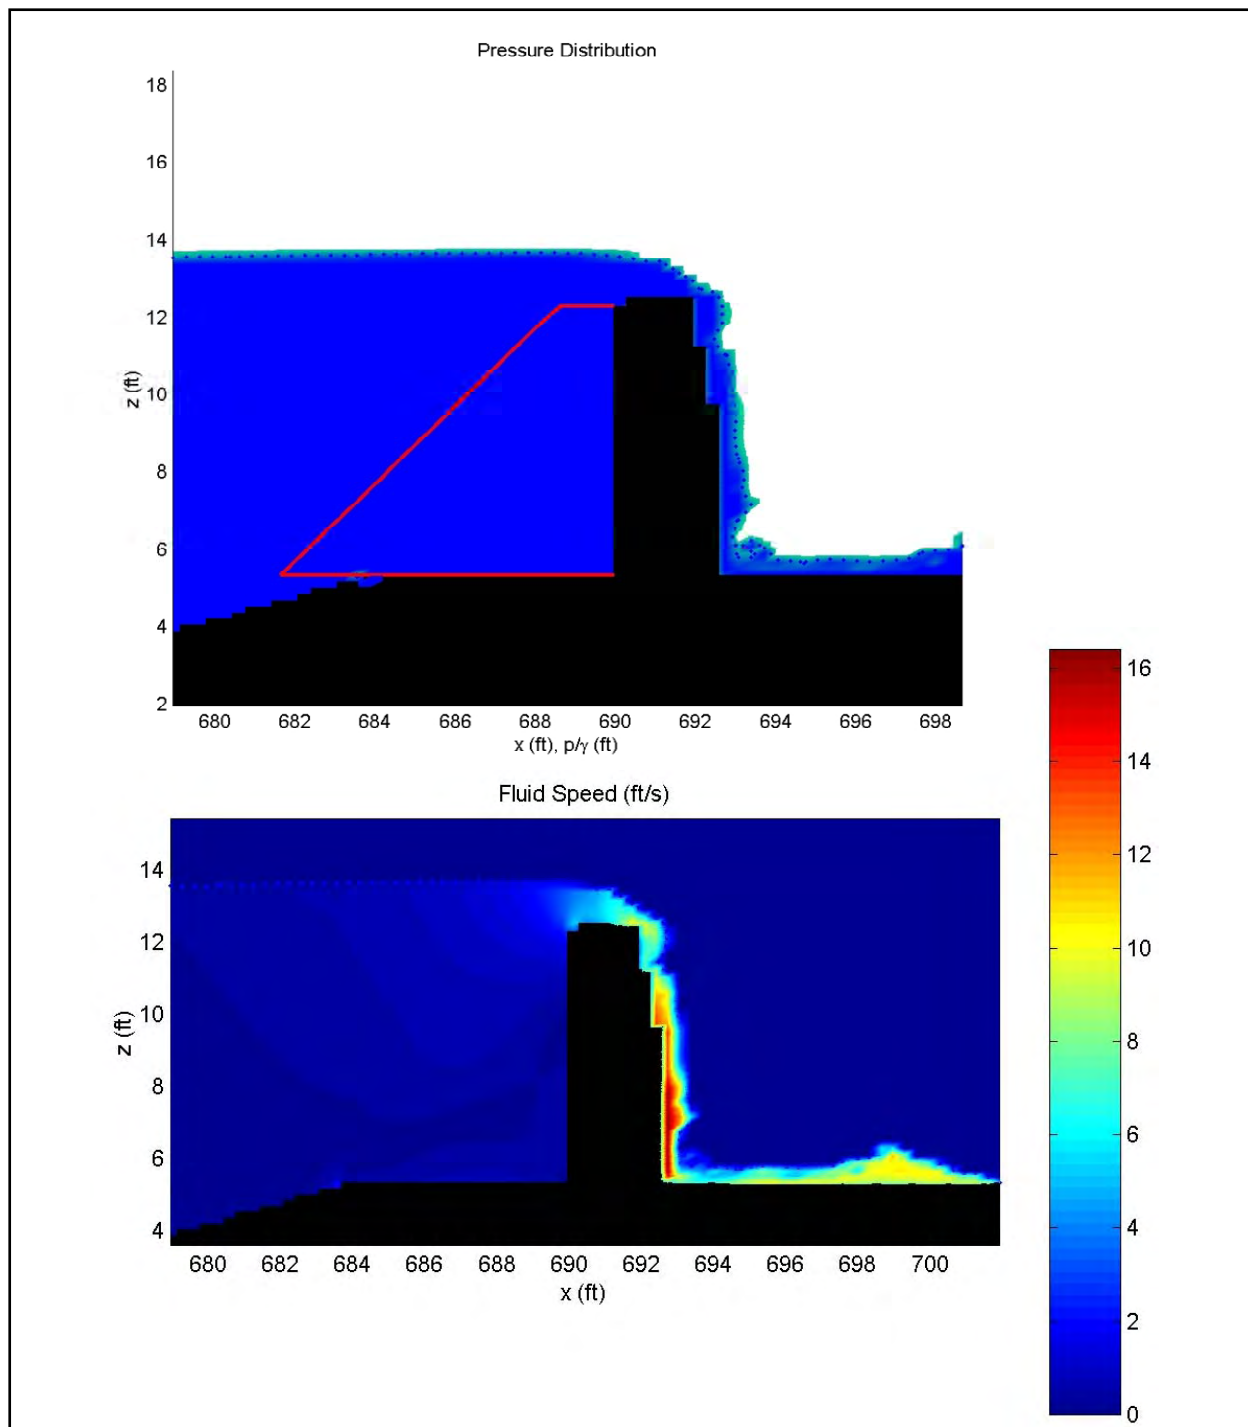
The general IHNC canal wall profile is taken from design memoranda. As the actual wall height is highly variable in the area of the failures, the simulations are reduced to a simple set where the surge is +1ft above the wall crest. Specifically, the surge is set as 13.5ft and the top of the wall at 12.5ft. Two simulations are run; one with no waves, and another with 1ft waves with a period of 5 seconds. Pressure distributions and fluid speeds are presented for both cases. Figure 15-29 shows the values for the no-wave case and Figure 15-30 for the wave case. What is evident here, as with all other canal simulations, is that the pressure is nearly hydrostatic, i.e. linearly varying from the instantaneous free surface elevation. The resulting force for the no-waves case is 1940 lb/ft, and 2260 lb/ft under the mean wave crest for the waves case. Note that this force is a mean value, not a 2 percent exceedence. The computational requirements of the Navier-Stokes simulations prohibit the long duration runs with input spectra required to derive statistical relations. Maximum fluid speeds on the backsides of the walls are close to free-fall speeds, near to 16 ft/s for both cases.

Figure 15-29. Surge overtopping an IHNC wall with no waves. The wall elevation is specified as 1ft below the surge. The top plot gives the water surface and pressure distribution, the lower plot gives the fluid speed field
