# Appendix 1

## Hydrograph and High Water Mark Analysis

### Introduction

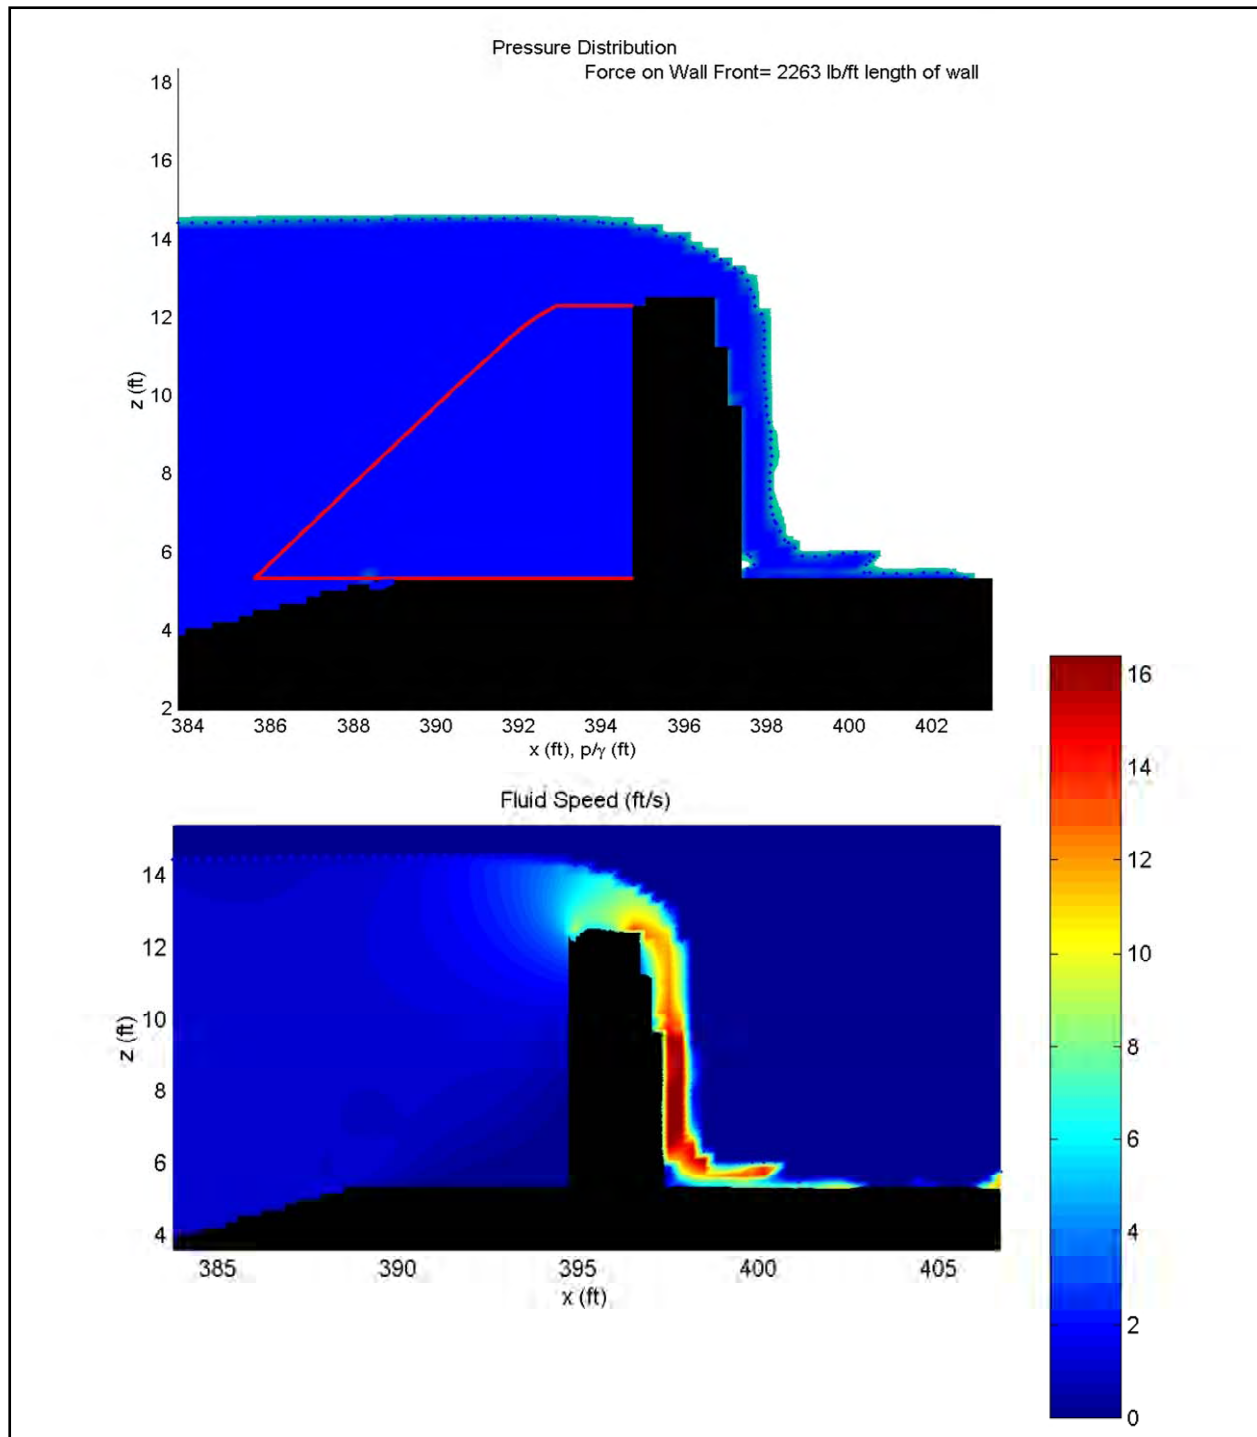
The general IHNC canal wall profile is taken from design memoranda. As the actual wall height is highly variable in the area of the failures, the simulations are reduced to a simple set where the surge is +1ft above the wall crest. Specifically, the surge is set as 13.5ft and the top of the wall at 12.5ft. Two simulations are run; one with no waves, and another with 1ft waves with a period of 5 seconds. Pressure distributions and fluid speeds are presented for both cases. Figure 15-29 shows the values for the no-wave case and Figure 15-30 for the wave case. What is evident here, as with all other canal simulations, is that the pressure is nearly hydrostatic, i.e. linearly varying from the instantaneous free surface elevation. The resulting force for the no-waves case is 1940 lb/ft, and 2260 lb/ft under the mean wave crest for the waves case. Note that this force is a mean value, not a 2 percent exceedence. The computational requirements of the Navier-Stokes simulations prohibit the long duration runs with input spectra required to derive statistical relations. Maximum fluid speeds on the backsides of the walls are close to free-fall speeds, near to 16 ft/s for both cases.

Figure 15-30. Surge overtopping an IHNC wall with 1 foot, 5 second waves. The wall elevation is specified as 1ft below the surge. The top plot gives the water surface and pressure distribution, the lower plot gives the fluid speed field.

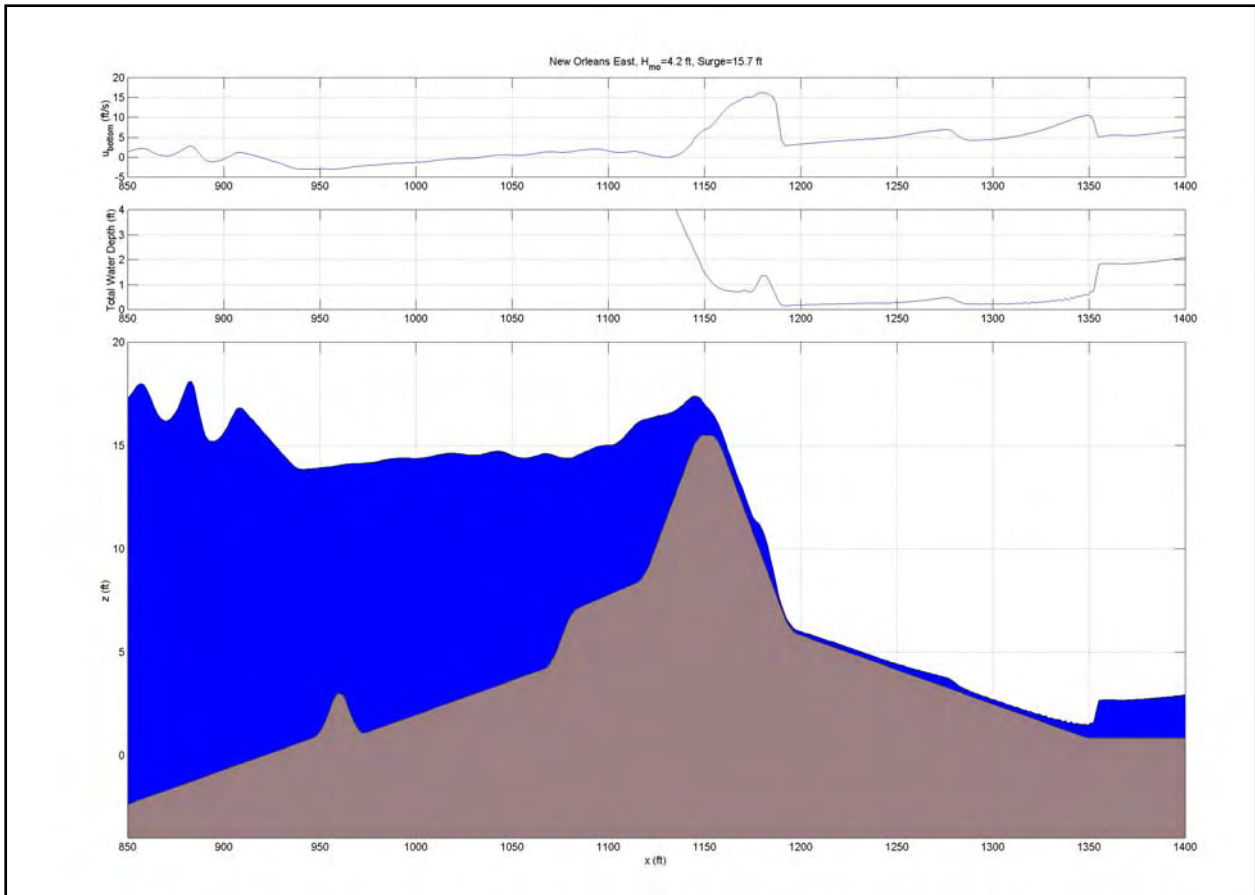
Firstly, the simulation at the far eastern levee along the GIWW is discussed. A snapshot of the numerical simulation is given in Figure 15-40. For this peak condition, the surge elevation is 15.7', the wave height is 4.2', and the peak wave period is 14 seconds. Time-averaged values of overtopping flux, crest velocity, and backface velocity are 1.0 ft<sup>3</sup>/s/ft, 2.0 ft/s, and 6.0 ft/s, respectively. The mean maximum values, associated with the wave crest, are 8.7 ft<sup>3</sup>/s/ft, 8.5 ft/s, and 12.5 ft/s, respectively

Figure 15-40. Snapshot from the numerical simulation of overtopping the far eastern GIWW levees. Conditions correspond to 1230 UTC on the 29<sup>th</sup>, with  $H_{mo}=4.2'$  and surge=15.7'. Spatial transects of near bottom velocity and total water depth are given in the top two subplots

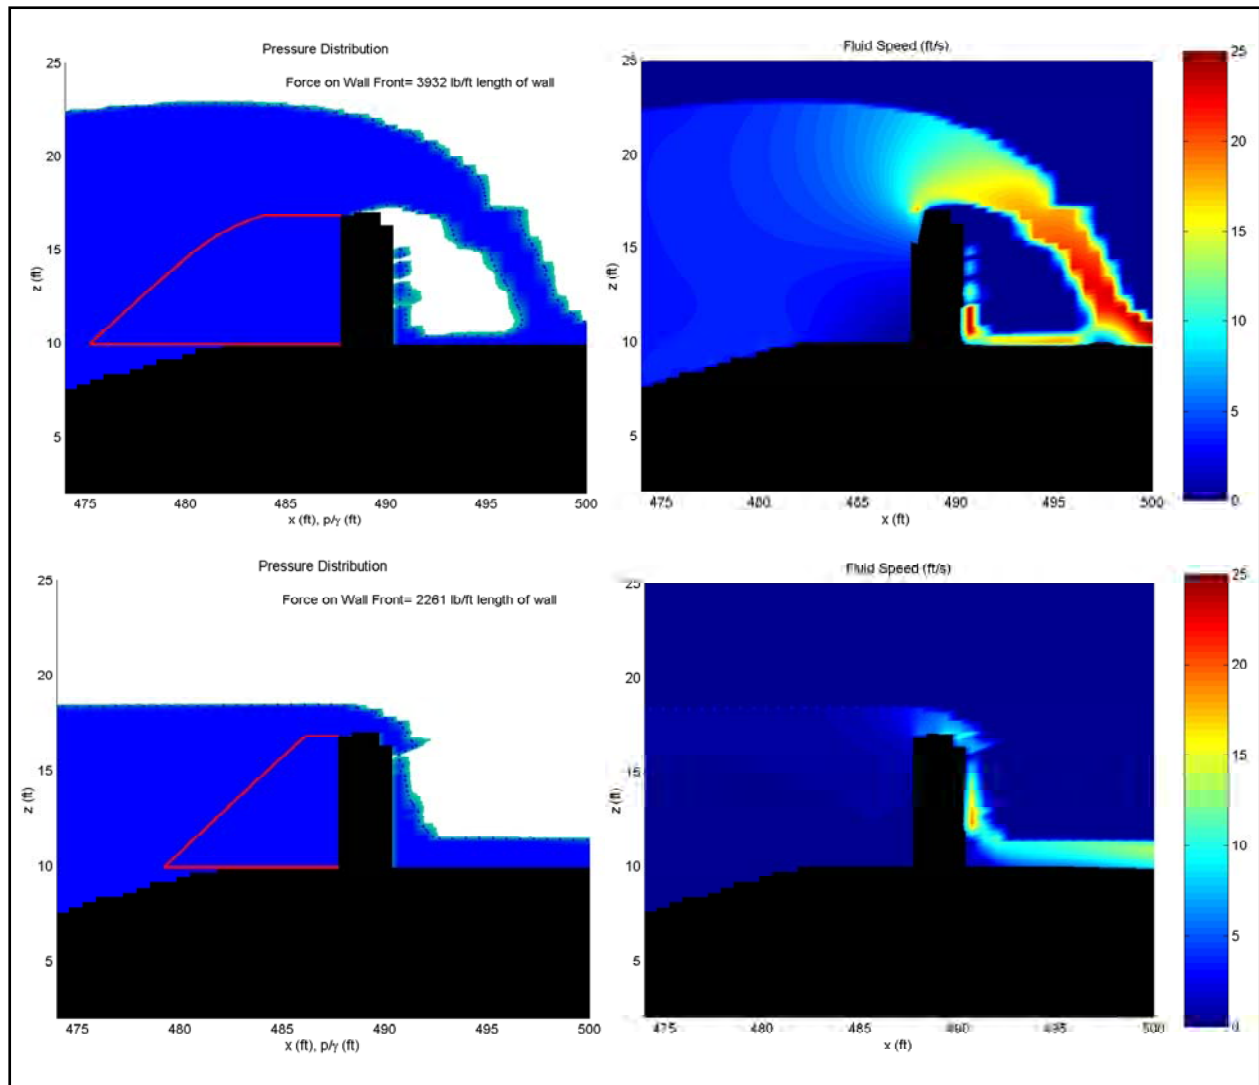
results of the simulation. Shown is the pressure distribution and speed field at the time of maximum (crest) and minimum (trough) force. Here, the dynamic impact can be seen in the pressure distribution under the wave crest, as the vertical distribution is not linear. Under the trough, however, the distribution is linear. This is an expected result with large amplitude waves. The force under the crest is 3930 lb/ft, and 2960 lb/ft under the wave trough. These forces are mean values, not a 2 percent exceedence. The computational requirements of the Navier-Stokes simulations prohibit the long duration runs with input spectrums required to derive statistical relations. Note that the dynamic effect under the crest adds approximately 6 percent to the total force acting on the wall; the hydrostatic load on this wall with a 23' instantaneous water surface elevation is 3710 lb/ft. Maximum fluid speeds on the backsides of the walls are extreme when the crest impacts the wall, near to 25 ft/s. Under the wave crest, there is sufficient horizontal velocity under the wave to create a jet which hits the soil 5-10' past the back of the T-wall. Overtopping flux under the wave crest is 67 ft<sup>3</sup>/s/ft; under the trough this dips to 9 ft<sup>3</sup>/s/ft. The wave-averaged value of overtopping flux is 22 ft<sup>3</sup>/s/ft, which is a value much closer to the trough due to the wave asymmetry.

Figure 15-44. Pressure distribution (left) and speed field (right) under the wave crest (top) and wave trough (bottom) for wave overtopping the levee wall
