Performance Evaluation of the New Orleans and Southeast Louisiana Hurricane Protection System

Draft Final Report of the Interagency Performance Evaluation Task Force

Volume V – The Performance — Levees and Floodwalls

1 June 2006

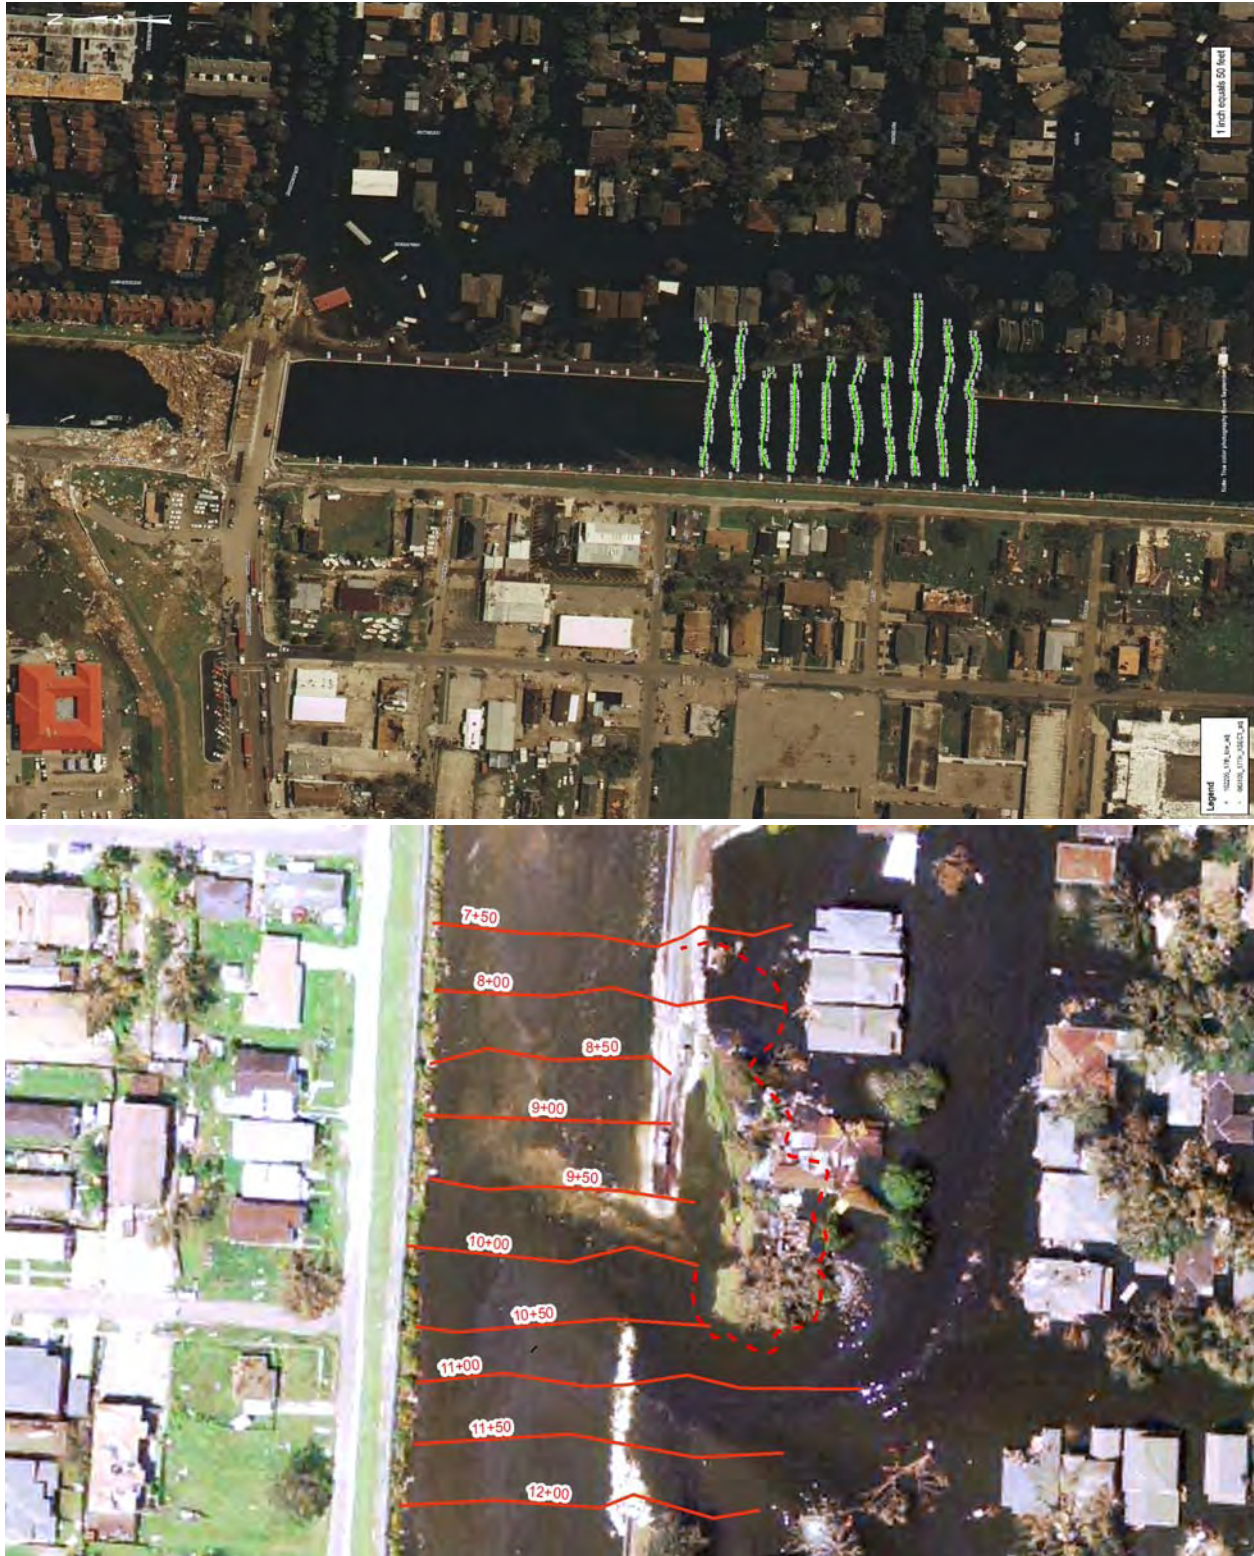
Figure 5. Location of Multi-Beam Sonar Survey Cross-Sections at the 17th Street Canal Breach

A transverse multi-beam sonar survey of the surface of the canal bottom and breach was conducted before construction of an emergency closure across the breach, at the cross section shown in Figure 5. Topographic cross sections developed from the results of this survey are shown in Figure 6a and 6b. The survey showed that the crest of the levee on the canal side remained essentially in place after the breach, as shown by the ground surface profile at Station 11+50, in Figure 7. It can be seen that the levee and floodwall moved about 40 ft laterally during the failure, and was tilted toward the landside at about 45 degrees after the failure.

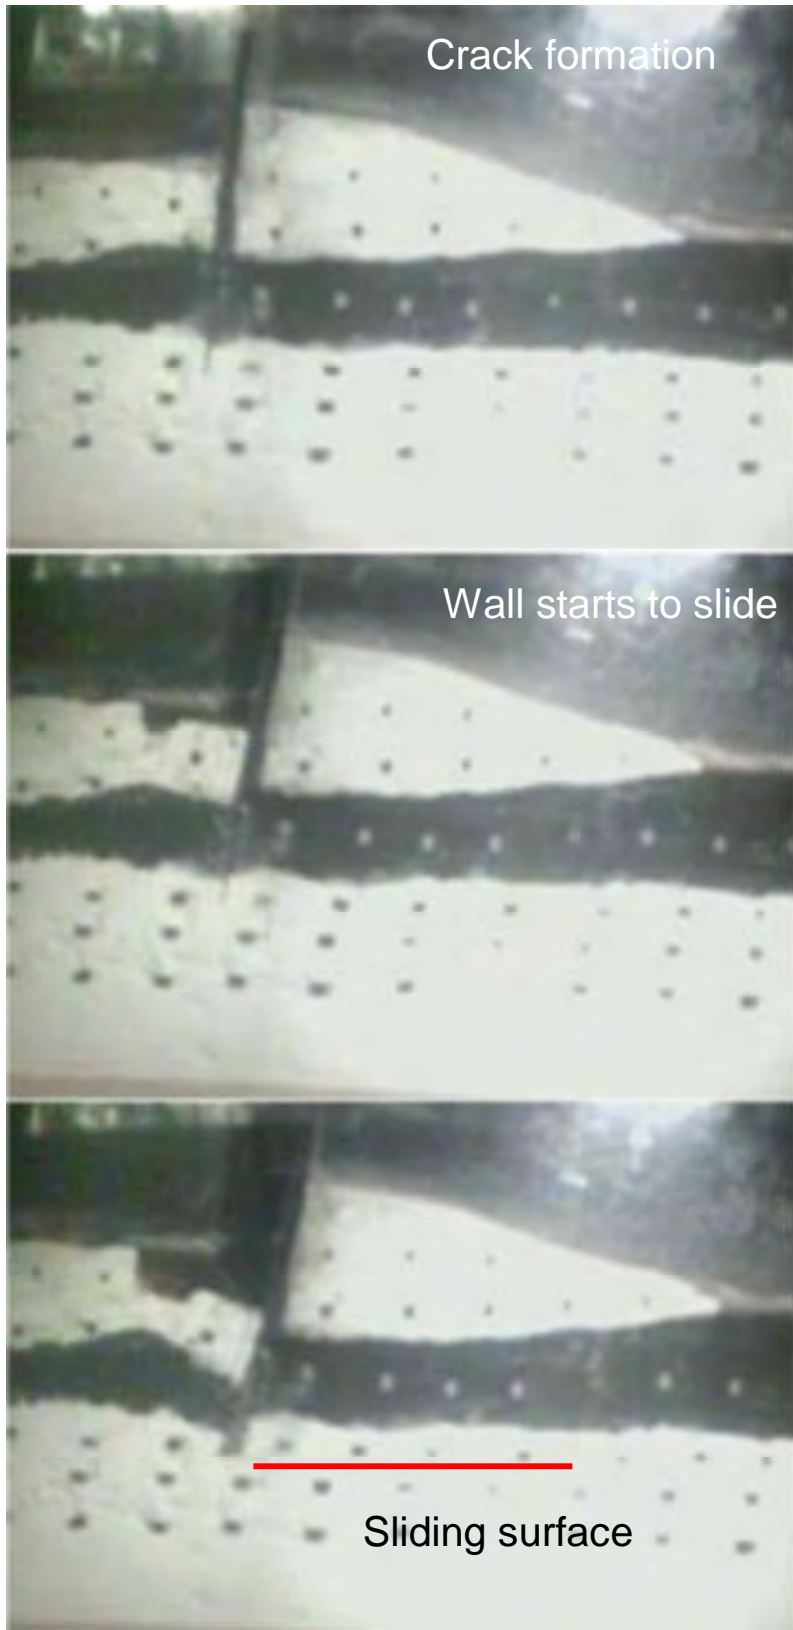
Figure 18. Sliding Surface Forms at Top of Clay Layer in 17th Street Canal Model 1

The centrifuge model results revealed that the gap formation had a major contribution to all of the breaches on the outfall canals. In all of the scale models where the toe of the sheet pile wall terminated in the clay layer, like the 17th Street Canal breach location, a translational failure occurred through the clay when the gap opened and filled with water. This is clearly seen in the instruments recording movement of the wall and in the video imagery, Figure 18.

The sliding surface developed near the top of the clay layer and progressed landwards until it was outside the levee, then turned upward to exit through the marsh layer. This mechanism is similar to the observations in the field from 17th Street. The movement of the model wall was arrested before larger displacements took place to capture the final state of the 17th Street model (Model 1), Figure 19. Despite the fairly significant lateral movement, there is minimal heave of the swampy marsh layer on the landward side at the stage shown in Figure 19.

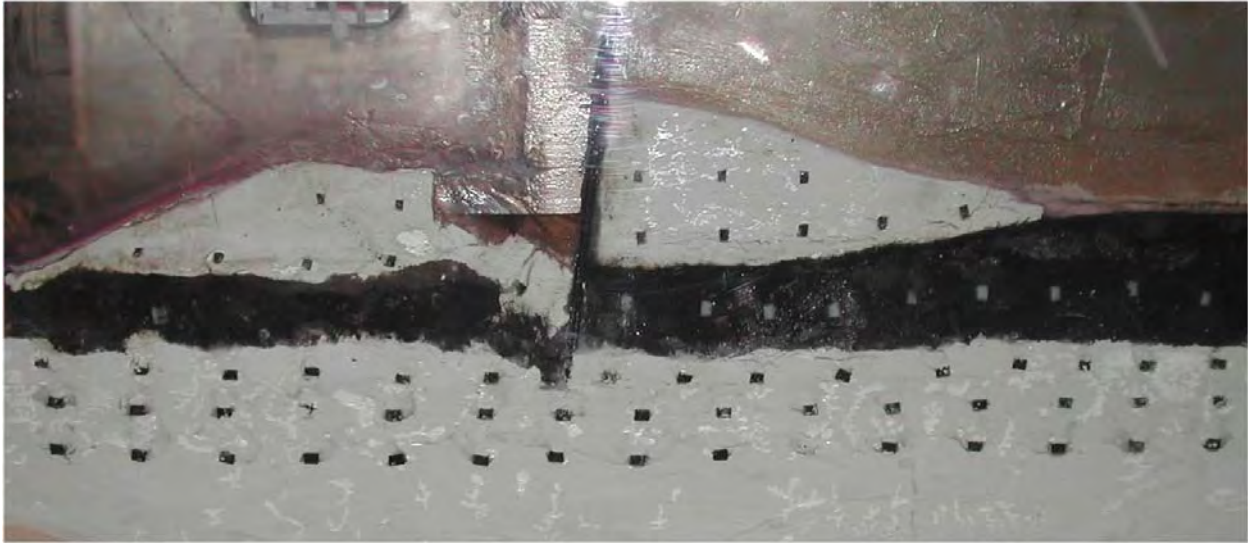
Figure 19. Final State of 17th Street Model 1 Showing Lateral Translation on Sliding Surface Starting at the Toe of the Wall and Progressing Landward

All of the clay foundation models failed with a similar mechanism under the flood loading, commencing with a small rotation and formation of a gap behind the wall, followed by further rotation and large translation associated with a shear plane that formed from the toe of the sheet pile wall and progressed landwards through the upper part of the clay layer. This was consistent with the field observations.

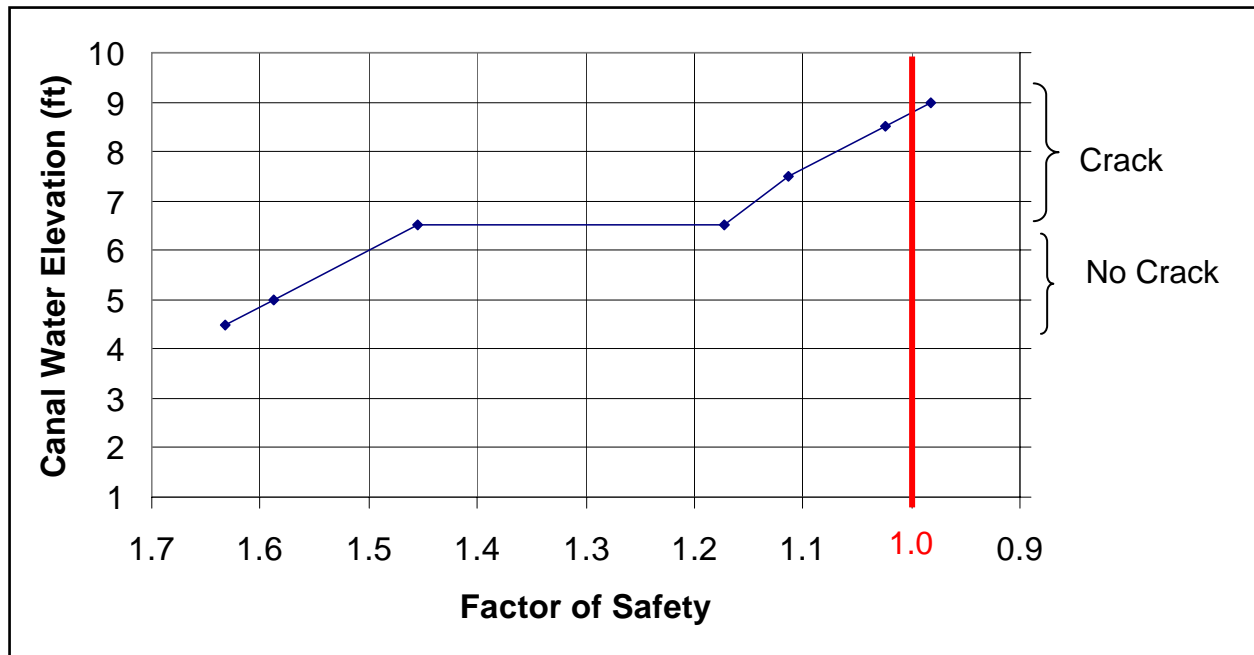
Figure 22. Factor of Safety Versus Canal Water Elevation Computed in the Soil-Structure Interaction Analysis of Station 10+00 on the 17th Street Canal East Side Breach

The finite element analyses show that gap formed as the water rose on the canal side of the wall. The criterion for gap formation was earth pressure against the wall less than the hydrostatic water pressure at that depth. When that condition was reached, the finite element mesh was adjusted to separate the soil elements from the wall elements with a gap. The gap began to open when the water in the canal rose to elevation 6.5 ft. Eventually, the gap extended to the tip of the sheet pile, which was at the lacustrine clay-marsh interface. Factors of safety were computed using the strength reduction method. The strength reduction method involves performing a series of finite element analyses using values of the strength parameters c and ϕ (or c' and ϕ') that are reduced by dividing them by assumed values of factor of safety. The correct factor of safety, as determined by this method, is the smallest value that results in unstable conditions in the analysis. When the gap developed and filled with water the factor of safety decreased suddenly by about 25%, from 1.45 to 1.16, as shown in Figure 22.

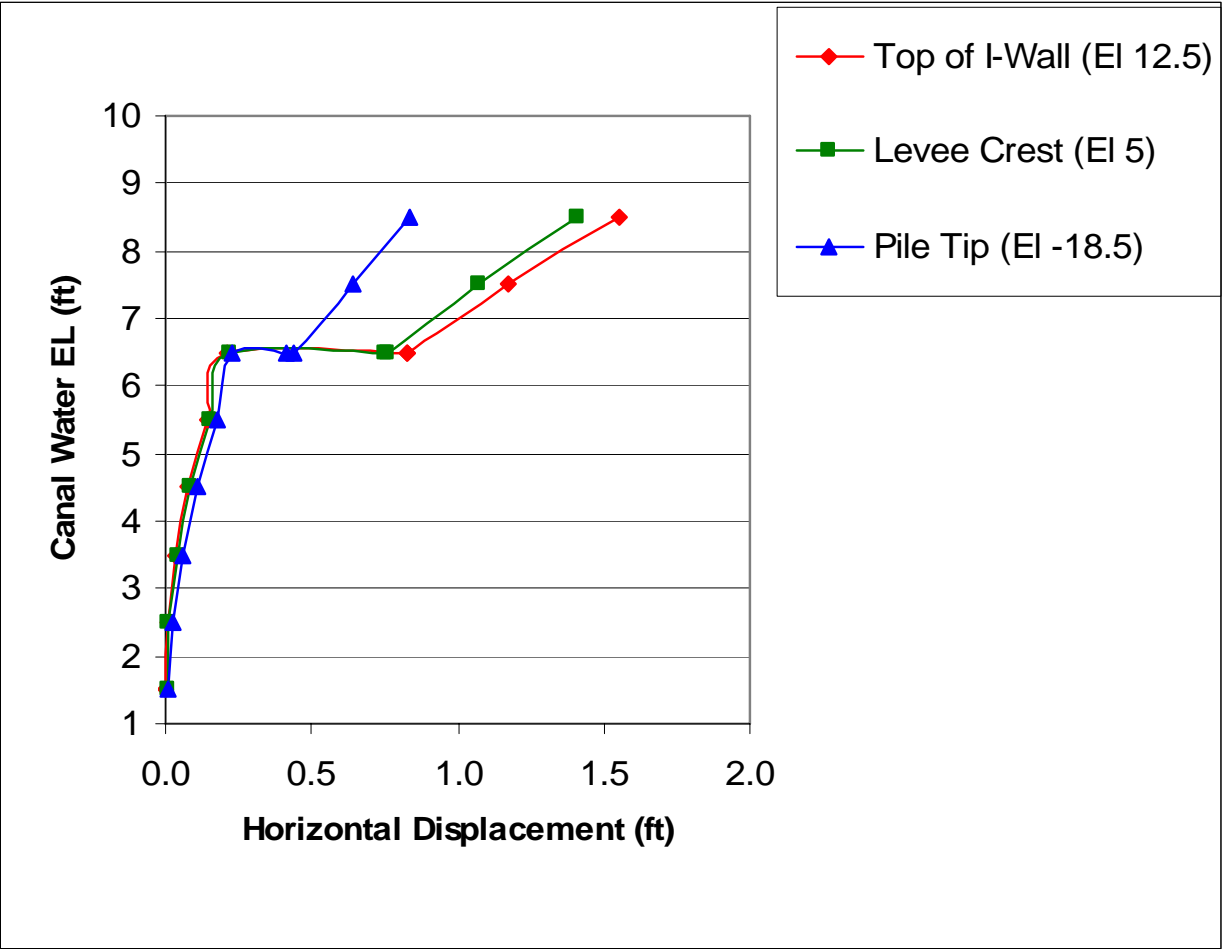
Figure 23. Horizontal Sheet Pile Deflections Versus Canal Water Elevation Computed in the Soil-Structure Interaction Analysis of Station 10+00 on the 17th Street Canal East Side Breach

The development of a gap, which immediately filled with water, resulted in a marked increase in calculated displacements, as shown in Figure 23. As the water in the canal rises from El 6.5 to El 9.0, the maximum lateral deformation increases from 1.6 ft, the condition shown in Figure 24, to 5.3 ft, the conditions shown in Figure 25; and the factor of safety decreases from 1.16 to 0.98. Figure 26 shows that the contours of maximum shear strains form a shear surface that compare well with the critical failure surface found in the limit equilibrium stability analysis, Figure 27.

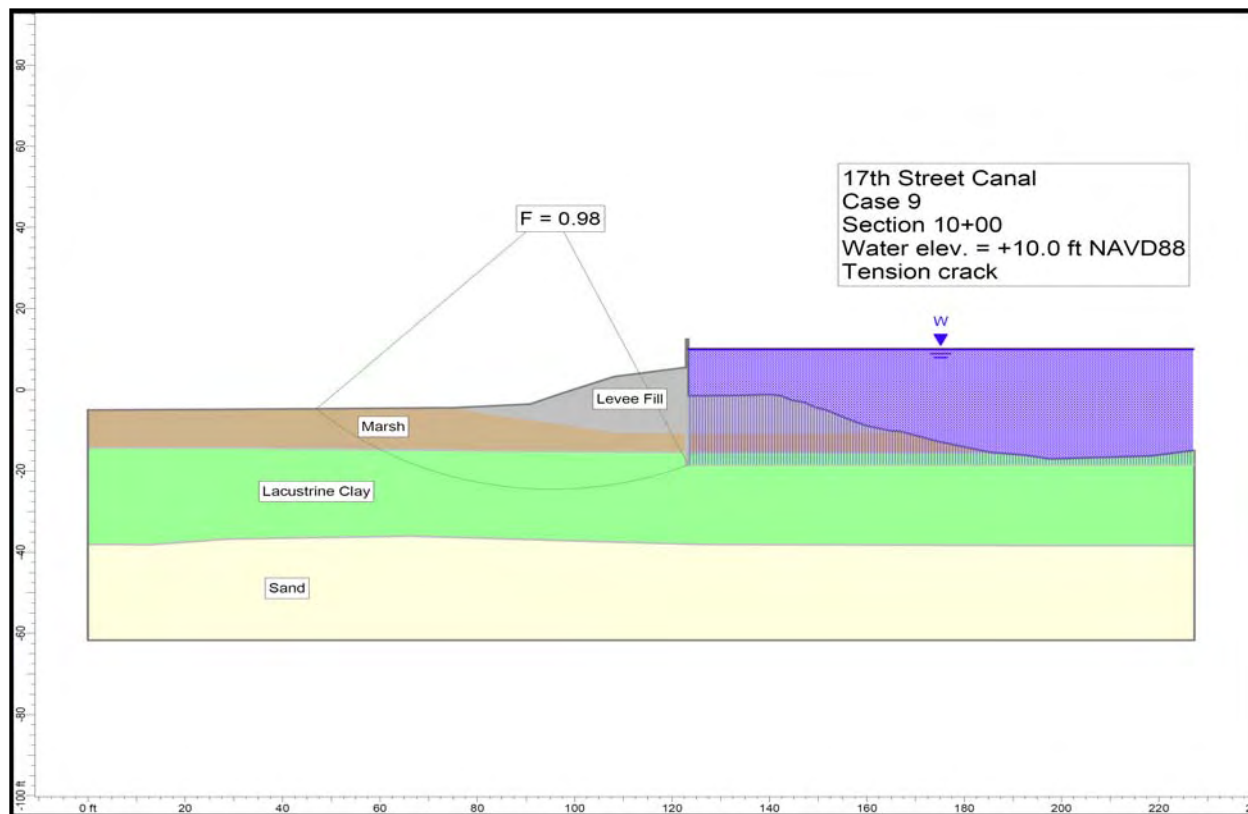
Figure 27. Critical Circle for 17th Street Canal Station 10+00 – Water Elevation 10 ft, With a Water-Filled Gap Behind the Wall

The results of the analyses are consistent with the performance of the I-wall in the breach area. Calculated water levels for factors of safety equal to 1.0 for the condition with a gap behind the wall vary from 9.8 ft to 10.6 ft, as compared with a water level of 7 ft to 8 ft at the time failure began based on an eyewitness report. It appears that wave effects might raise the effective water level by 1 to 2 ft, to as much as 10 ft. In addition, it was found that using non-circular slip surfaces reduced the calculated factors of safety by about 5% as compared with those calculated using circular slip surfaces. Thus, considering the influence of waves increasing the effective average water level, and non-circular slip surfaces resulting in lower factors of safety, it is apparent that the results of the stability analyses are in close agreement with the observed performance.

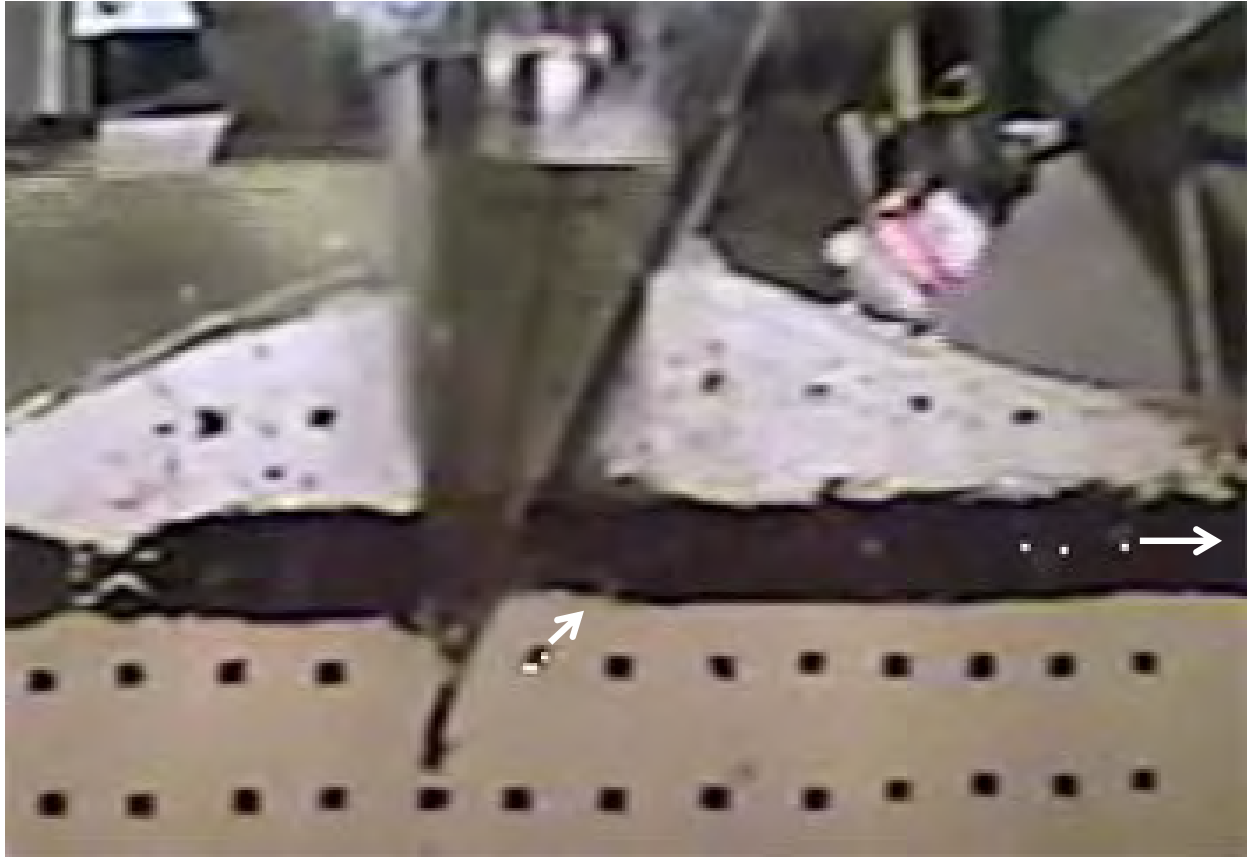
Figure 34 Superposition of Video Images of the Rotational Failure of the London South Model Wall, Model 1

In the London Avenue Canal model tests, where the toe of the sheet pile wall penetrated into the sand and was restrained from lateral movement by the sand, the opening of the gap on the canal side of the floodwall was followed by rotation of the top of the wall landward. With the opening of the gap, the model tests for the London south breach and the London north breach both showed gross movements indicative of wall failure, as may be seen in Figure 34. Rotation of the wall was accompanied by a translational sliding of the landward part of the levee and marsh layer, on top of the underlying sand. Rotation of the wall is linked to reduction in effective stress on the sand layer beneath the landward side of the levee. Once the gap was fully opened, pore pressure transducers in the foundation sand layer showed that the pore pressure in the sand rose very significantly. The increasing water pressure in the sand layer reduced the effective stress at the base of the marsh layer. The reduction in vertical effective stress has two effects: the first is to increase the likelihood of uplift of the swampy marsh (as the increasing water pressure in the foundation balances or exceeds the weight of the levee and marsh layer above) and the second is to reduce the stiffness of the sand surrounding the toe of the sheet pile wall, reducing the passive resistance that the sand provides.

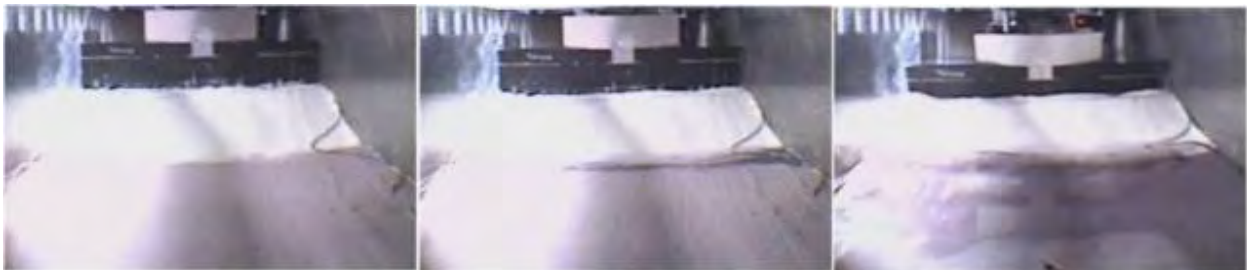
Figure 35. Water Emerging From Toe of Levee as Failure Progresses, London South Model 2

The high pore water pressures under the toe of the levee on the landward side and under the swampy marsh led to water being ejected from the ground at the toe of the levee. This may be deduced from the piezometric heads near the toe of the levee, and can be seen clearly in the video images of the landward toe. Figure 35 shows a view of the levee and floodwall as seen from the ‘backyard’ of houses behind the levee, showing ‘black’ water emerging from the toe of the levee as the flood wall rotates landward. This supports the earlier assessment based on seepage analyses that a rupture through the marsh layer overlying the sand at the south breach led to a failure initiated by erosion and piping.

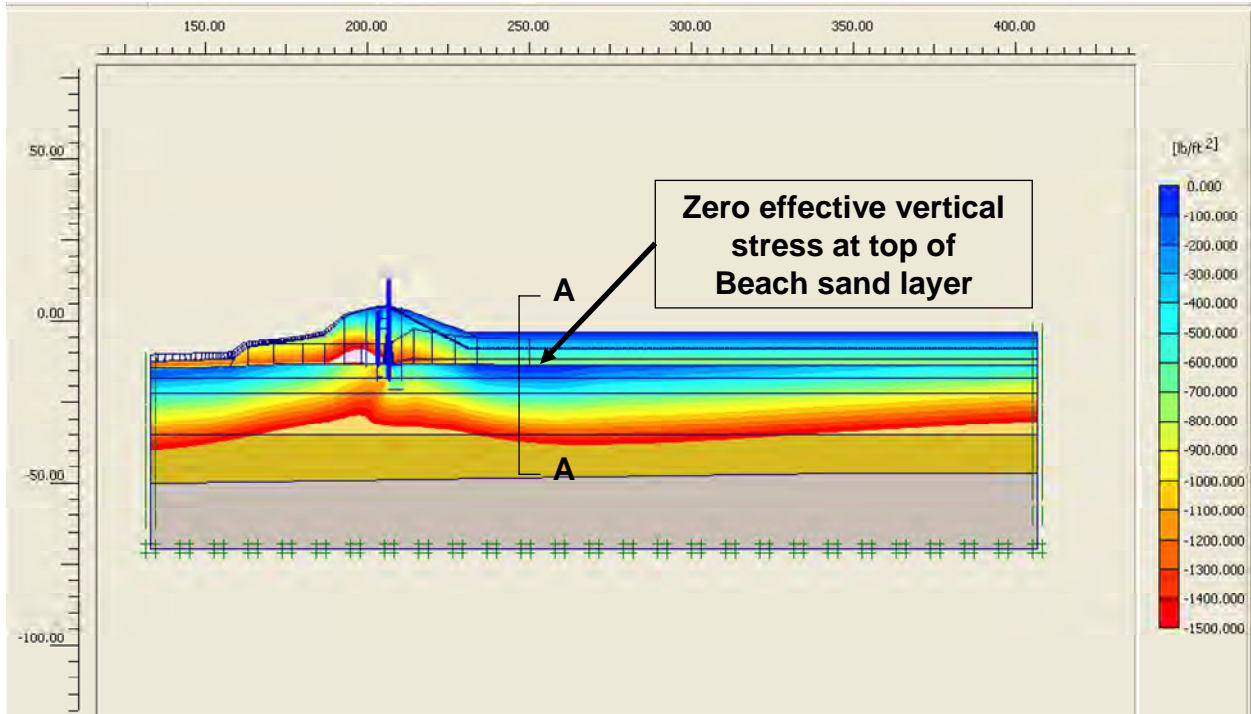
Once the gap extended full depth, the water pressure in the sand rose rapidly, and the elevated water pressure in the sand layer reduced the vertical effective stress at the base of the marsh layer, Figure 39. The reduction in vertical effective stress has two effects: the first is to increase the uplift pressure on the bottom of the marsh layer, as shown in Figure 39; and the second is to reduce the stiffness of the sand surrounding the tip of the sheet pile wall, reducing the passive resistance provided by the sand.

Figure 39. Effective Vertical Stress in the Beach Sand for the Analysis Using Average Stiffness Values with Canal Elevation 6.0 ft and Gap to Elevation -12.9 for the London Avenue North Breach

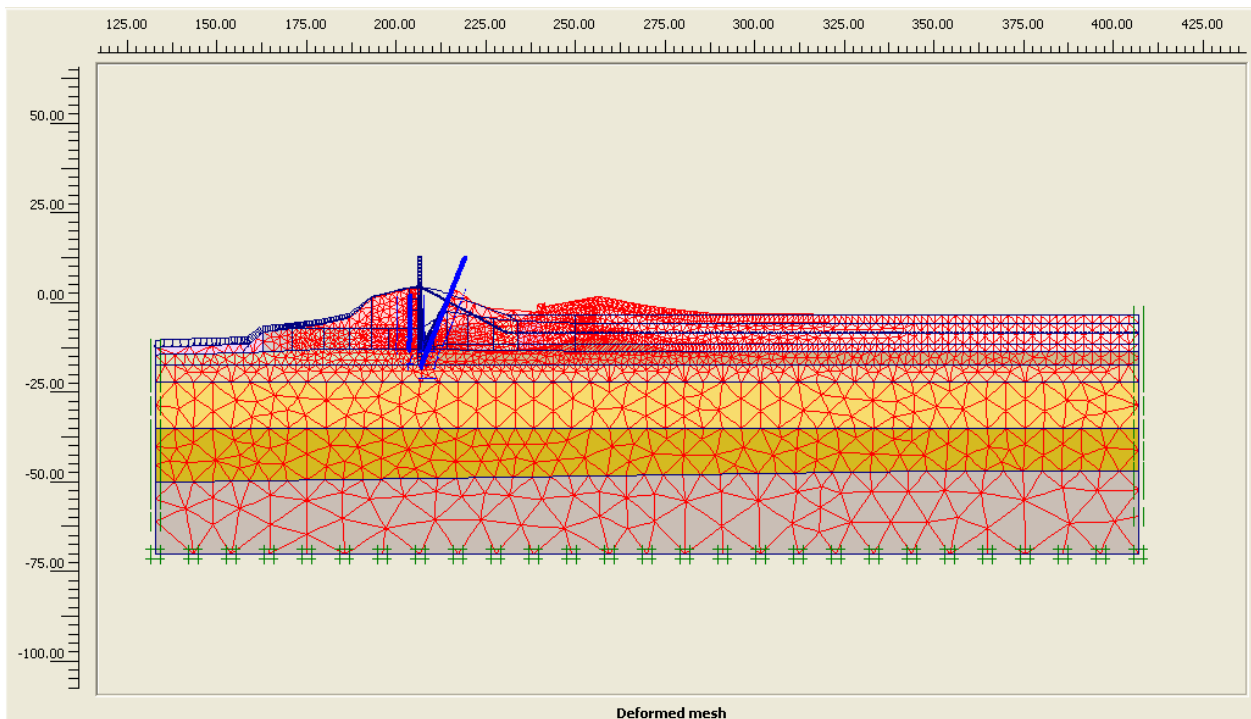
The finite element soil-structure interaction analyses are consistent with the behavior observed in the centrifuge tests, where the opening of the gap on the canal side of the floodwall was followed by rotation of the wall landward, as shown in Figure 40. Figure 41 shows the horizontal displacement of the top and tip of the wall as the canal water rises. It shows that the

Figure 40. Ultimate Mechanism from Strength Reduction Analysis Using Average Stiffness Values with Canal Elevation 6.0 ft and Gap to Elevation -12.9 ft, London Avenue North Breach (displacements are exaggerated)

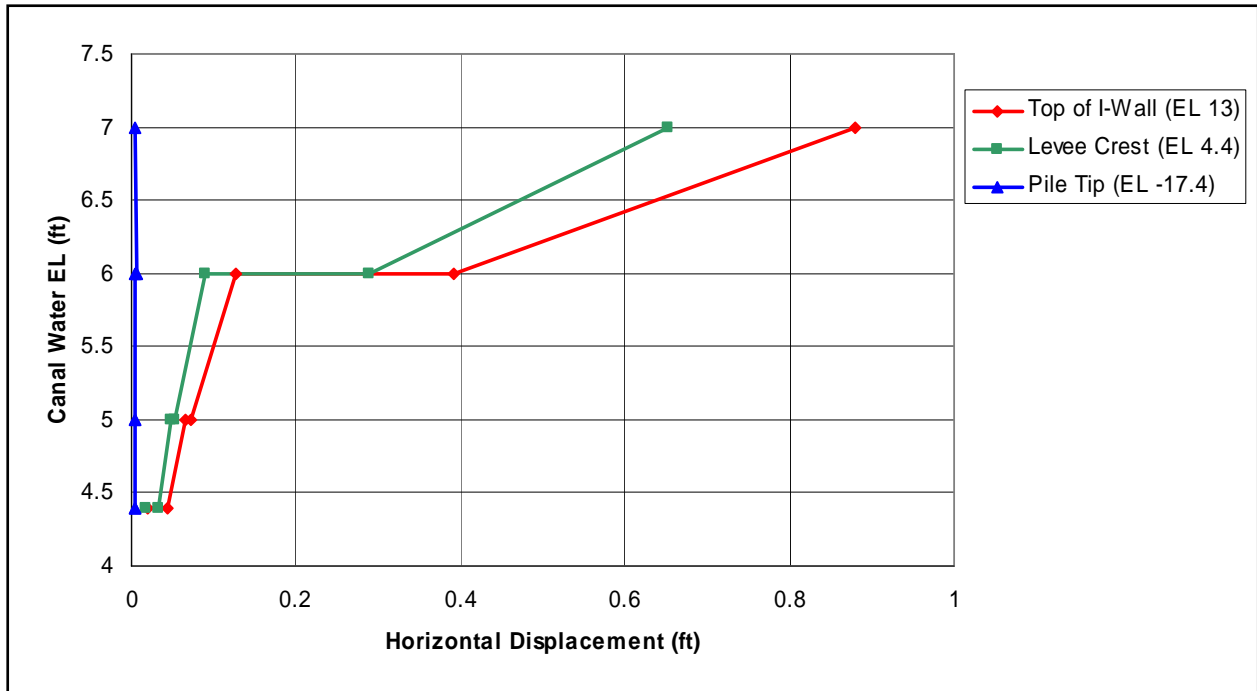
tip did not translate horizontally; instead, the wall rotated about the tip. Figure 41 also shows the significant increase in rotation of the wall once the crack reached the sand layer.

Figure 41. Horizontal Sheet Pile Deformations versus Canal Water Elevation Computed Using Average Stiffness Values for the London Avenue Canal North Breach

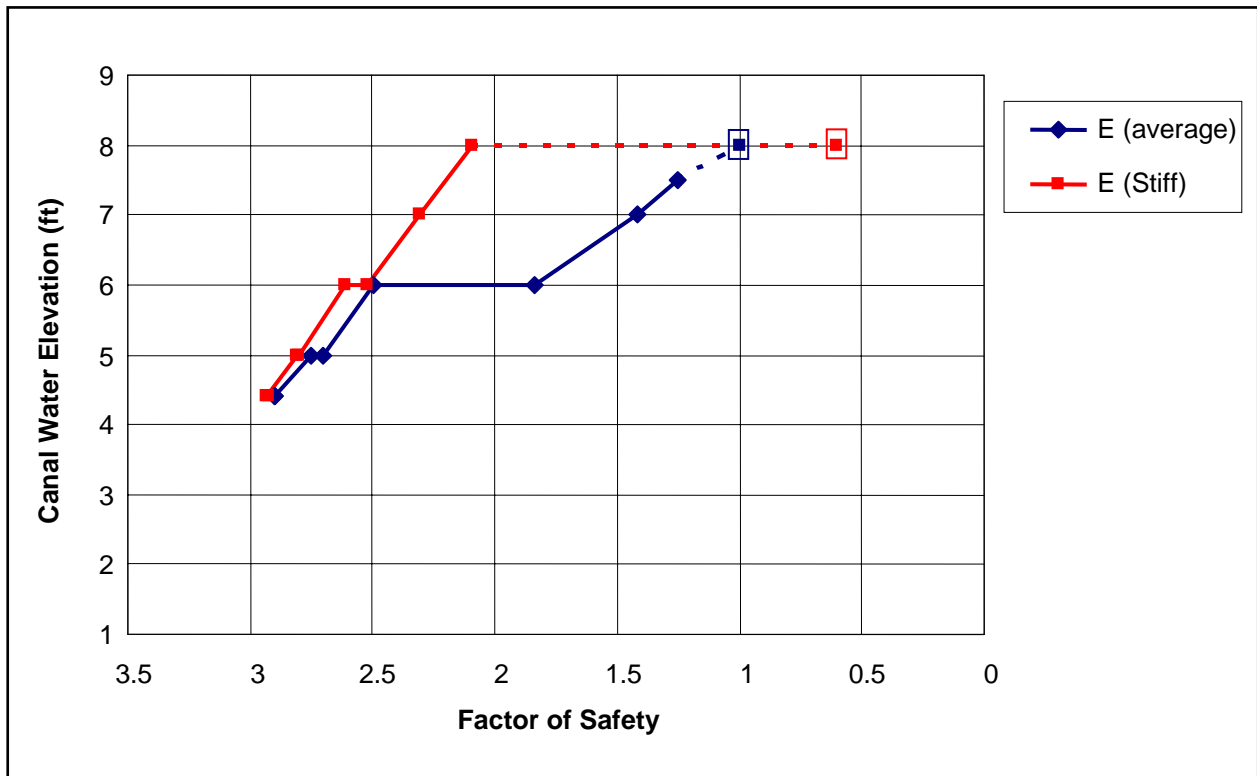
The factor of safety decreased substantially when the crack opened fully, as may be seen in Figures 41 and 42. When the crack (or gap) opened, the factor of safety decreased with no change in water level, as shown by the horizontal line segments in Figures 41 and 42. For the low-stiffness soil, the gap opened fully at a canal water elevation of 6.0 ft, and the factor of safety decreased from 2.5 to 1.8. For the stiff soil, the crack opened fully at a canal water elevation of 8.0 ft, and the factor of safety decreased immediately from 2.1 to below 1.0. If the canal bottom was covered with silt, and the sand layer was therefore not connected to the canal, the opening of the gap would be the means for connecting the sand layer to the canal.

Figure 42. Factor of Safety Versus Canal Water Elevation Calculated Using the Strength Reduction Method for the London Avenue Canal North Breach

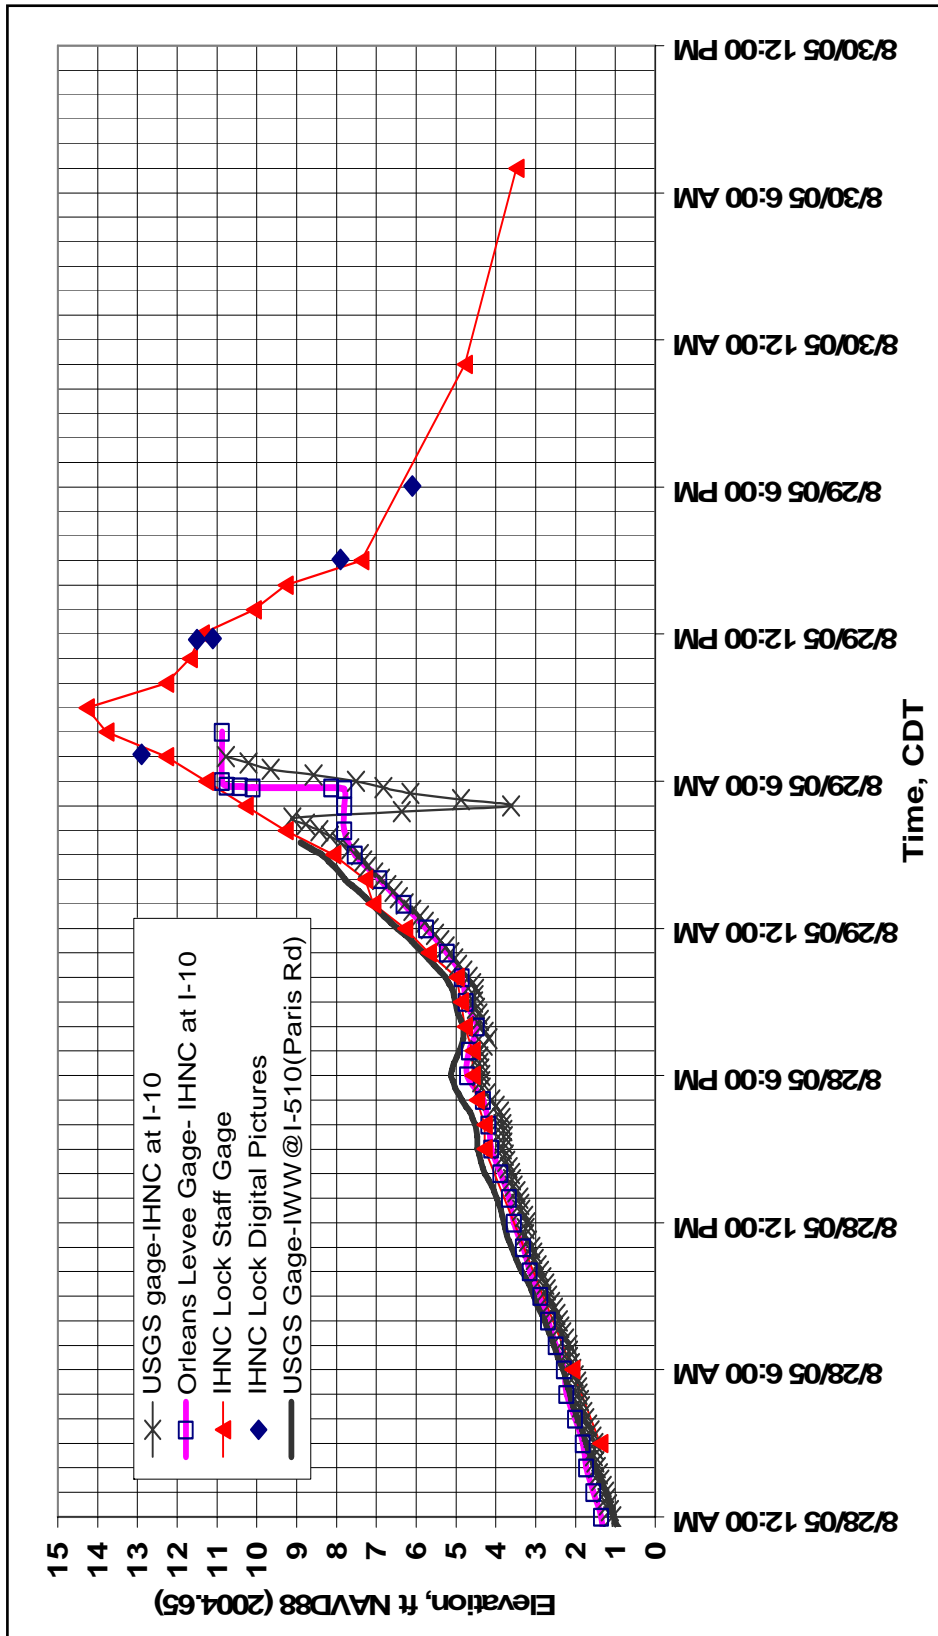
All of the IHNC floodwalls and levees were overtopped on August 29th. The peak storm surge elevation in the IHNC was 14.2 ft at 9:00 AM, as can be seen in Figure 44. This peak water level is about 1.7 ft above the tops of the floodwalls and levees. The reaches where the floodwalls and levees did not collapse have, therefore, survived water loading considerably higher than the design loading.

Figure 44. Katrina Hydrograph for the Inner Harbor Navigation Canal

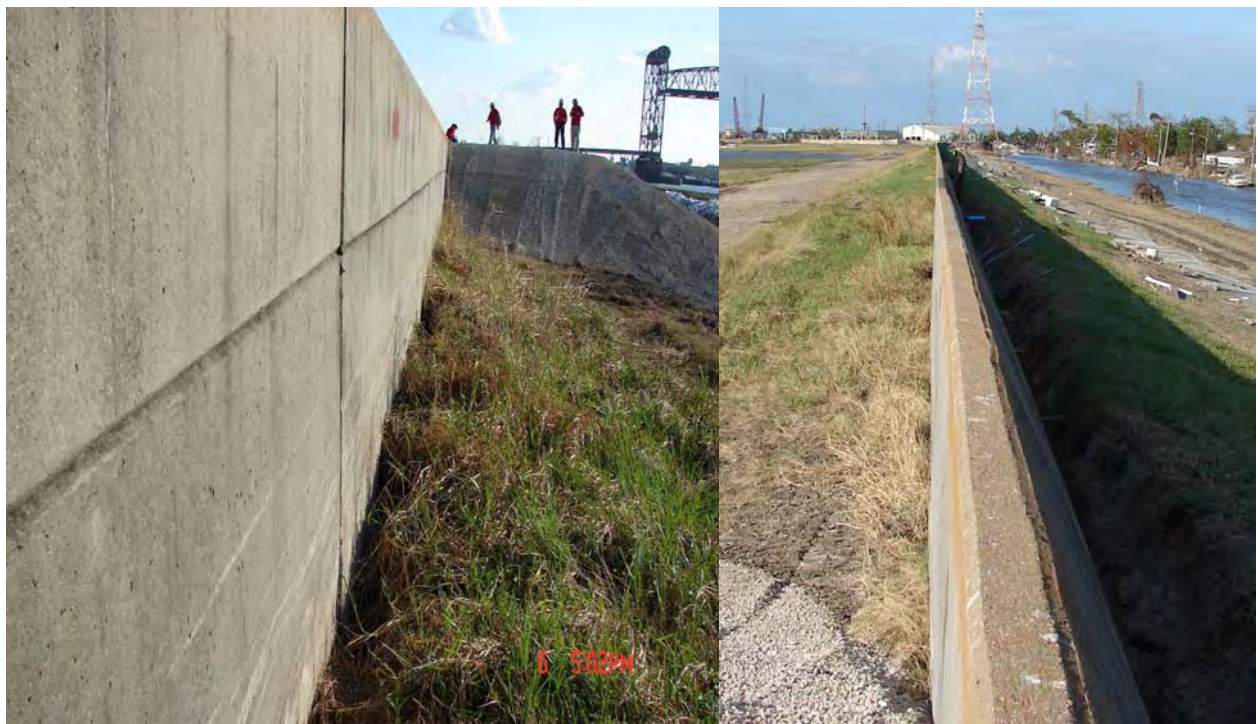
Formation of a gap on the canal side of the wall, allowing hydrostatic water pressure acting through the full depth of the gap, causes a very significant reduction in the value of the calculated factor of safety. Evidence that a gap did form behind the wall near the breaches can be seen in Figures 48 and 49.

Figure 48. IHNC East Bank – South Breach – Wall Movement

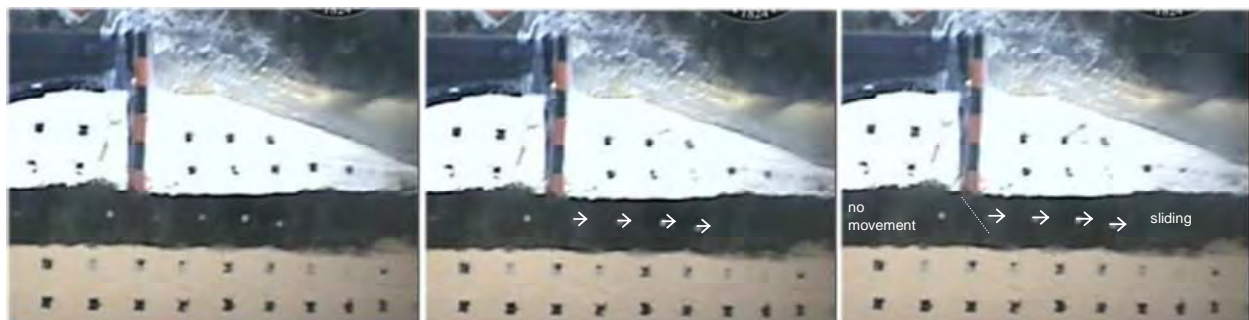
As the water level was raised above the Katrina flood level in the Orleans south model, a gap was seen to open to the toe of the floodwall, associated with small movements of the flood wall landward, as shown in Figure 55. Unlike the other models, this gap did not develop into a full failure condition; and no unstable movement of the floodwall was observed, despite the water level reaching the top of the floodwall. Translational movements were observed to be controlled by compression of the swampy marsh layer. Relative movement between the top of the sand and the swampy marsh was apparent, in a similar manner, to the uplift mechanism in the London Avenue models.

Figure 55. Small Sliding Movement of Marsh as Gap Forms, Orleans South Model

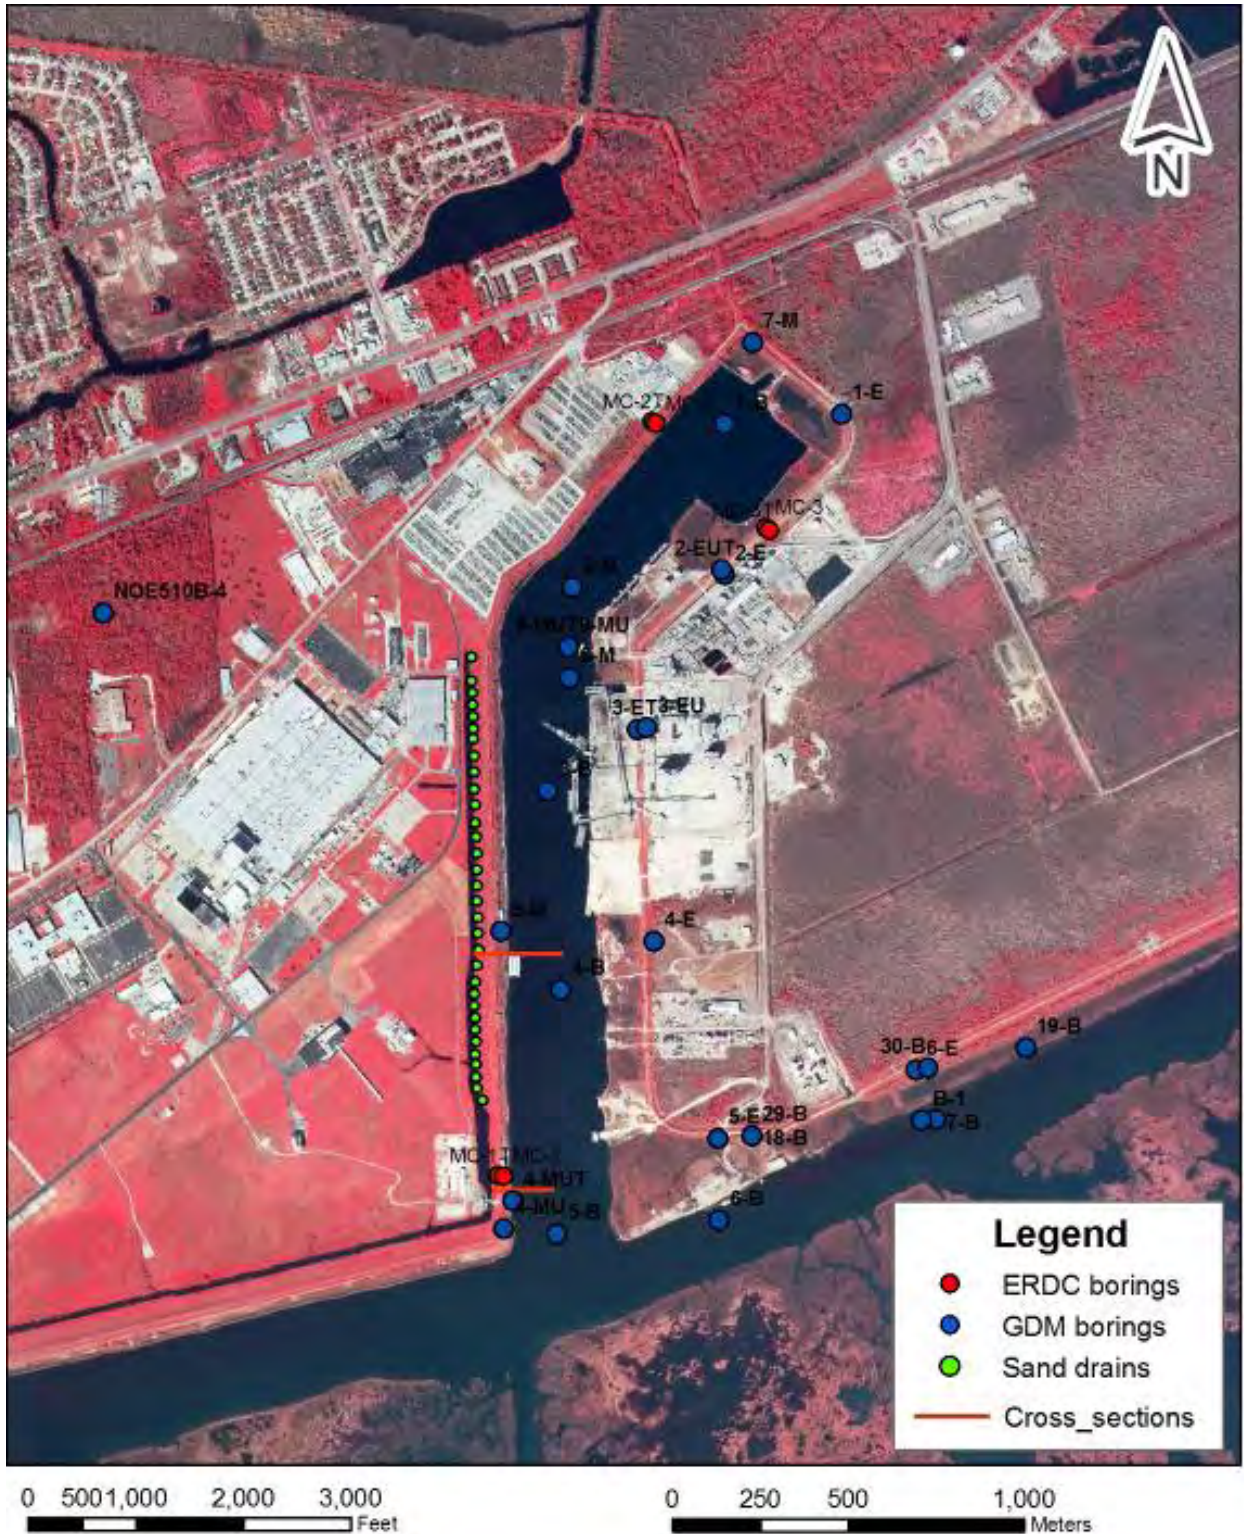
Although no breach occurred in the Michoud Canal I-walls, they are being rehabilitated with additional relief wells and stability berms because of concern for their possibly marginal stability. An evaluation of the performance of these I-walls is in progress. It will be added to Volume V when it has been completed. An aerial view of the Michoud Canal is shown in Figure 57.

Figure 57. Aerial Photograph of Michoud Canal

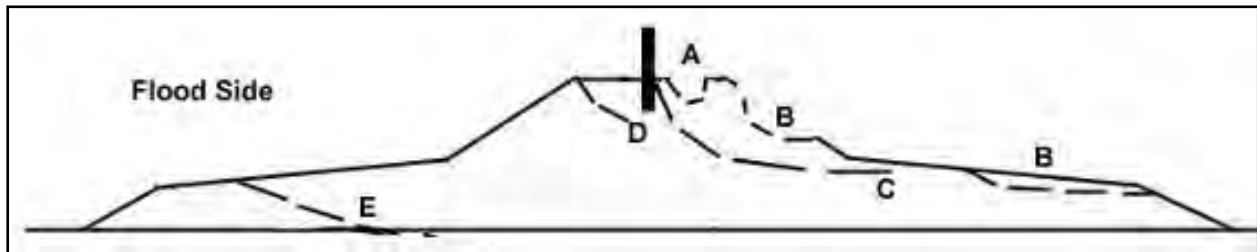
Figure 60. Erosion Progression Patterns for Earthen Levees, Floodwalls, and Exposed Sheet Pile

Scour pattern “A” indicates scour located on the protected side levee slope (or located immediately adjacent to the floodwall or sheet pile protected side); “B” indicates erosion on the protected slopes, including stabilizing transition slopes; “C” indicates erosion progressing to the levee crown adjacent to the floodwall or sheet pile protected side; “D” indicates scour on both the flood side and the protected side of the levee or floodwall; and “E” indicates that the original levee footprint has been significantly altered due to erosion, and the original foundation base may have scour holes or washouts.

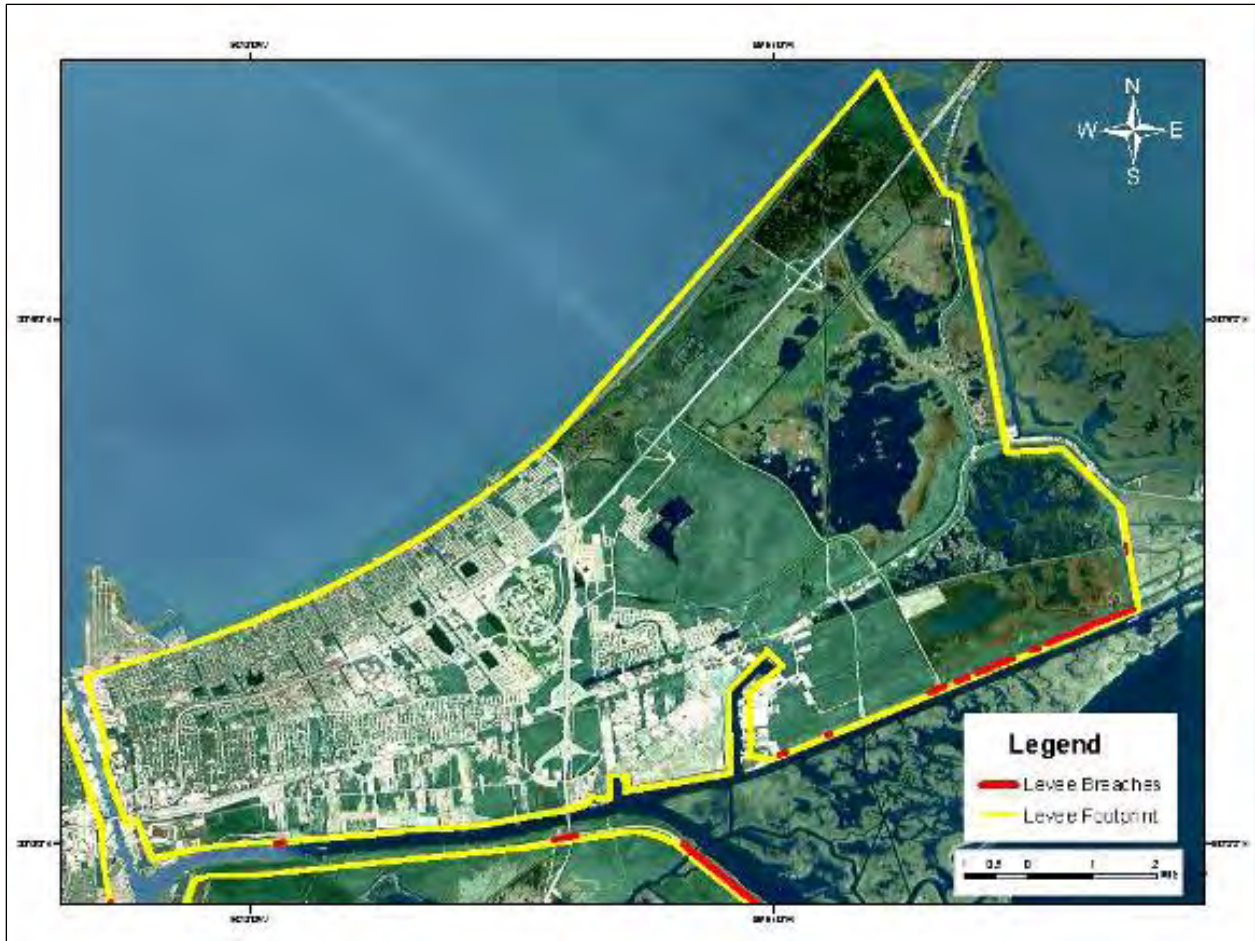
An example of the erosion of a hydraulically filled levee is the New Orleans East back levee, shown in Figure 63. Figure 64 shows the location of the breaches along the levee caused by erosion, and Figure 65 shows the section of the levee that was hydraulically filled. It can be noted that the breaches are located in the section that was constructed of hydraulic fill. However, this is not a perfect correlation and other factors need to be considered. Figure 66 shows locations where the surge and wave hydrographs have been determined from calculations and high water marks. Figure 67 shows a plot of pre-Katrina levee elevations and the surge height plus the peak wave height at these locations. It can be seen that the greatest erosion of the hydraulically filled levees occurs when the surge height plus the peak wave height had the greatest level above the crest of the levee. Examination of this information has shown that the

Figure 64. NOE Basin Post-Katrina Breaches
