# Volume V - The Performance:

## Analysis of the London Avenue Canal I-wall Breaches

### **Analysis of the London Avenue Canal I-wall Breaches**

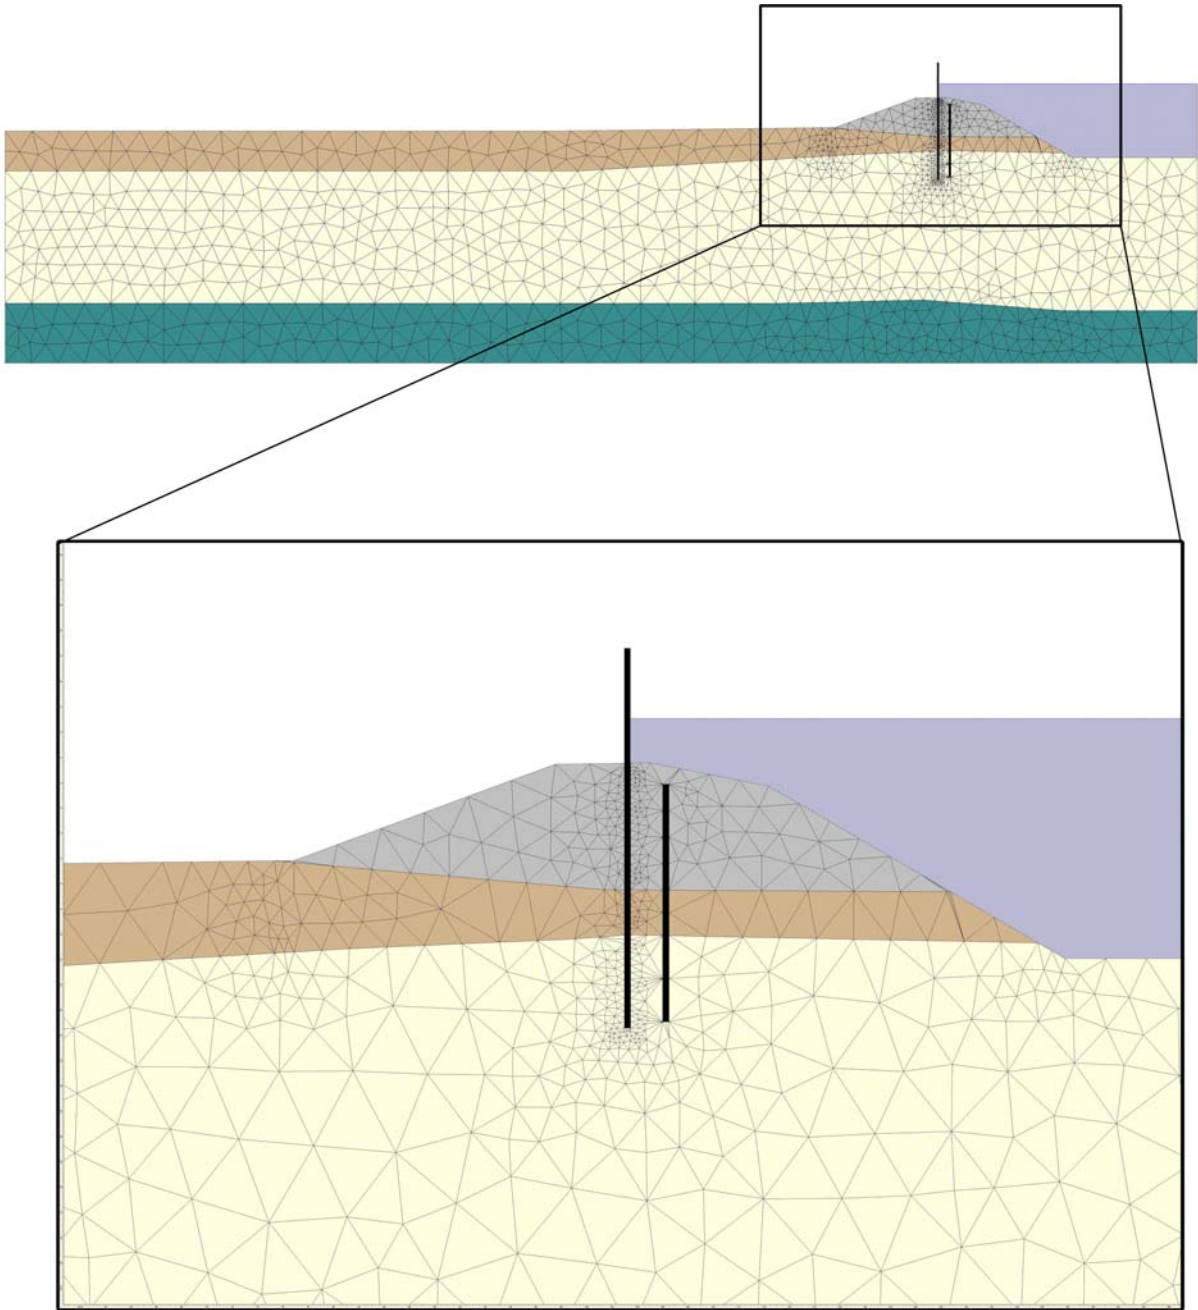
Figure 6 - Finite element mesh used for seepage analysis for London Avenue south breach.

Six-node triangular elements were used for the seepage analyses. The finite element mesh is shown in Figure 6. Computed total head contours for Case 1 are shown in Figure 7. It can be seen that the flow through the sand is predominantly horizontal, and that the total head on the landward side of the levee is above the ground surface, which is at elevation  $-5.1$  ft. The head contours for the other three cases shown in Table 1 had similar shapes, although the values varied somewhat depending on the canal water level and the Warrington Drive water level.

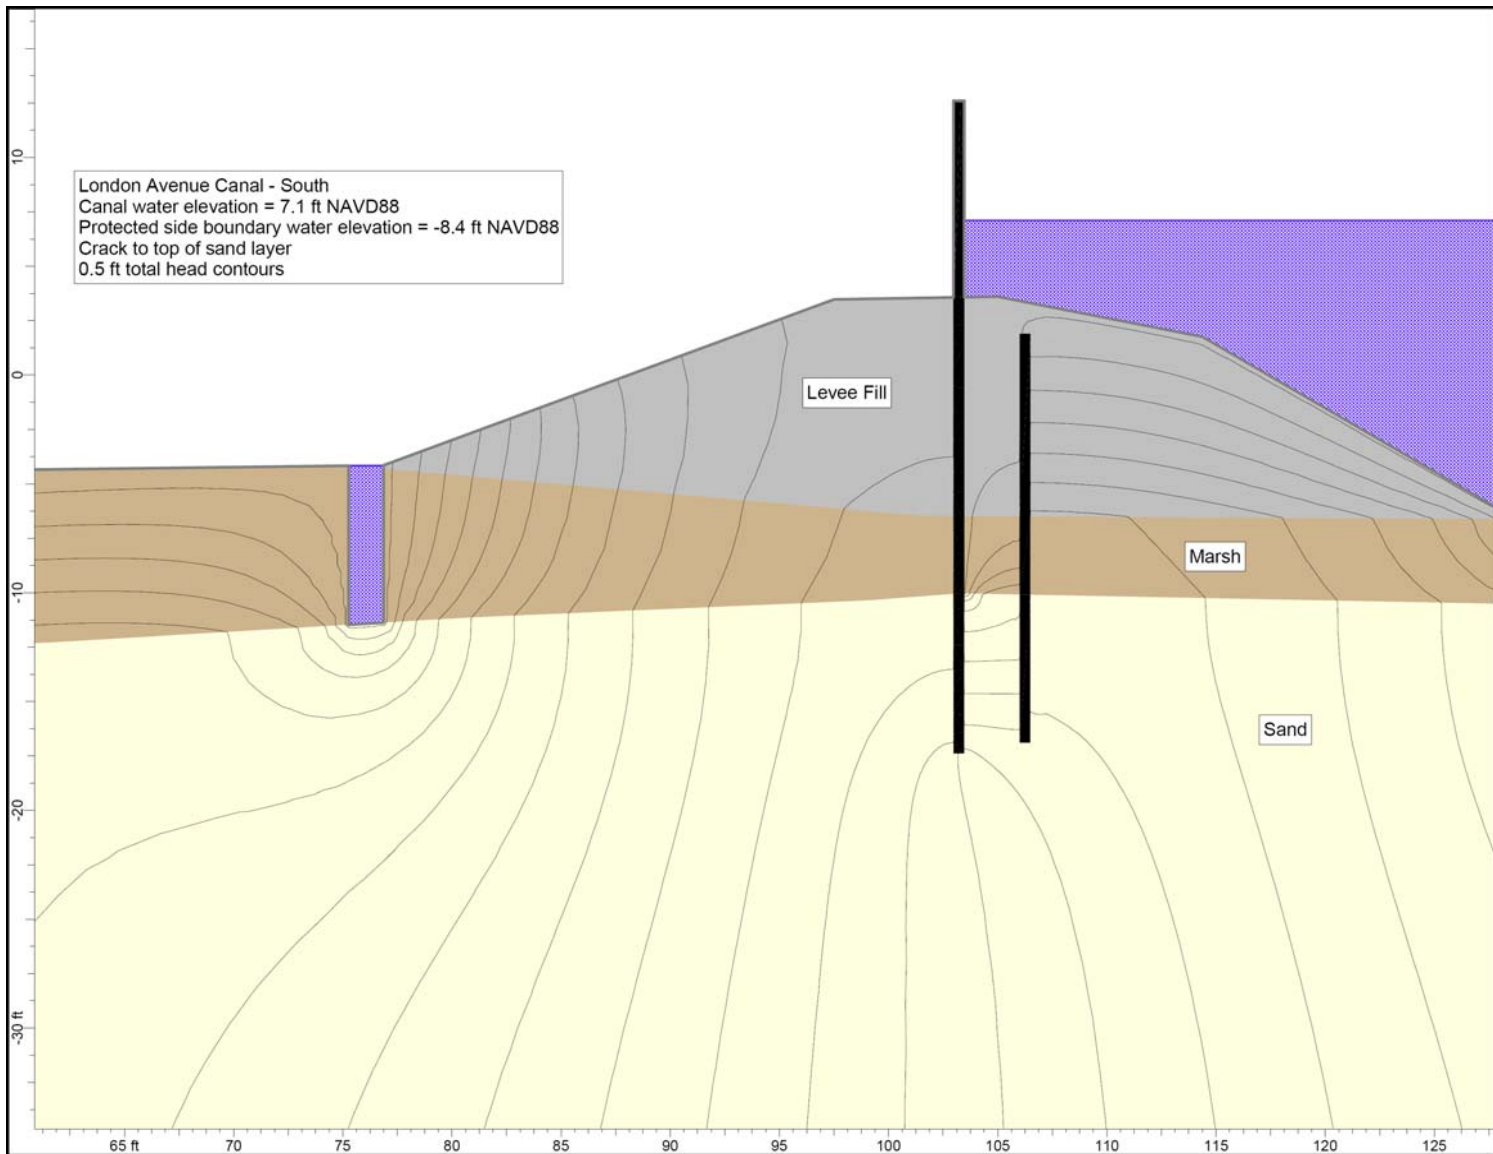
Figure 10 - Total head contours in vicinity of rupture for London south breach.

The narrower the assumed rupture zone, the higher the computed hydraulic gradient at the top of the sand below the rupture, because flow converges toward the rupture, and the flow velocities increase near the rupture. This converging flow is shown by the total head contours in the sand near the rupture in Figure 10. A rupture zone width equal to 1.6 ft was used in the analyses, based on a judgment of what seemed a reasonable and possible rupture zone size. Doubling the width of the rupture zone was found to reduce the computed hydraulic gradient by 23%, and cutting the width in half increased the hydraulic gradient by 33%. In the real case, flow would converge in three dimensions rather than two dimensions, as represented in these two-dimensional seepage analyses. It therefore seems likely that the actual hydraulic gradients would be higher than the values discussed in the following sections, but the magnitude of this three-dimensional effect cannot be quantified.

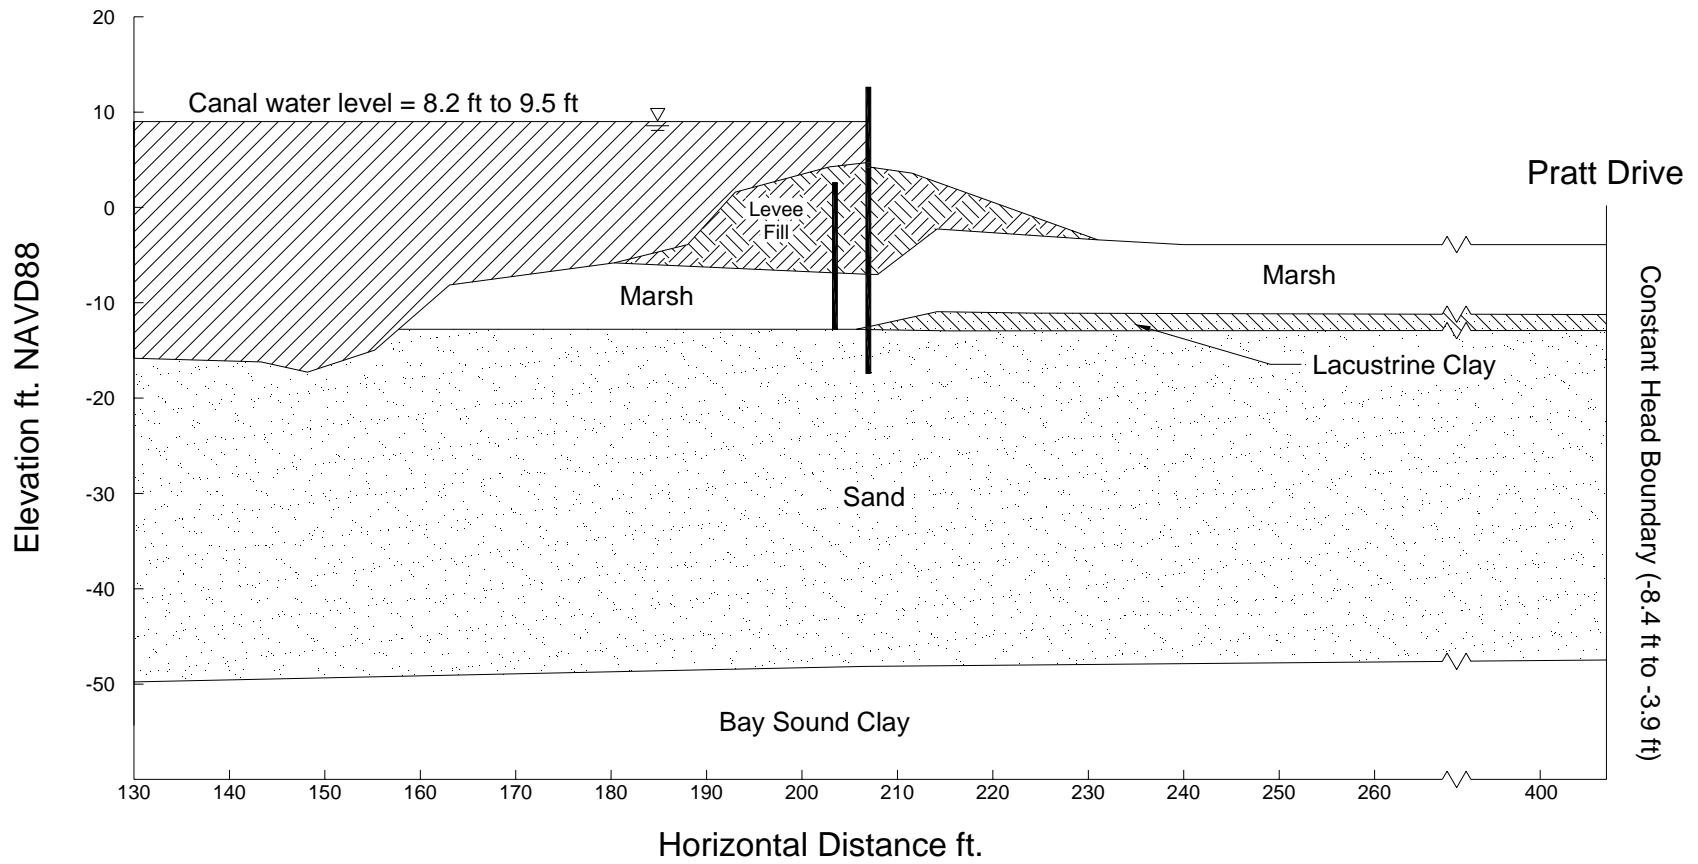
Figure 16 - Schematic cross section at London north breach, with seepage boundary conditions.

1. The seepage boundary conditions were different. The canal water level at the time of the north breach was 8.2 ft to 9.5 ft, higher than at the south breach because the north breach occurred later. The inland seepage boundary condition ranged from -8.4 ft to -3.9 ft because Pratt Drive is at a slightly higher elevation than Warrington Drive. Four cases were analyzed, using the seepage boundary conditions shown in Figure 16, and summarized Table 6. An additional analysis was performed to determine the canal water level required for a calculated factor of safety equal to 1.00.

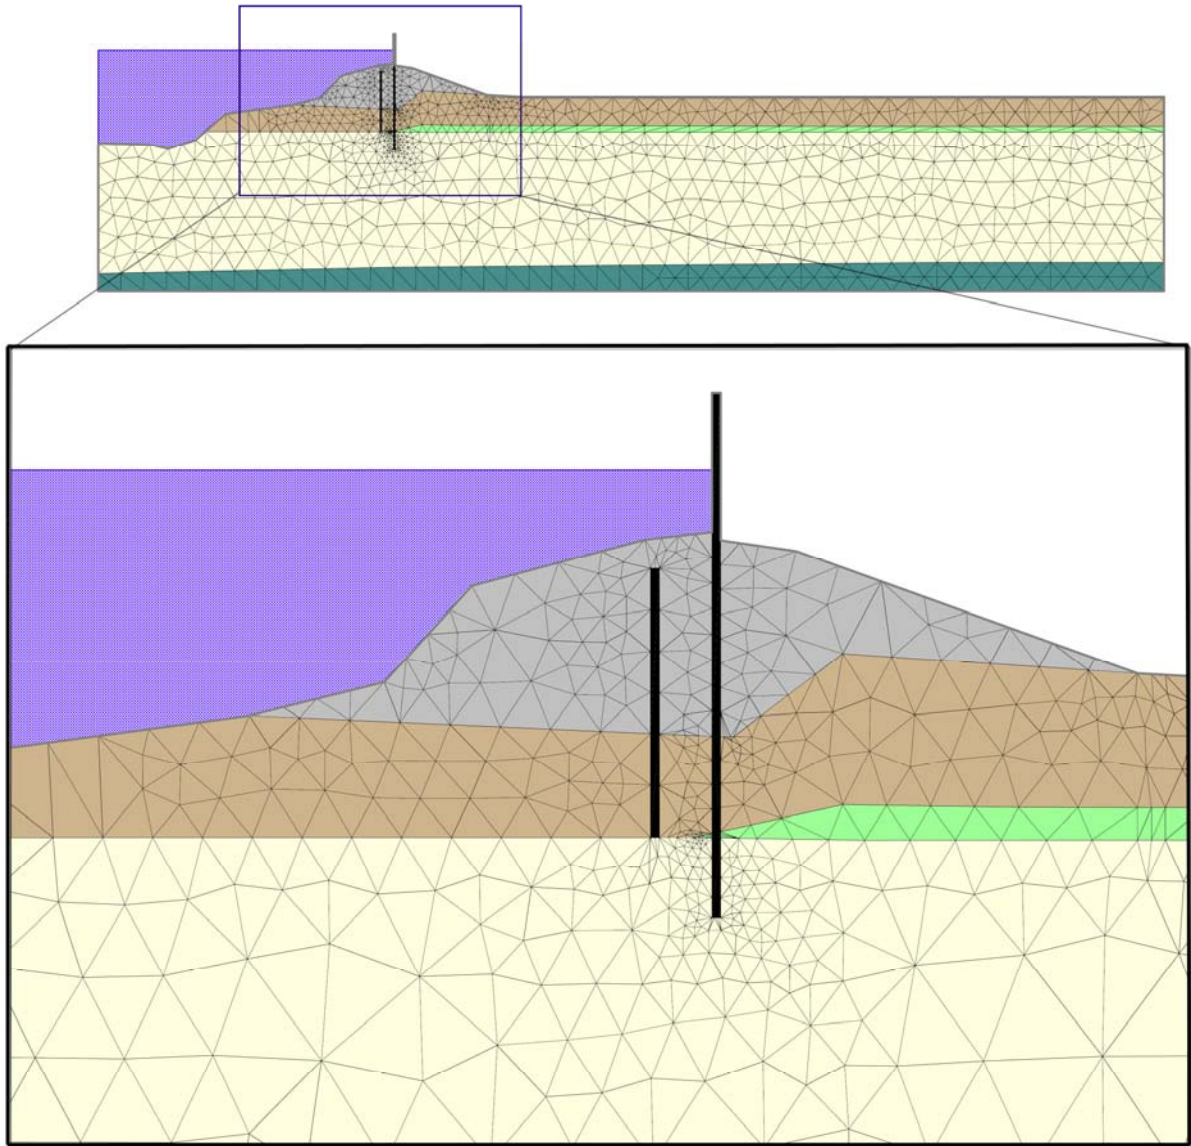
Figure 17 - Finite element mesh used for seepage analysis for London Avenue north breach.

Six-node triangular elements were used for the seepage analyses, as for the south breach. The finite element mesh for the north breach is shown in Figure 17. The same values of permeability were used as for the south breach. The lacustrine clay between the sand and the marsh layer was assumed to have a permeability of  $1 \times 10^{-6}$  cm/sec.

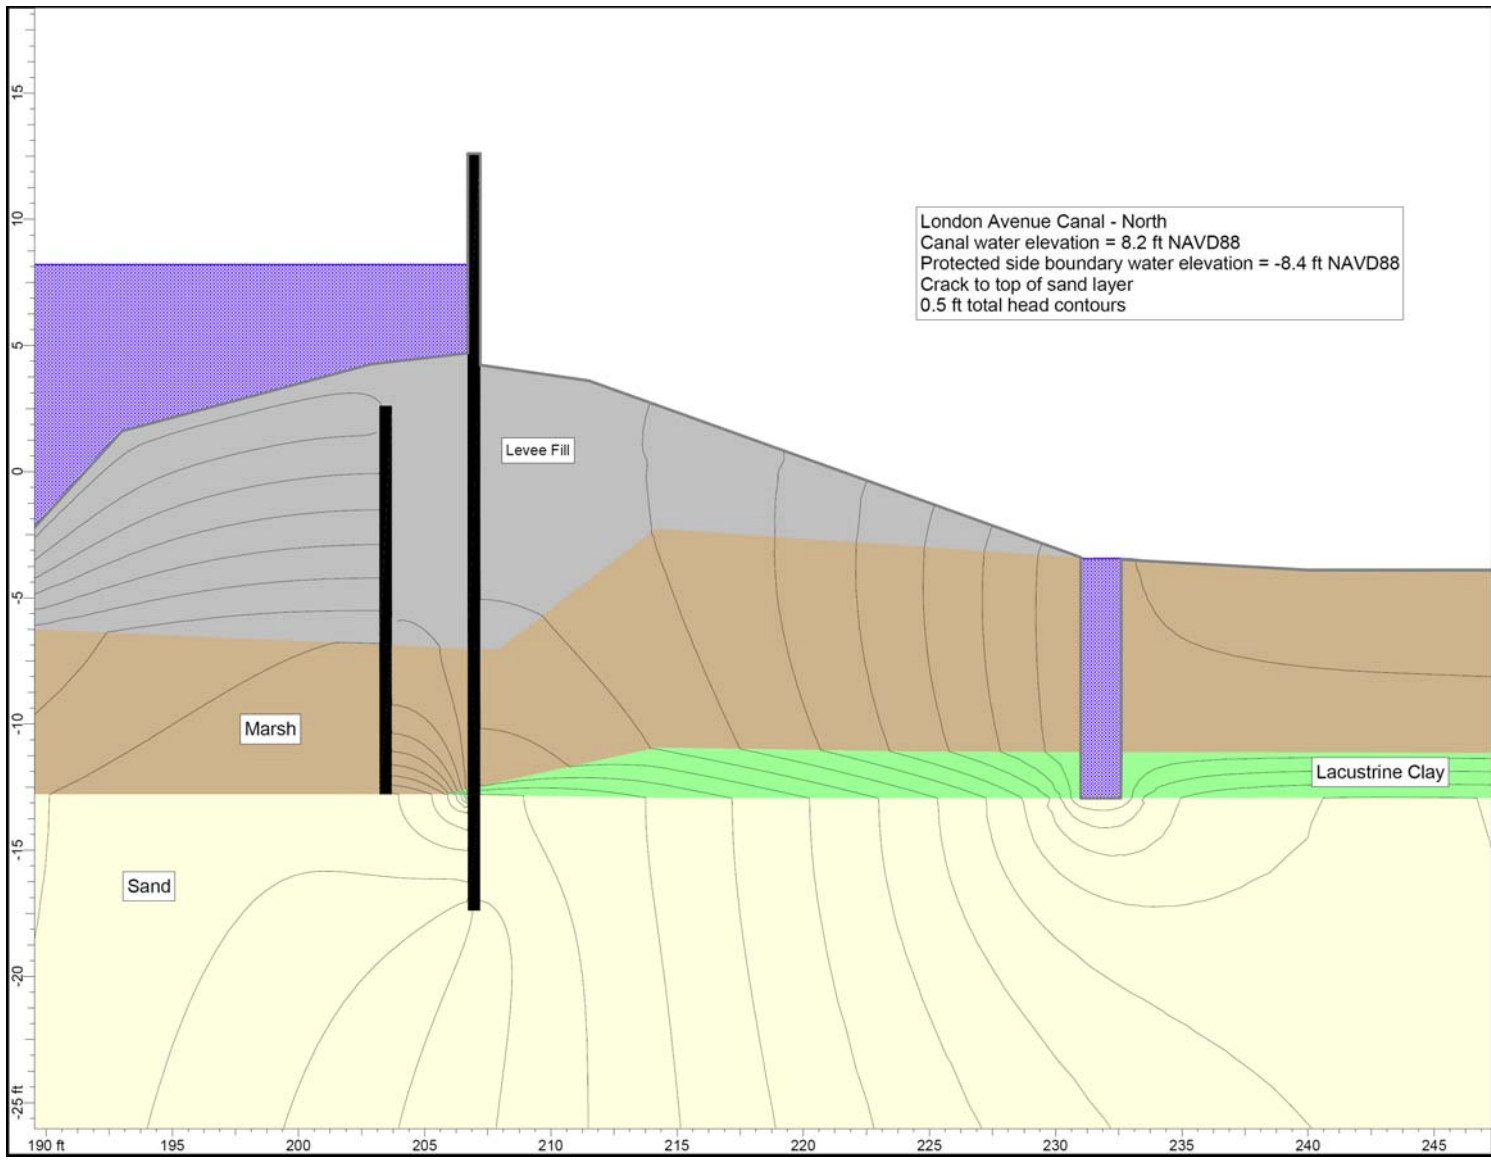
Figure 21 - Total head contours in vicinity of rupture for London north breach.

Additional seepage analyses were performed with revised boundary conditions, as was done in the south breach analyses, using the conditions shown in Figure 20. A rupture 1.6 ft wide, extending through the marsh layer and the lacustrine clay layer was assumed, and a hydraulic boundary condition with the water level at the ground surface was applied in the area of the rupture. Total head contours for the area around the assumed rupture through the lacustrine clay and peat are shown in Figure 21. The hydraulic gradients calculated for these conditions are shown in Table 7.
