LAKE PONTCHARTRAIN, LOUISIANA AND VICINITY

BAYOU BIENVENUE  
CONTROL STRUCTURE

PERIODIC INSPECTION REPORT NO. 2

27 JULY 1979

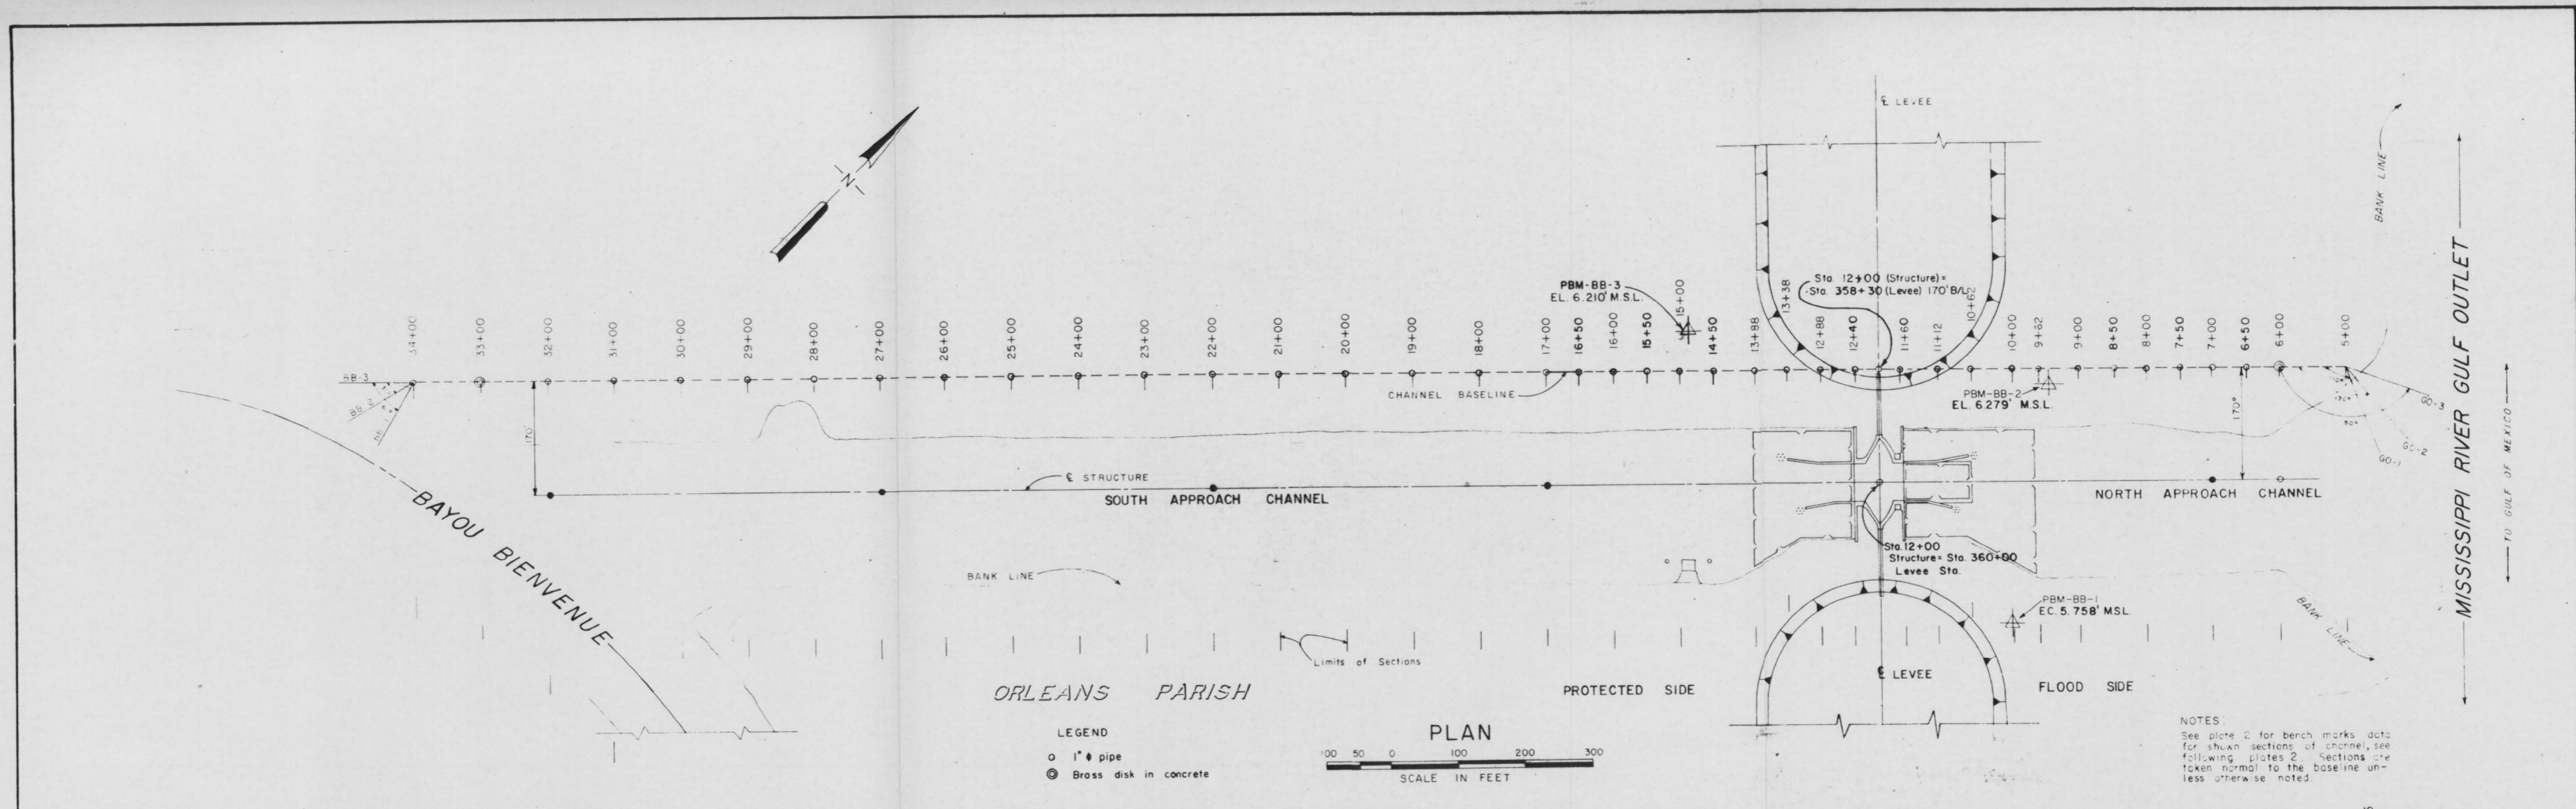
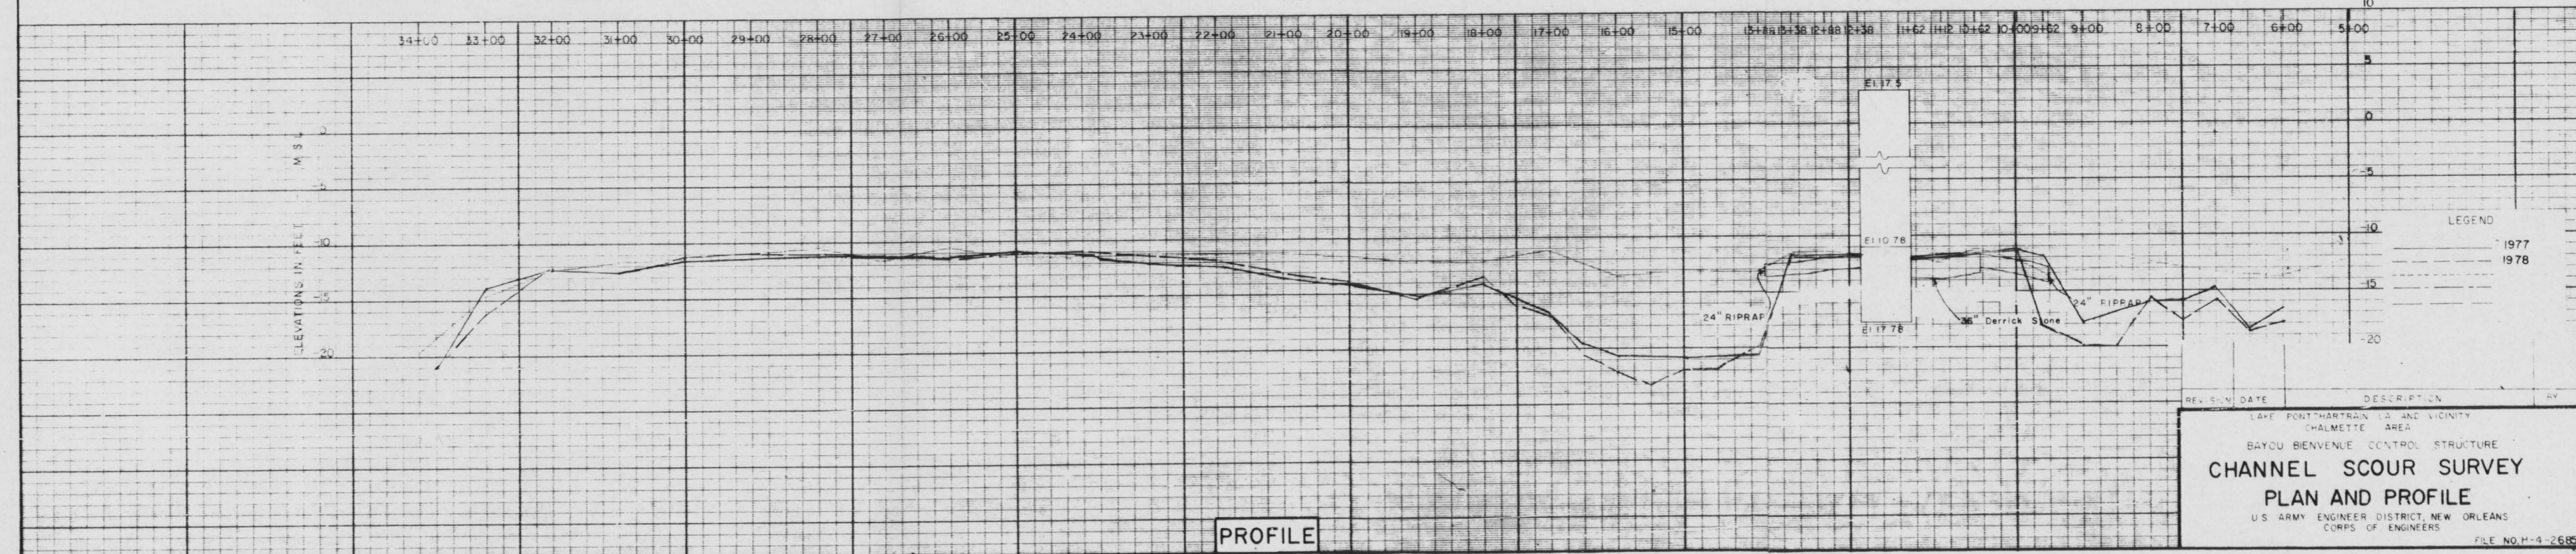
LAKE PONTCHARTRAIN LA AND VICINITY  
 CHALMETTE AREA  
 BAYOU BIENVENUE CONTROL STRUCTURE  
**CHANNEL SCOUR SURVEY**  
**PLAN AND PROFILE**  
 U.S. ARMY ENGINEER DISTRICT, NEW ORLEANS  
 CORPS OF ENGINEERS  
 FILE NO. M-4 2685

b. Para 6-02c, page VI-1. The scour surveys shown on plan and  
profile sheets on Plates 5 and 6 and also on the cross-sections on  
Plates 7 through 15 indicate considerable scouring is occurring from  
year to year in the vicinity of the structure. Although this scour is  
not presently endangering the integrity of the structure, repair work  
should be scheduled and performed within the next calendar year. This  
repair work should consist of a layer of riprap of sufficient size and  
gradation to preclude a similar scour problem in this area in the future.

b. Scour Survey. The 1978 survey shows scour on north and south approach channels. These scour holes lie on the centerline of the structure adjacent to the end of the riprap placement. On the north approach channel, the scour hole extends from station 9+62 to station 8+00. On the south approach channel it extends from station 13+88 to station 17+00. The holes are 10 feet and 20 feet deep respectively, compared to theoretical section line. To a lesser extent, the banks were eroding, but appear to have stabilized.
