LAKE PONTCHARTRAIN, LOUISIANA AND VICINITY
CHALMETTE AREA PLAN

**BAYOU BIENVENUE CONTROL STRUCTURE
PERIODIC INSPECTION REPORT NO. 8**

24 MARCH 1999

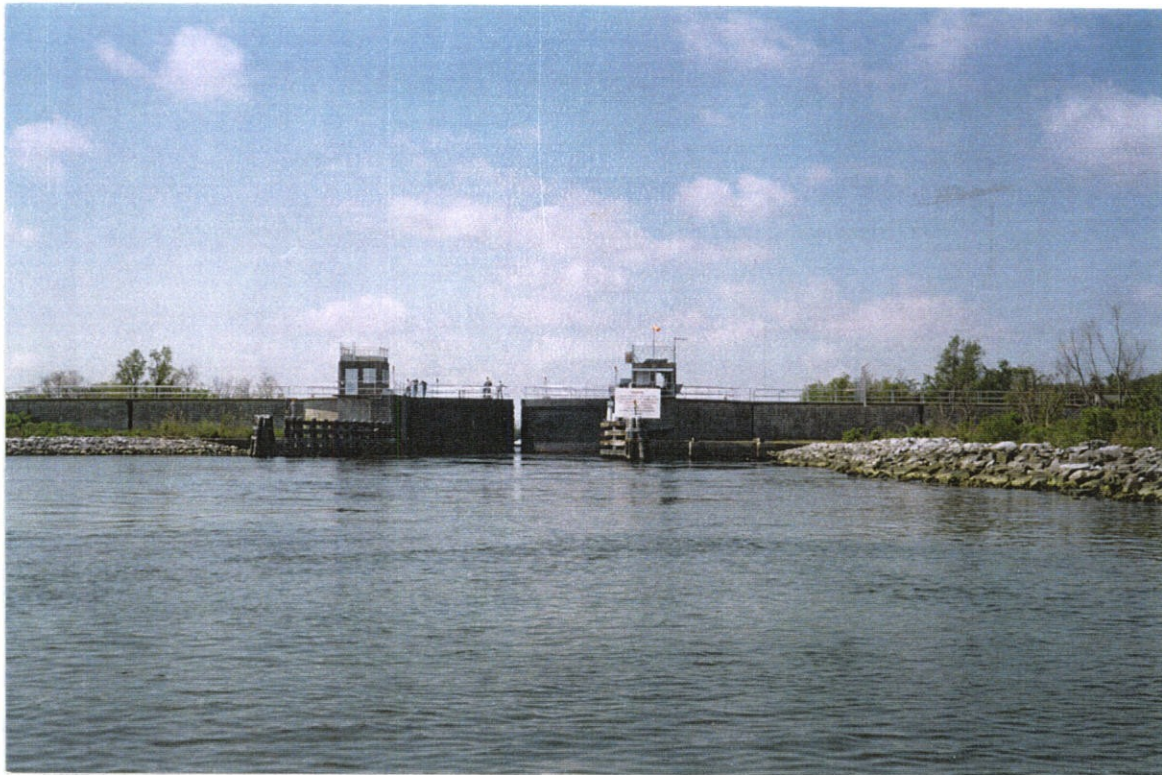
(1) The channel slopes and riprap slope protection appear to be in good condition in the vicinity of the structure. See Photo No. 1.

PHOTO NO. 1 – LOOKING WEST AT FLOODSIDE OF THE CONTROL STRUCTURE.

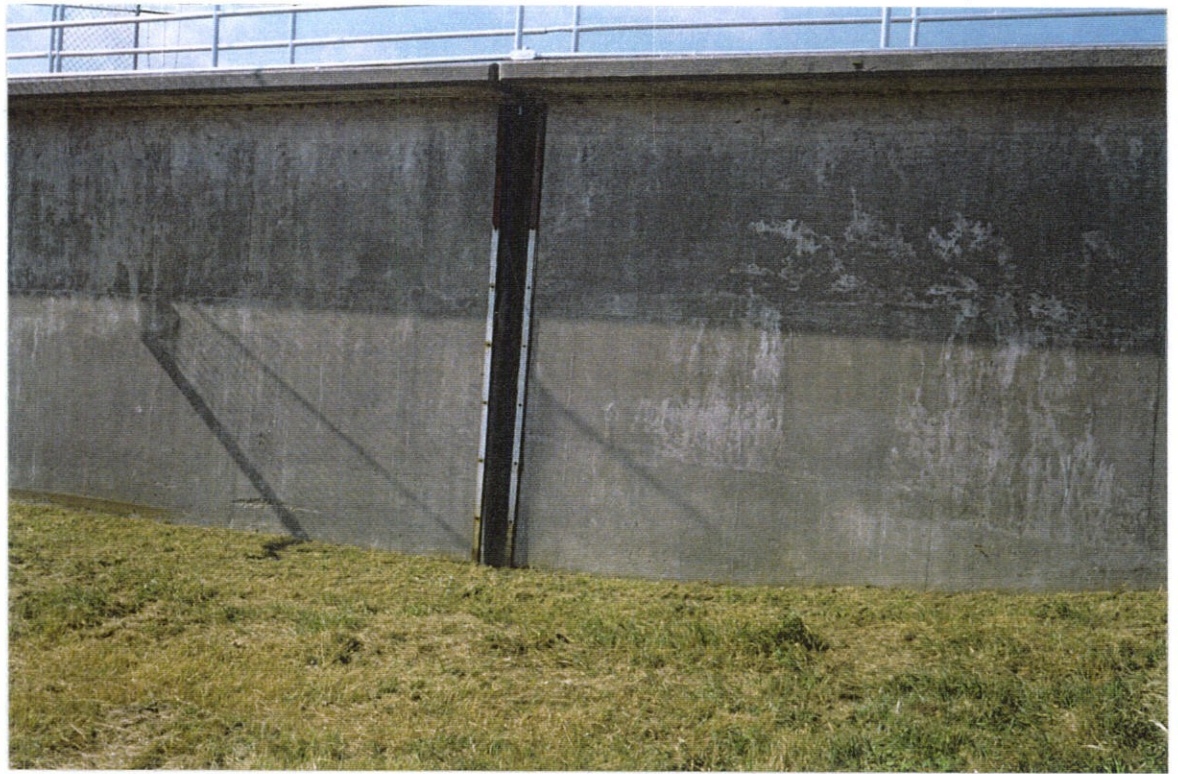
PHOTO NO. 3 - NEOPRENE SHEET OVER FLOODSIDE OF JOINT BETWEEN WEST "T" WALL MONOLITHS.

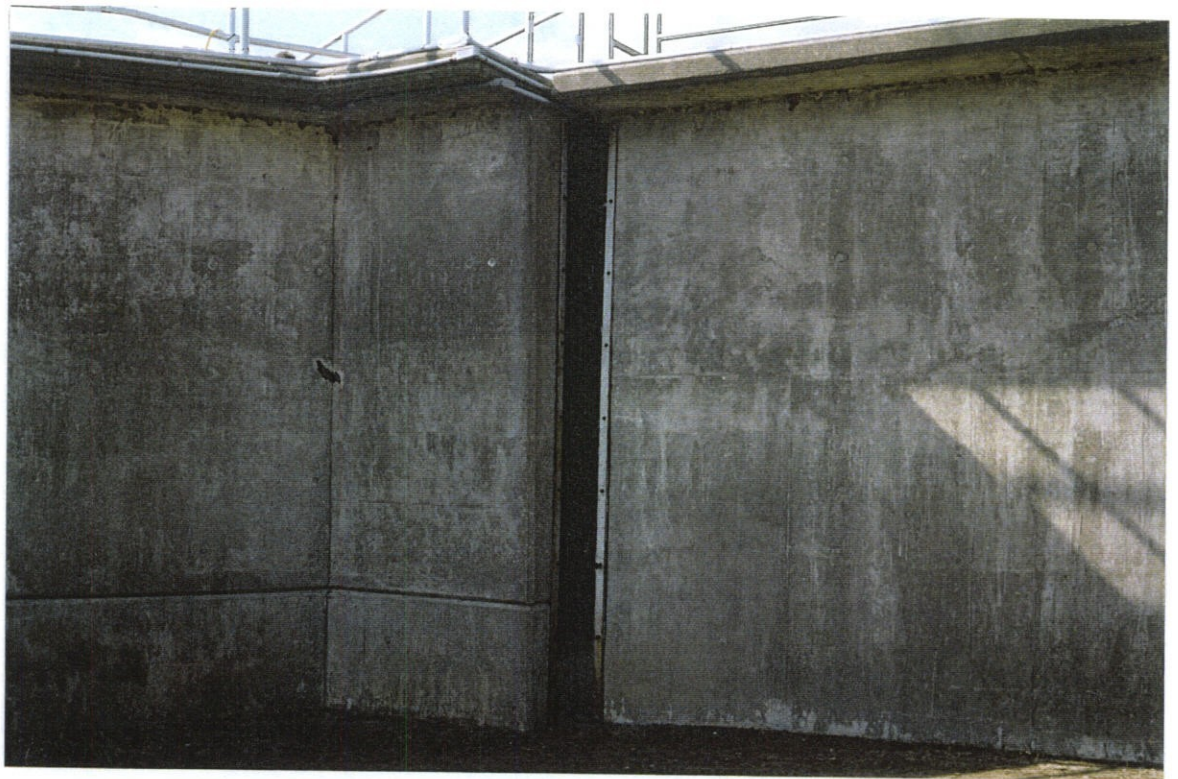
PHOTO NO. 4 - NEOPRENE SHEET OVER FLOODSIDE OF JOINT BETWEEN WEST "T" WALL MONOLITH AND GATE BAY MONOLITH.

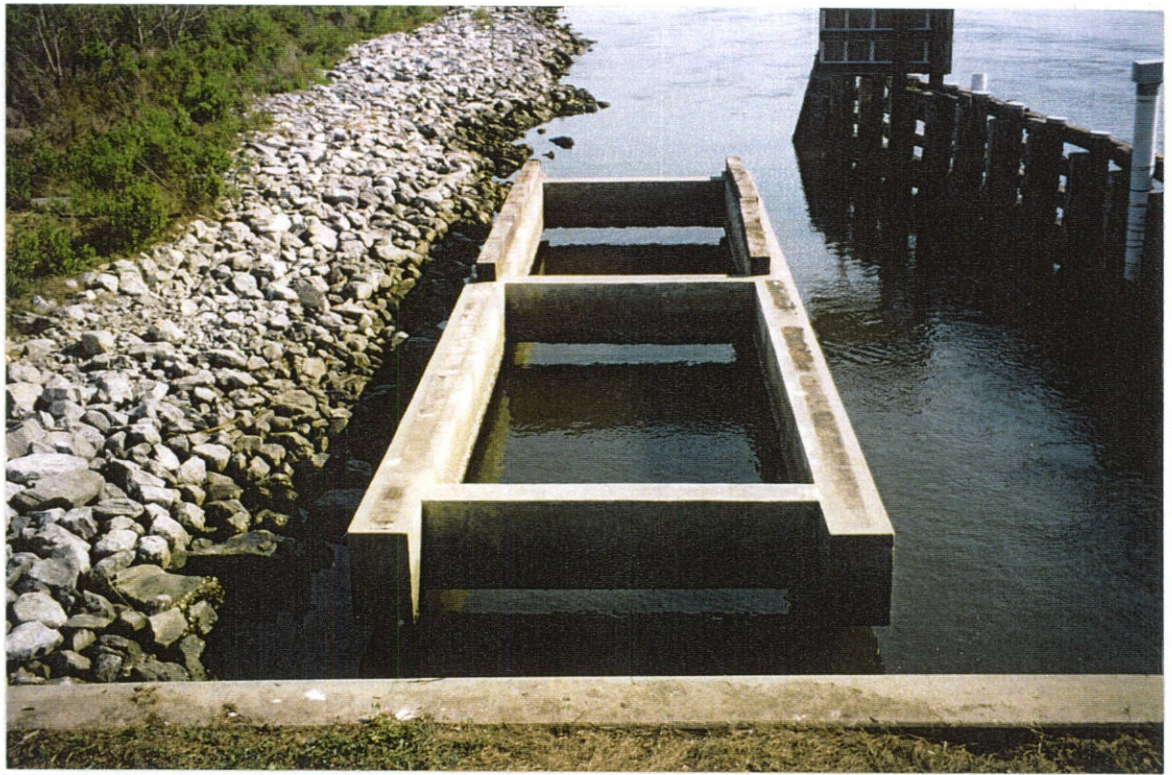
(8) The storage rack for the dewatering elements was in good condition. See Photo No. 7.

PHOTO NO. 7 – STORAGE RACK FOR DEWATERING ELEMENTS.

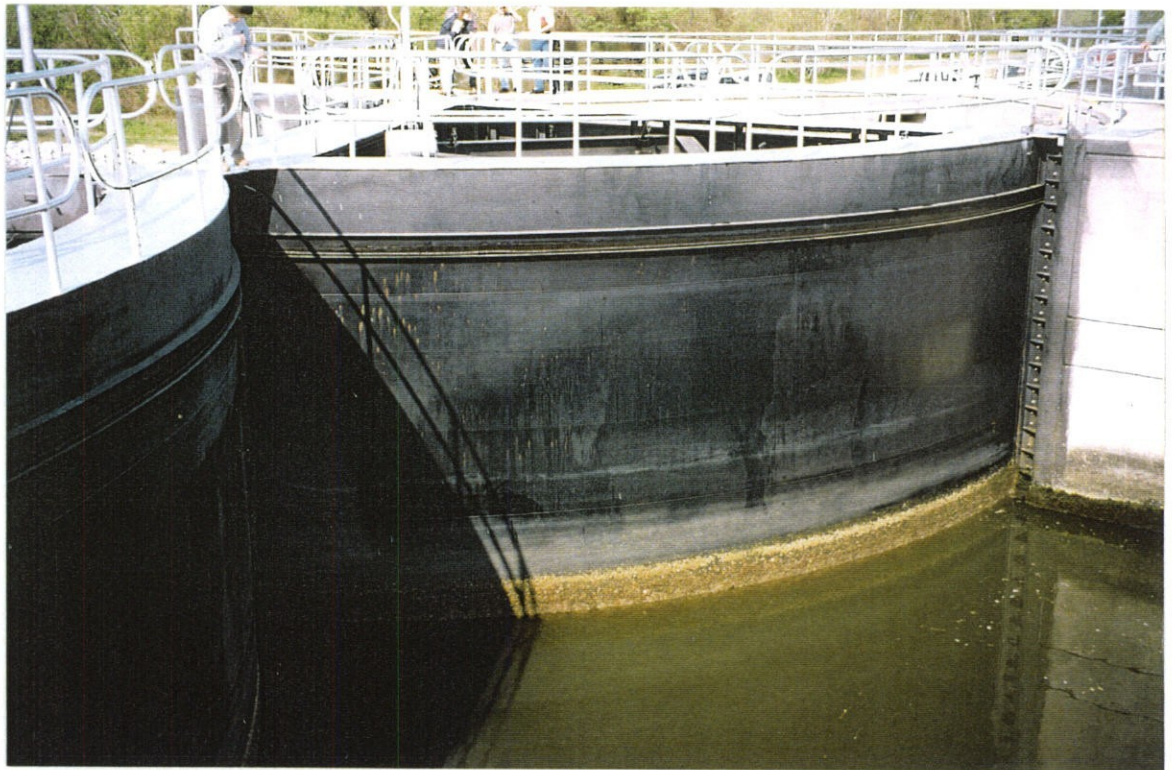
PHOTO NO. 8 – SECTOR GATE SKIN PLATE. NOTE BARNACLES AT SPLASH ZONE.

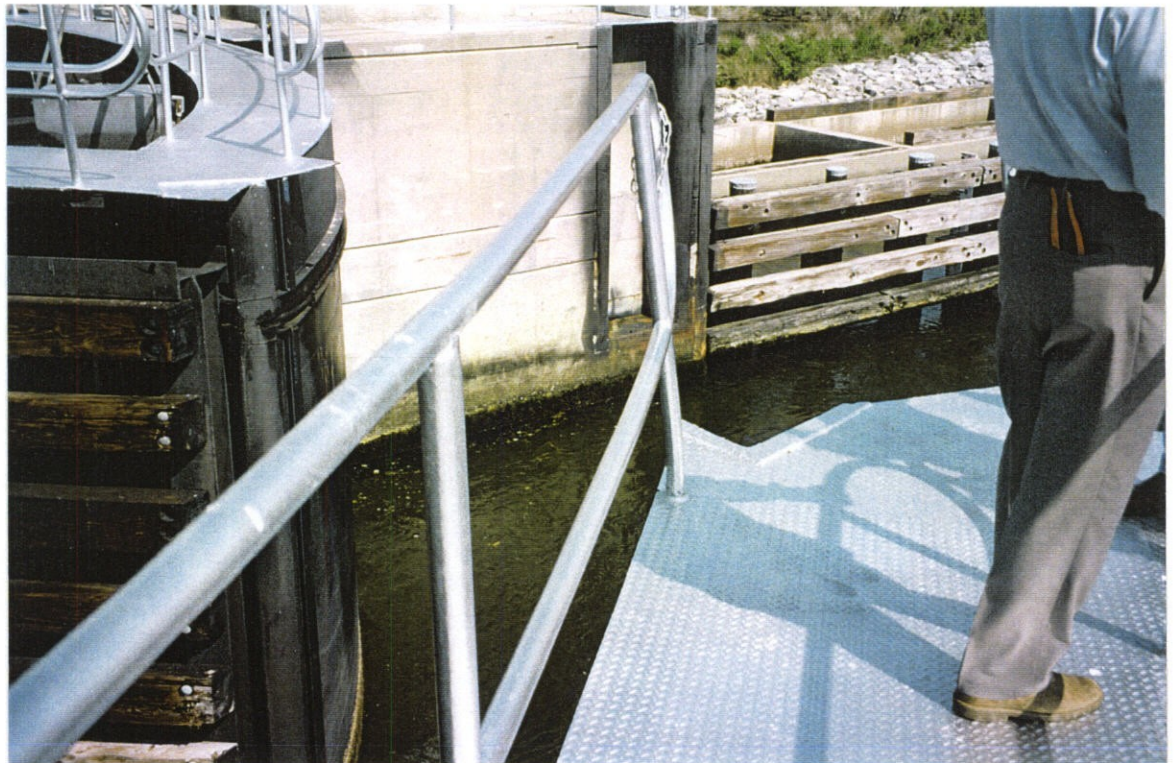
(2) Embedded metals at the needle girder recesses and the corner protection have corroded at the splash zone, but are in relatively good condition. See Photo No. 12.

PHOTO NO. 12 – SLIGHTLY BENT HANDRAIL POST ON MITER END OF EAST GATE SECTOR.

c. Embedded Metals. Corroded areas on embedded metals that are above normal water levels will be cleaned and painted by March 2000.

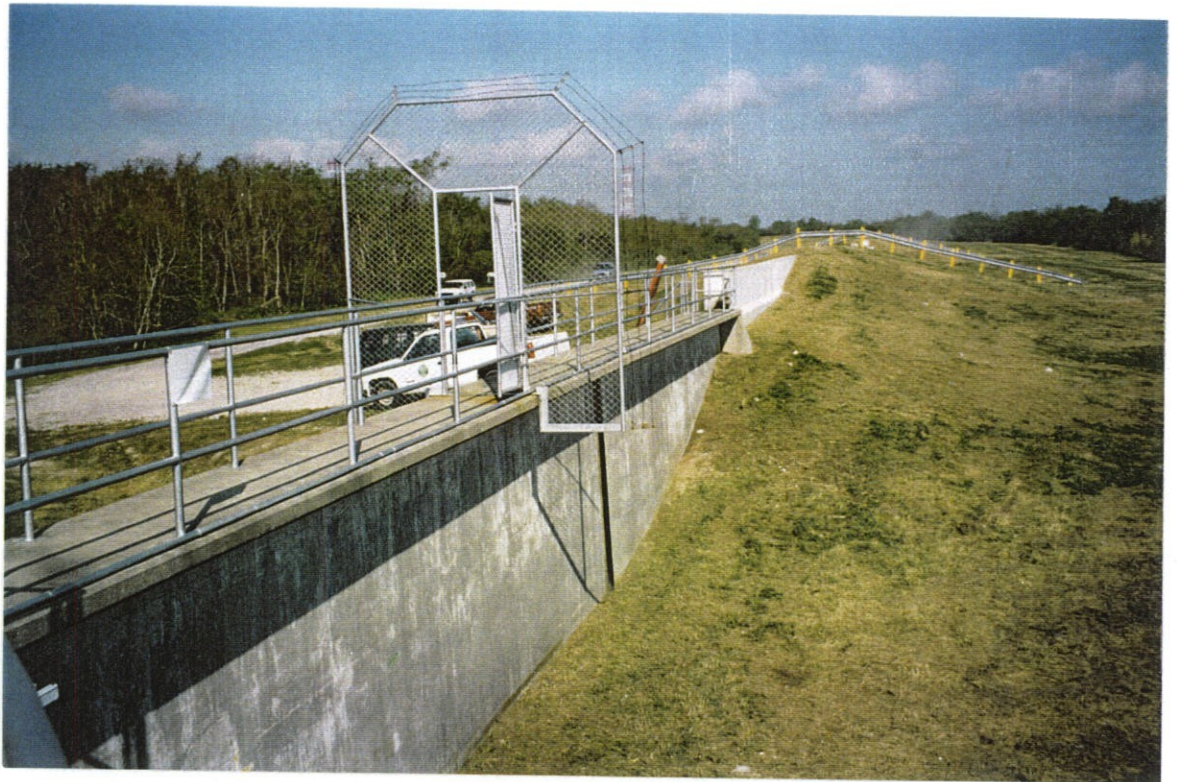
(1) Guardrails and access gates were in good condition, and had been recently painted. See Photo No. 13.

PHOTO NO. 13 – WEST "T" WALLS AND CONCRETE FLOODWALLS WITH SECURITY ACCESS GATE.

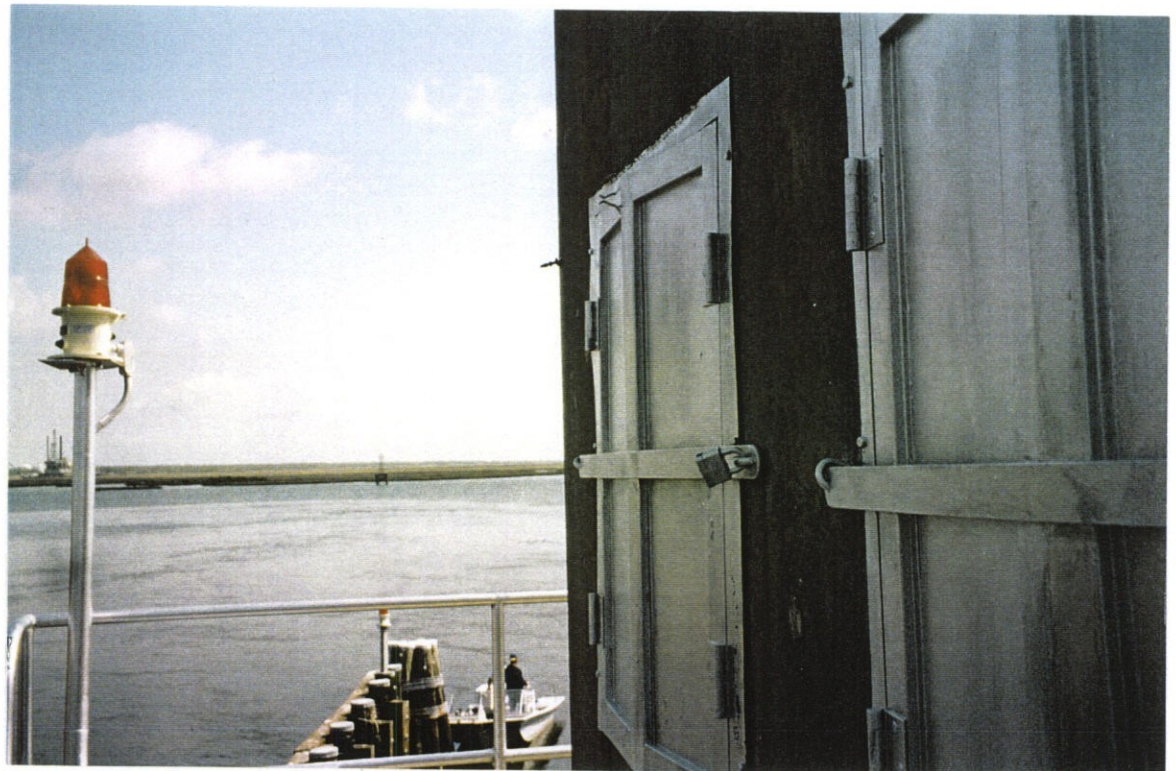
(3) The Orleans Levee District has installed protective steel shutters over the control house doors and windows. See Photo No. 14. There is some appreciable corrosion of the shutter frames but no corrective action is required at the present time.

PHOTO NO. 14 – STEEL SECURITY SHUTTERS ON CONTROL HOUSE WINDOWS.

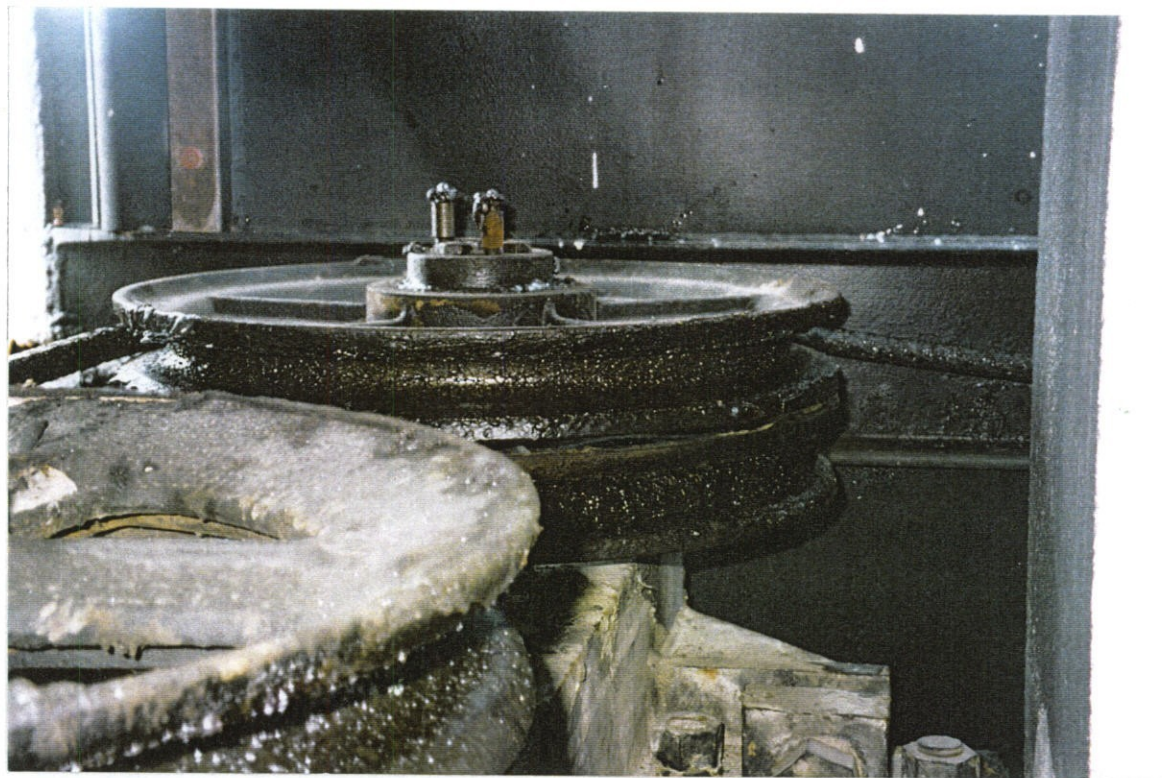
(1) The gate operating machinery functioned well during operation of the gate through several cycles. However, the wire ropes used to activate the gate sectors were too slack and had "jumped out" of the sheaves on both gate sectors. See Photo No. 15. The wire ropes should be adjusted (tightened) such that they do not "jump out" of the sheaves when operating the gate sectors.

PHOTO NO. 15 – WIRE ROPE SHEAVES. NOTE SLACK CABLE.

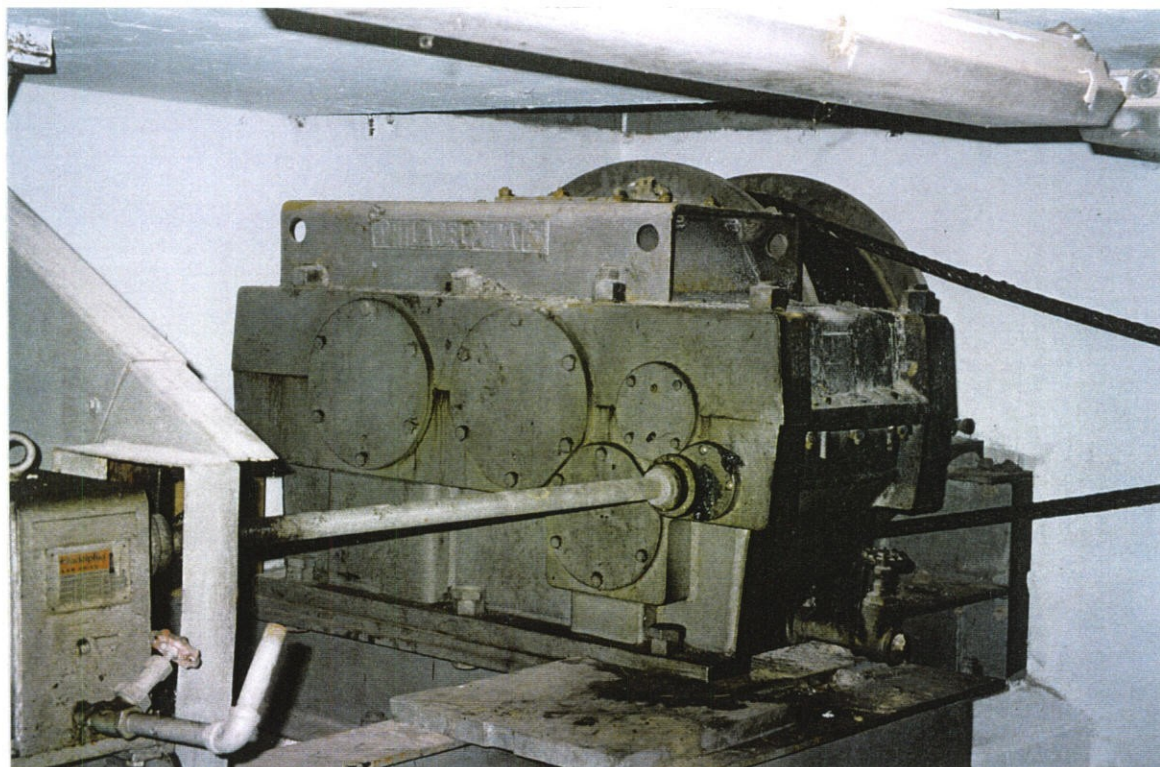
(2) The equipment recesses were clean and neat and had been recently painted. See Photo No. 16. However, the equipment was covered with dirt and grease and a light coat of sand or grit that appeared to have come from a sand blasting operation. See Photo No. 16. The equipment and sheaves should be cleaned to remove the dirt and sand before it gets into some of the gears, bearings or other moving parts and causes accelerated wear.

PHOTO NO. 16 – DOUBLE DRUM HOIST USED TO OPEN AND CLOSE GATE SECTOR.

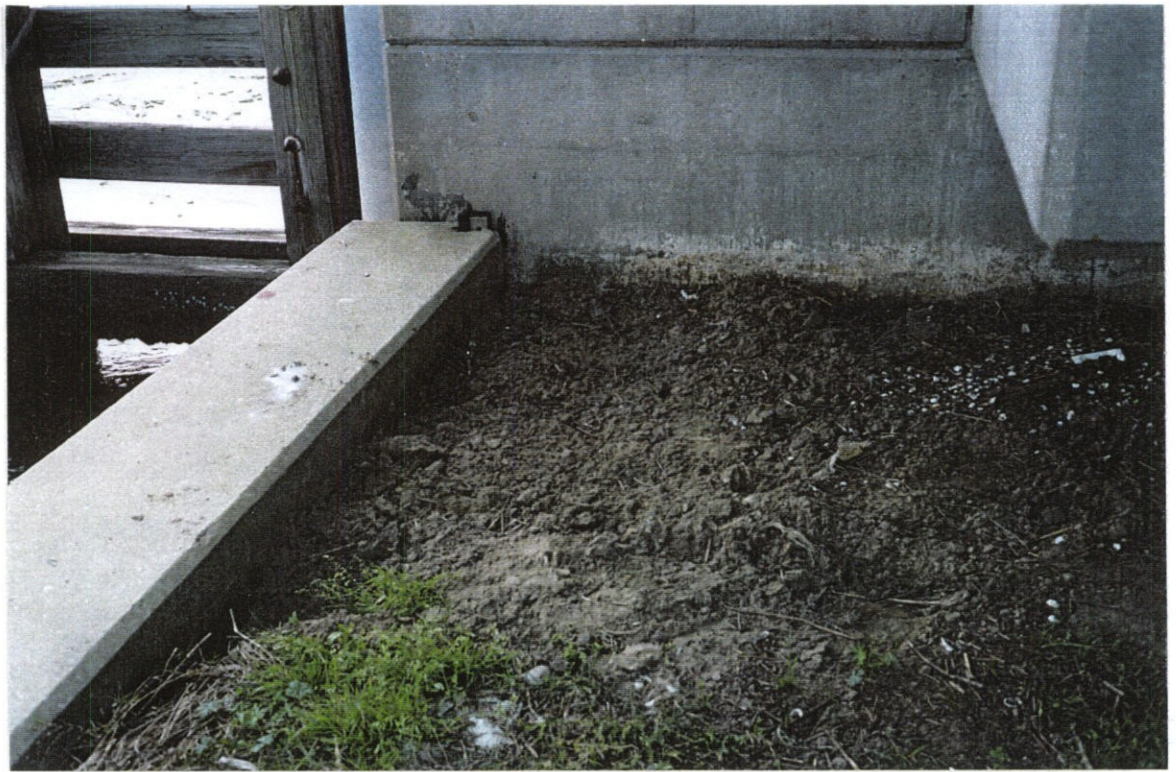
(2) The backfill behind the wingwalls was in good condition. The "j" bulb waterstops between the wingwalls and the gate bay monolith appeared to be in good condition. There is a past history of erosion of these backfills at the juncture of the wingwalls with the gate bay monolith. A minor amount of fresh fill was noted where the northeast wingwall abuts the gate bay monolith, indicating recent loss of backfill in this area. See Photo No. 21. Continued surveillance of the backfill areas, and continued filling of depressions resulting from loss of backfill is recommended.

PHOTO NO. 21 – FRESH FILL BEHIND NORTHWEST WINGWALL AT ITS JUNCTURE WITH THE GATE BAY MONOLITH.

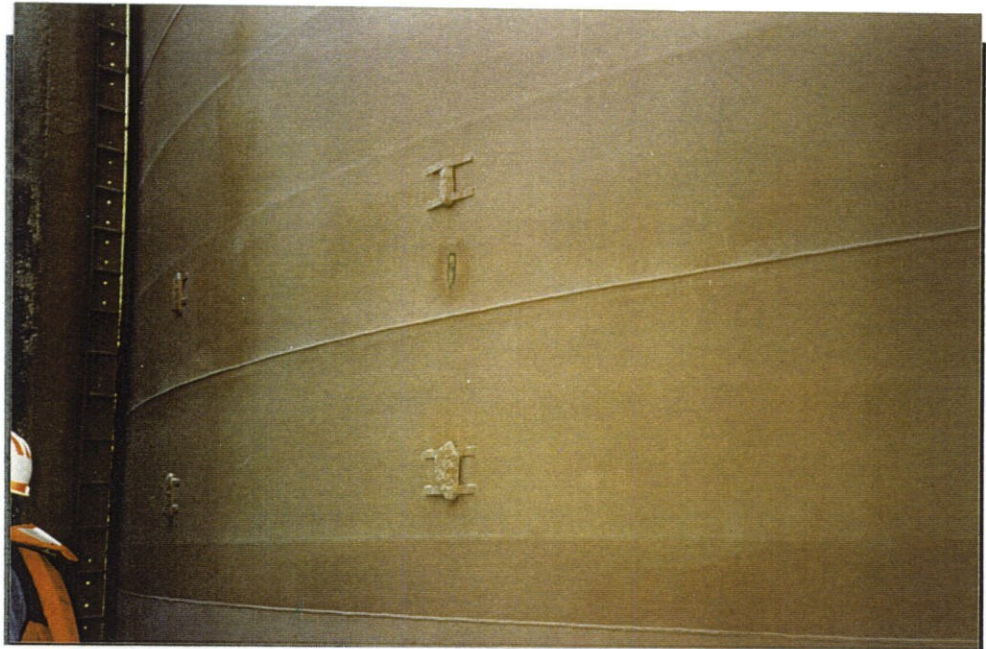
b. The gates were in good condition (see photos 2 and 3) except for a small section of skin plate at the waterline where the rubber seals bolted to the gates. Some of the bolt holes were enlarged because of corrosion. The gate old rubber seal appeared in good condition (see photo 4).

Photo 2. Sector Gate skin plate (Typical).
