LAKE PONTCHARTRAIN, LOUISIANA AND VICINITY

CHALMETTE AREA PLAN

BAYOU DUPRE CONTROL STRUCTURE

PERIODIC INSPECTION REPORT NO. 4

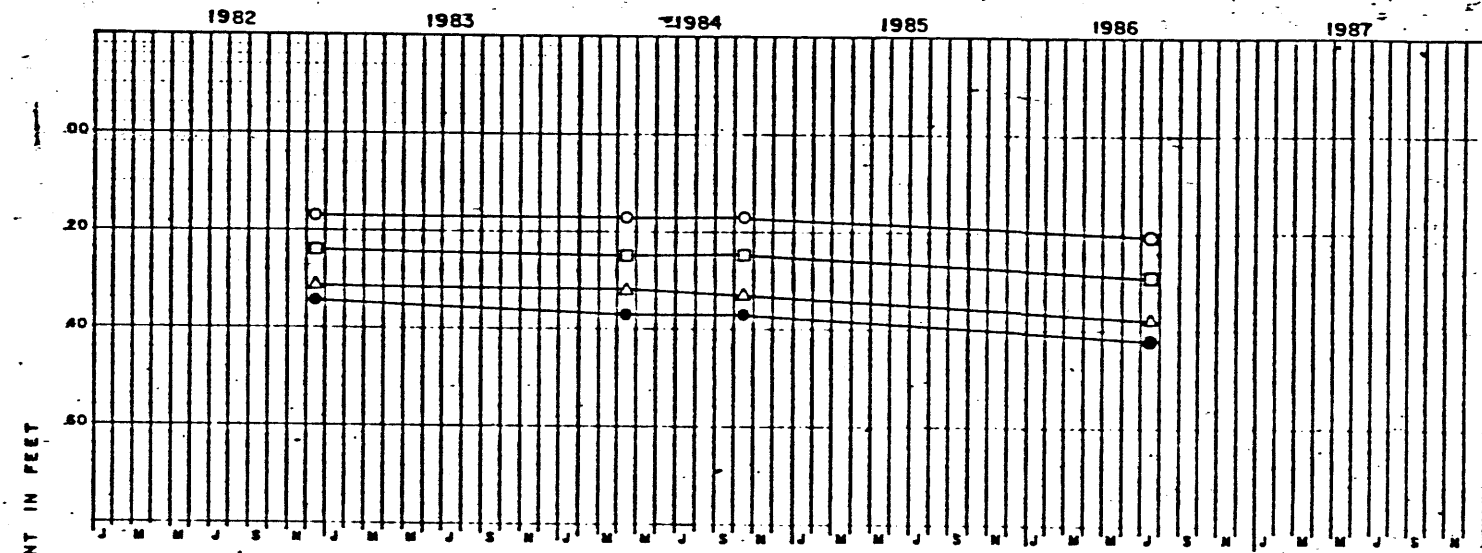
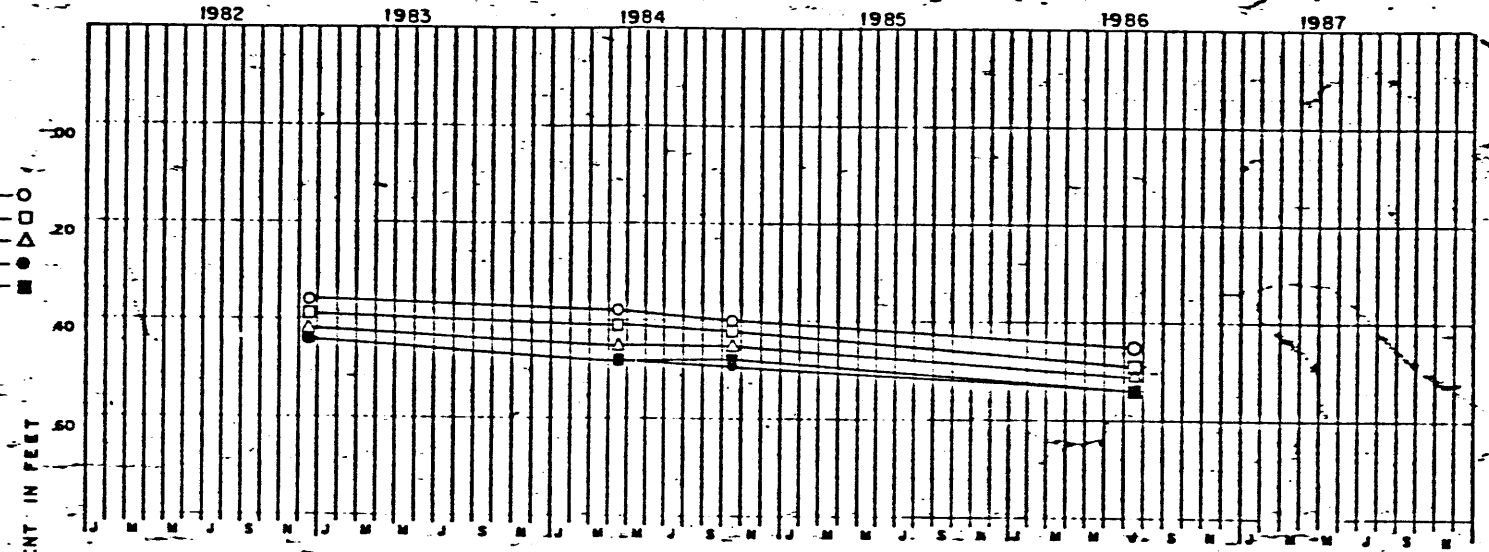
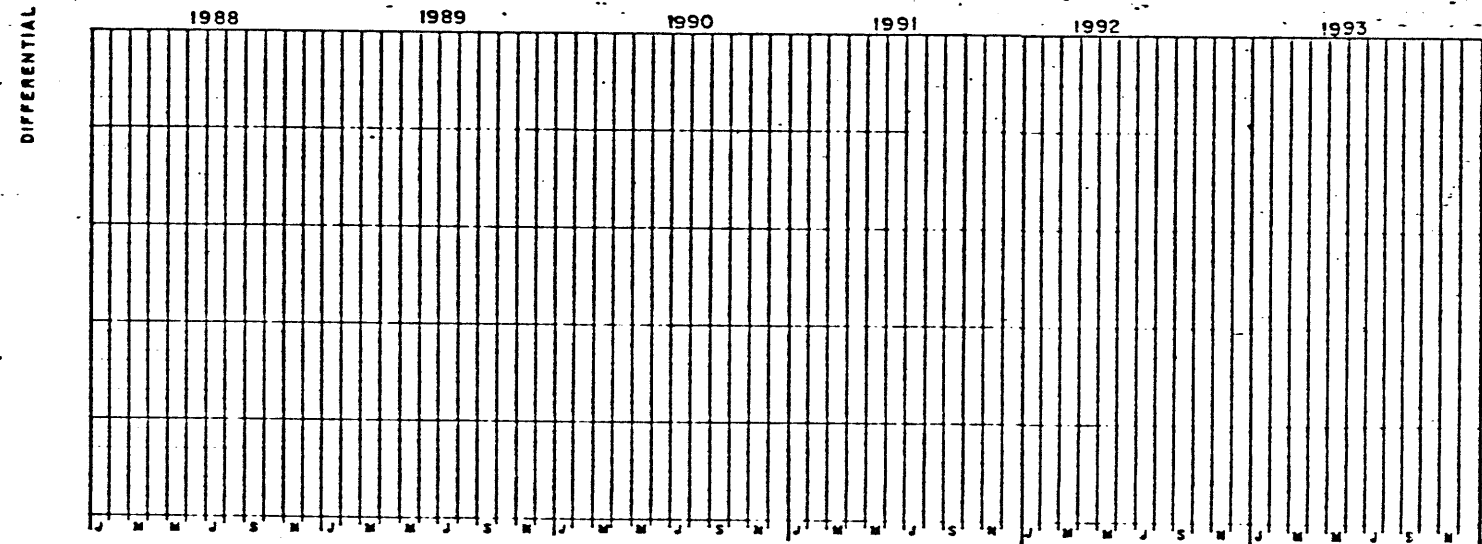
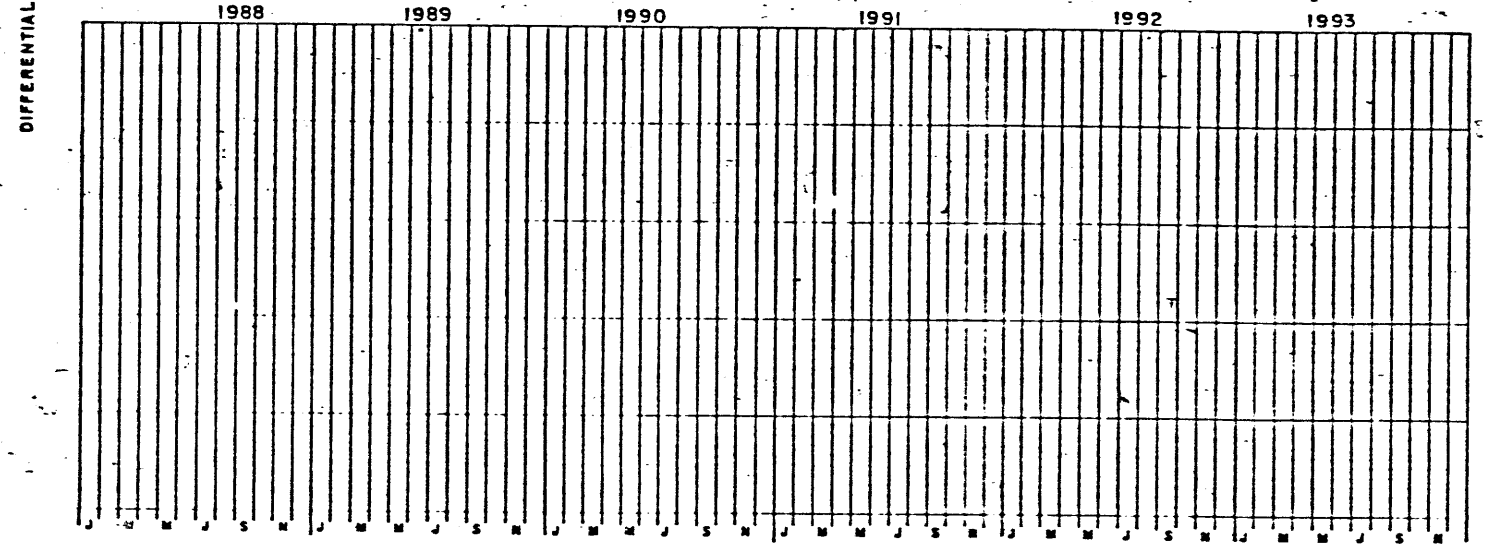
WEST CONCRETE SHEET PILE WALL

FILL PLACEMENTS NEAR WEST SIDE OF STRUCTURE

a. Para 4-03 a. and Plates 20 and 21. This paragraph should give a better explanation of the observed settlement. It should be noted that more fill has been placed in levee adjacent to the east sheetpile wall than the levee adjacent to the west sheetpile wall which explains the difference in total settlement between these two walls. The paragraph should point out that additional fill was placed near the east sheetpile wall in 1977 and 1982, and this additional fill placement caused additional settlement of the wall. Without these explanations, the reader gets the misleading impression that the same amount of fill placement has caused more settlement and a faster rate of settlement of the east wall than the west wall. It would be beneficial if the dates of the additional fill placements were noted on the plates.

b. Paras 4-03 a and 6-02 a (3) (a). References to endangering the safety of the structure should be deleted. Excess settlement of the walls may cause maintenance problems but would not endanger the structure. It is agreed that the walls should continue to be monitored.

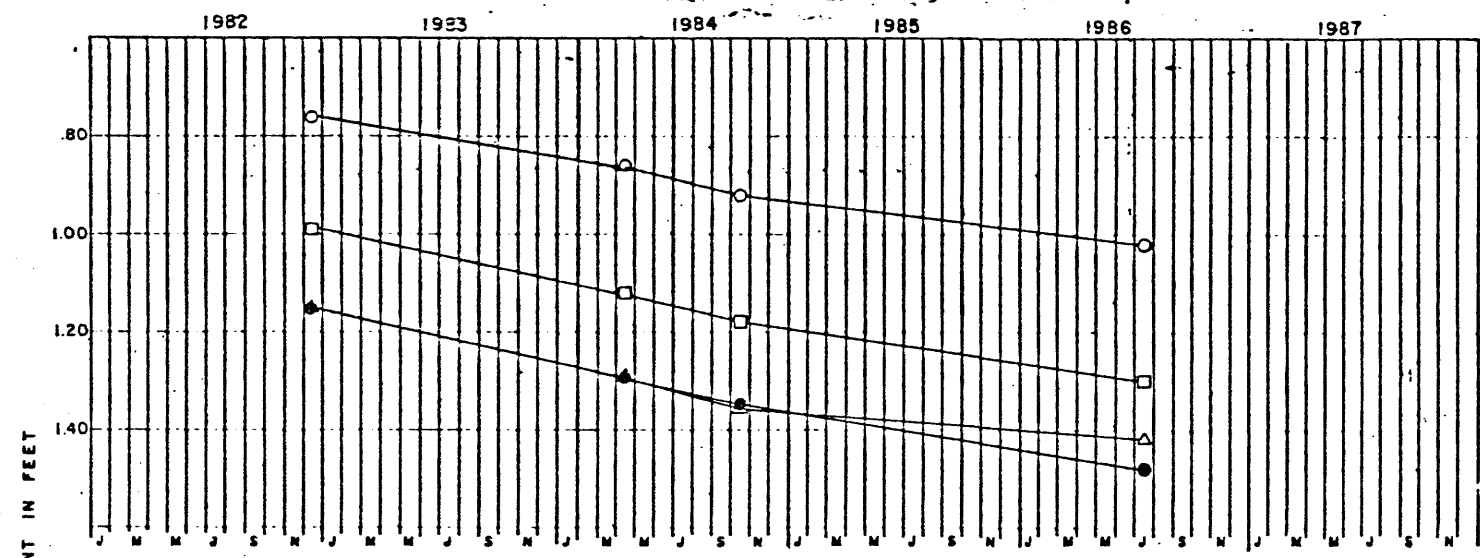
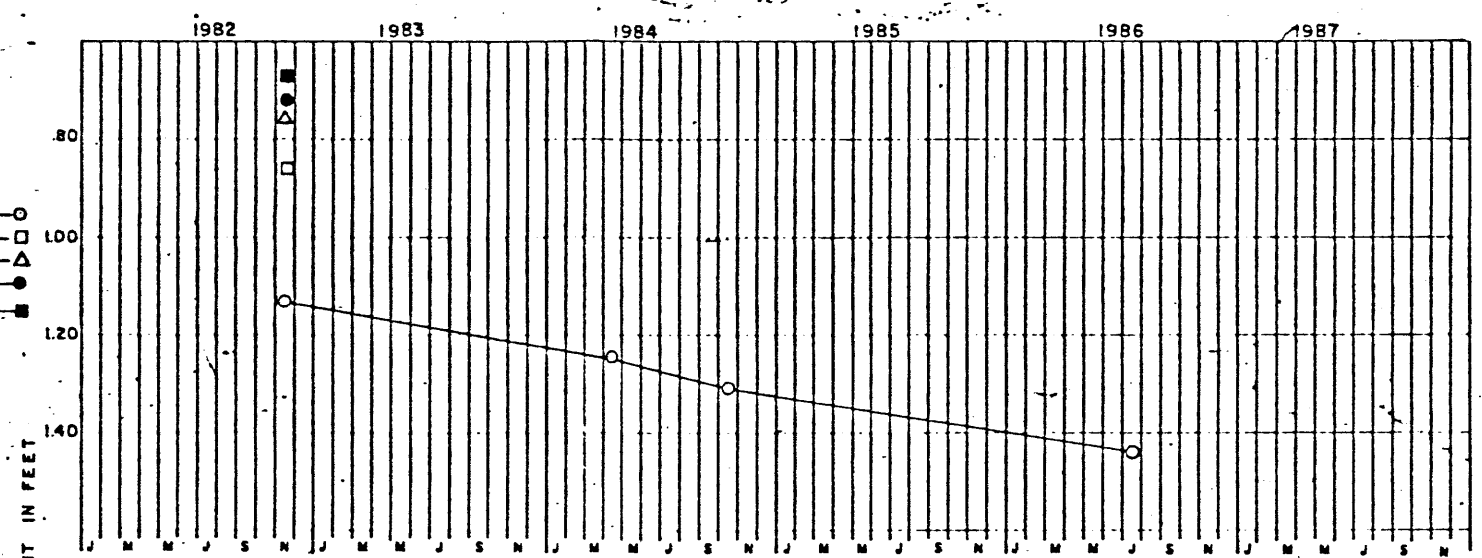
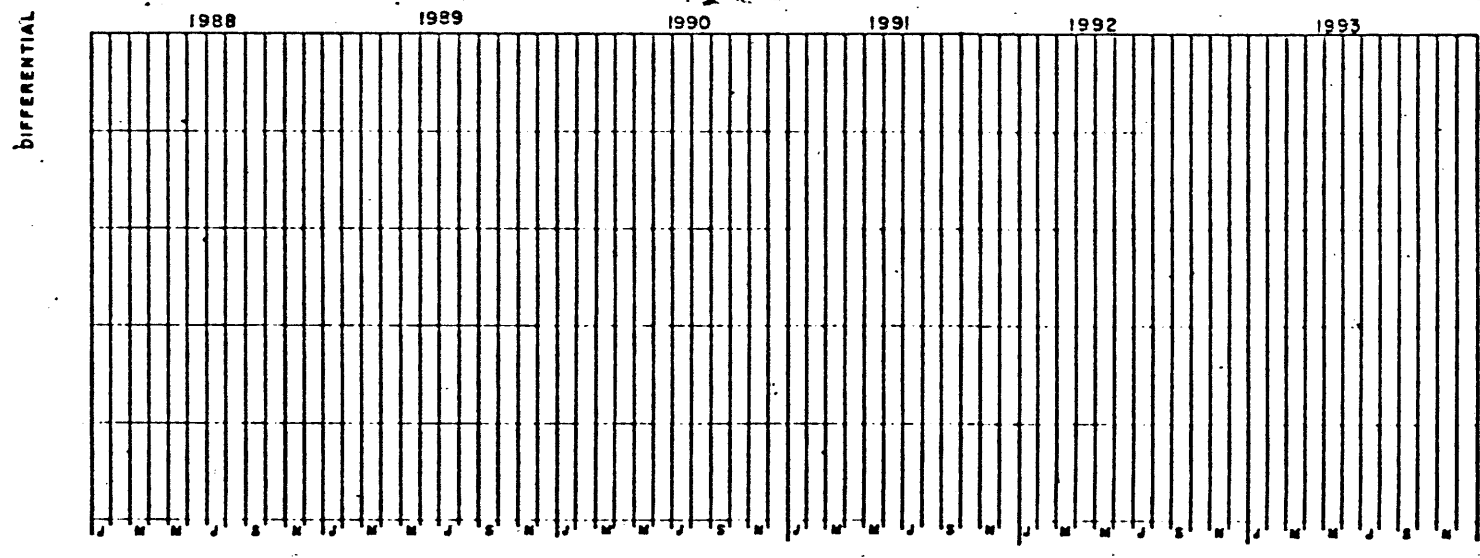
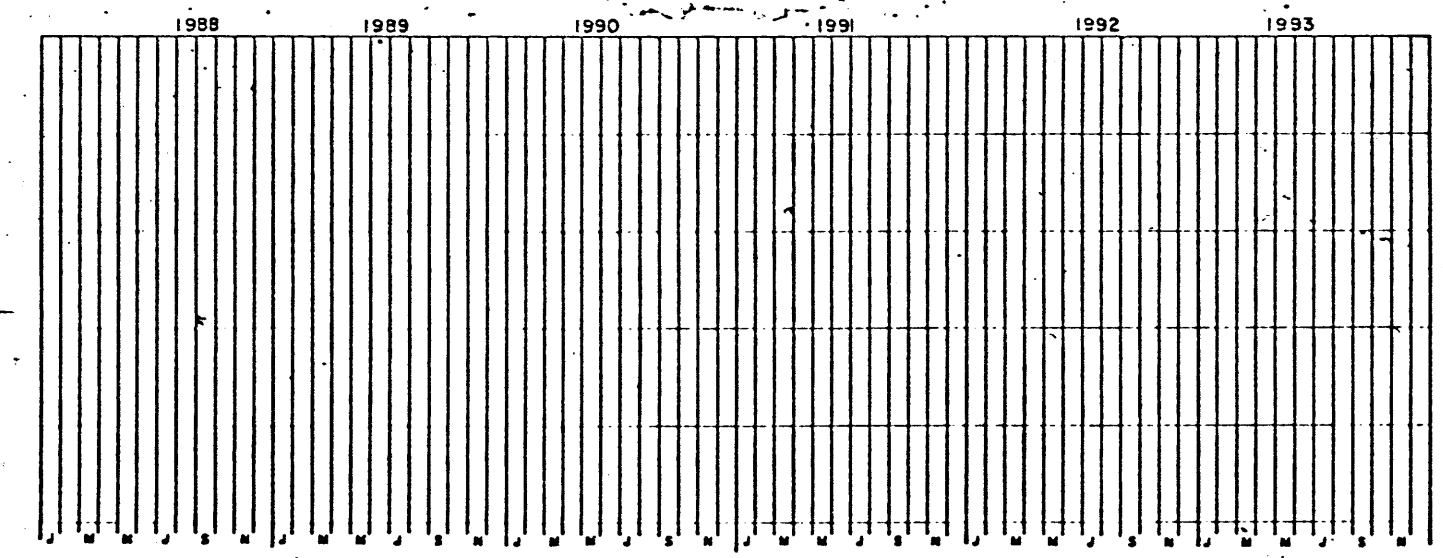
EAST CONCRETE SHEET PILE-WALL

FILL PLACEMENTS NEAR EAST SIDE OF STRUCTURE		
STATIONS	CONTRACT NO	DATES OF WORK
705+95-945+85	78-C-0274	JUL 78 TO JUL 79
708+00-945+00	83-C-0175	JUN 83 TO NOV 83

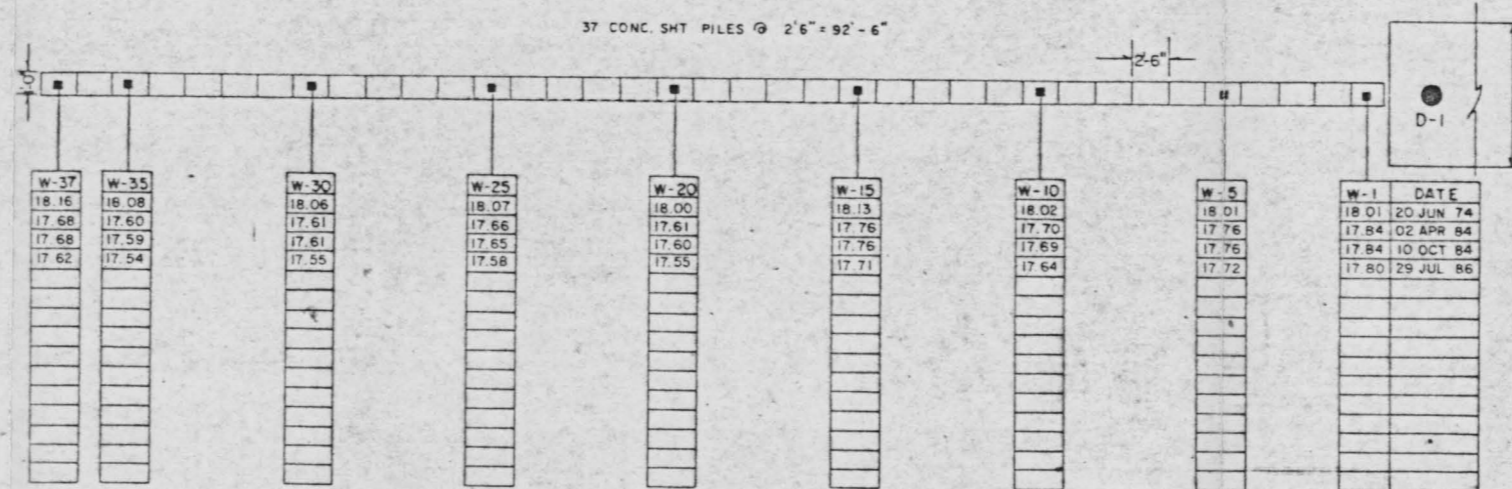
SETTLEMENT REFERENCE MARKS-CONCRETE SHEET PILE WALL

a. The I-walls which connect the pile-founded T-wall to the levee consist of prestressed concrete panels with full length tongue-and-groove with plastic interlocks. It was anticipated in design that these walls may settle as much as 1 ft, therefore, the walls were initially constructed 1 ft higher than the adjacent T-walls, i.e., to el 18.0 ft NGVD. Instrumentation data indicate that the top of west I-wall varies from about el 17.8 to el 17.6 and the top of the east I-wall varies from about el 16.6 to el 17.1. Visual inspection of the I-walls indicate that the top of the walls are "stair-stepped", i.e., each panel is at a slightly different elevation from adjacent panels. In spite of the apparent differential settlements, the interlocks between panels are all intact, the joints are tight and there are no signs of distress at the joints.

MARK	DATE	ELEVATION
W-37	18.16	18.08
	17.68	17.60
	17.62	17.54
W-35	18.06	18.06
	17.61	17.61
	17.55	17.55
W-30	18.07	18.07
	17.66	17.66
	17.58	17.58
W-25	18.00	18.00
	17.61	17.61
	17.55	17.55
W-20	18.13	18.13
	17.76	17.76
	17.71	17.71
W-15	18.02	18.02
	17.70	17.70
	17.64	17.64
W-10	18.01	18.01
	17.76	17.76
	17.72	17.72
W-5	18.01	18.01
	17.84	102 APR 84
	17.80	29 JUL 86
W-1	18.01	20 JUN 74
	17.84	102 APR 84
	17.80	29 JUL 86
