NEW ORLEANS TO VENICE, LOUISIANA

REACH B-1 - TROPICAL BEND TO FORT JACKSON

# EMPIRE FLOODGATE

PERIODIC INSPECTION REPORT NO. 3

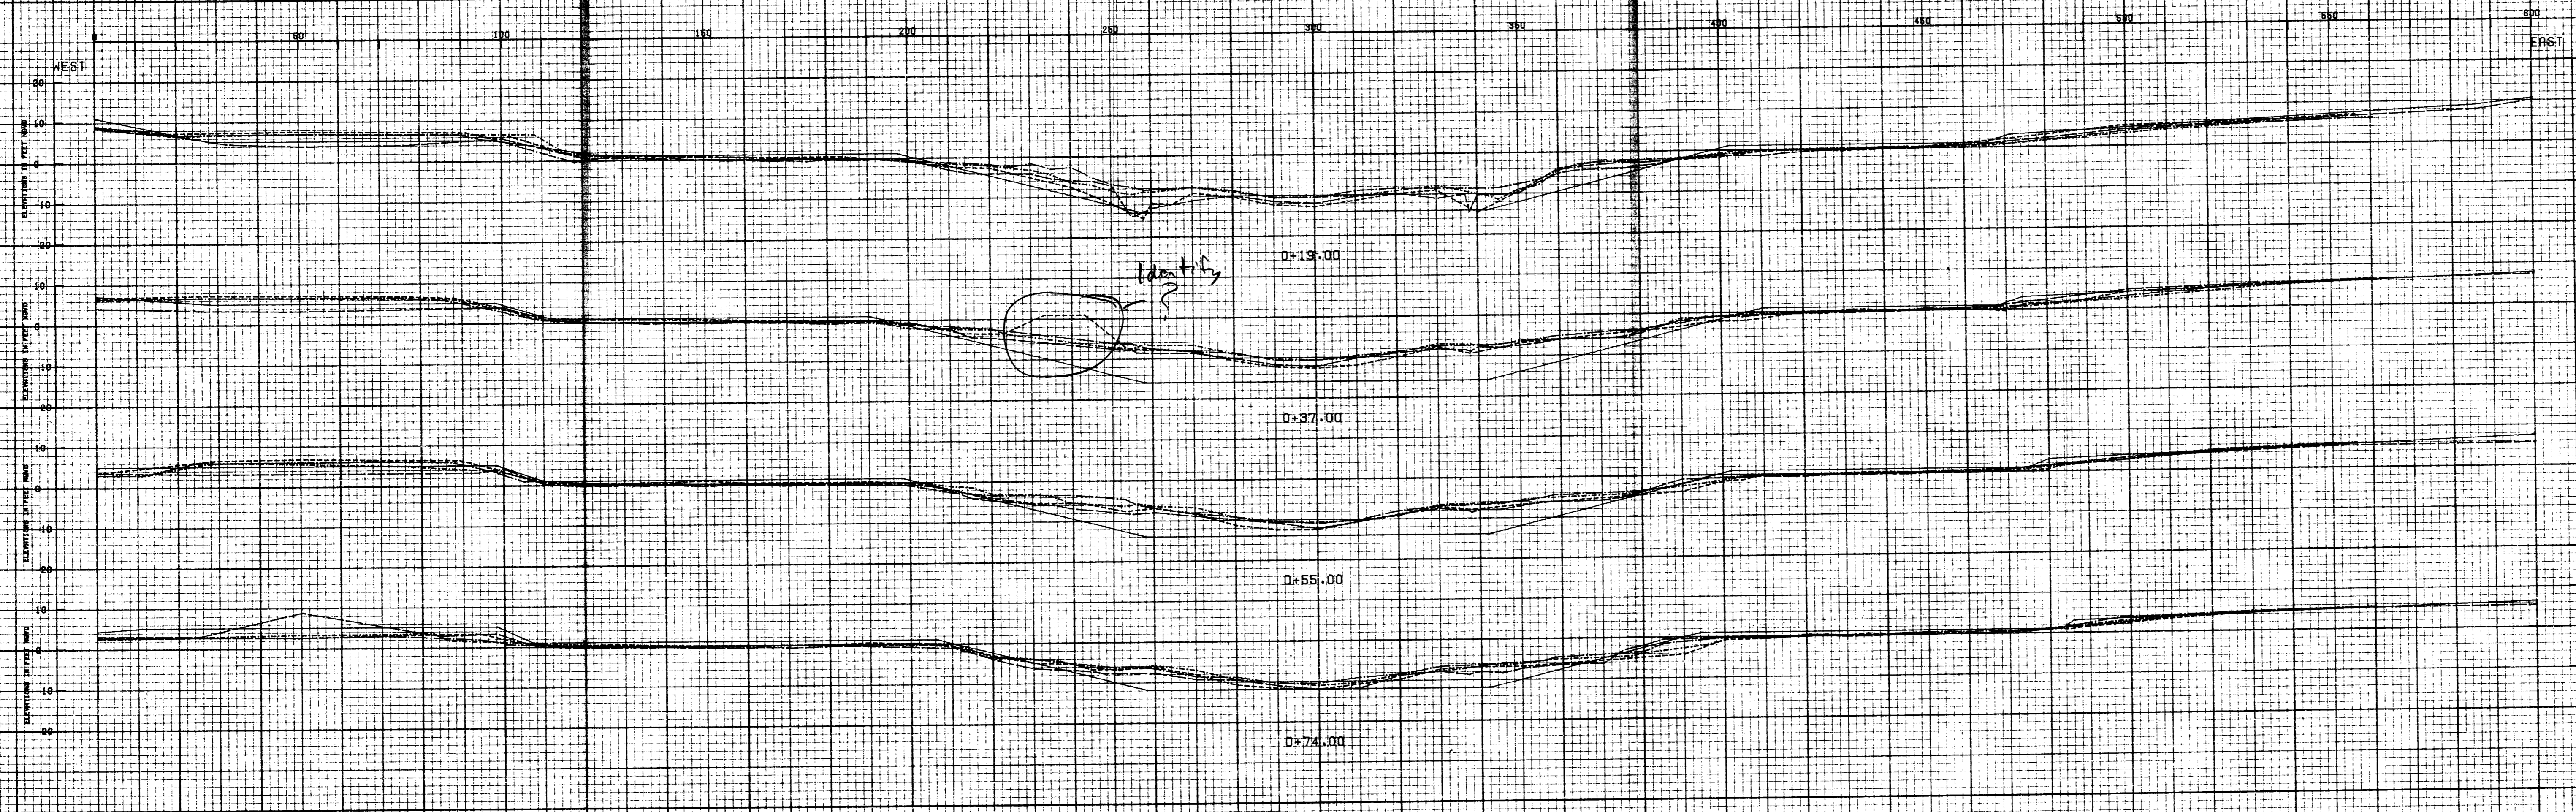
REVISION	DESCRIPTION	BY
	NEW ORLEANS TO VENICE, LA.	
	HURRICANE PROTECTION REACH B-1	
	PERIODIC INSPECTION	
	EMPIRE FLOODGATE	
<b>PLAN AND PROFILE</b>		
U.S. ARMY ENGINEER DISTRICT, NEW ORLEANS		
CORPS OF ENGINEERS		
SHEET 1 OF 1 SHEET		FILE NO. H-4-27323

d. Floodwall Alinement. The alinement surveys, as indicated by plates I-2 and I-2A, show an apparent movement to the north. This condition has not affected the structural integrity of the structure. The Alinement Differential Chart, plate I-2A, indicates that RM-5, RM-6, RM-7 and RM-8 have moved an average of one (1) inch since the last inspection in October 1978. As indicated on plate I-1, these reference marks are located on two adjacent concrete T-wall

monoliths. Possible cause of this movement is unknown but these reference marks will be monitored closely during future surveys.

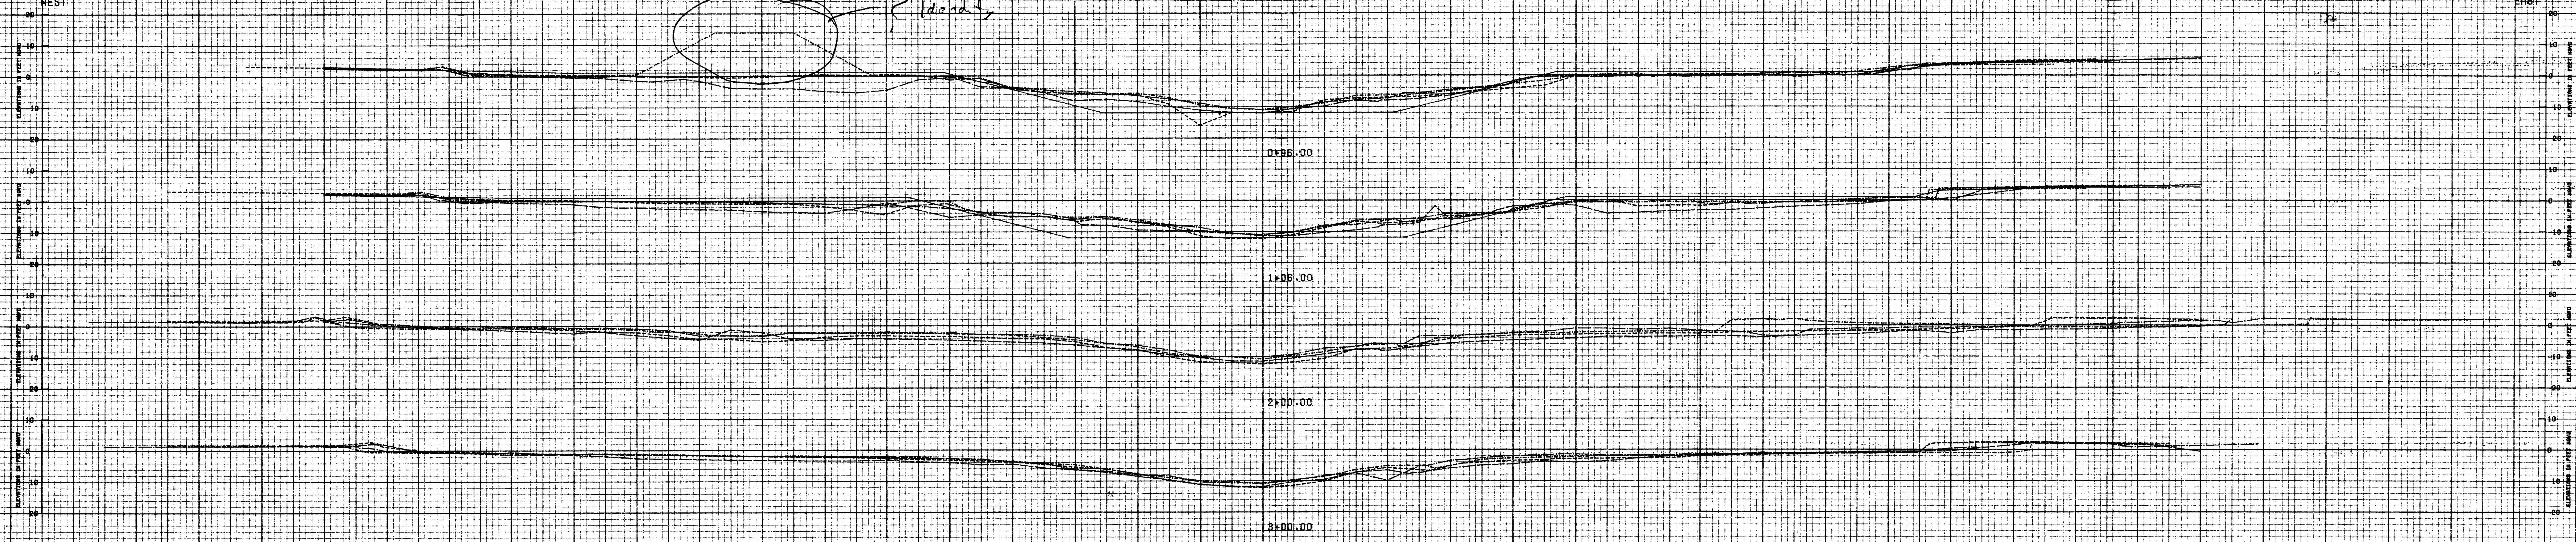
EMPIRE FLOODGATE NORTH APPROACH CHANNEL  
NEW ORLEANS TO VENICE LA.  
HURRICANE PROTECTION REACH  
SCOUR SURVEY (77-81)

- a. Scour Survey. Recent scour surveys indicate no appreciable scouring has occurred since the last inspection in October 1978.
- b. Alinement. The alinement surveys indicate an apparent movement to the north. This condition does not affect the structural integrity of the structure.
- c. Settlement. Between September 1978 and February 1981 negligible settlement has occurred at the structure.

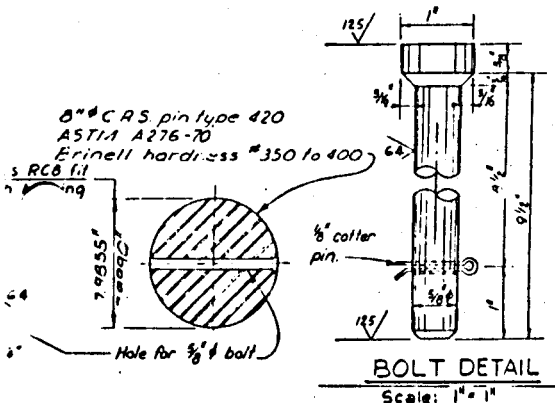
**SECTION THROUGH FLAP GATE**  
1'-1'-0

*Approx. location of dents*
