Lessons Learned

Environmental Impacts - Spills & Discharges

NOVEMBER 2011

Internal Tank Transfers... Worth Some Thought

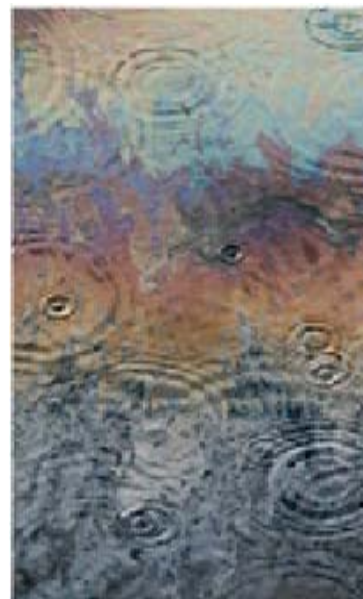
One hour into the clean-up, a sheen was discovered on the starboard side of the main deck. Diesel had discharged from the starboard vent pipe, into the coffer dam, through the unplugged coffer dam drain, across the deck, and overboard (Figure 1).
