## Fast Rescue Boat Davit Lesson Learned

# Lesson Learned

## More than Situational Awareness

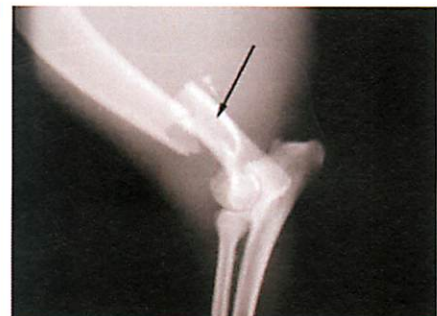
Figure 3 – X-ray of fractured arm – not actual X-ray from this case

The immediate cause of the injury was the employee was struck by the spinning crank arm when power was first applied to recover the FRB.
