U.S. Election Assistance Commission

Formal Investigation Report

Election Systems and Software Unity 3.2.0.0

December 20, 2011

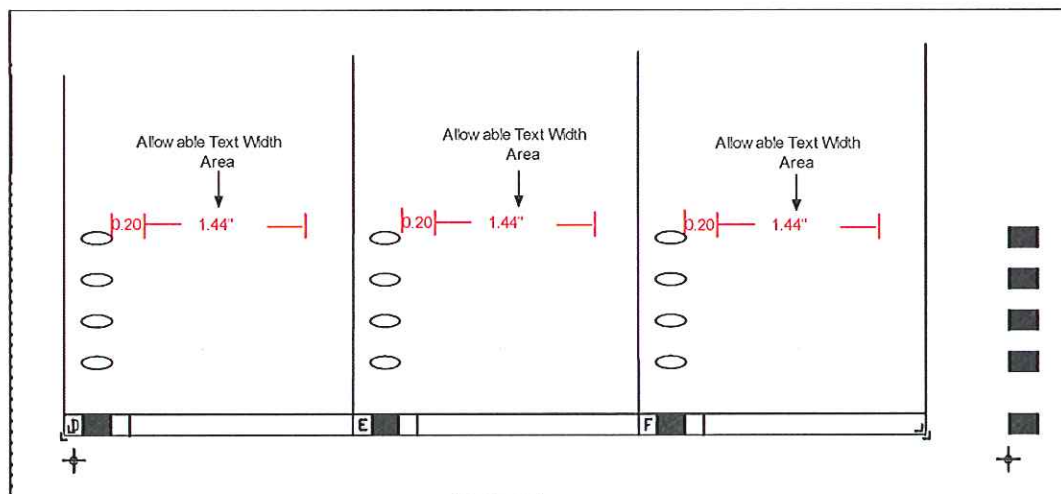
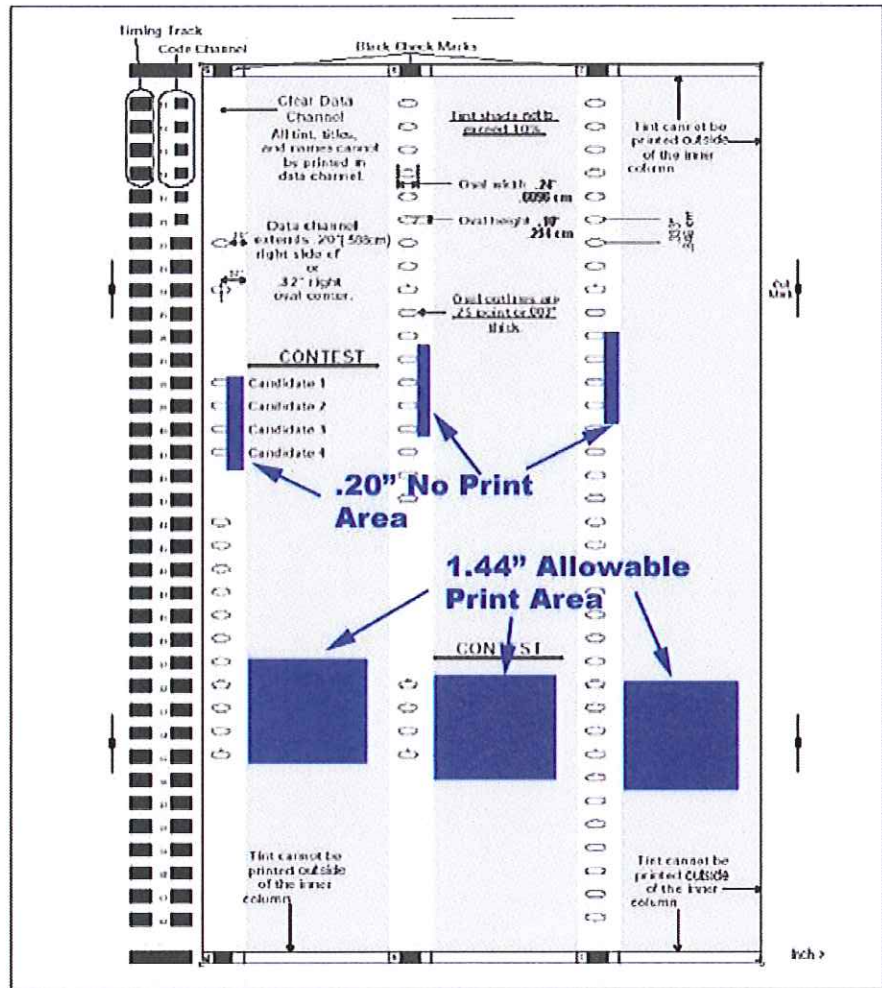
Resolution:

To completely avoid the problem, it is critical that users do not place any text or graphics closer than 0.20 inches from the edge of the oval and not allow it to extend more the 1.44 inches from that "no print zone" as shown. Contest titles and referenda can still use the full column width.

ES&S has modified the DS200's firmware to correct this issue in version 1.3.11.0 and will submit the updated firmware for EAC federal certification testing in October 2009.

Please refer to the drawing below for additional detail about the no print areas.
