**Boom Hoist Wire Rope Line Failure Results in Fatality  
High Island Area Block A557, Platform “A”  
OCS-G 03484  
16 August 2011**

**U.S. Department of the Interior  
Bureau of Safety and Environmental Enforcement  
Gulf of Mexico OCS Regional Office**

**New Orleans  
January 2013**

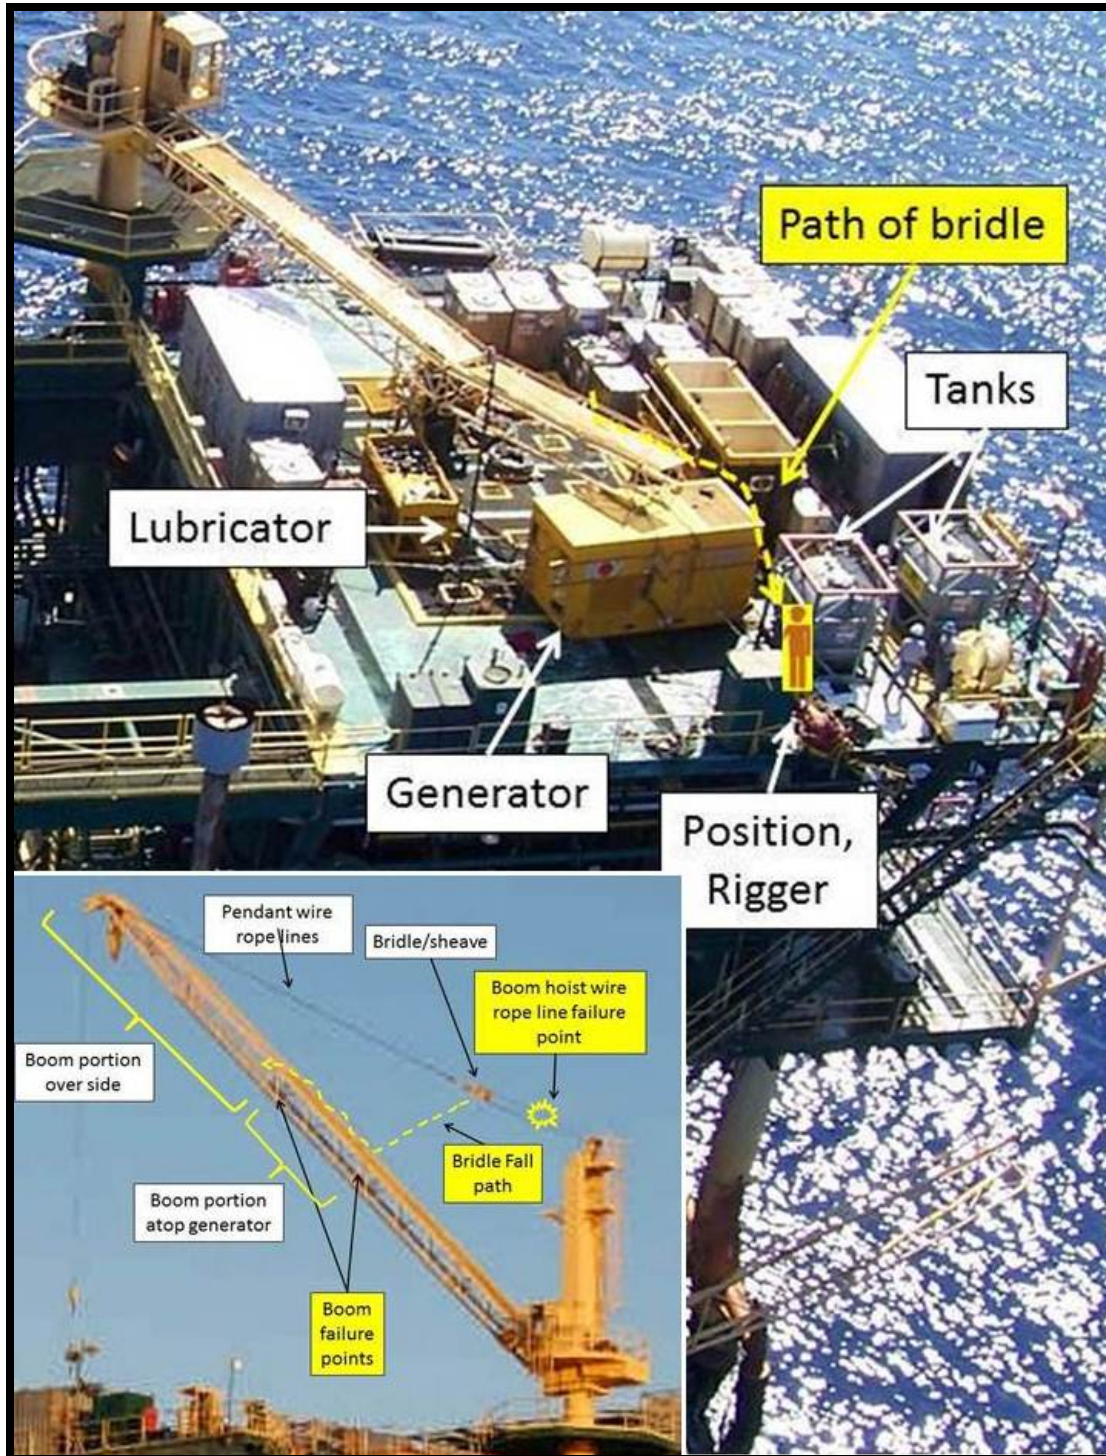
Figure 1 – Overview of accident

When the load was lifted, the crane’s boom hoist wire rope failed, the generator dropped to the deck, and the boom fell striking the generator. The boom subsequently broke into three sections; one section attached to the crane, the middle section resting on top of the dropped generator, while the nose section continued overboard. The crane’s main block hook subsequently disengaged releasing the connection between generator and boom nose.

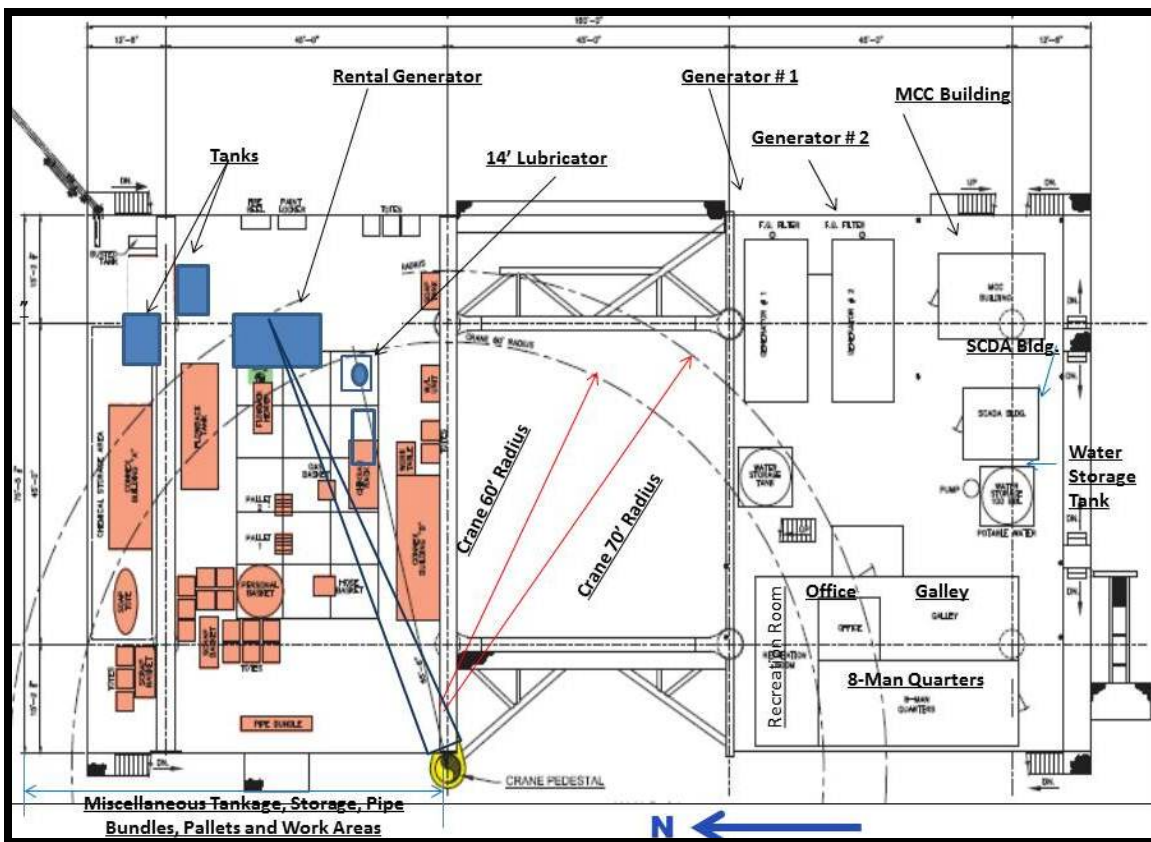
The key equipment positioned in the work area is shown in *figures 4 and 5*. The work deck space was occupied by the rental generator located immediately east of the well bay area. Two tanks (approximately 1,000 gallons each) were situated close to the generator, with these and other deck equipment limiting the work space on the north end of the Platform.

**Figure 4 – Post accident schematic of the Platform's main deck (after diagram, ERT)**

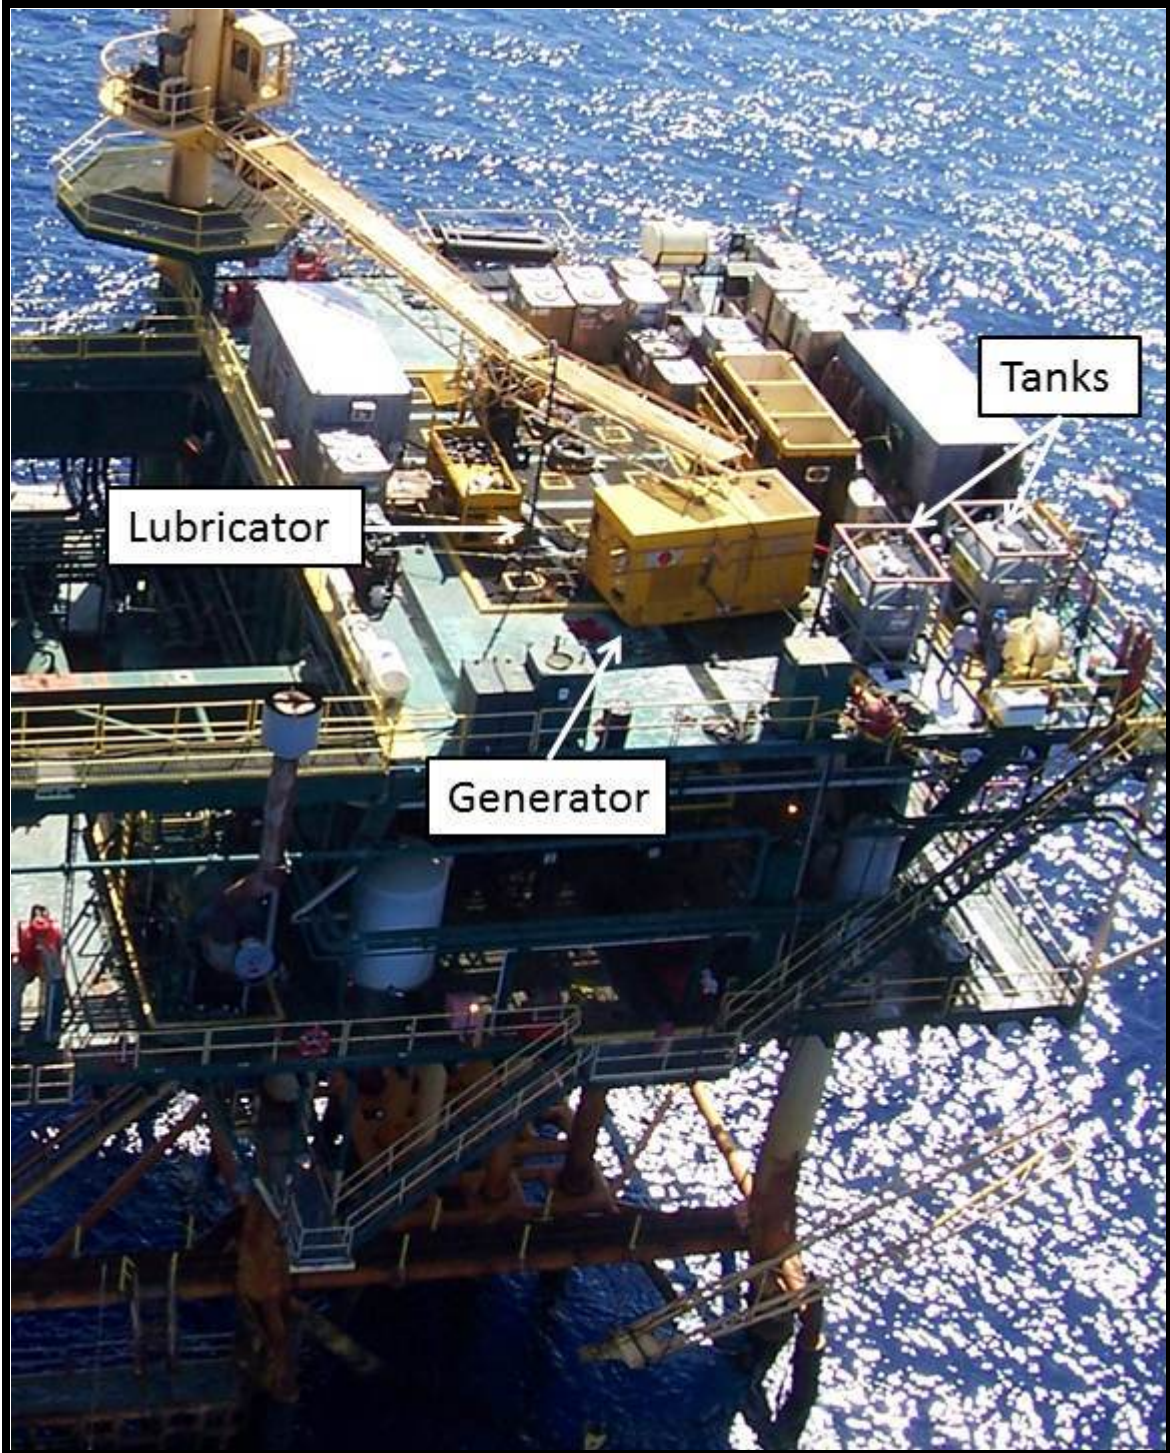
Also near the generator, a 30-ft long wireline lubricator was attached atop a well, extending approximately 14-ft above the deck. The lubricator was not guyed but was barricaded (*see figure 5*). The west side of the Platform's well bay area was almost wholly covered with material skids and other equipment.

*Figure 5 - Position of key lift and deck equipment elements, post-accident*

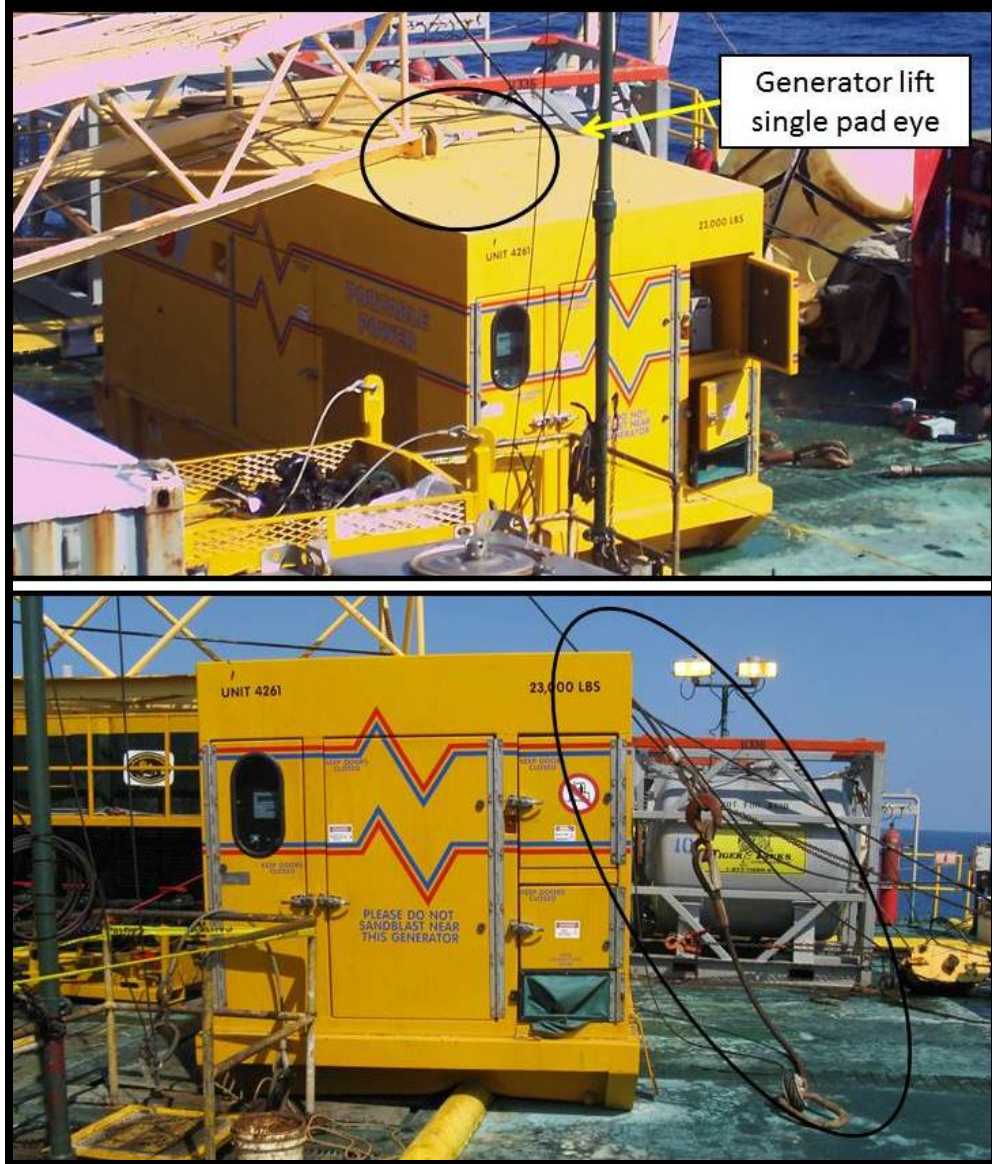
The lift was planned to be accomplished without removing the lubricator or relocating the tanks. The lift package of the generator was designed with only a single central point pad eye for a lift load that weighed in excess of 21,000-lbs (*see figure 10*). Under certain circumstances, a single point lift can be more unstable than one using four points. The instability can include static (weight distribution inequities) and dynamic (tendency to swing and/or spin) factors.

**Figure 10 - Generator lift point and rigging, post-accident**

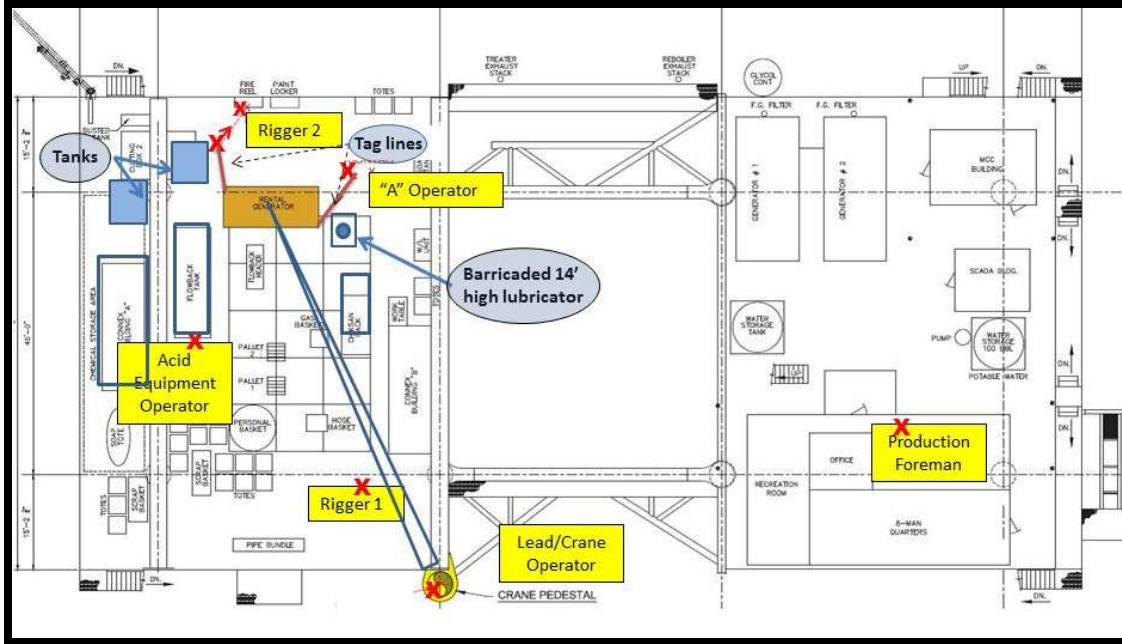
The location of both the tanks and the lubricator, and the attachment of the tag lines, also limited the positioning of the men manning the tag lines (*see figures 12, 13 and 14*).

The two tanks to the north of the generator, and the decision to attach the tag line to the northeast corner of the generator, prevented Rigger 2, holding the tag line on that end of the lift load, from

**Figure 12: Positioning of personnel and equipment during lift**

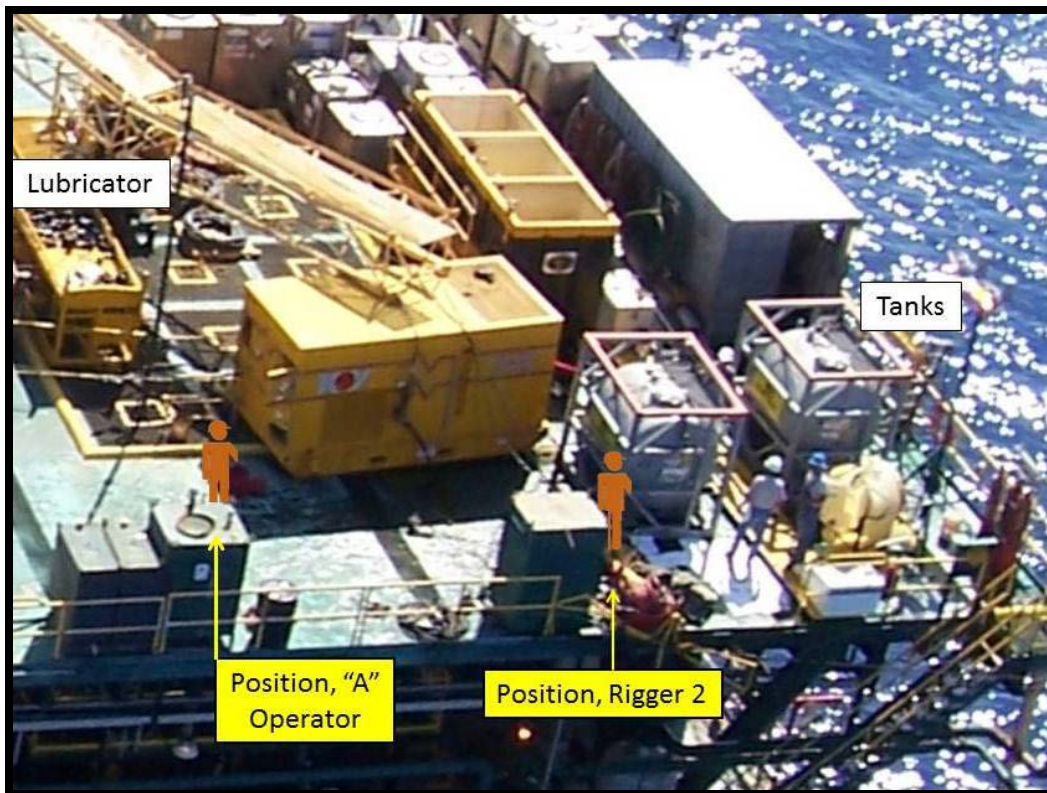
**Figure 13 - Position of riggers, equipment**

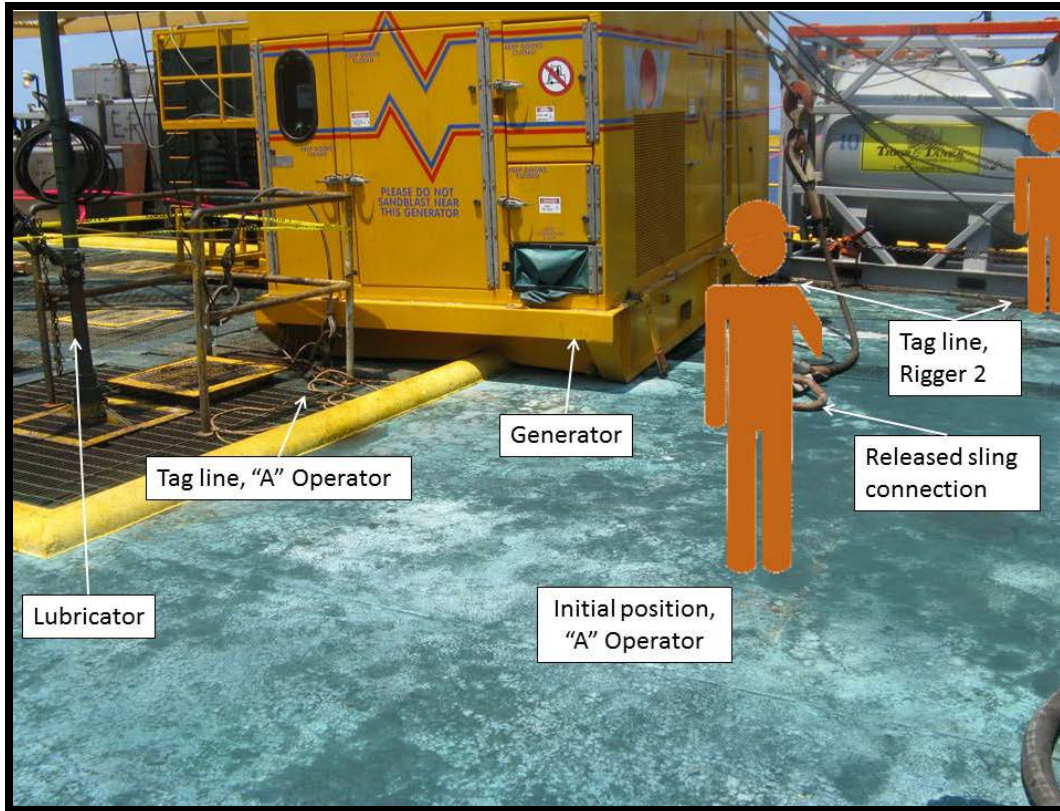
**Figure 14 – Position of riggers, equipment, tag lines**

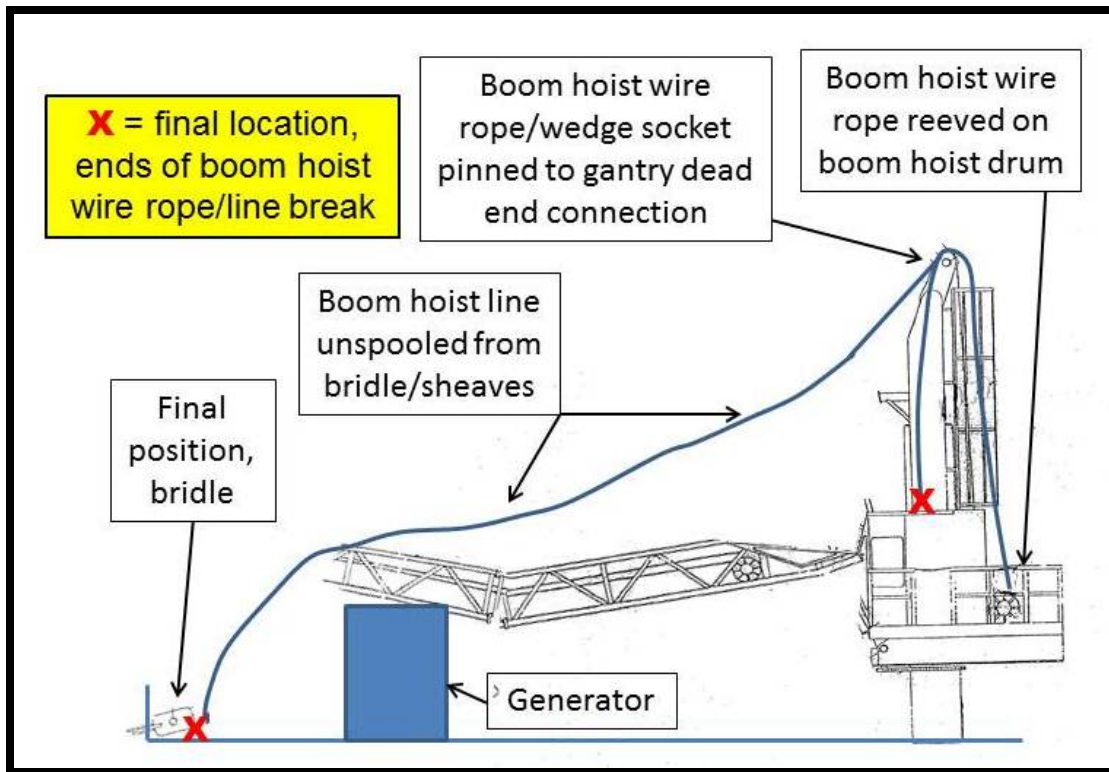
The portion of the boom hoist wire rope that was still reeved to the boom hoist drum remained looped over the gantry sheaves while the parted end dropped and came to rest hanging near the

Crane cab. The section of the boom hoist wire rope pinned to the gantry dead end connection unspooled behind the bridle, following the bridle to its final position (see figure 16).

**Figure 16 –Representation of final configuration of boom hoist wire rope after break**

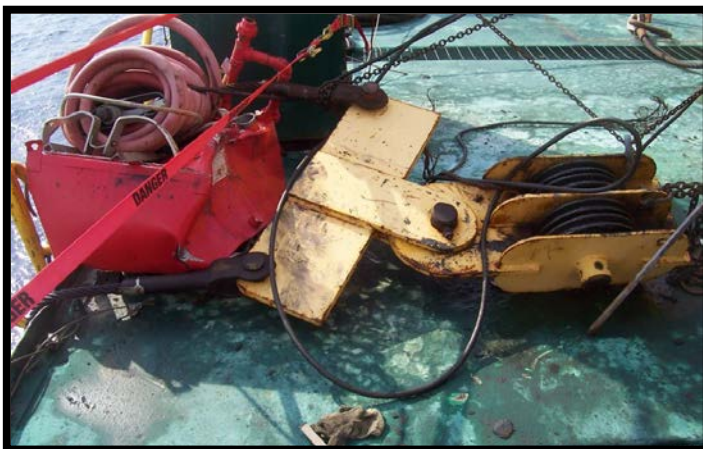
The 850-pound bridle then struck Rigger 2 and pinned him against a fire hose reel (see figure 17). After action ceased, the “A” Operator yelled to Rigger 2 but he did not answer. The AEO immediately attended to the victim by checking for a pulse, but did not find one; with the Production Foreman doing the same and getting the same results.

**Figure 17 – Final location of bridle**

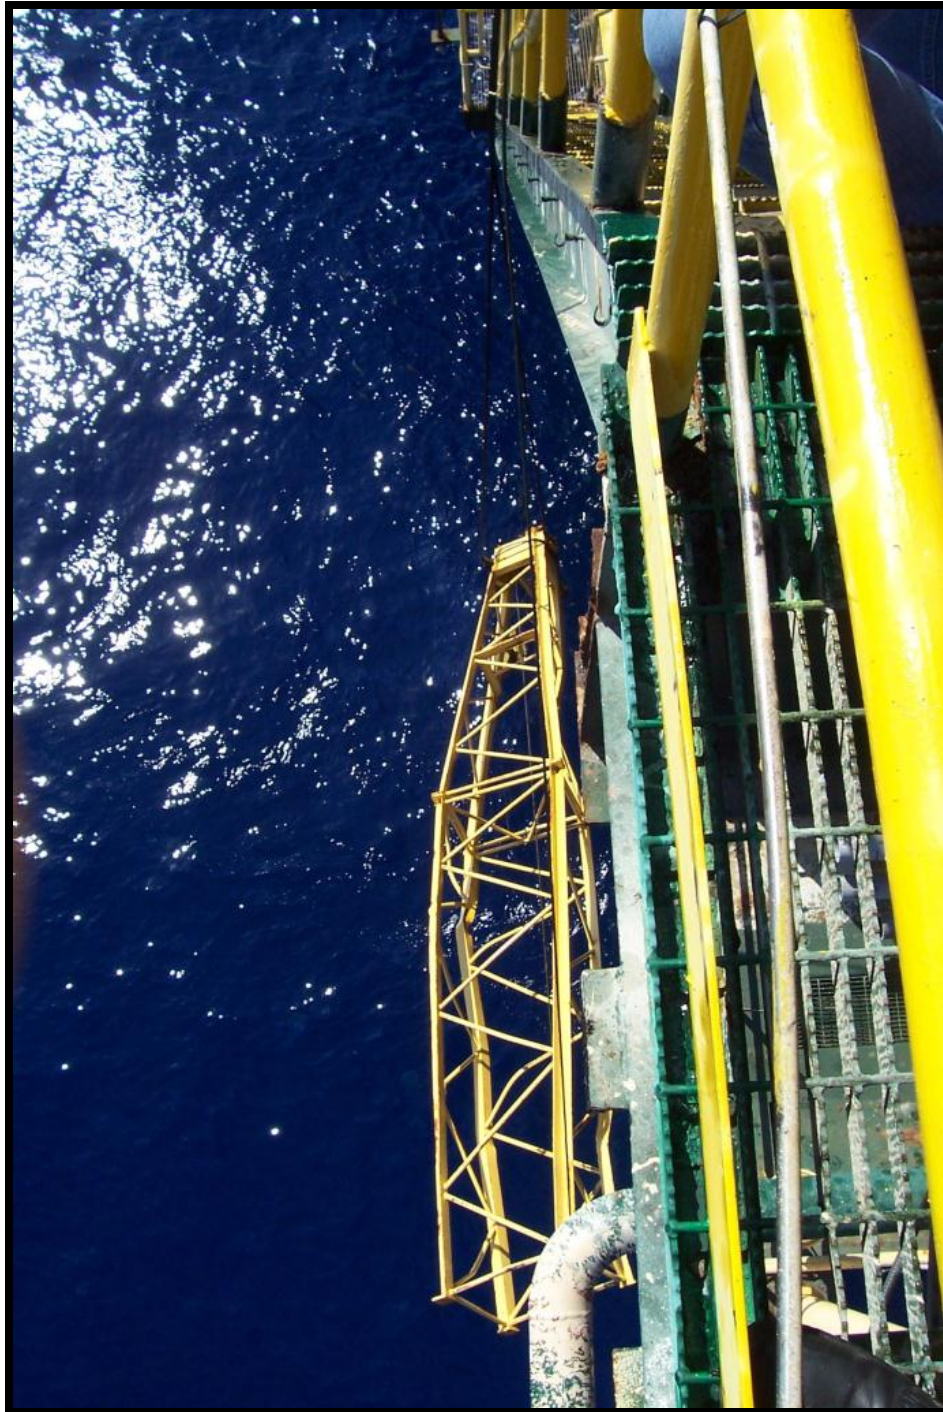
The two (2) “nose” boom sections that separated from the remainder of the boom landed on the handrail on the east side of the platform, breaking the handrail from the Platform, and continued overboard. The fall of the overboard boom sections was finally arrested by the main load line running inside the

boom lattice, and the two pendant wire ropes attached to the bridle which caught against equipment on the Platform toe-board. This prevented the suspended boom sections from falling into the Gulf waters (*see figure 18*).

**Figure 18 – Separated boom section suspended overboard the Platform**

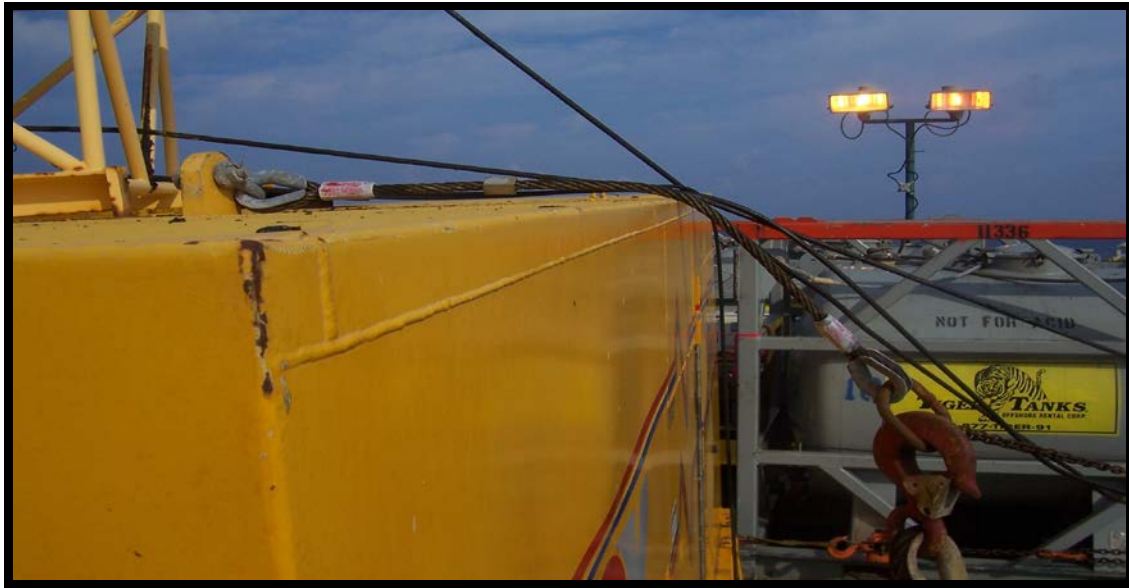
**Figure 26 – Stinger hook attached to the generator rigging**

After the incident, the stinger's Crosby hook remained attached to the generator rigging (see figure 26), but the Crane's main block hook became detached from the master link on the other end of the stinger (see figures 27, 28).
