GEOLOGIC CHARACTERISTICS AND MOVEMENT OF THE MEADOW CREEK LANDSLIDE, PART OF THE COAL HILL LANDSLIDE COMPLEX, WESTERN KANE COUNTY, UTAH

FRANCIS X. ASHLAND¹ AND GREG N. McDONALD²

ABSTRACT

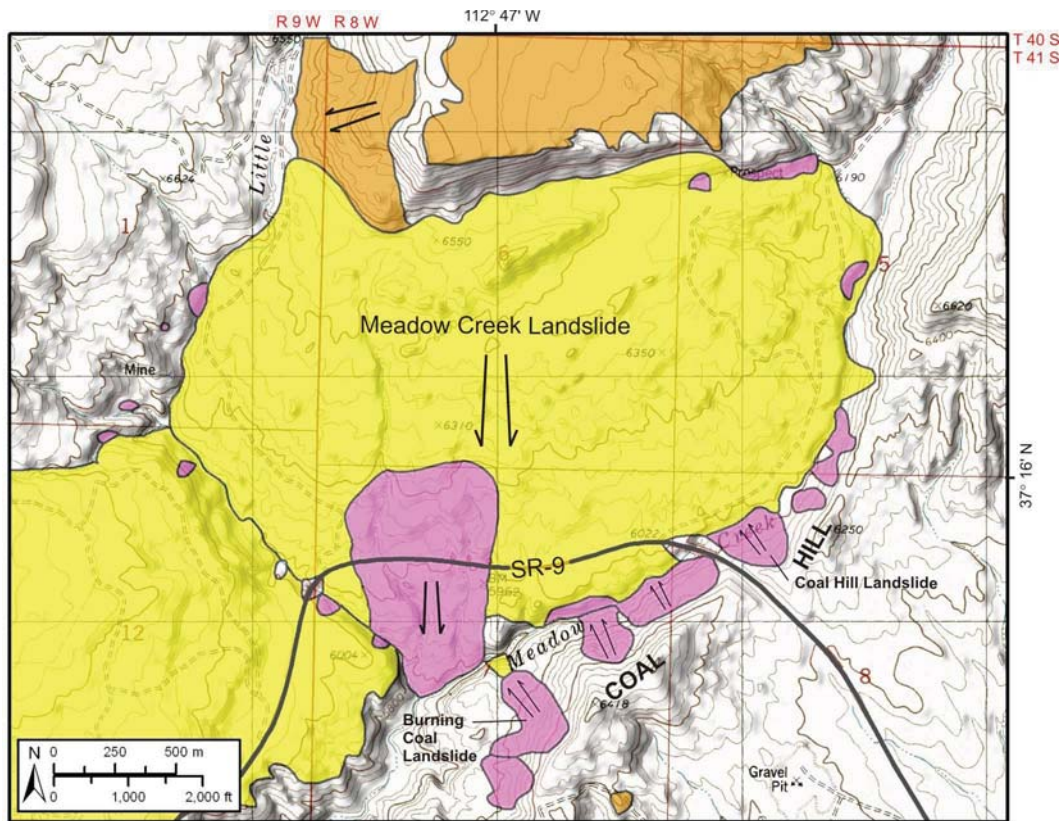
The Coal Hill landslide complex includes three previously named landslides (the Meadow Creek, Coal Hill, Burning Coal slides) and several unnamed landslides (figure 3). The largest of these is the Meadow Creek landslide (Ashland and others, 2009) that is bound by Meadow Creek on the east and south, Little Meadow Creek on the west, and a large south-facing escarpment on the north. The Coal Hill and Burning Coal landslides (Stouffer, 1964) are two of a cluster of slides on the northwest-facing slope of Coal Hill southeast of Meadow Creek.

Figure 3. Simplified geologic map of the Coal Hill landslide complex, western Kane County, Utah. Older (orange), younger (yellow), and historical (pink) landslides shown. Historical slides include Coal Hill and Burning Coal landslides (Stouffer, 1964). Arrows show approximate movement directions of selected landslides. State Route 9 (SR-9) crosses the Meadow Creek landslide. Modified from Hylland (2000). Base map from USGS Clear Creek Mountain 7.5 minute quadrangle.

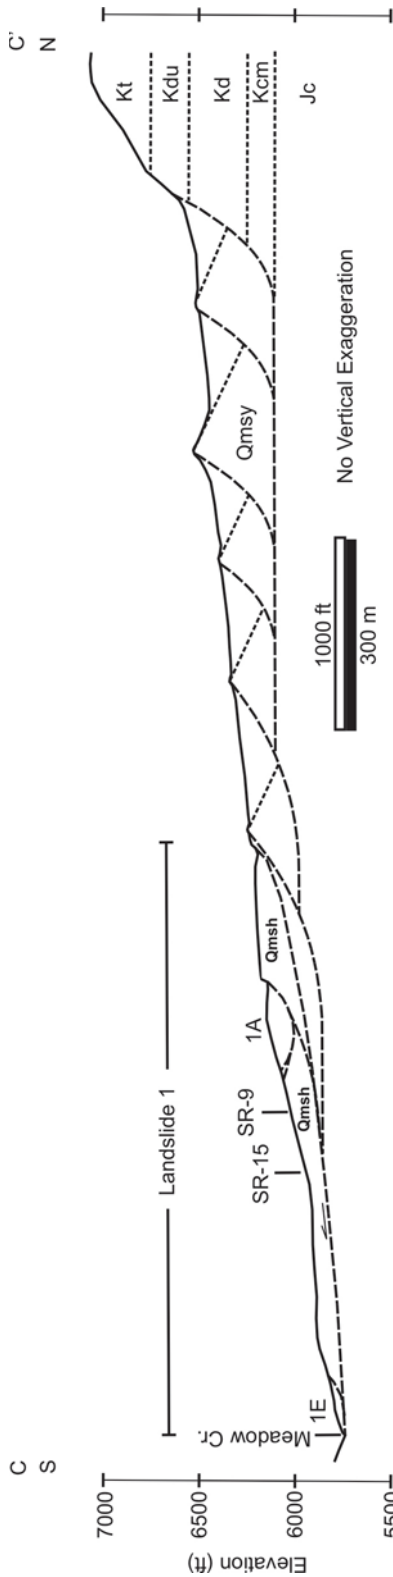
Figure 4. Conceptual geologic cross section of the Meadow Creek landslide. See figure 5 for section line location. Geologic units: Qmsh – historical landslide 1 (including landslides 1A and 1E), Qmsy –Meadow Creek landslide, Kt – Tropic Shale, Kdu – upper member of Dakota Formation, Kd – main body of the Dakota Formation, Kcm – Cedar Mountain Formation, Jc – Carmel Formation. Bedrock unit thicknesses estimated from Hylland (2000).

Significant uncertainty exists regarding the depth of the Meadow Creek landslide (as shown in figure 4) and the smaller slides within it. The dimensions of the Meadow Creek landslide, the main-scarp escarpment height, and the main-scarp heights of the smaller slides within it suggest a depth of 100 feet (30 m) or greater upslope of SR-9, likely increasing toward the escarpment where the relief locally exceeds 400 feet (120 m) (figure 4). South of SR-9 and along the perimeter of the Meadow Creek landslide, the depth of the landslide is likely less than 100 feet (30 m). Data from a geotechnical borehole and seismic refraction line (Stouffer, 1964) and more recent Spectral Analysis of Surface Waves (SASW) testing (Ashland and others, 2009) suggest that the Meadow Creek landslide may be about 40 feet (12 m) deep along its southeastern edge near where SR-9 crosses onto the slide. The subsurface geometries of landslides 1 and 1A shown in figure 4 are constrained by field mapping of the toe and

main-scarp locations and, for landslide 1, the depth determined by SASW testing along former SR-15. The basal surface of rupture of landslide 1 is likely in or overrides an erosional surface on the Carmel Formation, although landslide debris at the surface appears to be mostly derived from overlying formations.

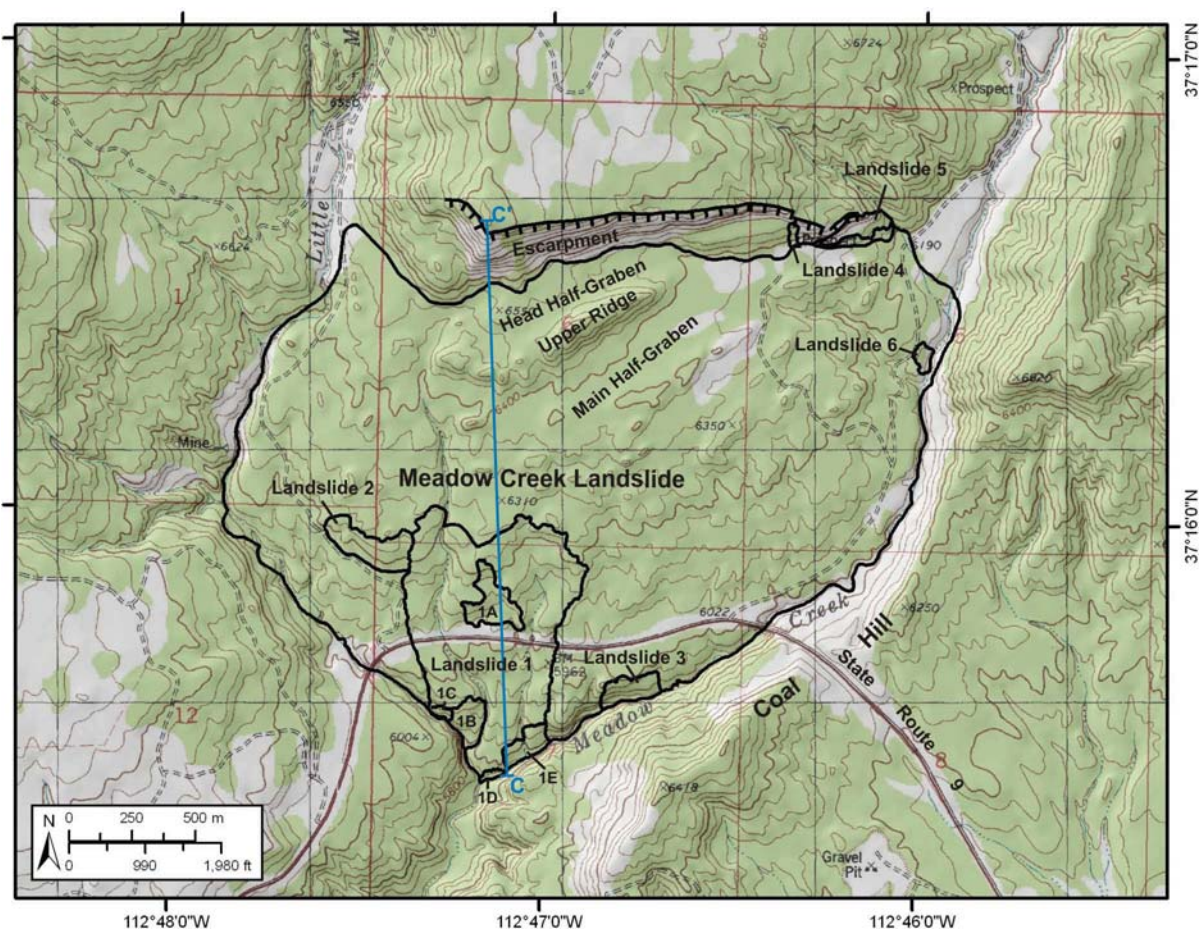
The Meadow Creek landslide contains six historical landslides (numbered 1 through 6) (figure 5), two in the escarpment slope and four in the lower part of the main slide. Hylland (2000) mapped four of these landslides, Stouffer (1964) mapped another, and Ashland and others (2009) identified the sixth. Reactivation of landslides 1, 2, 3, and 5 occurred in 2005, and some evidence, such as ground cracks and locally oversteepened slopes, suggests minor movement of the other two slides (landslides 4 and 6). Table 1 summarizes measured dimensions and average slopes of the historical landslides.

Figure 5. Generalized map of the Meadow Creek landslide in western Kane County, Utah. Landslide perimeter modified from Hylland (2000). Boundaries of mapped landslides within Meadow Creek slide shown. Cross section shown on figure 4. Base from U.S. Geological Survey Clear Creek Mountain 7.5' quadrangle. Shaded relief from 10-meter Digital Elevation Model (DEM).

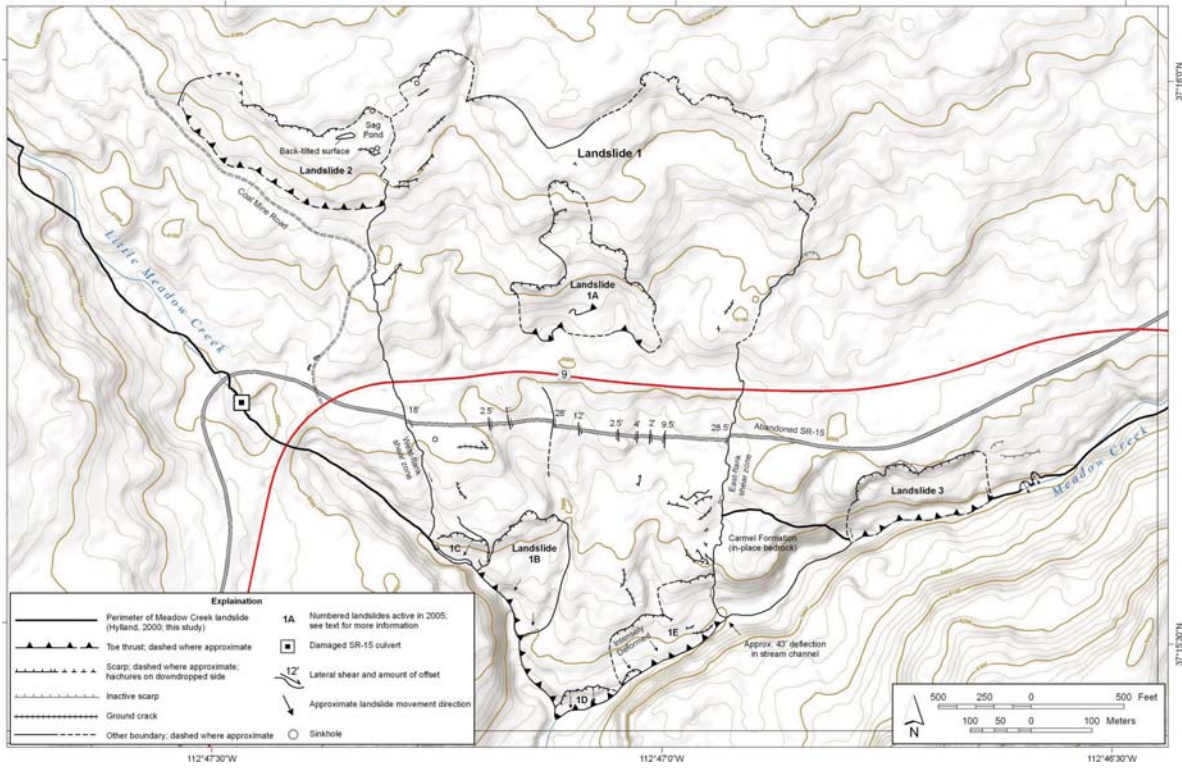
Landslide 1: Landslide 1 (figure 6) is the largest historical slide in the Meadow Creek landslide (table 1) and contains five smaller slides (landslides 1A through 1E) within its boundaries that were active in 2005. Movement of three of these (landslides 1A, 1D, and 1E) caused considerable local ground deformation. Road-damage inventories along SR-9 and former SR-15 conducted in 2005 (Ashland and others, 2009) indicate that most of the damage occurs within the boundaries of landslide 1.

Figure 6. Detailed map of the southwestern part of the Meadow Creek landslide and landslides 1, 2, and 3.

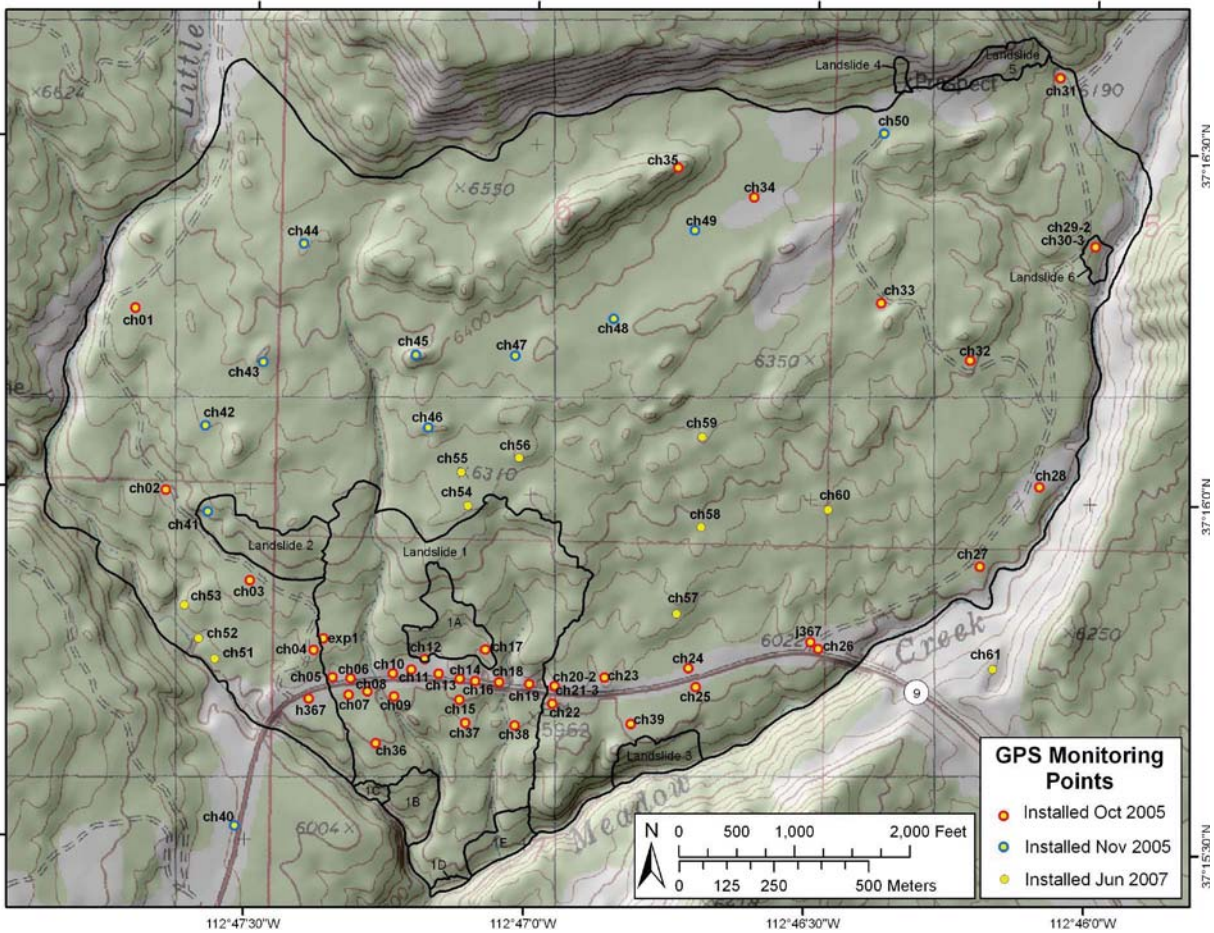
We performed landslide movement monitoring between October 2005 and October 2008 using a Trimble 5800 survey-grade Global Positioning System (GPS) instrument. The initial surveying was conducted in October 2005, with subsequent measurements taken in November 2005, June 2006, June 2007, July 2008, and October 2008. Additional survey points were installed in the upper, central, and western parts of the Meadow Creek landslide in November 2005 and June 2007, respectively (figure 13).

Figure 13. Locations and installation dates of survey points used to monitor movement of the Meadow Creek landslide using a survey-grade Global Positioning System (GPS) instrument. Survey point ch40 is an off-slide survey point. Survey point ch61 was installed in June 2007 to monitor movement of the Coal Hill landslide, which was inactive between June 2007 and October 2008.

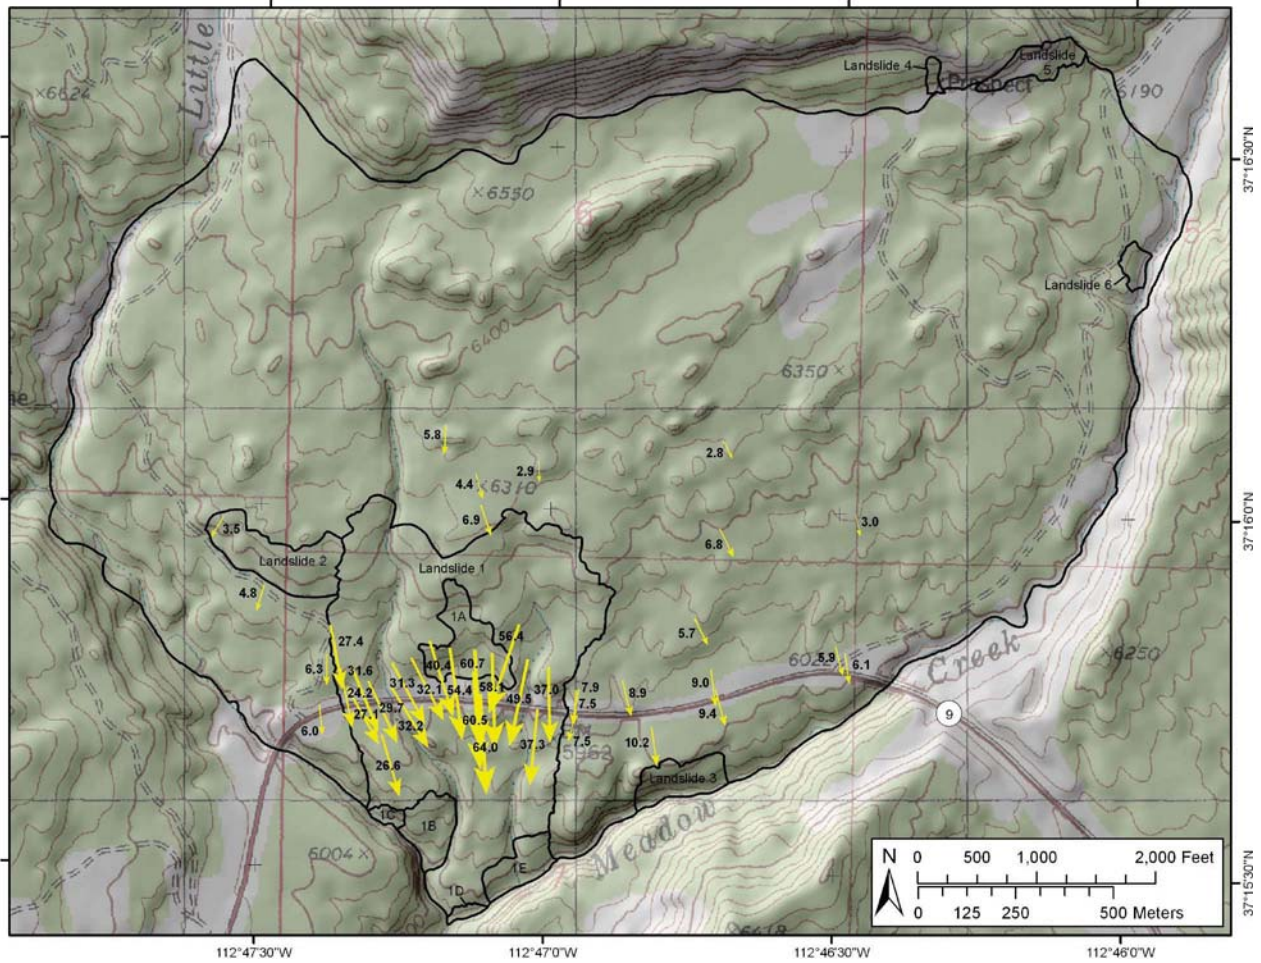
Movement of the southern half of the Meadow Creek landslide, including the part crossed by SR-9, was detected during the measurement period (October 2005 through October 2008), and the most movement occurred within the boundaries of landslide 1, where we measured a maximum horizontal displacement of about 64 inches (163 cm) (figure 14). Outside of the mapped boundaries of landslide 1, movement along SR-9 ranged from 6 to 10 inches (15-25 cm) during the same period. Interestingly, the most movement (greater than 9 inches [>23 cm] at four survey points) along the highway outside of landslide 1 occurred upslope of landslide 3. Stouffer (1964) mapped this active part of the slide, including part of landslide 1, as the “creep zone” and reported minor displacement, typically a few inches per year, of former SR-15. We detected no movement along the eastern and western edges of the Meadow Creek landslide, upslope of the intersection of SR-9 and Meadow Creek and along Coal Mine Road north of landslide 2, respectively. However, we measured between about 3 to 7 inches (8-18 cm) of movement (over a 16-month measurement period between June 2007 and October 2008), directly

Figure 14. Movement of the Meadow Creek landslide between the initial survey date (see figure 13) and October 2008. Most of the survey points along State Route 9 were installed in October 2005. Arrows show movement direction. Movement amounts in inches.

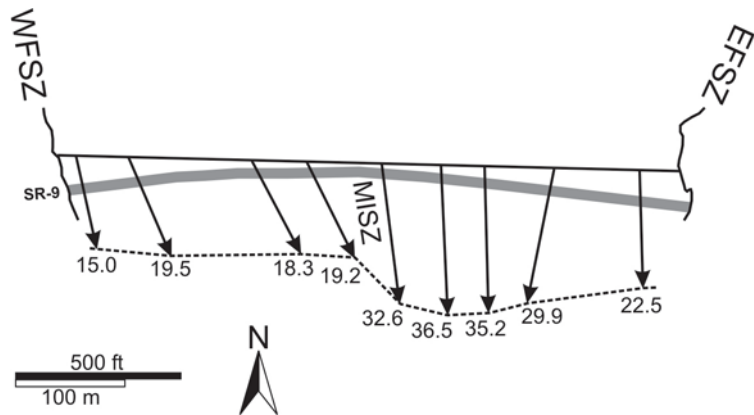
Figure 15. Variation in displacement across landslide 1. Figure shows the horizontal displacement (inches) of a hypothetical straight line across the slide during the measurement period (October 2005 to June 2007). Displacement has a generally bow-shaped pattern (in plan view) increasing toward the right center of the slide from both flanks. A significant step in displacement occurs across the main internal shear zone (MISZ). Parts of east- and west-flank shear zones (EFSZ, WFSZ) and SR-9 shown.

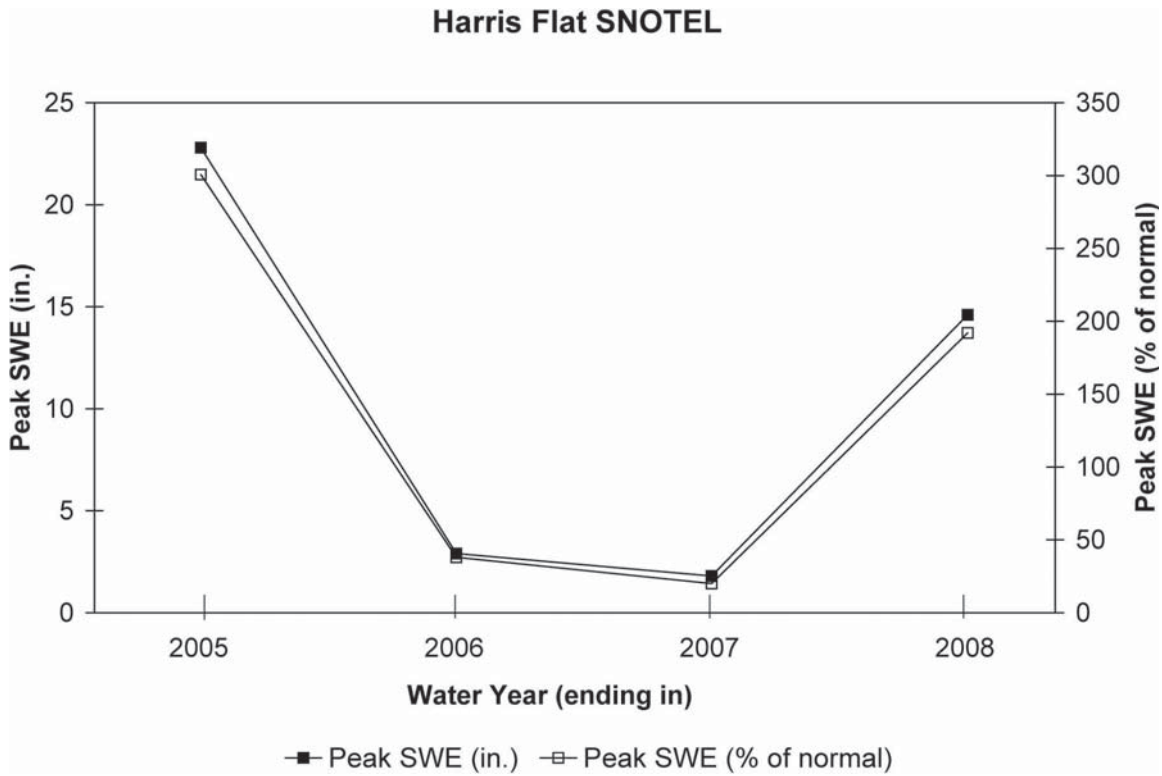
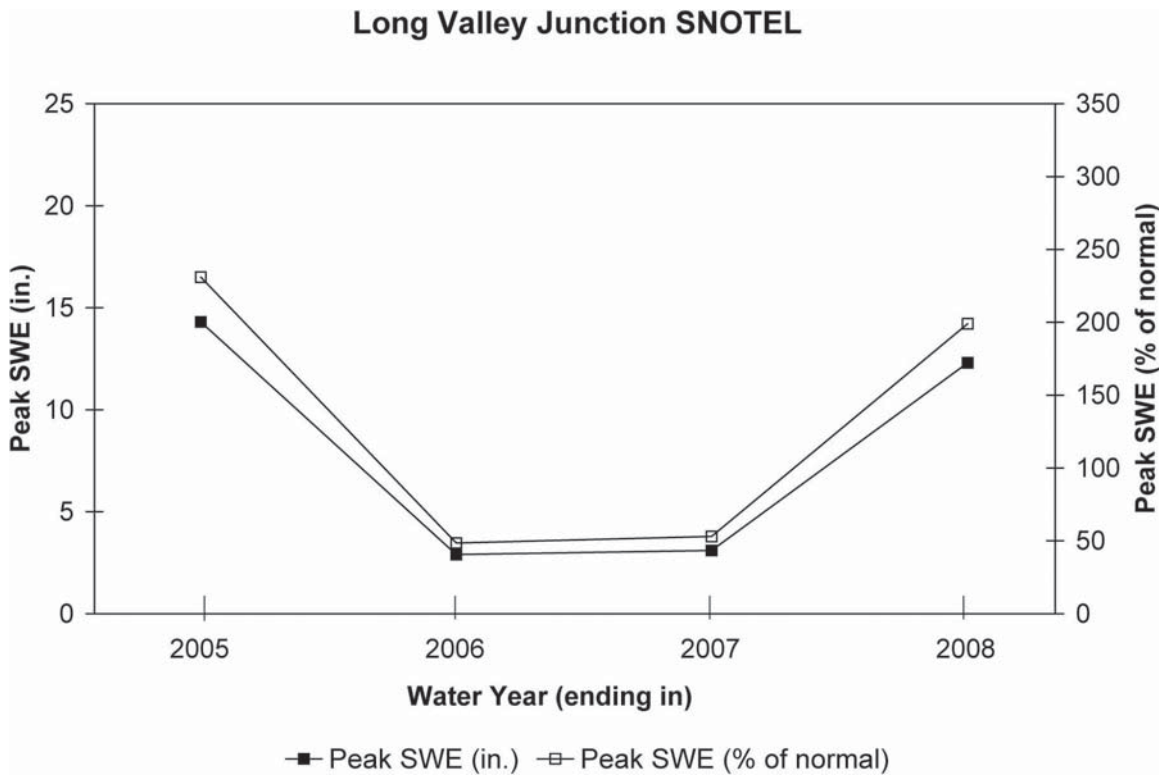
Figure 16. Comparison of peak snow water equivalent (SWE) of snowpack at two nearest SNOTEL stations to the Meadow Creek landslide for the 2005 through 2008 water years.

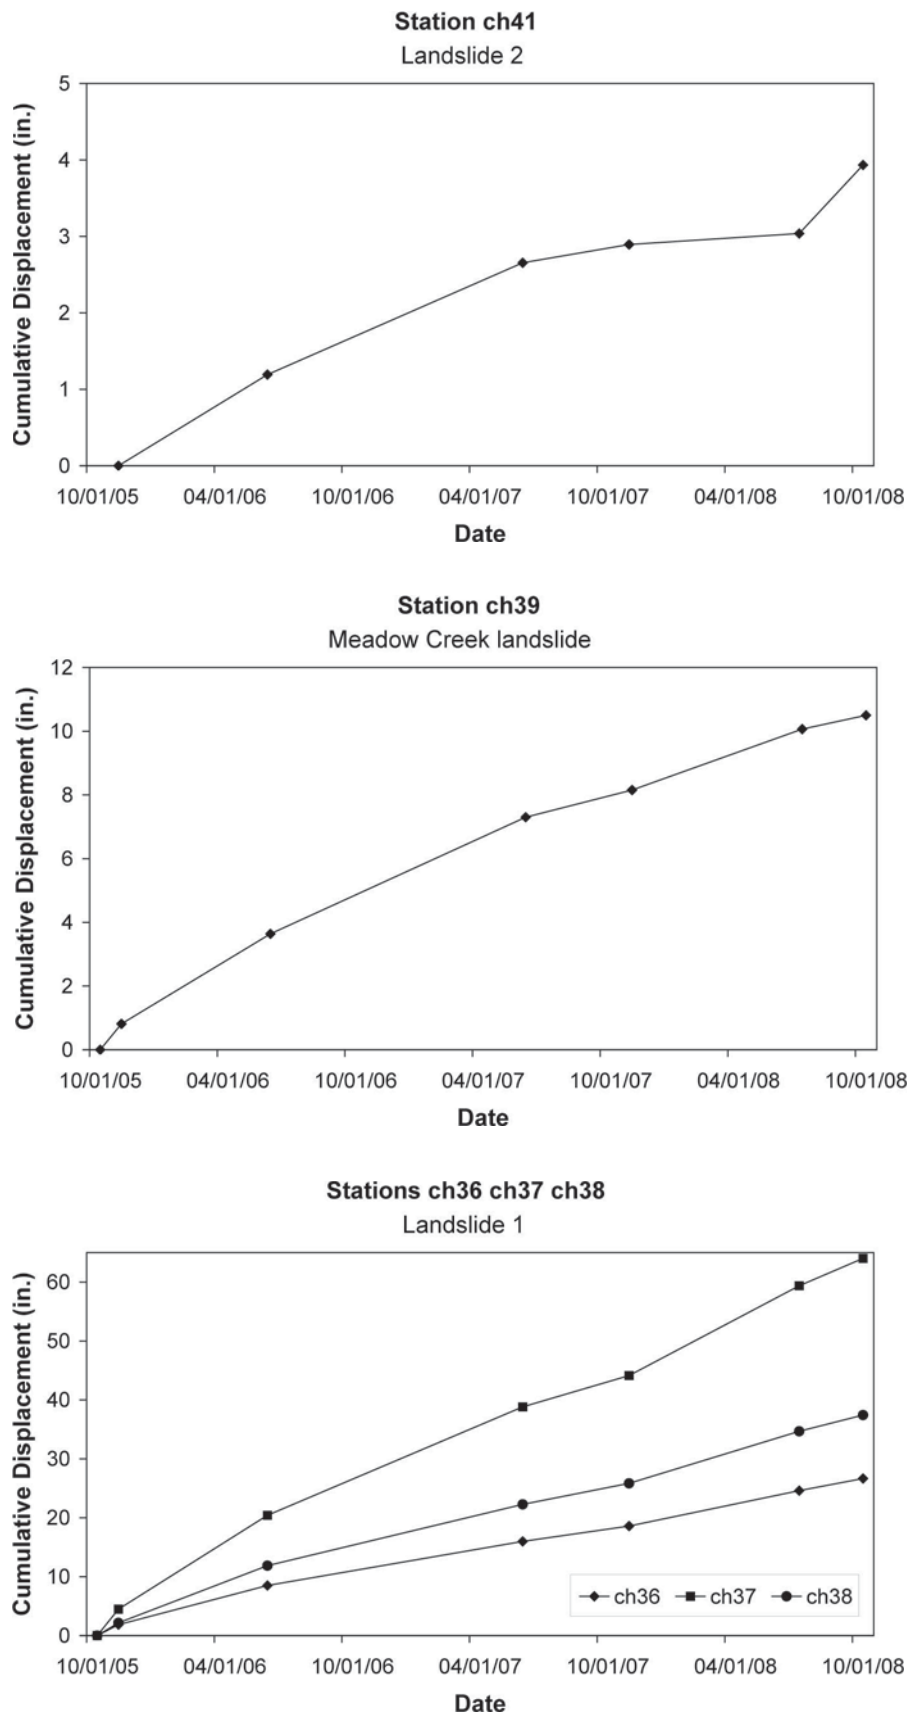
Figure 17. Plots showing cumulative movement of selected survey points on the Meadow Creek landslide and landslides 1 and 2. The average rate of movement of all three landslides decreased in the dry years of 2006 and 2007, but increased following the wet winter in the 2008 water year (see figure 16).
