Subject: **Docket No. 50-361**
Confirmatory Action Letter - Actions to Address Steam Generator Tube Degradation
San Onofre Nuclear Generating Station, Unit 2

SONGS Unit 2 Return to Service Report

SONGS 2C17 Steam Generator Condition Monitoring Report

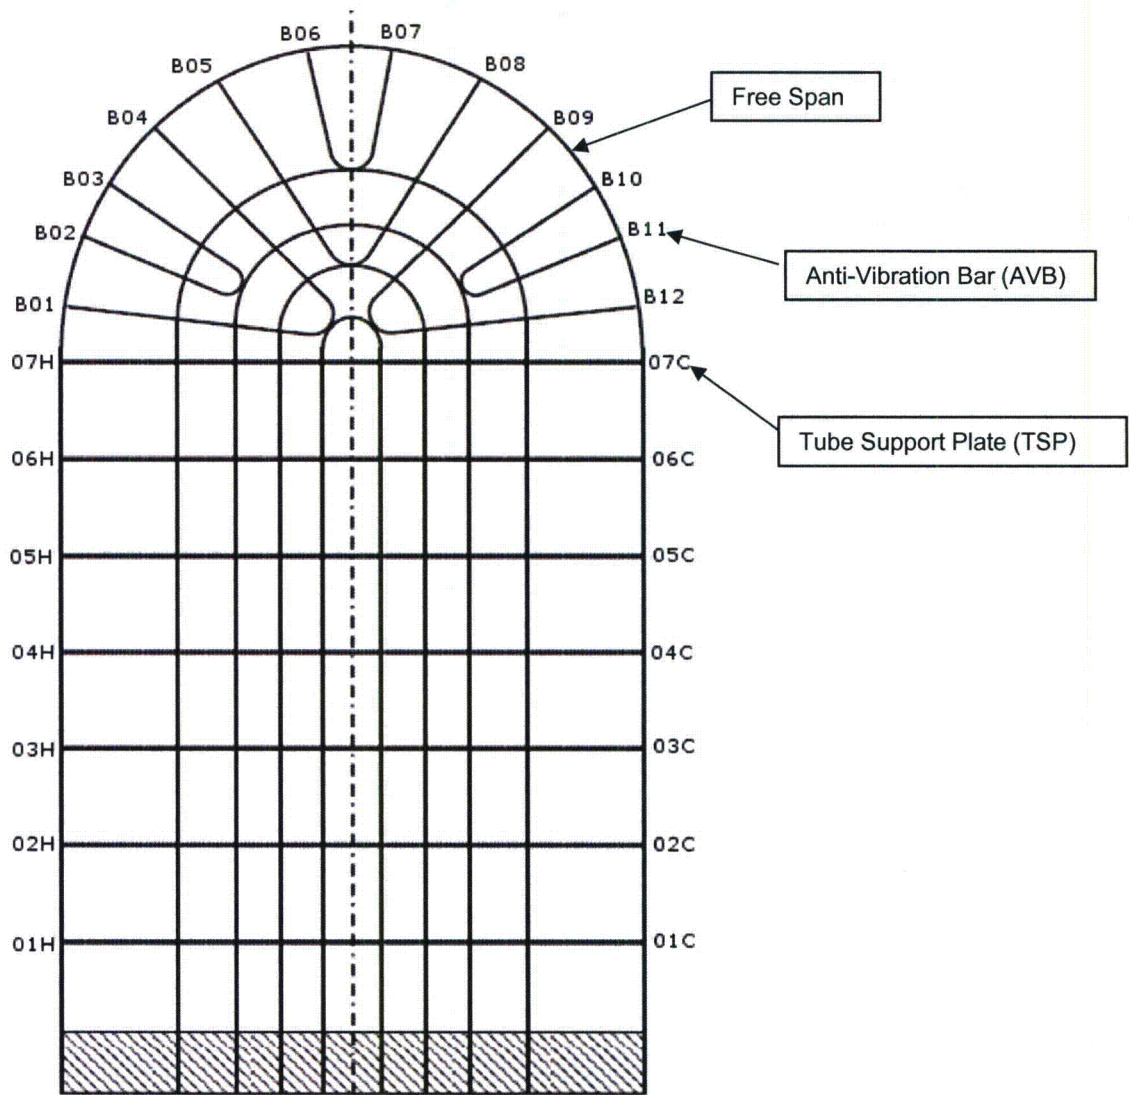
Figure 6-1: Steam Generator Section View Sketch

Following the identification of SG tube leakage in the Unit 3 SG 3E-088, extensive inspections were performed to determine the location and cause of the leak. The location of the leak was identified by filling the SG secondary side with nitrogen and pressurizing to 80 psig. The test identified the tube located at Row 106, Column 78 (R106 C78) as the source of the leakage. Using eddy current bobbin and rotating probes, the tube at R106 C78 and those immediately adjacent to it were inspected and the leakage location was confirmed. The leak location was in the U-bend portion of the tube in the “freSPAN” area between AVB support locations (refer to Figure 6-1).

To determine the extent of the wear that had resulted in a leak, an eddy current bobbin probe examination of the full-length of all tubes in both Unit 3 SGs was performed. The locations of tubes with TTW are shown on Figures 6-7 and 6-8. Based on the results of the bobbin probe examinations, TTW indications were then examined using a more sensitive +Point™ rotating probe. Figure 6-6 illustrates a comparison of the sensitivity of the two types of examinations. The more sensitive rotating probe examinations were also performed on a region of tubes adjacent to the tubes with detected TTW. This region is also shown on Figures 6-7 and 6-8. TTW indications were identified in 161 tubes in 3E-088 and 165 tubes in 3E-089. All of the TTW flaws were located in the U-bend portion of the tubes between TSPs 7H and 7C (shown on Figure 6-1).

Secondary side remote visual inspections were performed to supplement the eddy current results and provide additional information in support of the cause evaluation. The inspections included the 7th TSP and inner bundle passes at AVBs B04 and B09 (shown on Figure 6-1). The 7th TSP inspection revealed no unexpected or unusual conditions. The inner bundle passes included several inspections between columns 73 and 87 and showed instances of wear indications that extended outside the AVB intersection. This was confirmed by eddy current data. Additional passes were made between columns 50 and 60. These inspections did not show any AVB wear outside the AVB intersections.

Most of the tube wear identified in the SGs is adjacent to a tube support. Figure 6-1 is a side view of an SG, showing the relationship of the tubes to the two types of tube supports: TSPs in the straight portions and AVBs in the U-bend portions of the tubes. All tubes are adjacent to many of these two types of tube supports. The RB supports are not shown because a very small number of tubes are adjacent to them.

TTW indications occurred in the free span sections of the tubes. The “free span” is that section of the tube between support structures (AVBs and TSPs shown in Figure 6-1). TTW occurred almost exclusively in Unit 3 and is located on both the hot and cold leg side of the U-tube. In many cases, the region of the tube with TTW has two separate indications on the extrados and intrados of the tube. The wear indications on neighboring tubes have similar depth and position (ranging from 1.0 to 41 inches long and 4% to 100% throughwall) along the U-bend, confirming the tube-to-tube contact.

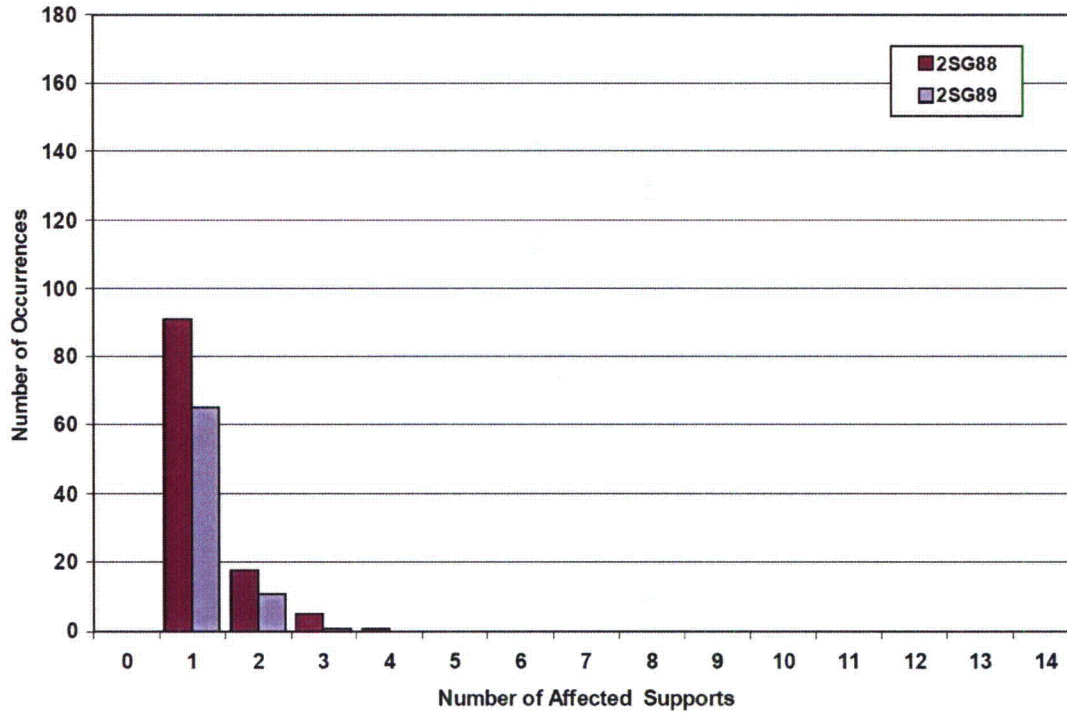
Figure 6-4: Unit 2 Distribution of Wear at TSP Supports

Table 6-1 provides the Wear Depth Summary for each of the four SGs based on eddy current examination results. Detailed results of the examinations performed are provided in the Units 2 and 3 CM reports included as Attachments 2 and 3. Figures 6-2 through 6-5 provide distributions of wear at AVB and TSP supports for all four SGs.

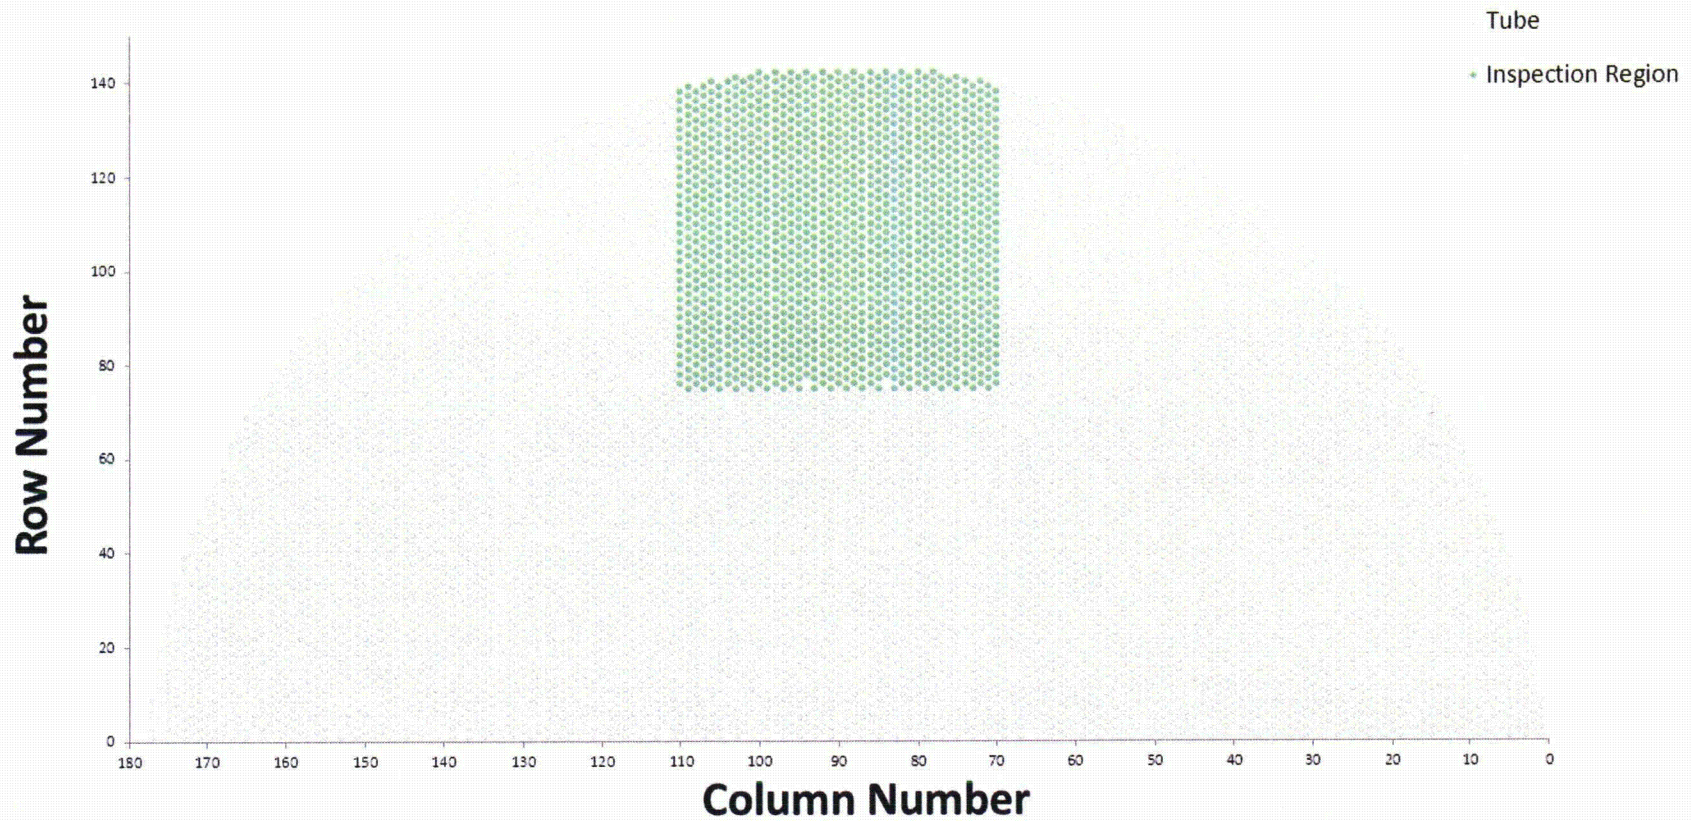
Figure 7-1: 2E-088 Rotating Coil Inspection Region

Rotating Pancake Coil ECT and Ultrasonic Testing (UT) were performed to measure the tube-to-AVB gap sizes in the Unit 2 SGs. Tube-to-AVB gap data was used to validate the contact force distribution model used in the TTW OA, (Attachment 6, Appendix B).

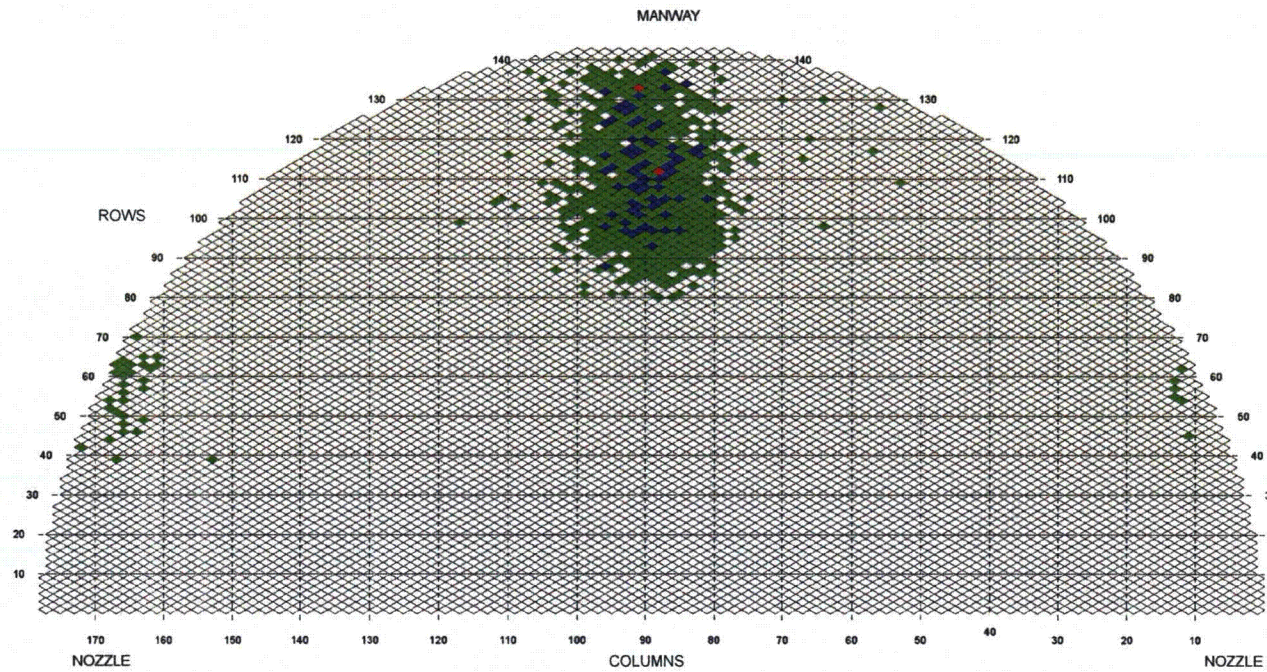
Figure 6-1: SG 2E-088 AVB Wear

GROUP	TUBES	>=35% TWD	2	20-34% TWD	72	<20% TWD	594
GROUP	TUBES									
>=35% TWD	2									
20-34% TWD	72									
<20% TWD	594									
<p>S/G 88 Repl HOT and COLD Leg Indications PRIMARY FACE</p>	<p>AREVA - FOMD max model Version 11.3</p> <p>TOTAL TUBES: 9727 SELECTED TUBES: 595 OUT OF SERVICE (#): NA</p>	<p>SCALE: 0.066571 X Fri Aug 10 15:30:03 2012</p>

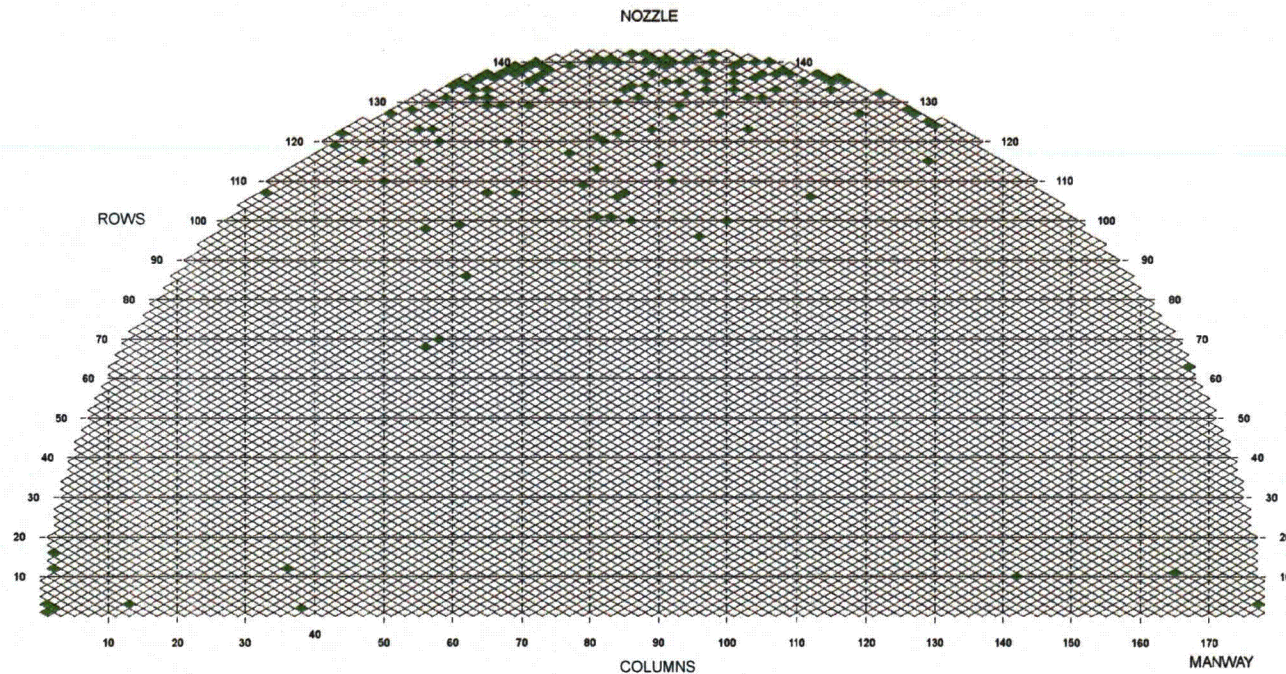
Figure 6-3: SG 2E-088 TSP Wear – Hot Leg

<p>SCE-SONGS Unit 2 - REPL Hot Leg TSP Wear</p>		<p>GROUP</p> <p>>=35% TWD 0</p> <p>20-34% TWD 0</p> <p><20% TWD 141</p>
<p>S/G 88 Repl HOT PRIMARY FACE</p>		<p>AREVA - FORM msp module Version 11.4</p> <p>TOTAL TUBES: 9727</p> <p>SELECTED TUBES: 141</p> <p>OUT OF SERVICE (#): NA</p>
		<p>SCALE: 0.086571 X</p> <p>Fri Aug 10 15:42:56 2012</p>

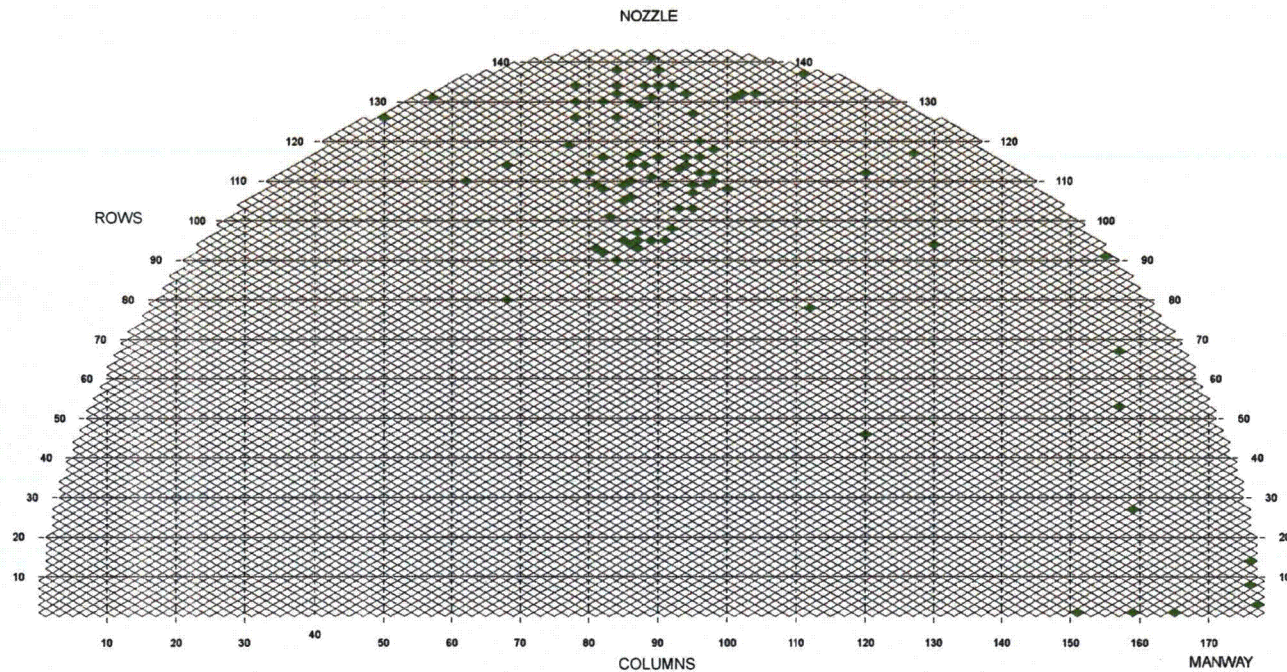
Figure 6-5: SG 2E-089 TSP Wear – Hot Leg

<p>SCE-SONGS Unit 2 - REPL Hot Leg TSP Wear</p>		<p>GROUP</p> <p>>=35% TWD 0</p> <p>20-34% TWD 0</p> <p><20% TWD 86</p>	<p>TUBES</p> <p>0</p> <p>0</p> <p>86</p>
<p>AREVA - TSPMS Hot Leg Model Version 11.0</p>		<p>TOTAL TUBES: 9727</p> <p>SELECTED TUBES: 86</p> <p>OUT OF SERVICE (#): NA</p>	
<p>SG 89 Repl</p> <p>HOT</p> <p>PRIMARY FACE</p>	<p>SCALE: 0.086571 X</p> <p>Fri Aug 10 15:51:07 2012</p>

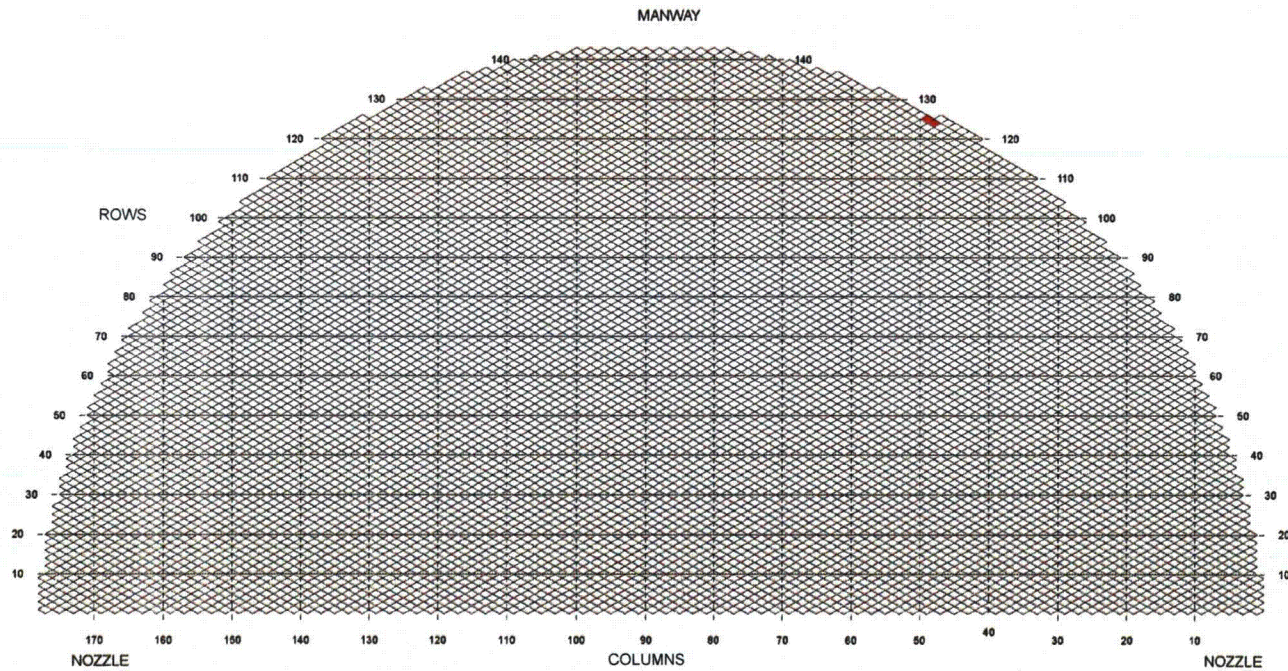
Figure 6-7: SG 2E-088 Retainer Bar Wear

<p>SCE-SONGS Unit 2 - REPL Retainer Bar Wear Indications</p>		<p>GROUP B 803</p>	<p>TUBES 2</p>
<p><small>AREVA - 2008 max model version 11.0</small></p>		<p>TOTAL TUBES: 9727 SELECTED TUBES: 2 OUT OF SERVICE (#): NA</p>	
<p>S/G 88 Repl HOT Leg Indications PRIMARY FACE</p>		<p>SCALE: 0.066571 X Fri Aug 10 11:25:33 2012</p>

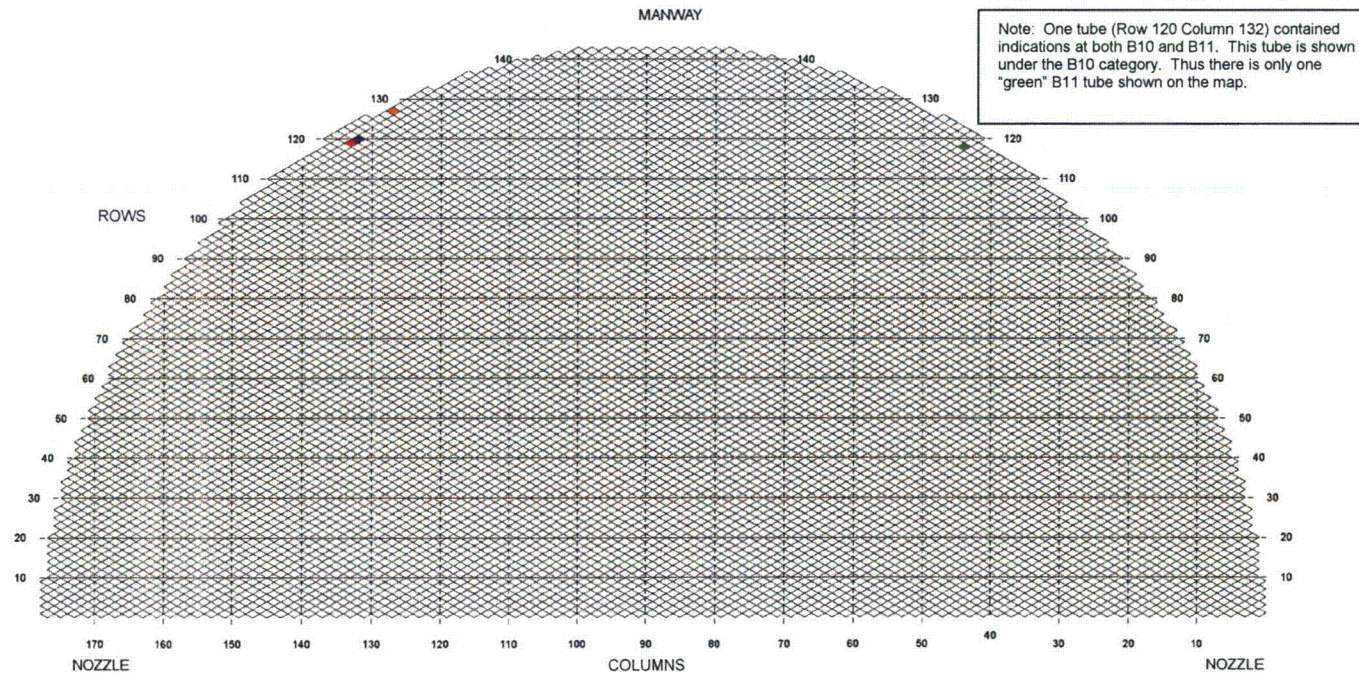
Figure 6-8: SG 2E-089 Retainer Bar Wear

GROUP	TUBES	B02	1	B03	1	B10	1	B11	2
GROUP	TUBES											
B02	1											
B03	1											
B10	1											
B11	2											
<p>AREVA - FOMIS map module Version 11.2</p>	<p>TOTAL TUBES: 9727 SELECTED TUBES: 4 OUT OF SERVICE (#): NA</p>	<p>SCALE: 0.066571 X Fri Aug 10 16:00:40 2012</p>										
<p>SG 89 Repl HOT and COLD Leg Indications PRIMARY FACE</p>

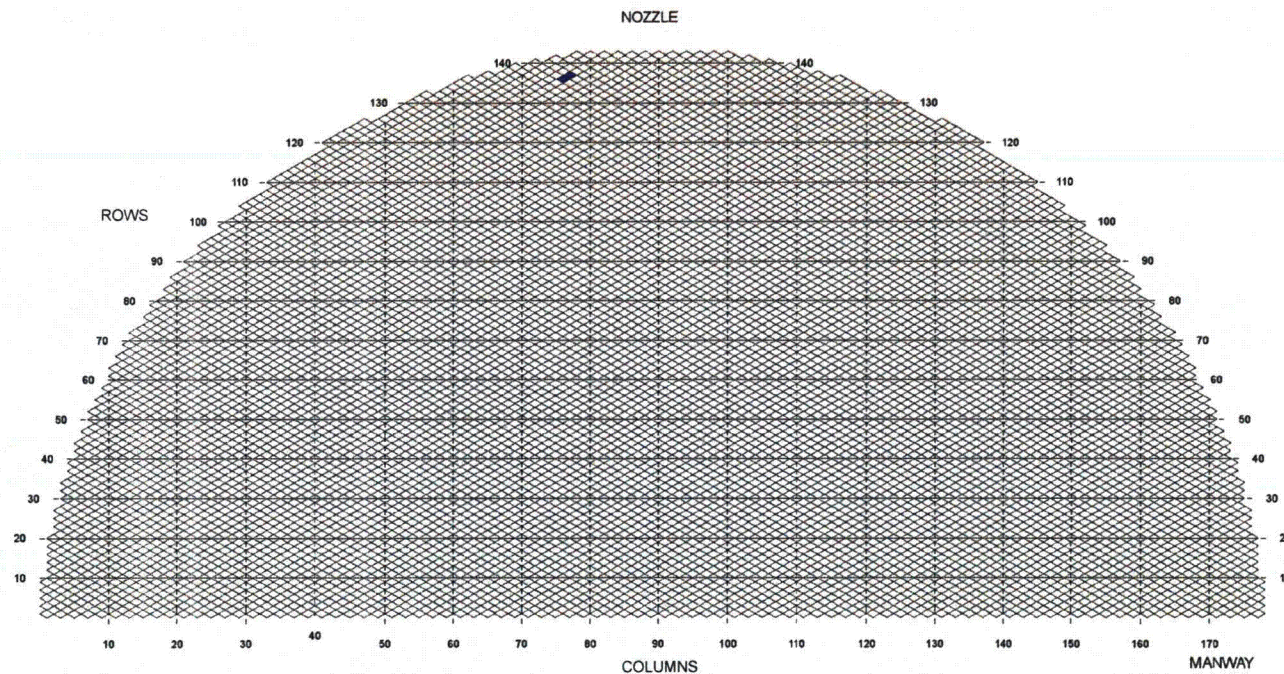
Figure 6-9: SG 2E-088 Foreign Object Wear

<p>SCE-SONGS Unit 2 - REPL Foreign Object Wear (@04H)</p>		<p>GROUP TUBES F Foreign Object Wear 2</p>
<p><small>AREVA - TOWS max module version 1.2</small></p>		
<p>SG 88 Repl HOT PRIMARY FACE</p>	<p>TOTAL TUBES: 9727 SELECTED TUBES: 2 OUT OF SERVICE (#): NA</p>	<p>SCALE: 0.066571 X Fri Aug 10 11:34:38 2012</p>
