**AREVA Document 51-9180143-001
SONGS Unit 3 February 2012 Leaker Outage
Steam Generator Condition Monitoring Report**

Document No.: 51 - 9180143 - 001

SONGS Unit 3 February 2012 Leaker Outage - Steam Generator Condition Monitoring Report

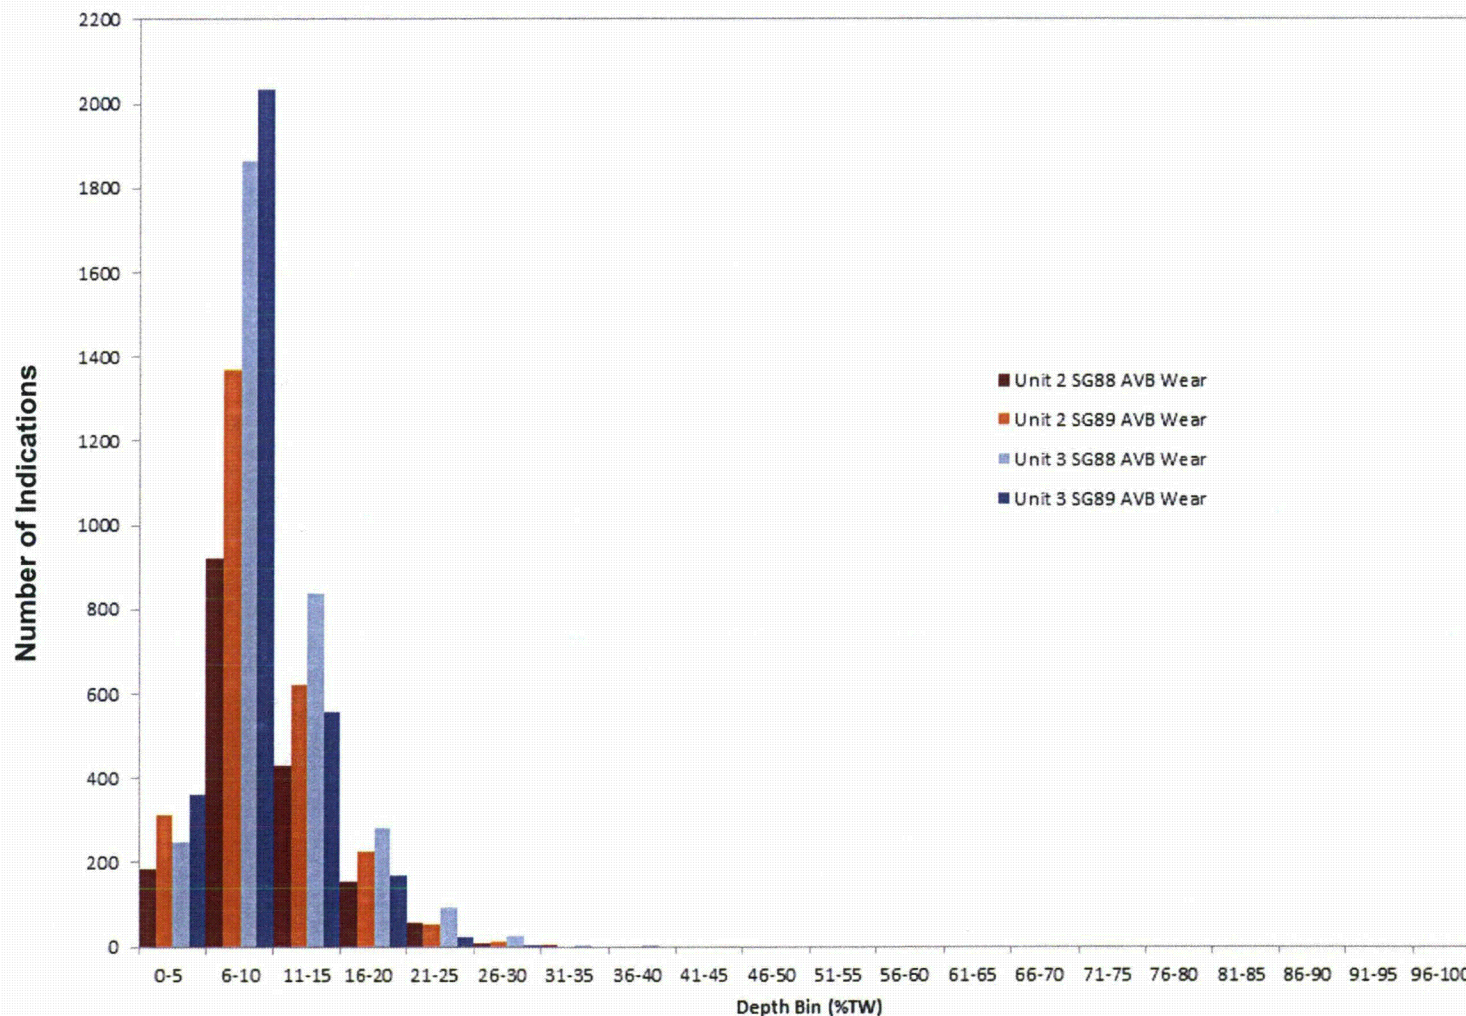
Figure 7-2: Comparison of Unit 2 and Unit 3 AVB Wear Depth Distribution (Indication Count)

Figure 7-1 provides histograms of reported AVB wear depths for both SGs which demonstrate that the vast majority of AVB wear was less than 25 %TW. Approximately 50% more AVB wear indications were identified in Unit 3 than in Unit 2; however, the depth distributions at both units were very similar (Figure 7-2). However, since Unit 3 operated for only part of a cycle, it must be concluded that AVB wear is progressing more aggressively at Unit 3 than at Unit 2.

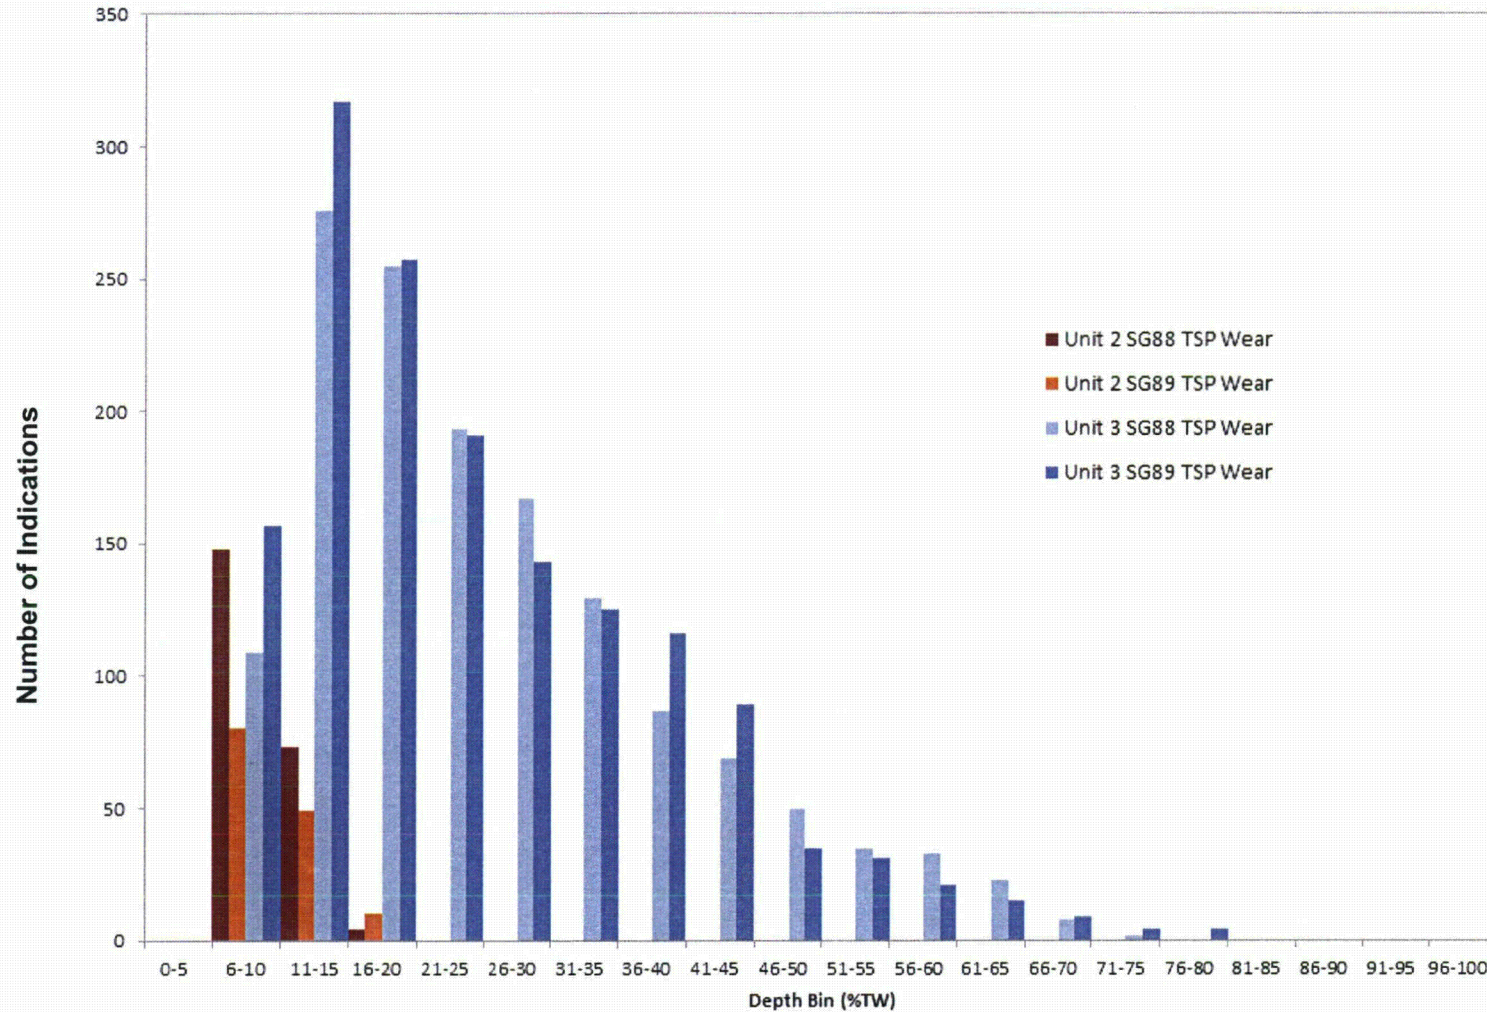
Figure 7-4: Comparison of Unit 2 and Unit 3 TSP Wear Depth Distribution (Indication Count)

Figure 7-3 provides histograms of reported TSP wear depths for both SGs. This data illustrates that a significant number of tubes experienced TSP wear with throughwall depths in excess of the criteria for plugging. This contrasts sharply with the relatively minor TSP wear identified at Unit 2 after a full cycle of operation (Figure 7-4).

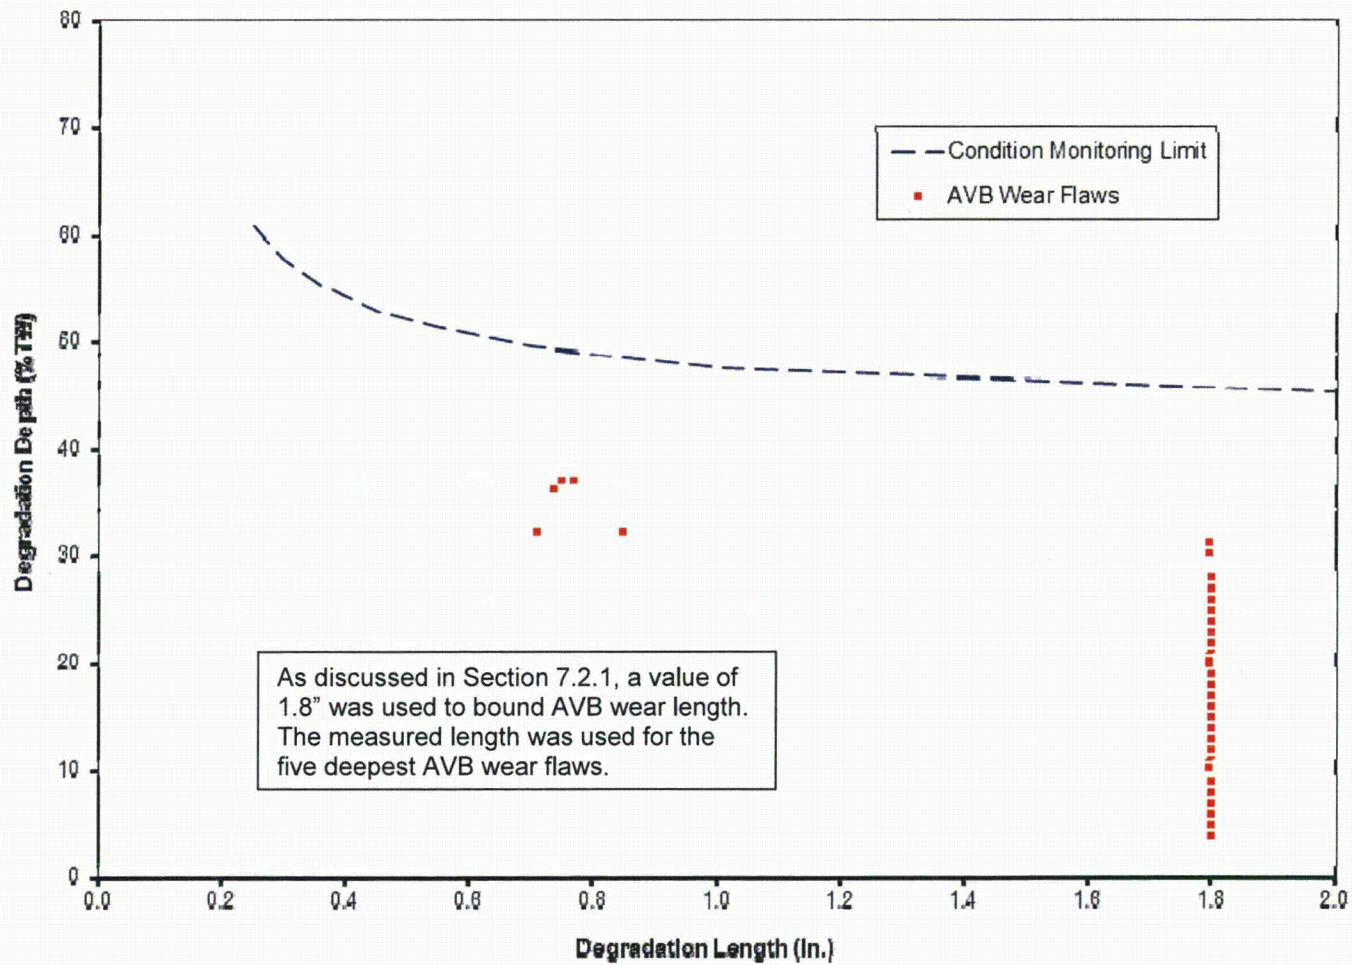
Figure 8-1: CM Limit for AVB Wear, Both SGs, ETSS 96004.1

The bobbin probe was used to measure the depth of AVB wear through the application of ETSS 96004.1. A CM limit curve for AVB wear based upon ETSS 96004.1 and the parameters provided in Table 8-1 and Table 8-2 is provided in Figure 8-1. This figure also includes the throughwall depth of each indication reported. The five largest indications are plotted at their measured axial length, while the rest are plotted at the assumed axial length of 1.8 inches. The assumed flaw length for AVB wear indications was derived from measurements taken on over 350 AVB wear indications in the Unit 3 SGs, wherein the maximum indicated length was 1.59 inches. The field of the eddy current probe extends beyond the dimensions of the coil and thus the probe will sense a flaw before the coil is physically over the flaw. This effect occurs on both ends of the flaw, and the effect becomes more significant as the flaw depth increases. This phenomenon is known as "probe look-ahead" and the net effect is that the axial length reported for a wear flaw will normally be longer than the actual flaw length. Because the above AVB wear measurements were not adjusted downward to reflect the impact of ECT probe look-ahead, these measurements are considered to be appropriately conservative.

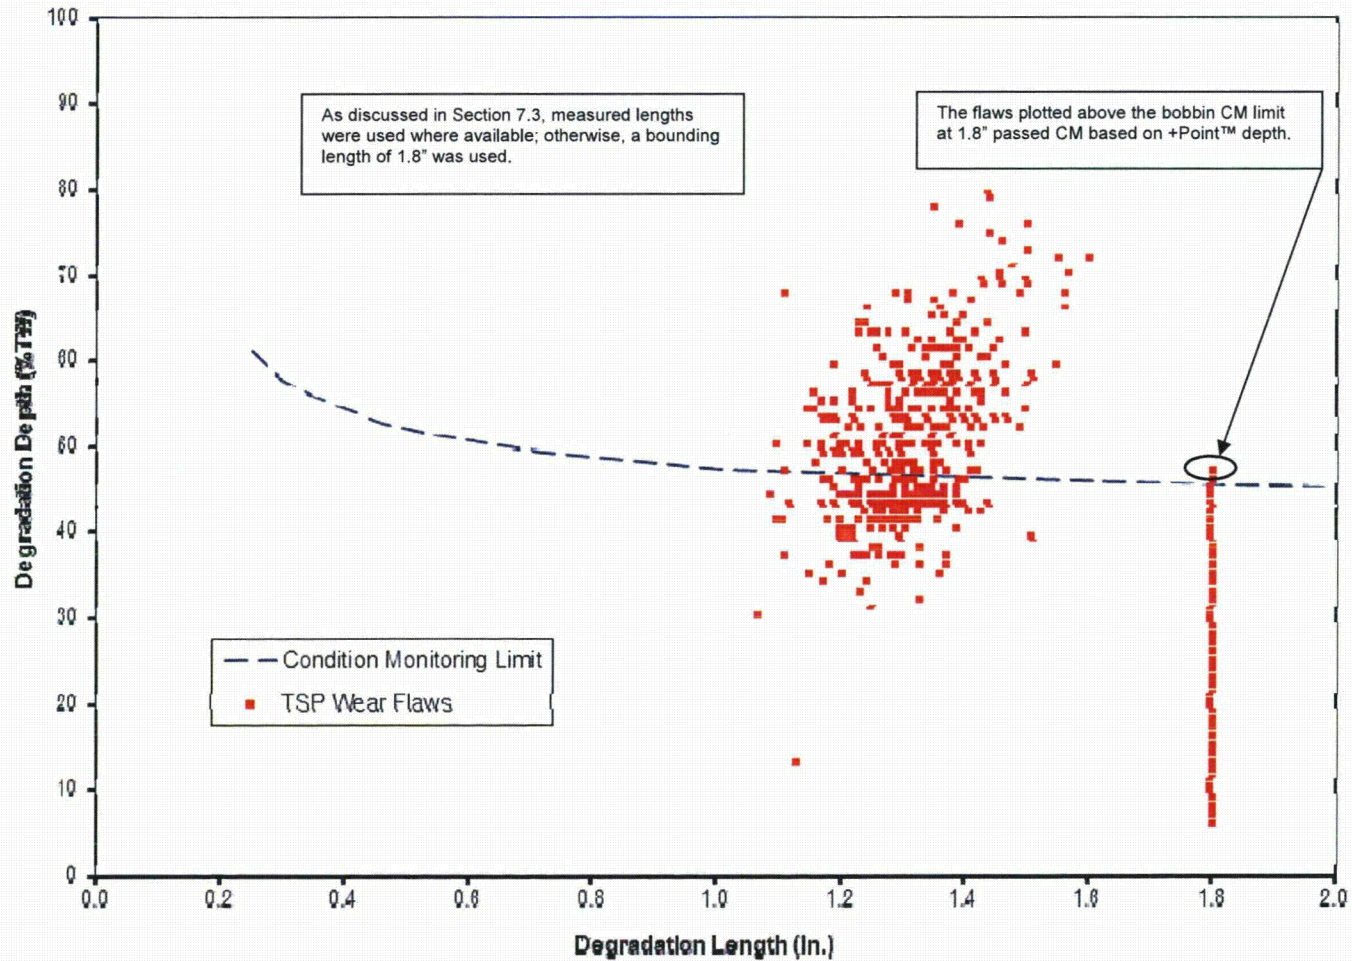
Figure 8-2: CM Limit for TSP Wear, Both SGs, ETSS 96004.1

The bobbin probe was used to estimate the depth of TSP wear through the application of ETSS 96004.1. A CM limit curve for TSP wear based upon ETSS 96004.1 and the parameters provided in Table 8-1 and Table 8-2, is provided in Figure 8-2. This figure also includes the throughwall depth of each indication reported. Indications for which axial length measurements were available are plotted using the bobbin-measured lengths. The rest of the indications are plotted at an assumed axial length of 1.8 inches. This value was derived from measurements taken on over 400 TSP wear indications in the Unit 3 SGs, wherein the maximum indicated length was 1.6 inches. Because these measurements were not adjusted downward to reflect the impact of ECT probe look-ahead, and because the actual flaw length is expected to be limited to the TSP thickness (1.38”), this assumption is considered to be appropriately conservative.

Figure 8-2 illustrates that a substantial number of TSP wear indications exceeded the CM limit. However, this result is based upon bobbin probe estimates of maximum indication depth, assumed to occur over the entire bounding indication length. This is a very conservative approach.

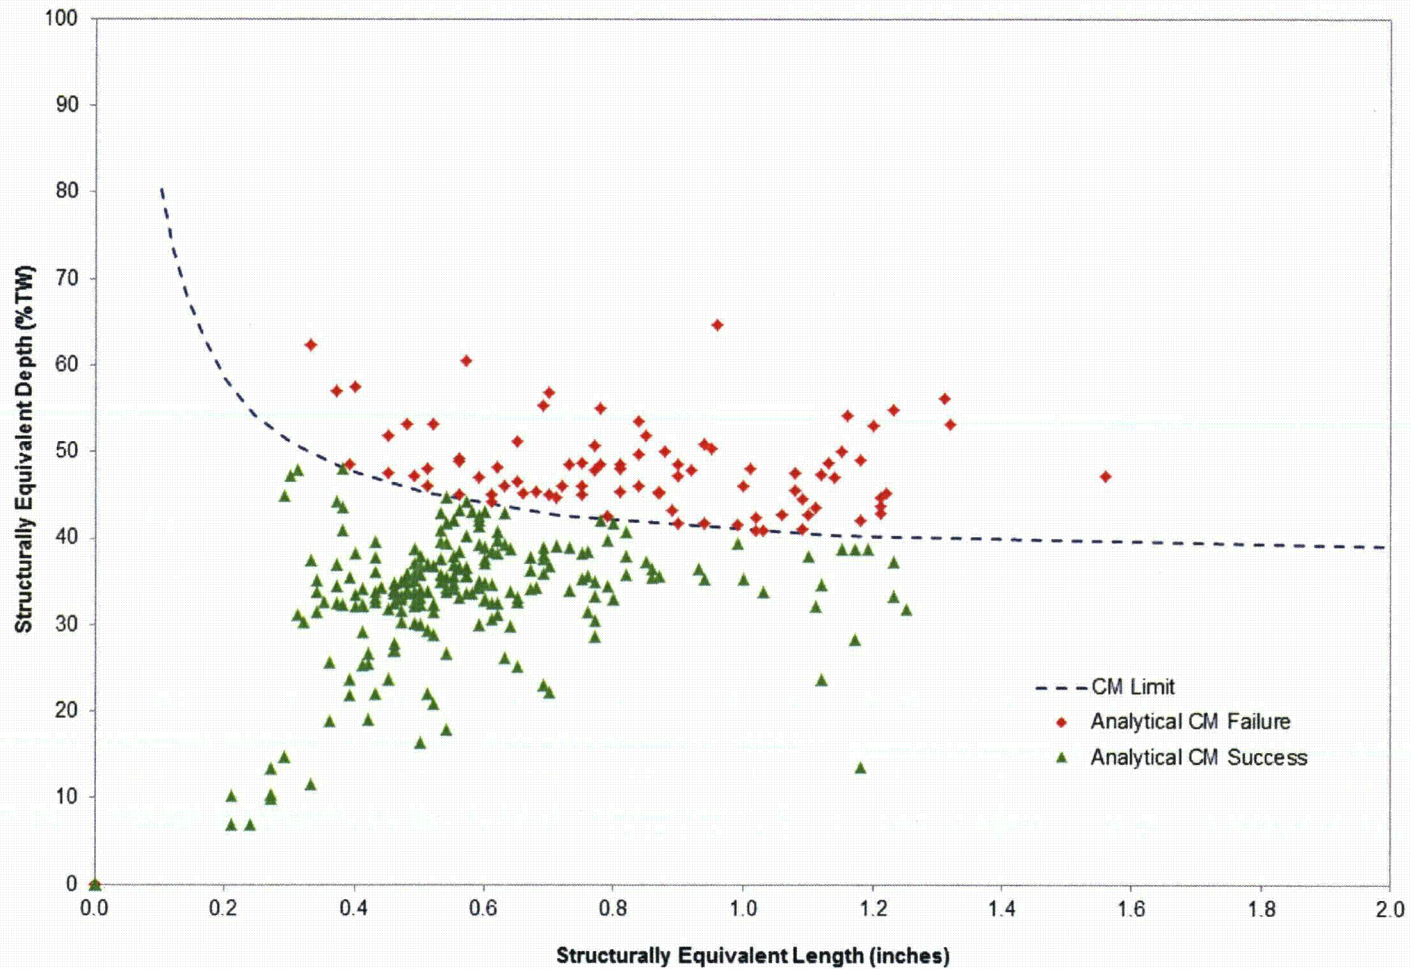
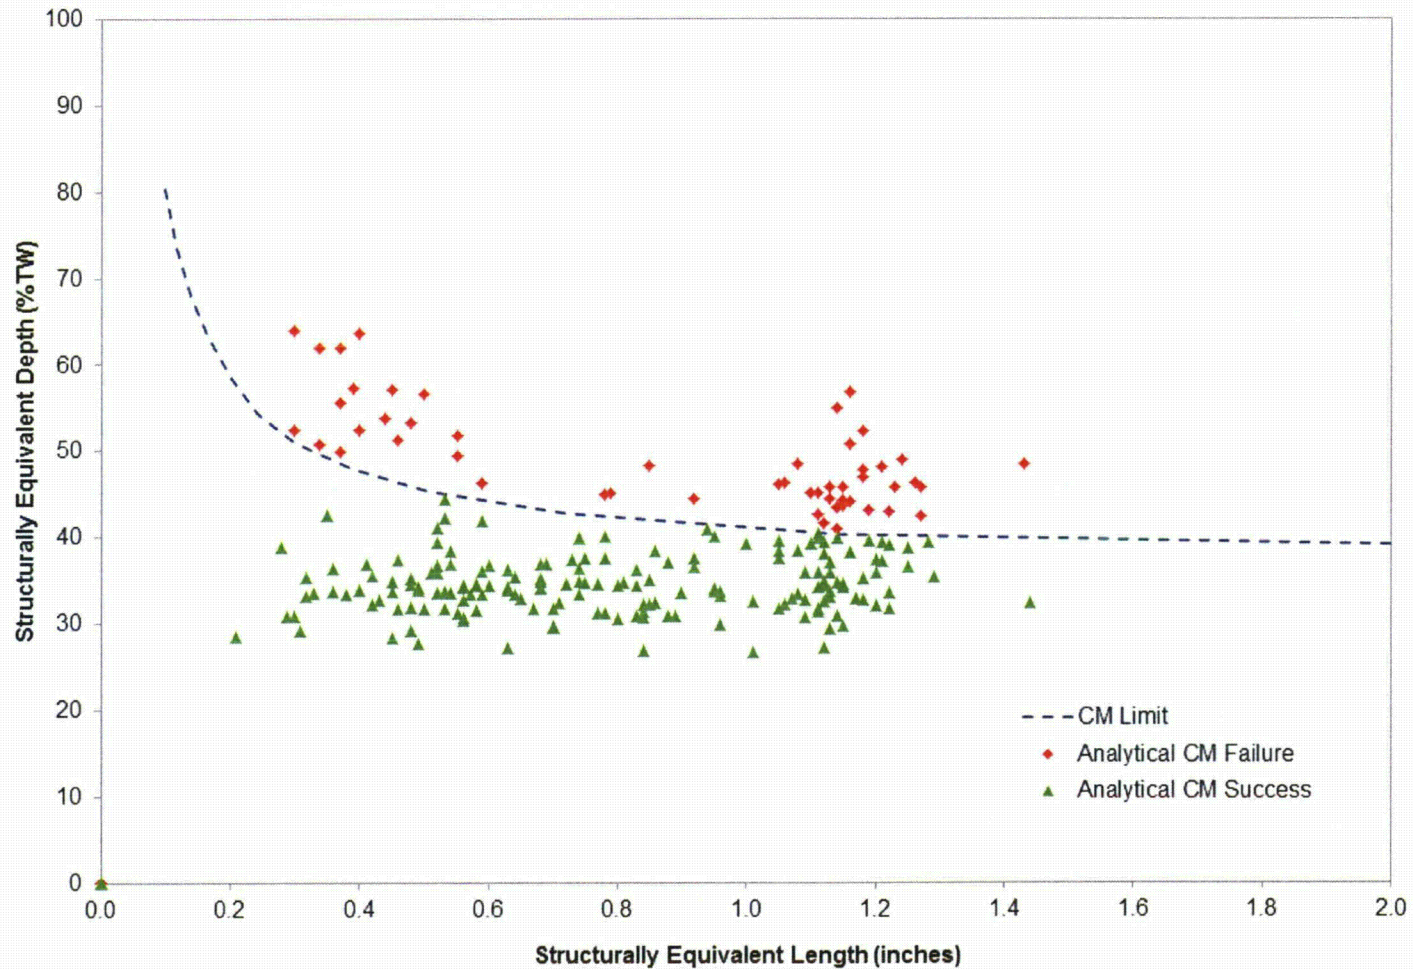
CM limit curves for TSP wear based upon ETSS 96910.1 are provided for SG 3E-088 and SG 3E-089 in Figure 8-3 and Figure 8-4, respectively. This figure also depicts the structural dimensions of all indications for which axial depth profiling was performed, including those that exceeded the CM curve in Figure 8-2. Note that any given TSP elevation may have multiple wear flaws (i.e., at more than one land contact) and one of the flaws is typically deeper than the others. Since, in some cases, depth profiling was performed on all of the flaws at a given TSP elevation, the figures include many TSP wear indications of lesser significance than those that exceeded the CM curve in Figure 8-2.

Figure 8-3 and Figure 8-4, many TSP wear indications exceeded the CM curve thus; satisfaction of the CM criteria could not be analytically demonstrated. Consequently, all of the TSP wear flaws that exceeded the CM limit were subjected to in-situ pressure testing in an attempt to demonstrate CM criteria compliance.

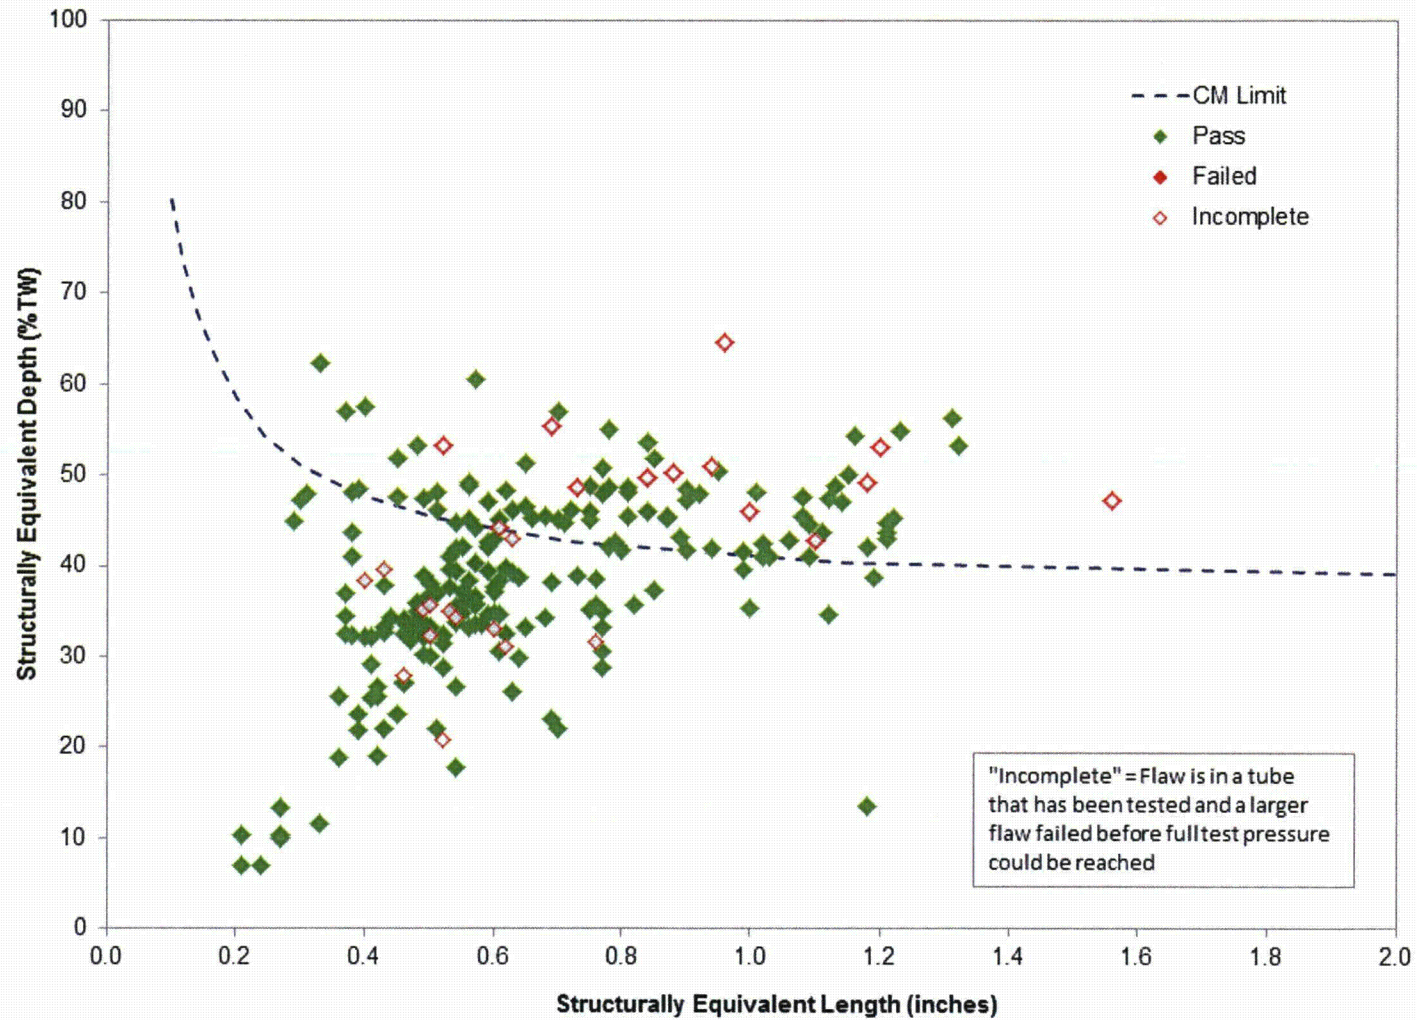
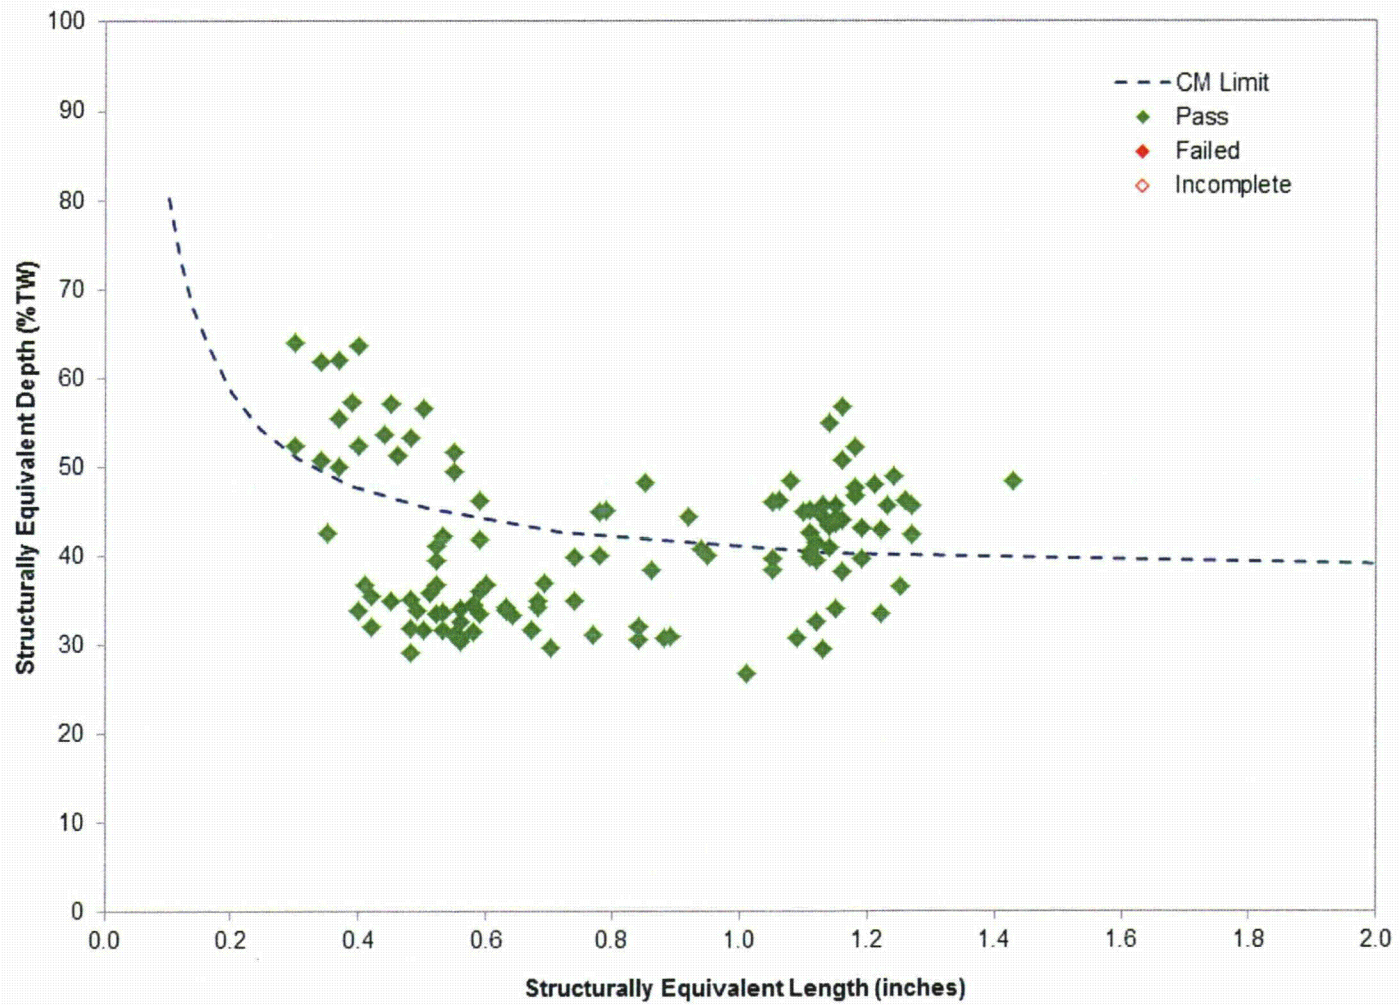
Figure 8-5 and Figure 8-6 summarize the results of in-situ testing of TSP wear flaws in each SG. All tested TSP wear in SG 3E-089 satisfied the structural integrity and accident leakage performance criteria. In SG 3E-088 a number of indications could not be tested to the required pressure levels because more limiting TTW in the same tube failed below the target pressure thus terminating the test. These indications are depicted in Figure 8-5 as "Incomplete." In the absence of a successful in-situ pressure test, those indications identified as incomplete which lie above the CM curve must be considered to be CM structural integrity performance criteria (SIPC) failures. These indications are listed in Table 8-3.

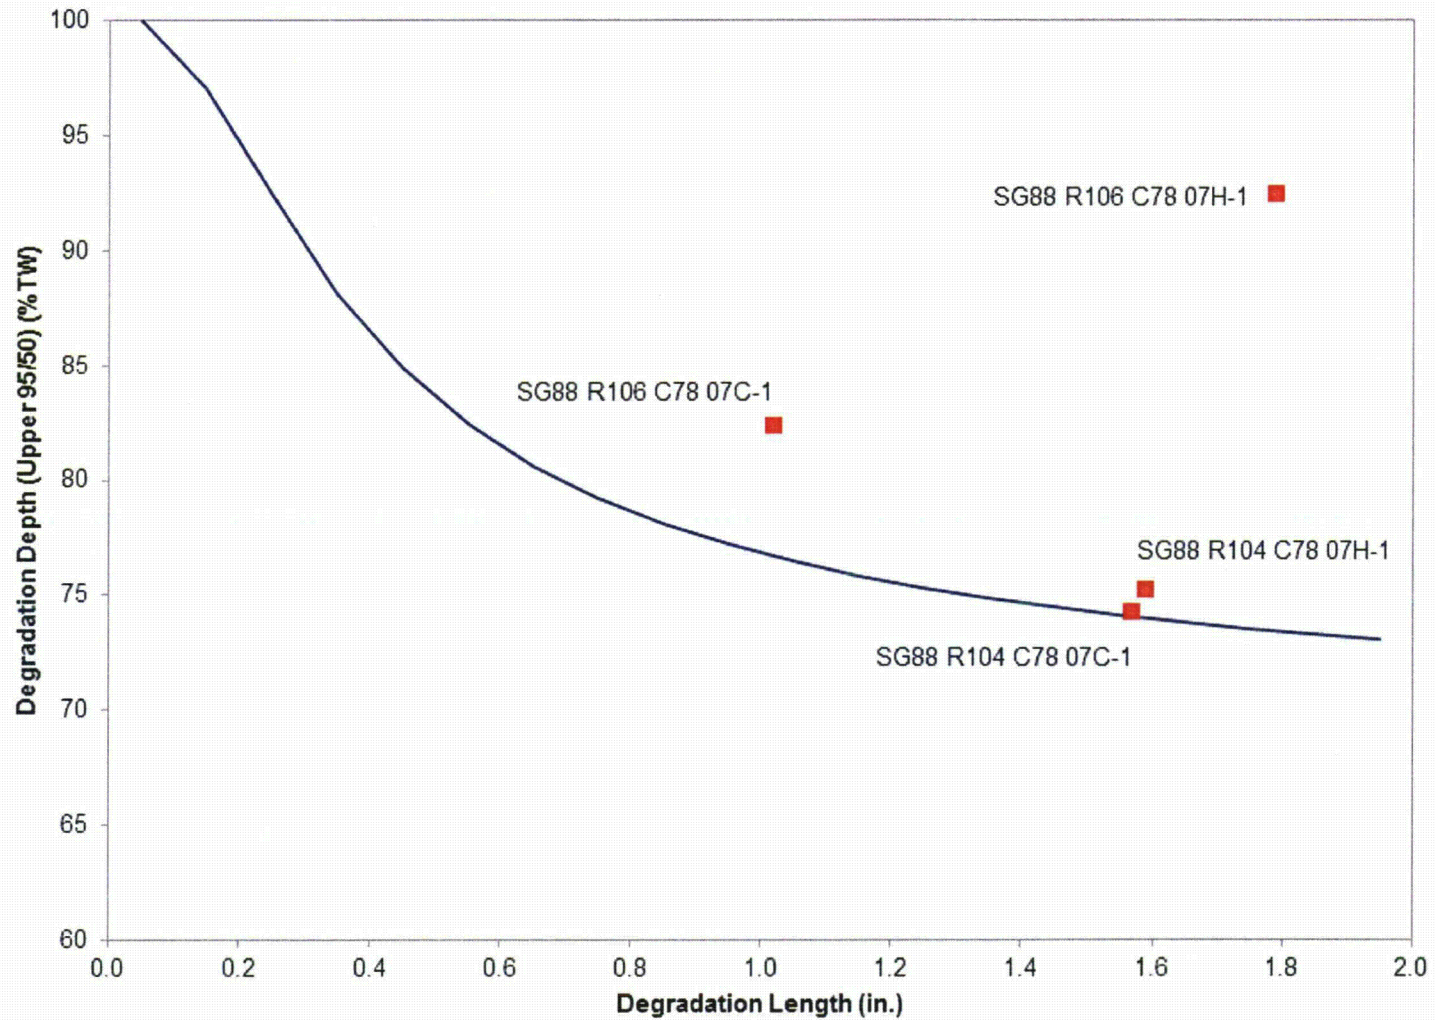
Figure 8-8: Axial Pop-Through Limit for TSP Wear

circumferential orientation. The axial pop-through evaluation performed for TSP wear and summarized in Figure 8-8 is applicable for RB wear and provides the basis for concluding that the limiting RB wear satisfied the AILPC in the axial direction. Hence, all four of the RB wear indications satisfied the SONGS AILPC during the operating period prior to the leaker outage.

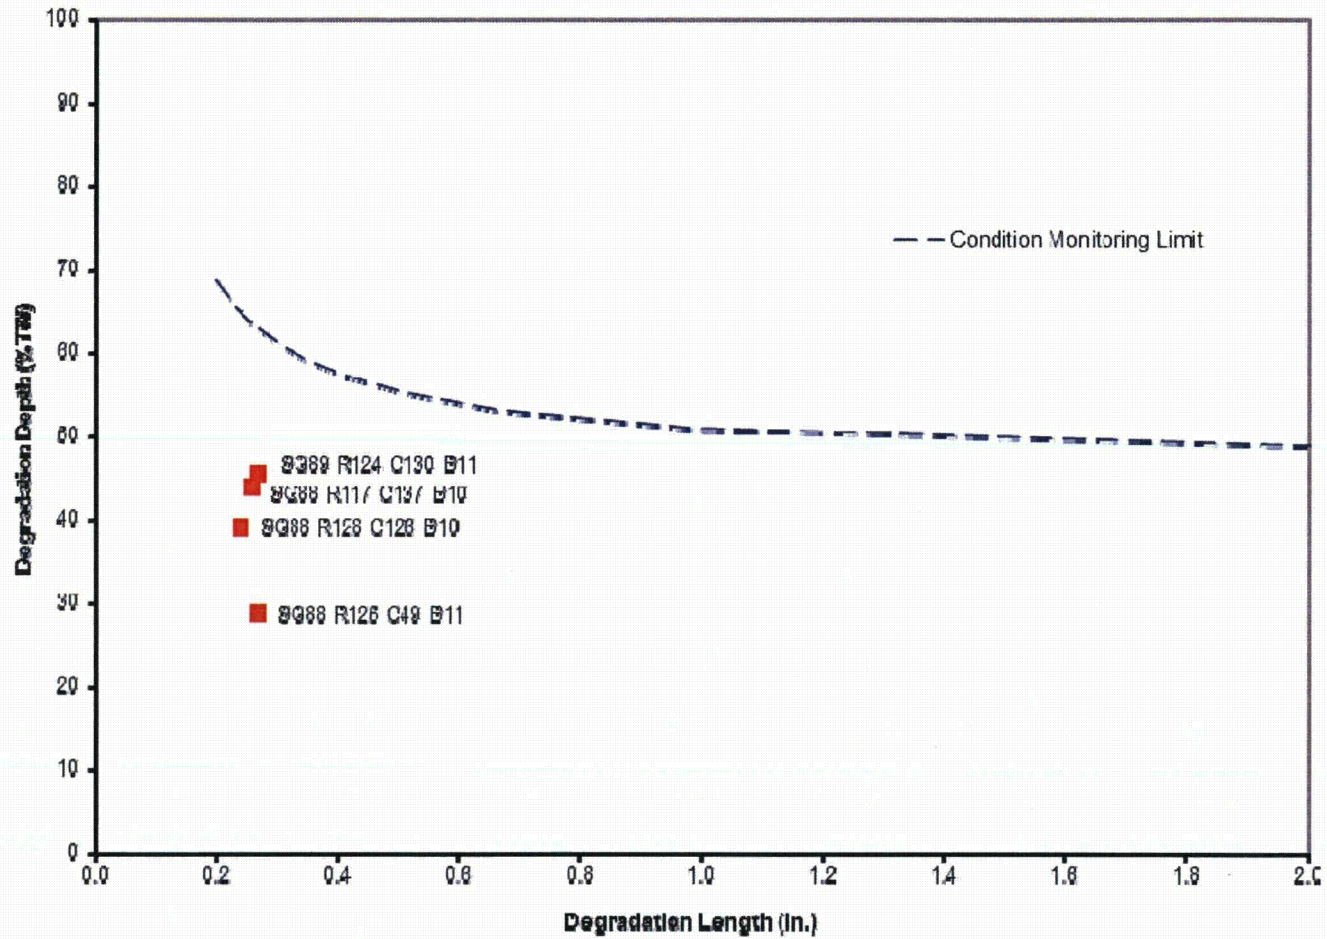
Figure 8-9: CM Limit for RB Wear, ETSS 27903.1

The axial depth profile of each RB wear indication was measured using ETSS 27903.1, and this data was used to determine the structurally significant dimensions of the indications using the methods described in Section 5.1.5 of Reference 4. The results are provided in Table 7-6 and are plotted on the CM curve provided in Figure 8-9. Since all four RB wear indications lie well below CM curve it is concluded that all Unit 3 RB wear satisfied the structural integrity performance criteria.
