National Transportation Safety Board

Marine Accident Brief

Accident No.	DCA-12-LM-008 ¹
Accident Type	Collision
Vessels	Uninspected towing vessel <i>Natures Way Commander</i> pushing loaded barge <i>ACBL 3111</i> Two moored U.S. Army Corps of Engineers deck barges
Location	Gulf Intracoastal Waterway, Morgan City–Port Allen Alternate Route, near Port Allen Lock, Louisiana 30°26.195' N, 91°13.118' W
Date	February 1, 2012
Time	1630 central standard time ²
Injuries	None
Environmental damage	None
Weather³	Winds 34 mph west-southwest, gusts to about 40 mph Air temperature 63° F
Waterway characteristics	Canal was 324 feet wide in accident area, with available clear width reduced by barges (per U.S. Coast Guard)

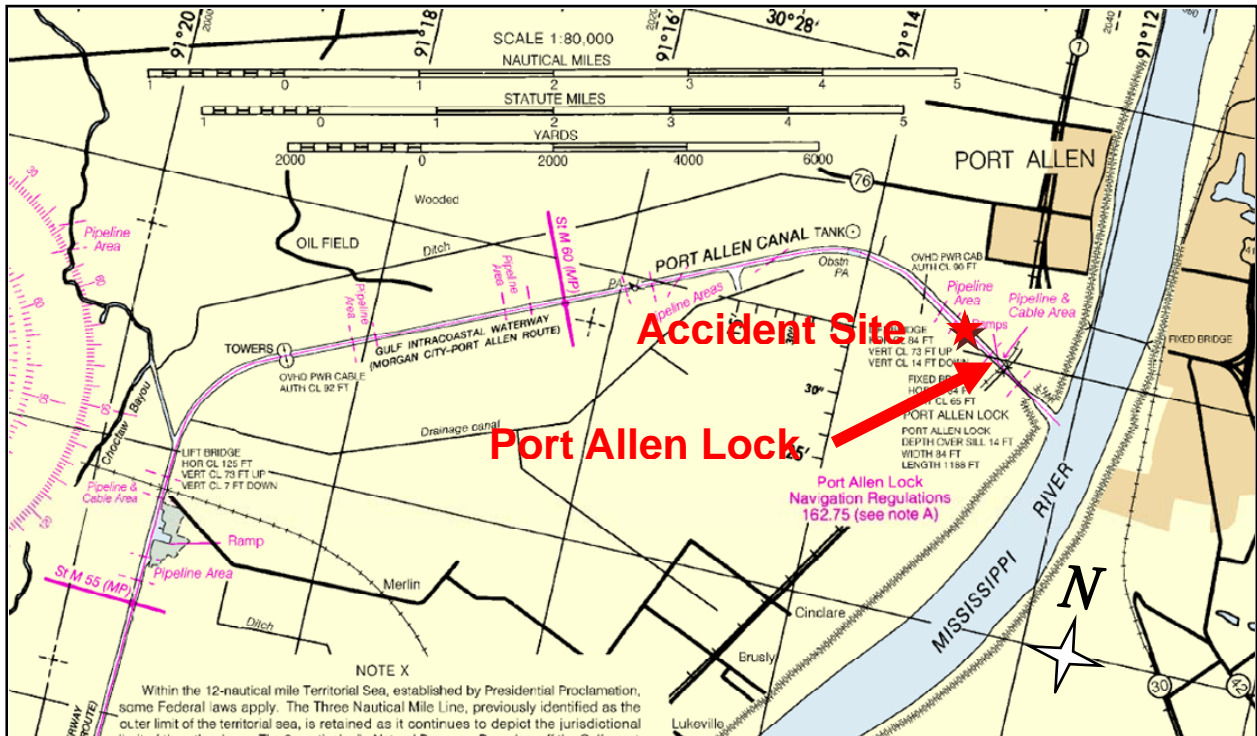
Figure 2. Section of National Oceanic and Atmospheric Administration (NOAA) nautical chart 11354 in the area of Port Allen Lock. The accident location is shown by the red star; the Port Allen Lock is shown by the red arrow.
