BAB SHAMS POLICE STATION  
MOSUL, IRAQ

SUSTAINMENT ASSESSMENT

**SIGIR PA-06-091**  
**APRIL 25, 2007**

## Bab Shams Police Station Renovation Mosul, Iraq

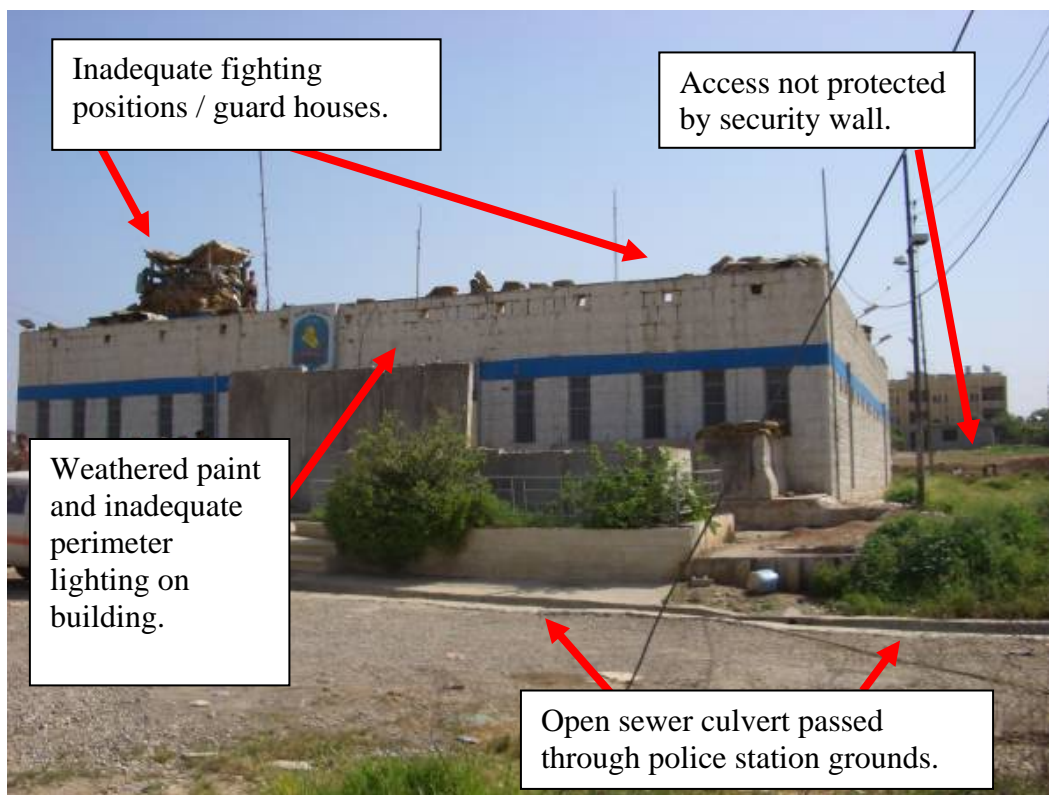
**USACE Pre-Construction Photo 1.**

As an overview of general requirements, USACE Pre-Construction Photo 1 documented several pre-existing conditions that needed to be addressed in the renovation project. For example, an open sewer, shown in USACE Pre-Construction Photo 2, passed near the front of the station; the building and grounds were not protected by a solid material security wall, building perimeter security lighting was inadequate, exterior paint was severely weathered, and rooftop fighting positions were inadequate. The subsequent status of all of the aforementioned pre-existing conditions are described and/or shown more clearly via photos taken by USACE officials during construction or by SIGIR inspectors while on site on 28 January 2007. Significant issues relating to the (1) open sewer, (2) electrical system improvements, and (3) construction of the security wall are discussed in detail later in this report.

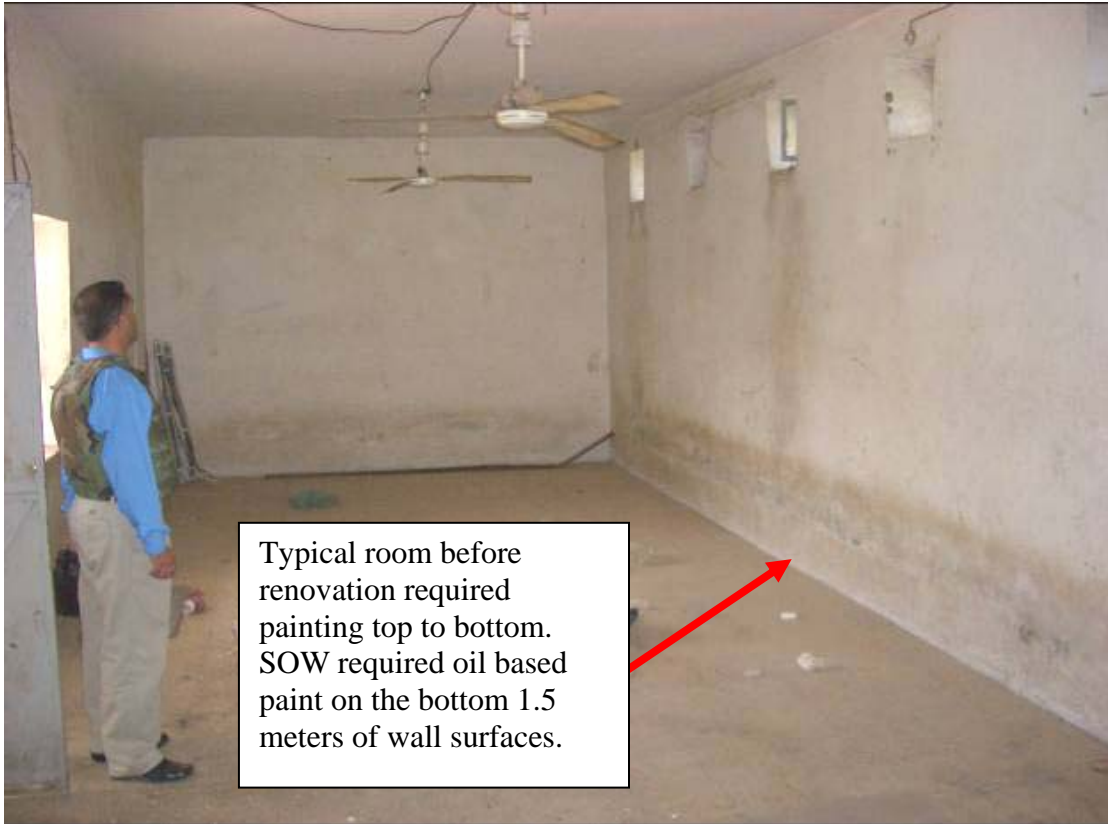
**USACE Pre-Construction Photo 7.**

The renovation also required the contractor to paint interior rooms and place tile on all steps. The SOW specified that oil based paint was to be used on the lower 1.5 meters of walls. USACE Pre-Construction Photo 7 shows a typical room in need of new paint while unsealed concrete steps are shown in USACE Pre-Construction Photo 8.

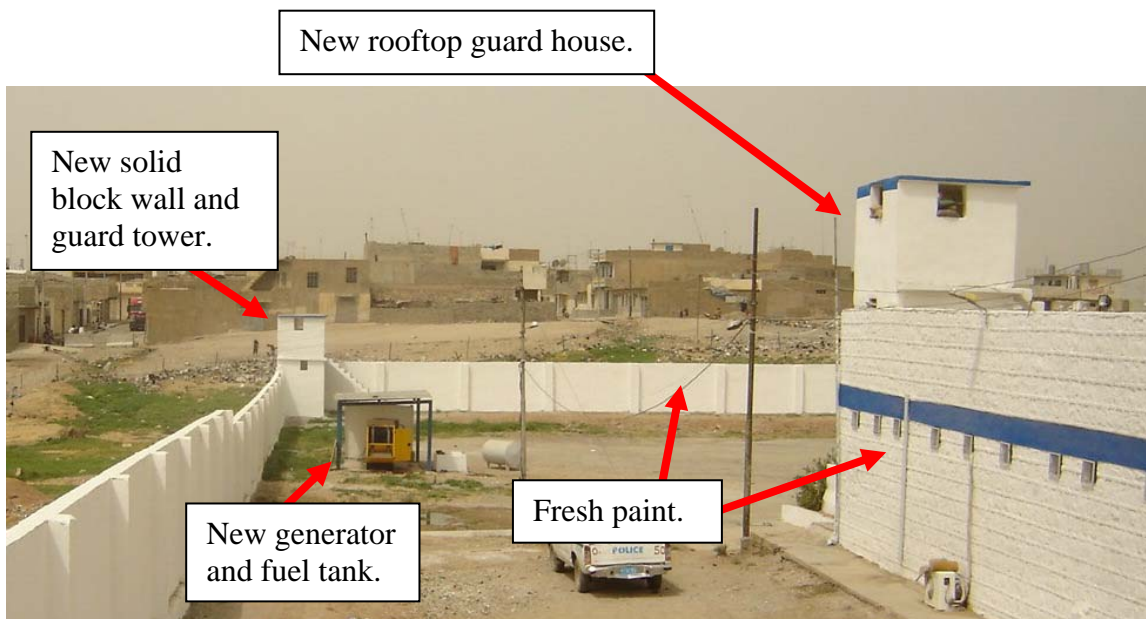
USACE Construction Photo 1 (12 Aug 05)

USACE Construction Photo 1 shows five high value requirements: generator system (\$79,000), painting (\$58,800), rooftop guard houses (\$18,000), solid block security wall (\$120,000) and guard towers (\$22,000). All were very likely constructed or installed in accordance with contract requirements. When combined, the aforementioned high value requirement totaled \$297,800 or approximately 84% of the contact's total value of \$353,400.

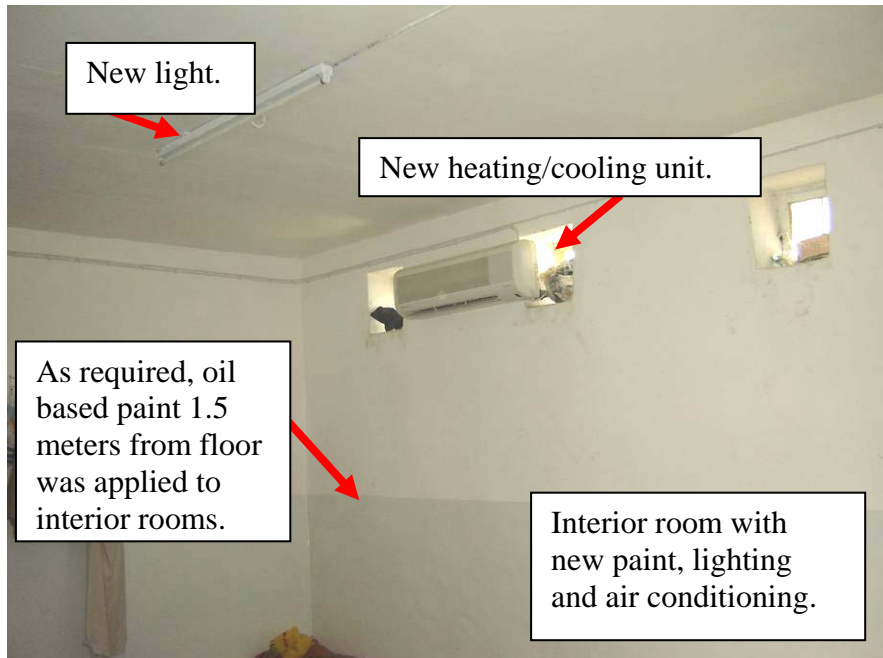
**USACE Construction Photo 10 (11 Aug 05)**

New light.

New heating/cooling unit.

Interior room with new paint, lighting and air conditioning.

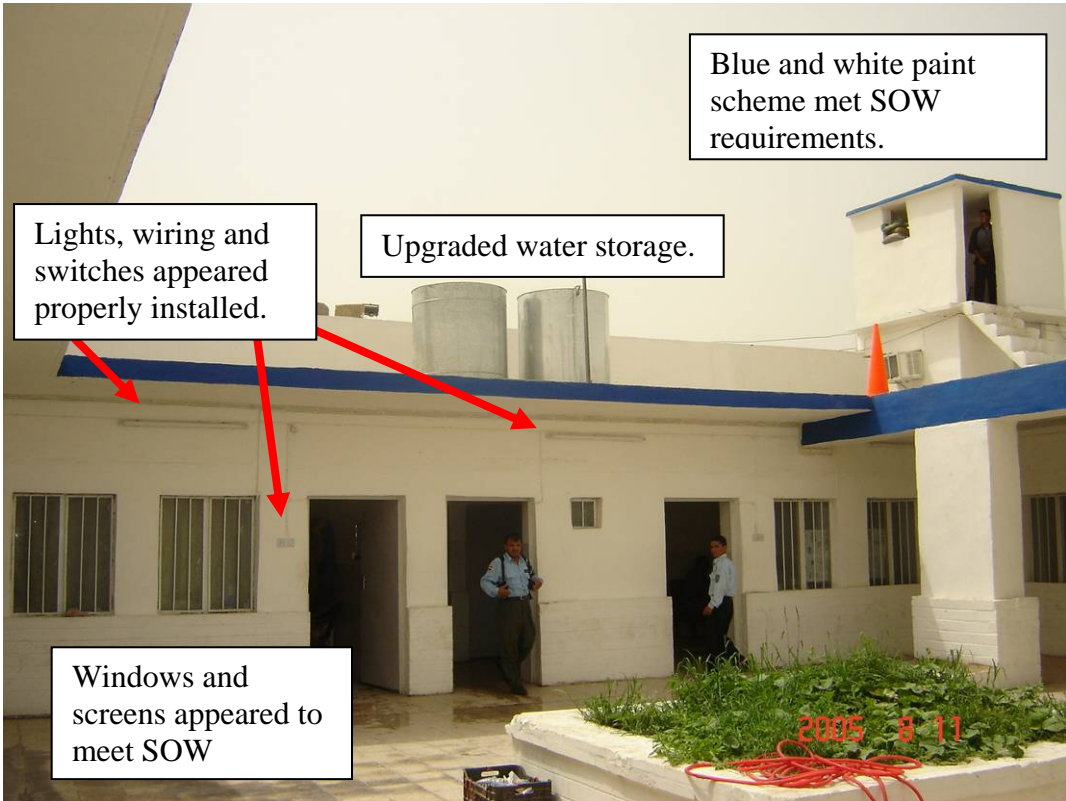
USACE Construction Photo 13 (11 Aug 05)

SIGIR inspectors used USACE Construction Photo 13 to present a general overview of the facilities' interior condition following renovation. The interior is that part of the facility inside the outside perimeter of the building and generally accessed from the courtyard area. In USACE Construction Photo 13, it appeared that windows, screens, and painting met SOW requirements. In addition, an upgraded water storage system can be seen in USACE Construction Photo 13.

Blue and white paint scheme met SOW requirements.

Lights, wiring and switches appeared properly installed.

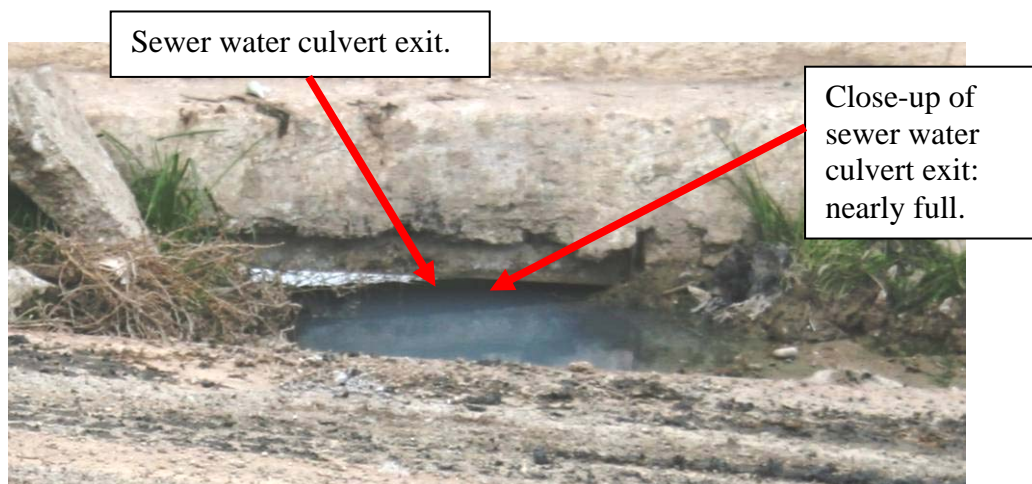
Site Photo 8.

At the time of the site inspection, the conditions were dry and not impacted by recent rains. Nevertheless, Site Photo 7 shows that the open culvert on the high side or half of the compound was running free and able to handle the waste water volume entering the compound that day. However, Site Photo 8 taken at the exit and the open culvert's lowest spot within the confines of the compound shows the open culvert nearly full. It would not take much rain water runoff to create a flooded condition within parts of the IP compound area.
