RELIEF AND RECONSTRUCTION
FUNDED WORK AT MOSUL DAM
MOSUL, IRAQ

SIGIR PA-07-105
OCTOBER 29, 2007

SUBJECT: Report on Relief and Reconstruction Funded Work at Mosul Dam, Iraq
(Report Number SIGIR PA-07-105)

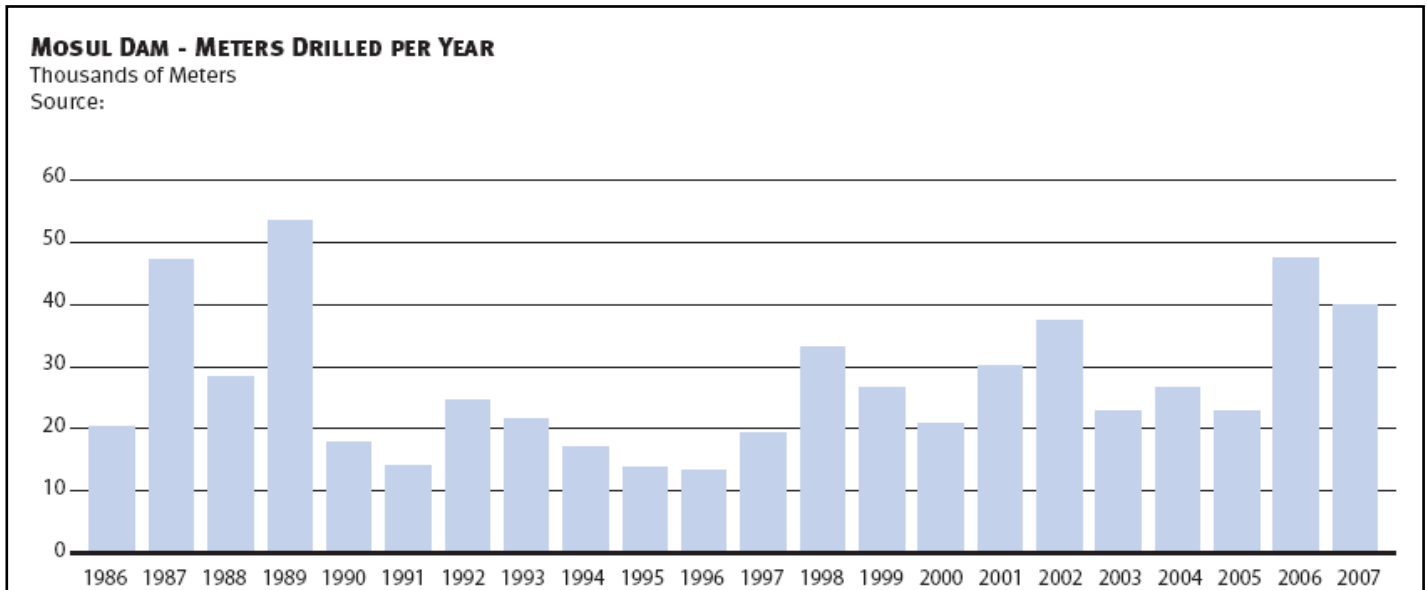
Figure 7. Meters drilled per year at the Mosul Dam from 1986-2007 (Data provided by dam management)

Figures 7⁸ and 8⁹ provide monthly drilling and grouting production from 1986 to 2007. Figure 7 indicates that the average drilling production over the years is generally less than one half of that attained in 1987. Figure 8 appears to show a general trend of decreasing grout injection over the years. While Figure 8 seems to indicate that grouting may have some success in sealing karst channels and reducing erosion or solution, it is also worth noting the significant amount of grout and massive grout still required to fill large voids.

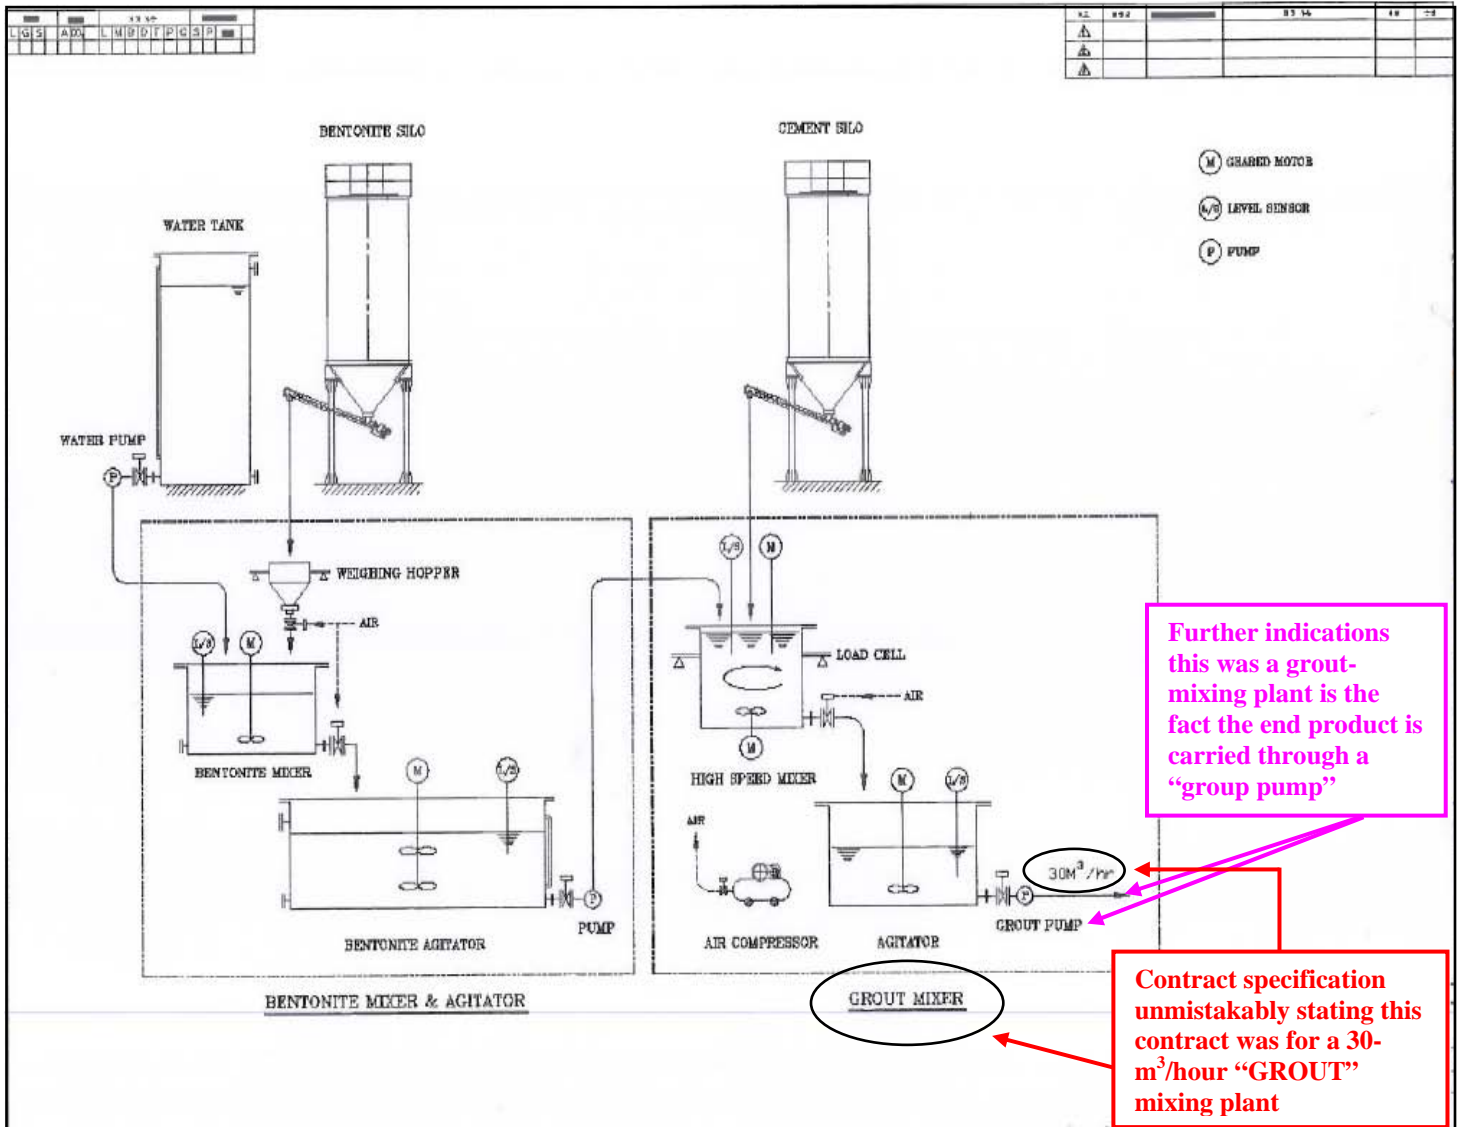
Figure 11. Specifications attached to the 30-m³/hour grout-mixing plants contract

plant for massive grouting Output 100-m³/h” mixing plant. For all five grout-mixing plants, the contract stated that “complete specifications are attached.” For the 30-m³/hour grout-mixing plants, the specifications consisted of a simple three page schematic drawing, which lacked significant details, such as the control room, pump sizes and their capacity, and a mechanism to fill the silos. The contract specifications did clearly indicate the 30-m³/hour mixing plants were to be grout-mixing plants (Figure 11).

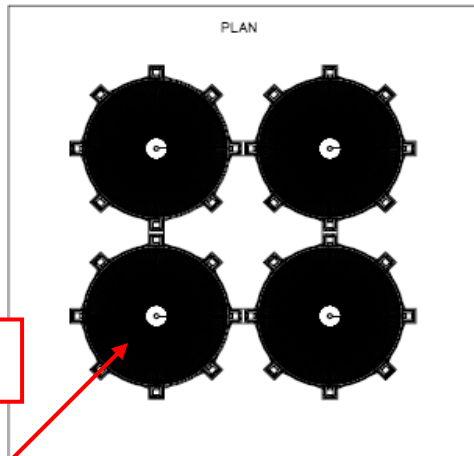
Figure 16. Top view of four stationary silos

The "Plans and View [sic]" design submittal provided multiple views of the finished stationary silo (Figures 16 and 17). According to the design drawings, each silo was to be approximately 120 feet high (from the base to the top). After thoroughly reviewing all available design drawings, we found the designs lacked significant details, such as lateral bracing support for the entire height of the silos (Figure 19), notes for the thread size, length, washer size, base plate requirement, and torque (for the foundations bolts – Figures 18-21), how the MWR personnel will deposit cement into the silo, and safety concerns. The lateral bracing supports for the entire height of each silo are important in order to keep each silo in its intended vertical position while allowing the load to transfer to the matt foundation during the cement filling process. The proportion of the silos is very large, since the height to diameter ratio is almost 6 (Figure 17), which could result in the silos overturning. According to an internal GRD document, the "standard practice is to resist overturning by a ratio of 1.5." A consulting engineer for GRD stated the silos looked like an "inverted pendulum." Further, detailed information for the foundation bolts is critical, since the foundation bolts will be required to counter all gravitational forces that would cause the silo to tip over, under most conditions. Further, since the opening to fill each silo is located at the top (120 feet high), for safety reasons, we are concerned that the contractor's designs did not include a safety ladder to climb or a safety bar and railing at the top (Figure 17). Additionally, no secure walkway with safety railings is shown to connect all silos at the top.

Loading each silo occurs at the top

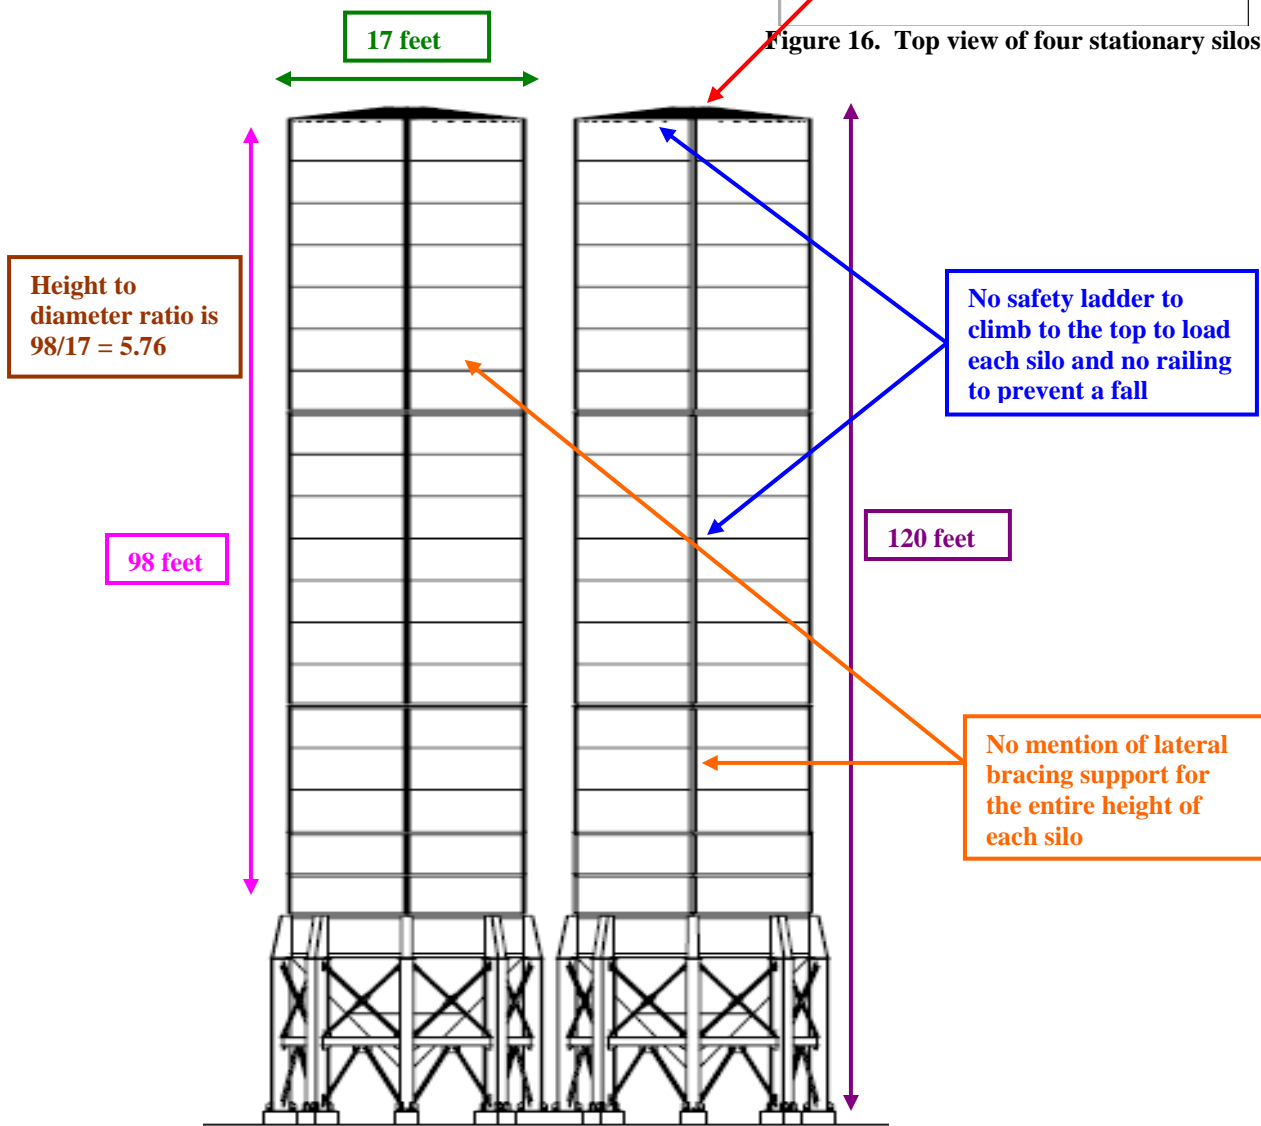
Figure 17. View of two stationary silos

Height to diameter ratio is $98/17 = 5.76$

No mention of lateral bracing support for the entire height of each silo

Since the stationary silos, in total, will hold up to 6,000 tons of cement, the issues we identified need to be thoroughly examined and reviewed in order to determine the adequacy of the contractor's proposed structure submittal.

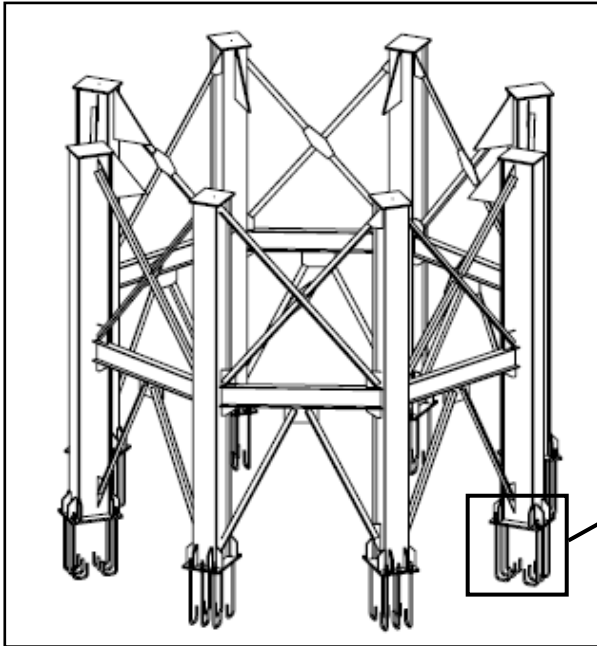
Figure 18. View of column group for the stationary silos

Design does not mention diameter size, thread size and length and strength grade for steel

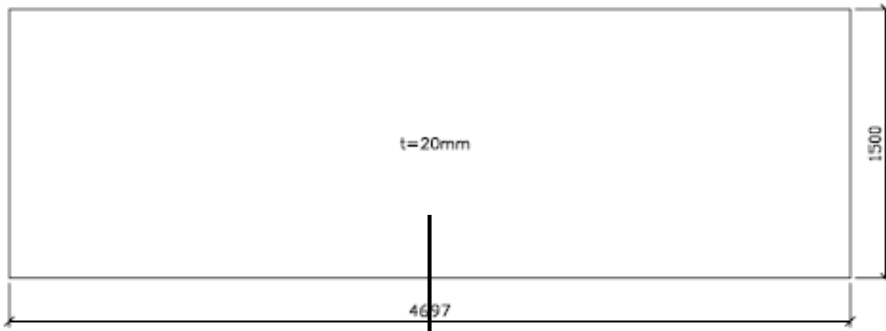
Figure 22. Delivered piece of straight steel

Further, the SPCOC should have identified from a review of the contractor’s design drawings that this structure would be extremely labor intensive to construct. According to the design drawings, the contractor’s construction will require the bending and subsequent welding of straight 20 millimeter (mm), more than 3/4 inch thick, steel plates to form the cylindrical holding tanks (Figures 22, 23, and 24). This process will require experienced welders and detailed efforts by the construction crew. Consequently, the SPCOC, after reviewing the contractor’s design drawings, should have identified this as a construction project and required the contractor to provide a detailed cost and delivery schedule to determine the breakdown of costs

(materials versus labor) and the timeframe for completing the project (not just delivering the materials on site). In addition, detailed quality control and quality assurance programs are essential for a project of this complexity.

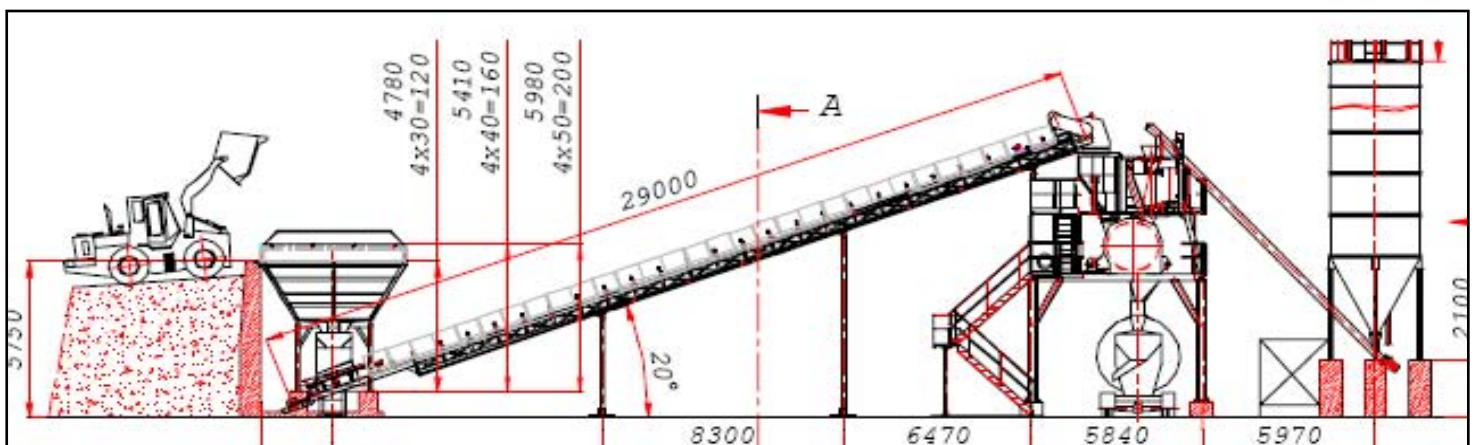
Figure 25. Original contractor design for the 100-m³/hour concrete-mixing plant

In our opinion, the 100-m³/hour mixing plant design submittal also clearly indicated the contractor was offering a concrete-mixing plant, not a grout-mixing plant (Figure 15). The design submittal lacked a bentonite silo, water and hydration tanks, associated weighing and measuring devices, and additional pumps and motors, which are essential for a grout-mixing plant (Figure 13).

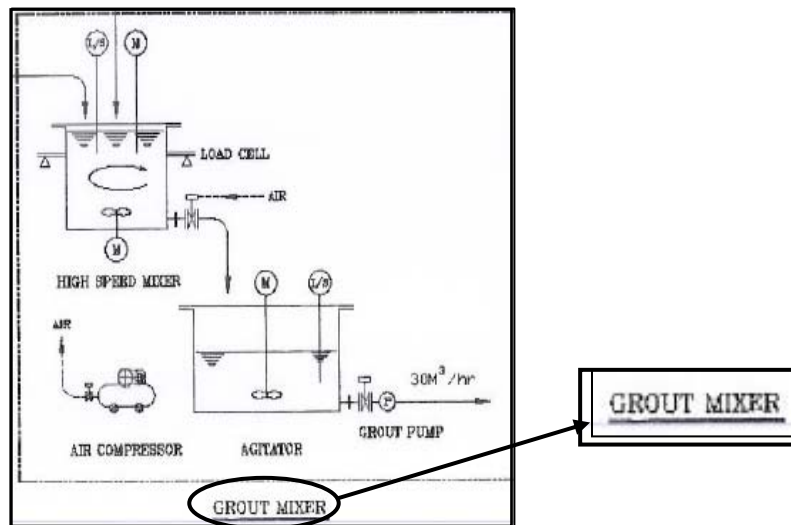
Figure 26. Partial view of contract specification for a 30 m³/hour grout-mixing plant

On 6 September 2006, the contractor delivered two unassembled 30-m³/hour concrete-mixing plants. However, according to CH2MHill/Parsons, the contractor delivered concrete-mixing plants "...as opposed to the grout mixing plant as requested in the solicitation." As mentioned in the Project Design section of this report, the contract specifications required the delivery of a 30-m³/hour grout-mixing plant (Figure 26), which clearly confirms that the contractor delivered the wrong equipment. When the delivery arrived, dam personnel identified the error and notified GRD representatives.

Since it was the U. S. government that did not identify the contractor's incorrect submittal for concrete-mixing plants, on 3 August 2006, Contract Modification #2, in the amount of \$920,000, was issued to modify the five concrete-mixing plants into grout-mixing plants. The cost of modifying the four 30-m³/hour concrete-mixing plants into grout-mixing plants was \$515,000 (\$128,750 each).

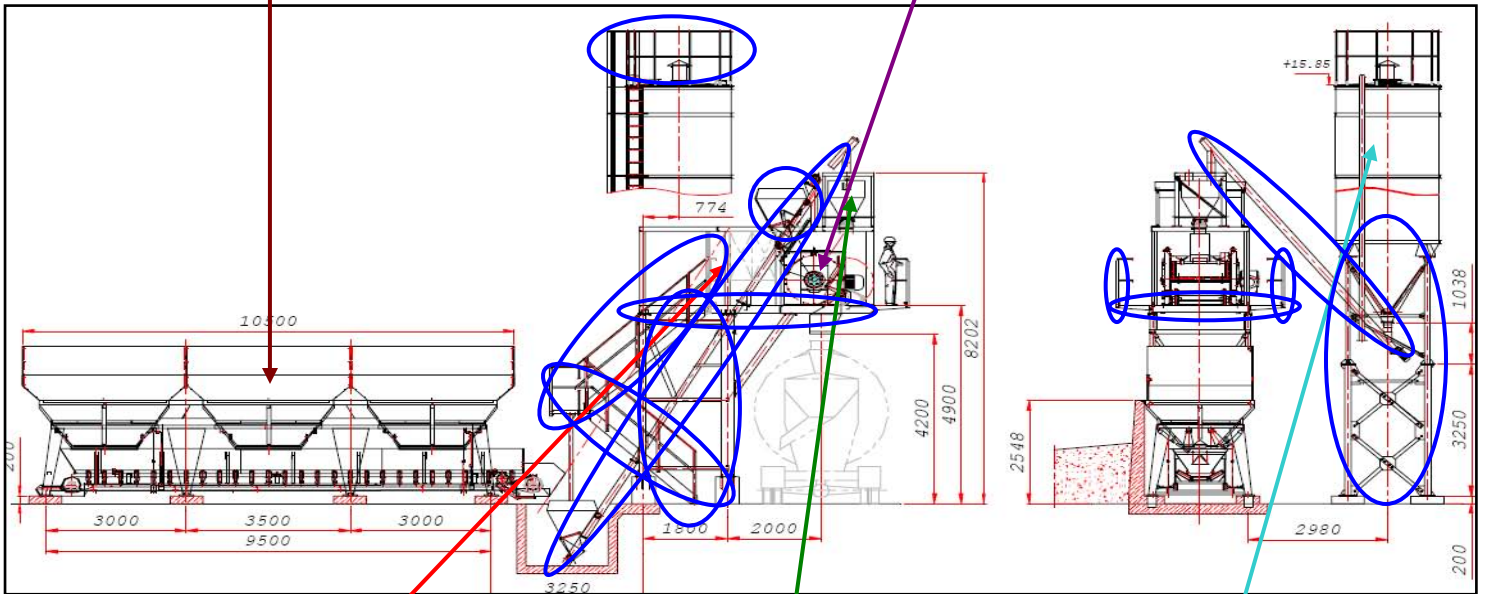
Figure 27. The contractor's design drawing for the 30-m³/hour concrete-mixing plant (Colored arrows identify pieces found at the site and what relationship they are to the design) (Areas circled in blue are equipment required by the design that could not be accounted for/located during site visit)

On 7 July 2007, the JCC-I/A partially terminated the contractor for cause, because the contractor was unable to successfully modify the two delivered 30-m³/hour concrete-mixing plants into grout-mixing plants. At the time of the termination, the contractor had not only been unsuccessful in modifying the mixing plants, the two delivered concrete-mixing plants were still unassembled. However, the contractor had already been paid the entire amount for the two mixing plants (\$560,000), which included assembly. In addition, the contractor was paid \$44,000 for providing design drawings attempting to modify the concrete-mixing plants into grout-mixing plants.

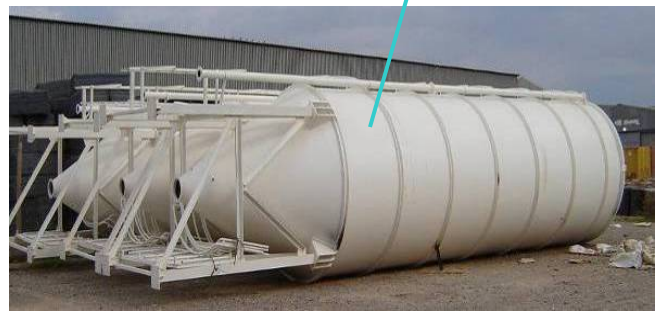
Site Photo 15. Three silos (two needed for each mixing plant)

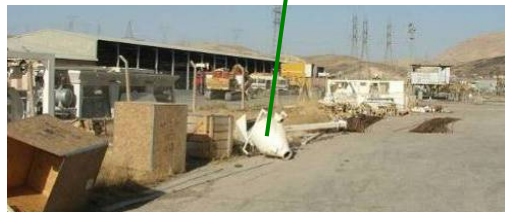
Site Photo 16. Miscellaneous 30 m³/hour concrete-mixing plant parts

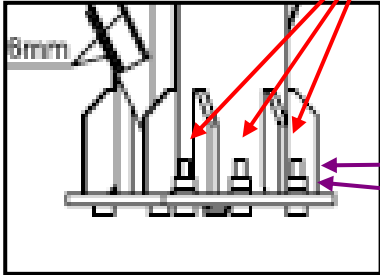
Figure 28. Requirements of the design drawings

Contractor's design drawings required bolt threads extend beyond the nut and washer

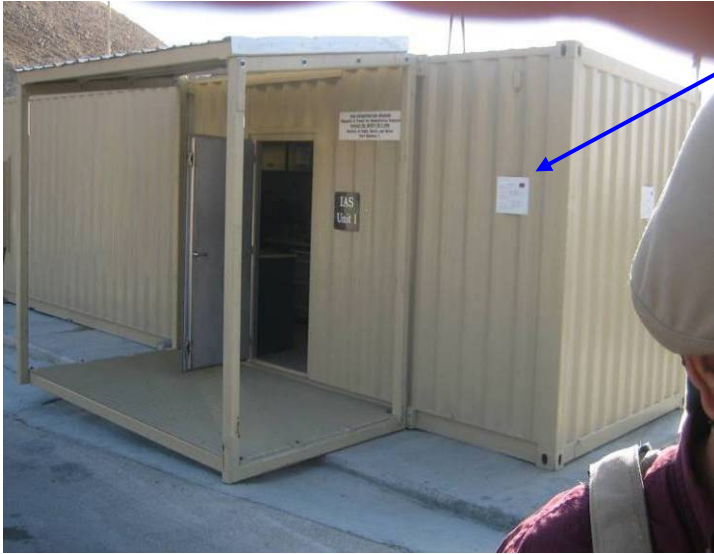
During our site visit, we observed one IAS located near the western side of the Mosul Dam gallery (Site Photos 27 and Figure 30). According to dam personnel, the IAS units arrived in May 2007. The IAS was contained in the required 10 foot by 40 foot trailer with climate control, central vacuum, and lighting protection systems. In addition, we identified the equipment called for in the contract, such as four PC monitoring stations, each with three 17-inch flat screen monitors, one 50-inch plasma monitor, and one 36-inch color inkjet plotter (Site Photos 28 and 29).

Site Photo 27. Exterior view of an IAS unit

According to dam personnel, the three IAS units are currently not being used for several reasons. First, all three IAS units are experiencing air conditioning problems. Each IAS unit contains non standard, high powered computers to analyze and process collected data from multiple drilling assemblies. Each IAS unit creates and recommends location specific unique solutions by specifying grout materials and additives, needed volume, and monitors grout injection progress. This entire process from start to finish collects data and stores it into a database for further use to create graphic presentations, as well as, to maintain automated records of operation. This unique IAS computer system generates a sizeable heat load, and according to dam personnel, the air conditioning system within each IAS unit does not have the capacity to continuously keep the unit cool, which has led to failures. In addition, one IAS unit is experiencing CADD problems and the software will not boot up.

Since our September 2007 site visits, GRD has attempted to resolve the outstanding issues with the IAS units. According to GRD representatives, the IAS HVAC system components arrived at the Mosul Dam and have been installed. In addition, three computers and miscellaneous parts were delivered. Two computers were rejected by the dam manager because they were damaged and the third computer experienced some technical problems.

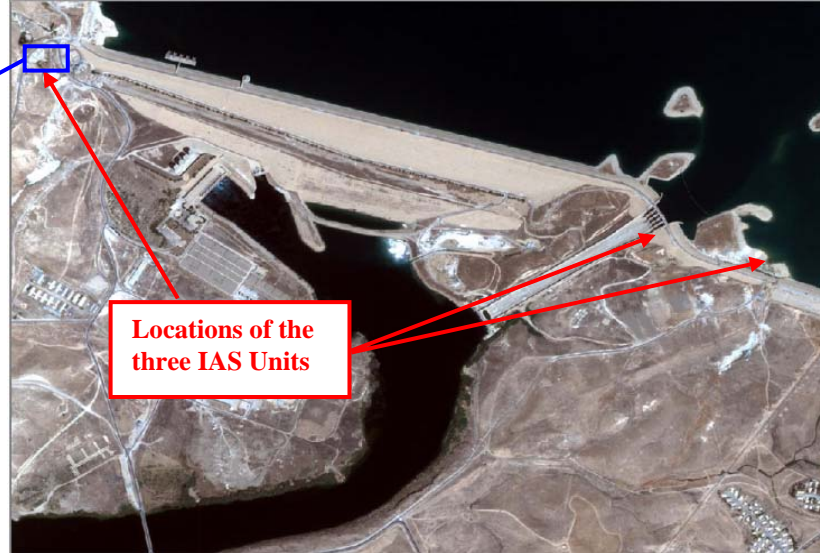
Figure 30. Locations of the three IAS units

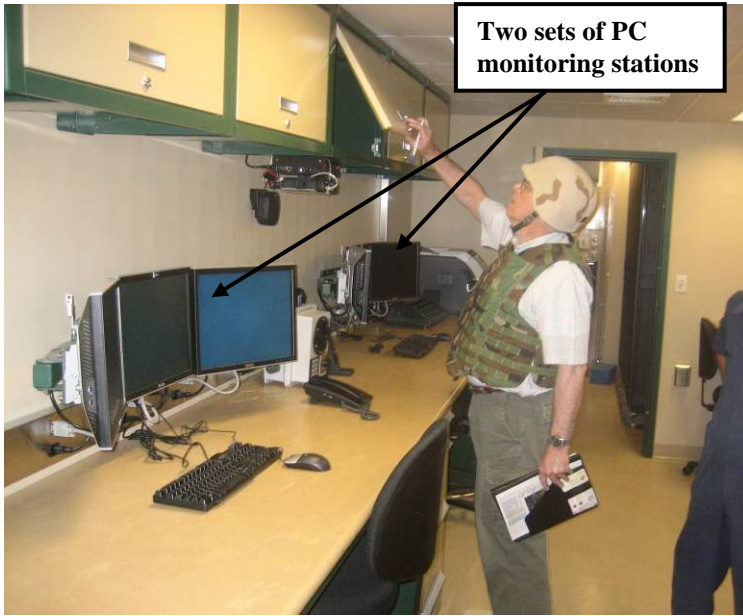
Two sets of PC monitoring stations

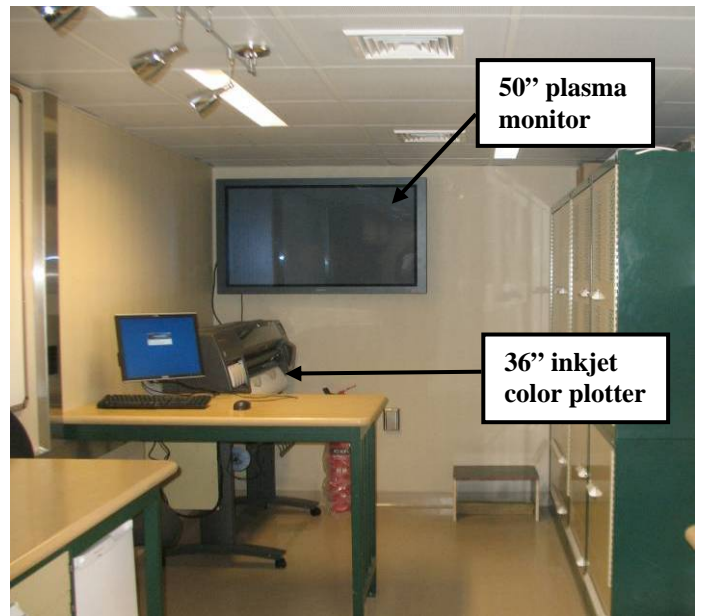
50" plasma monitor

36" inkjet color plotter

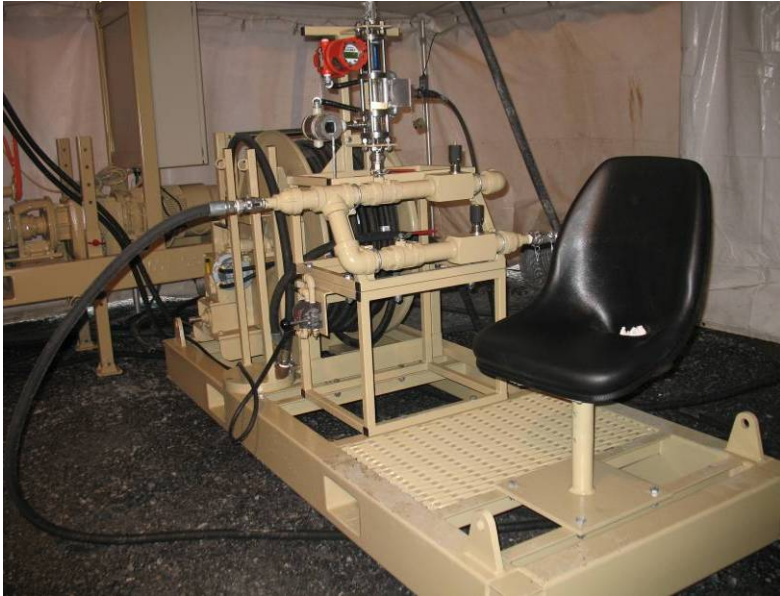
**Site Photo 38. Final control point
(Photo courtesy of USACE)**

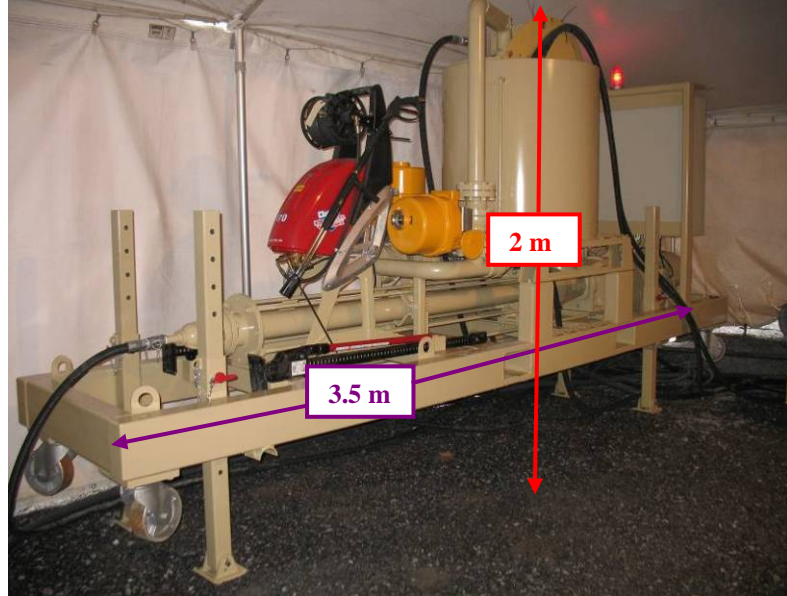
**Site Photo 39. Satellite mixing plant
(Photo courtesy of USACE)**

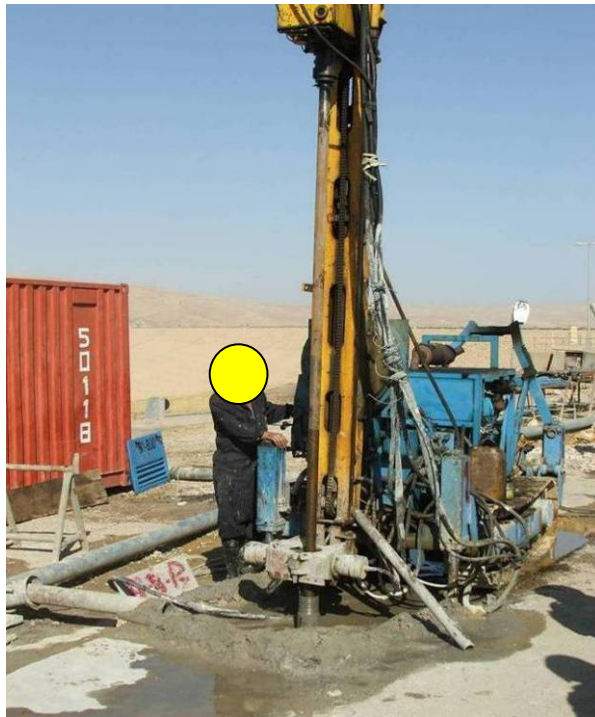
During our site visits, we observed dam personnel conducting drilling and grouting work outside and inside the gallery. We observed outdoor drilling (Site Photo 41), which must be done prior to grouting. Inside the gallery, we witnessed one hole being actively grouted. Specifically, we viewed an agitator actively mixing grout (Site Photo 42) and a grout pump actively placing the grout into a hole (Site Photos 43 and 44). In addition, ITAO representatives stated grouting activities were also ongoing during a previous site visit (Site Photo 45). Figures 8 and 9 also verify that the dam personnel are still operating a continuous grouting program.

Site Photo 41. Dam personnel conducting above ground drilling operations

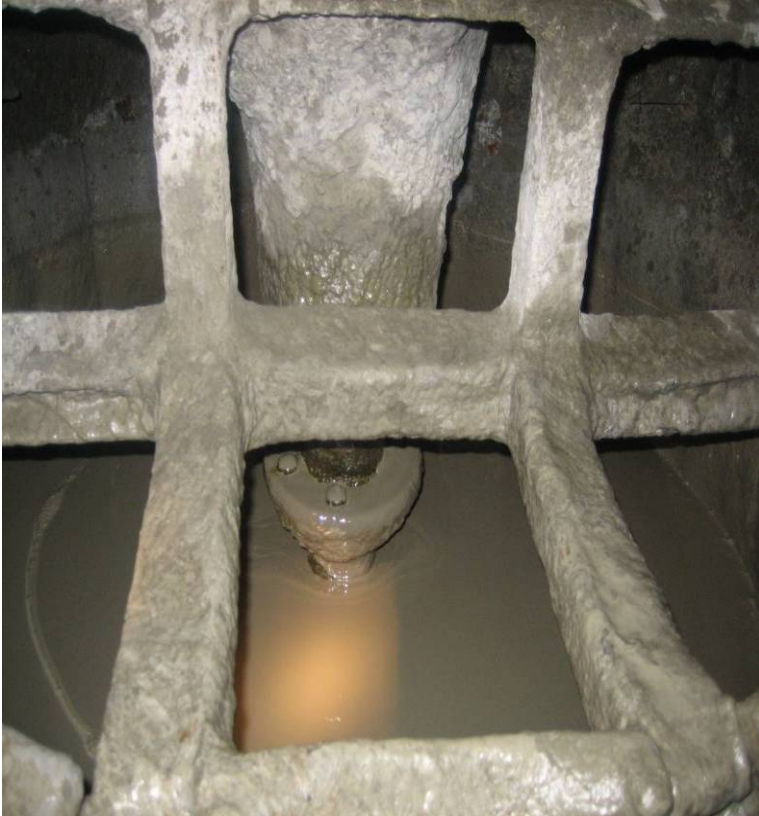
Site Photo 42. Existing agitator within the gallery actively mixing grout

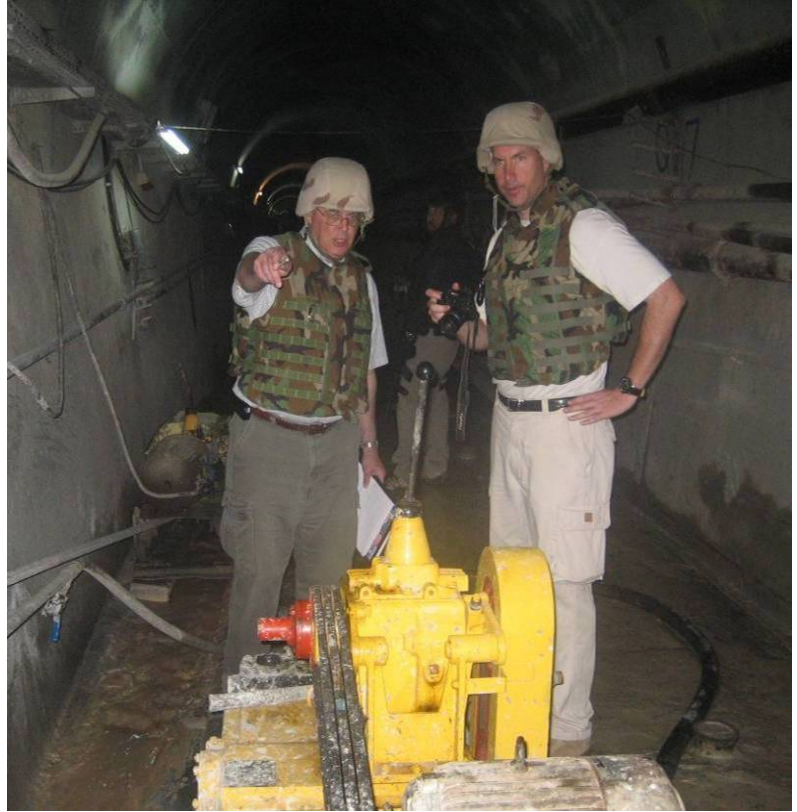
Site Photo 43. SIGIR inspector pointing out an active grout pump placing grout into a hole

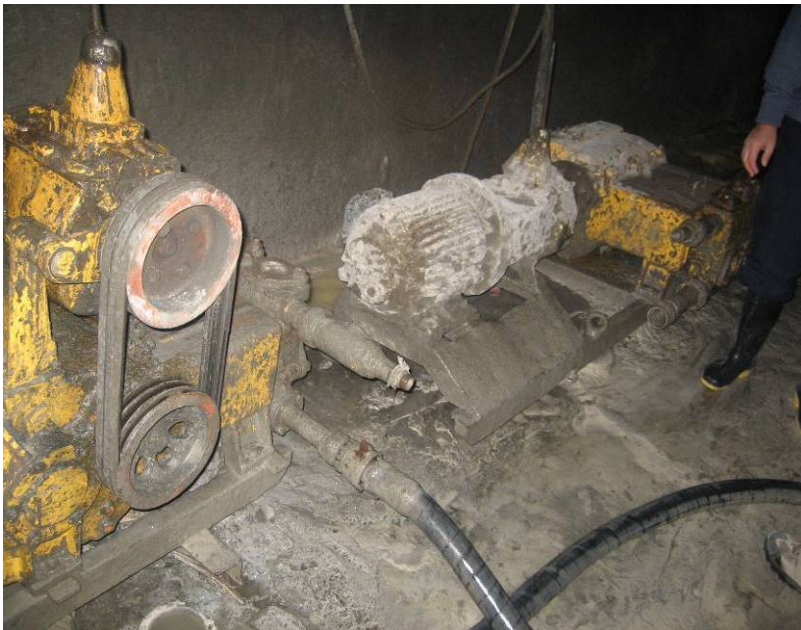
**Site Photo 44. A grout pump actively placing grout into a hole
(Photo courtesy of ITAO)**

Page 41, Site Photo 44. The quoted picture shows a considerable improvement in grouting along the saddle dam. In 2006 Mosul Dam project did not have casing/drill pipes and as a result, the dam manager made the decision to grout upstream of the saddle dam. This practice has the potential to cause the water to overtop the grout curtain. It was essential that the grout curtain be tied to the saddle dam core. The US Government initiated the procurement of the casing/drill pipes for the dam to allow drilling through the core. However, due to delays in delivery, and ordering pipe with the wrong dimensions, the casing pipes did not arrive on site at the date of the SIGIR site visit. The Ministry of Water Resources ordered and delivered casing/drilling pipes. As can be seen in Site Photo 44, the Mosul Dam staff are now drilling and grouting along the saddle dam crest, hence tying the grout curtain with the saddle dam core which is a considerable improvement.

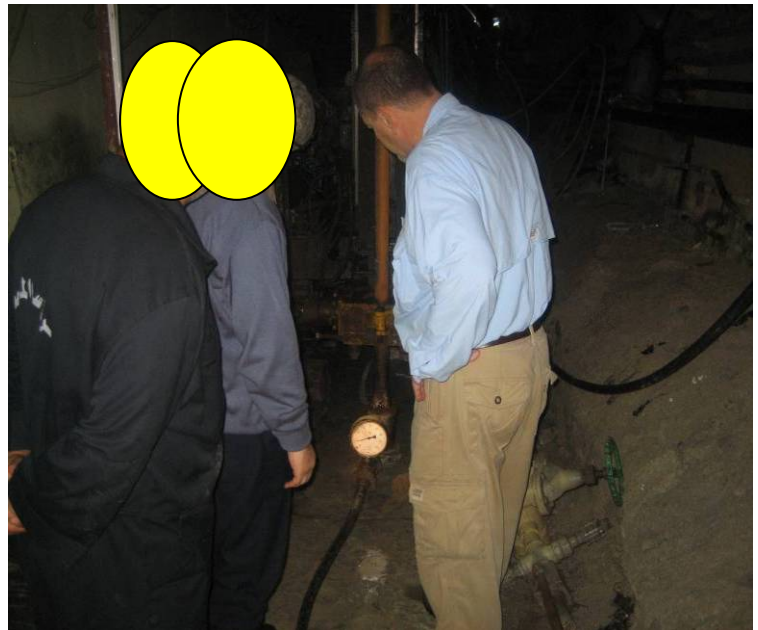
**Site Photo 45. A hole being actively grouted
(Photo courtesy of ITAO)**

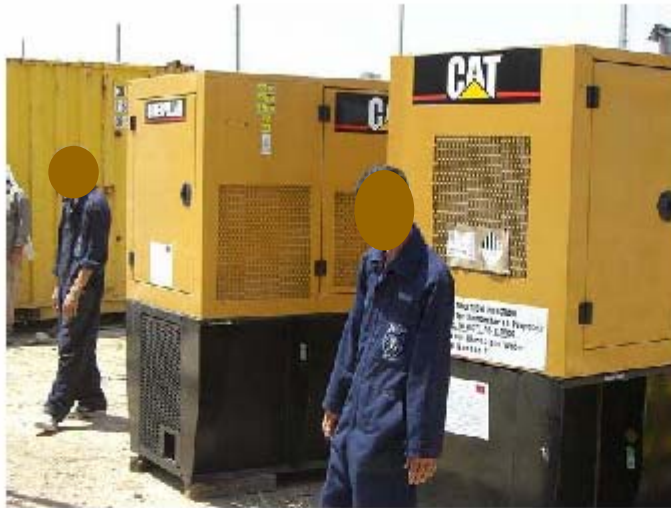
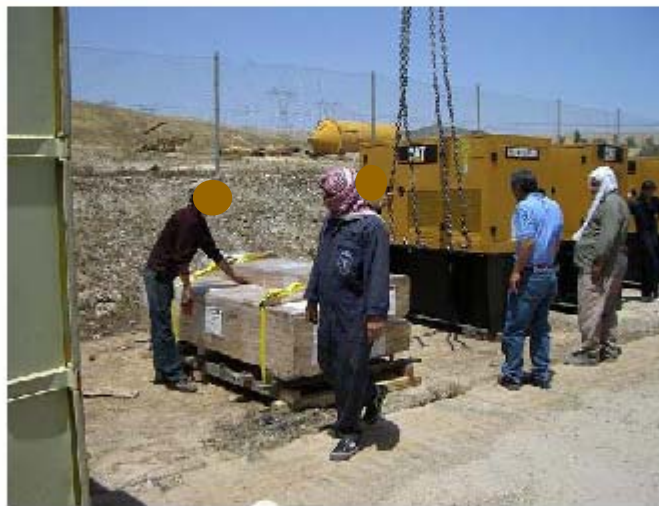
f. General SIGIR Question. GRD Engineering Geologist [SIGIR removed name] also makes reference to generators for the grout plants. We have reviewed all of the design drawings for the grout plants and didn't see any mention of generators.

GRD Comment. Please refer to the photographs provided above from the field showing the delivery of the generators in question.
