**HADITHA DAM PERIMETER SECURITY
HADITHA, IRAQ**

SUSTAINMENT ASSESSMENT

**SIGIR PA-09-192
APRIL 13, 2010**

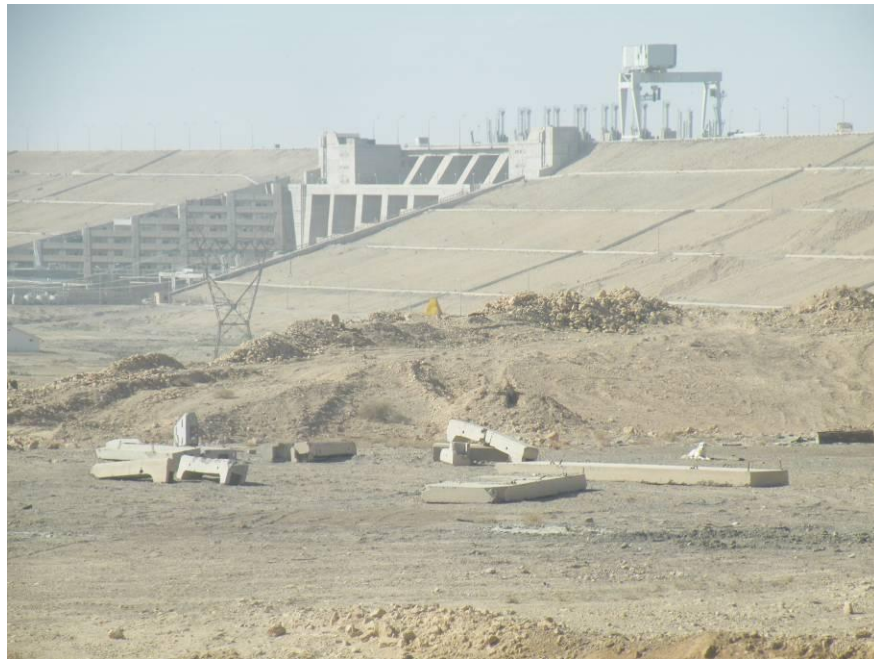
Site Photo 1. Haditha Dam

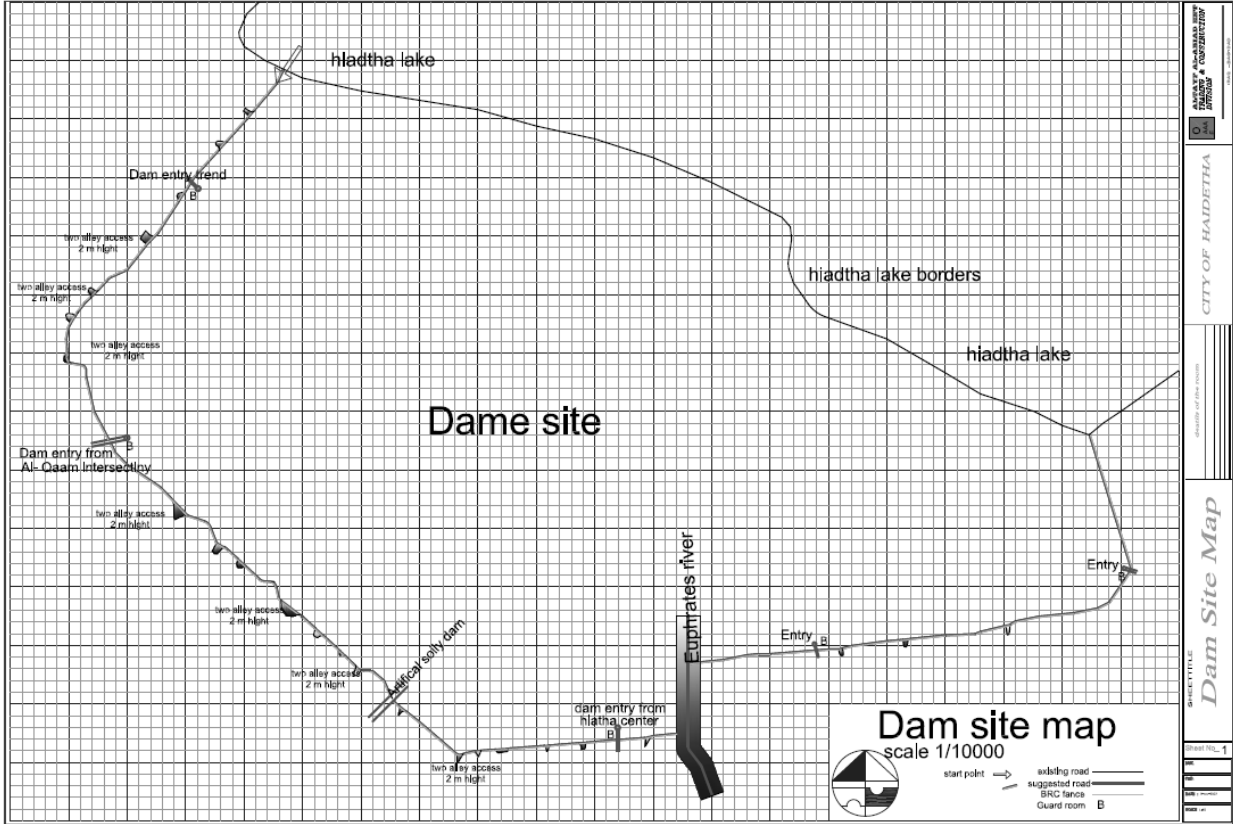
The contractor provided an overall site plan (Figure 1) and profile for the perimeter fence and access drive. The plan and profile were based on topographic information and included physical features of the project area and the proposed improvements.

Figure 1. Haditha Dam perimeter security site plan
(Courtesy of GRC)

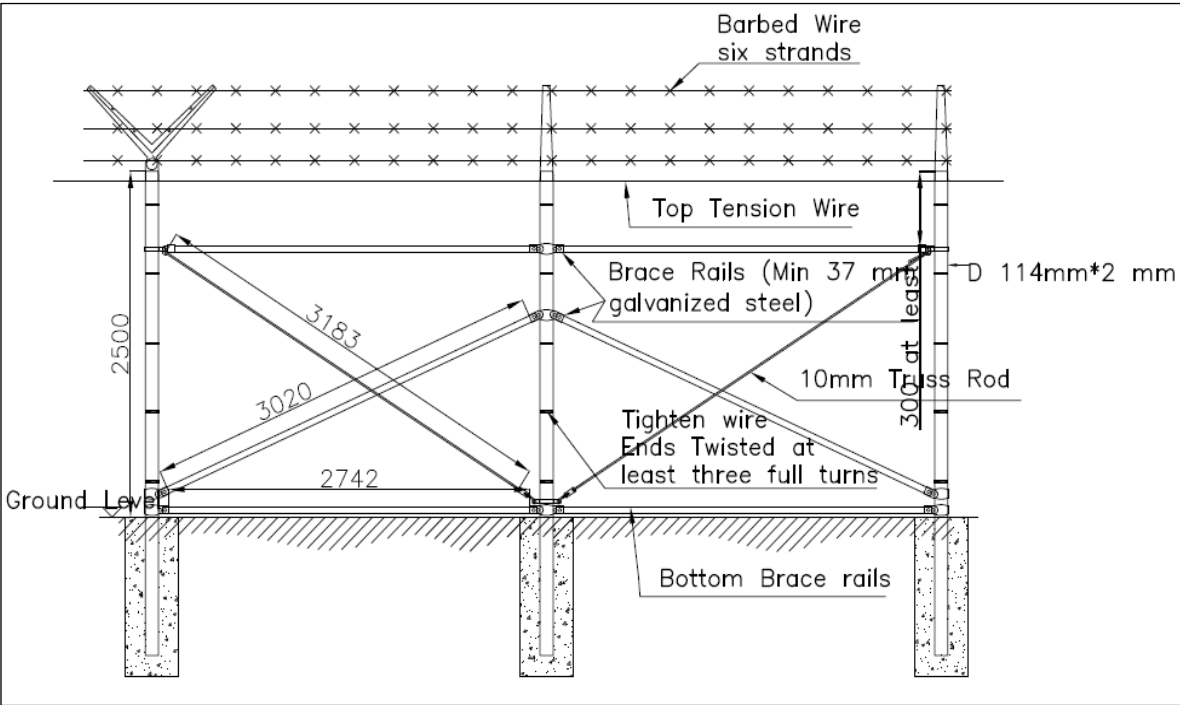
The contractor submitted details in the design drawings for construction of the perimeter fence (Figure 2). These details were based on the standard drawings provided with the contract and provided additional dimensions and details.

Figure 2. Contractor's design of typical fence section
(Courtesy of GRC)
