ANALYSIS OF NAPTF TRAFFIC TEST DATA
FOR THE FIRST-YEAR RIGID PAVEMENT TEST ITEMS

PRESENTED FOR THE 2002 FEDERAL AVIATION ADMINISTRATION AIRPORT
TECHNOLOGY TRANSFER CONFERENCE

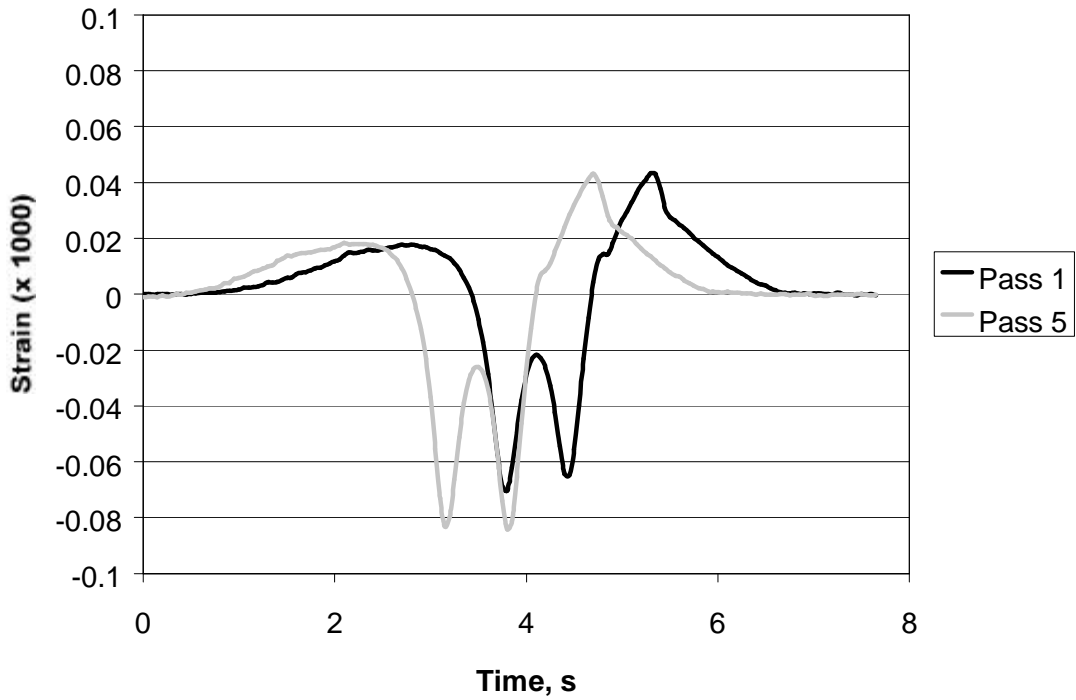
(a) Strain gage at top of slab (CSG – 303)

Sensors were installed near both the top and bottom surfaces of the slabs in order to provide measurements of the tensile and the compressive strains that develop during loading. Figures 6(a) and (b) compare the strains recorded at the top and bottom sensor positions at a slab location along the south longitudinal joint (see Figure 2). The concrete strain gage (CSG) designators are given to facilitate retrieval of strain gage data from the NAPTF database [1]. Strains plotted in Figure 6 were recorded during passes 1 and 5 of the vehicle. Figure 3 shows the lateral position of the carriage during these two passes. In both cases, one line of tires tracks exactly along the longitudinal joint line, while the other line of tires is at an offset. The difference is that for pass 5 both lines of tires are on the same side of the joint, while for pass 1 the carriage straddles the joint. Hence, for pass 1 the contribution of the second line of tires to the strain response at the sensor is reduced relative to pass 5 since only a portion of the wheel load is transferred through the longitudinal joint. This is consistent with Figure 6, which shows that the peak strains resulting from pass 1 are somewhat smaller than those resulting from pass 5.

Figure 6. Typical Strain Responses in Test Item LRS for Loading of the South Longitudinal Joint (Four-tire Load)
