## Visual Streambank Assessment

### TOOKANY CREEK WATERSHED MANAGEMENT PLAN

Township of Cheltenham  
 Rock Creek Watershed

Assessed by the Tookany Creek Watershed Steering Committee Members

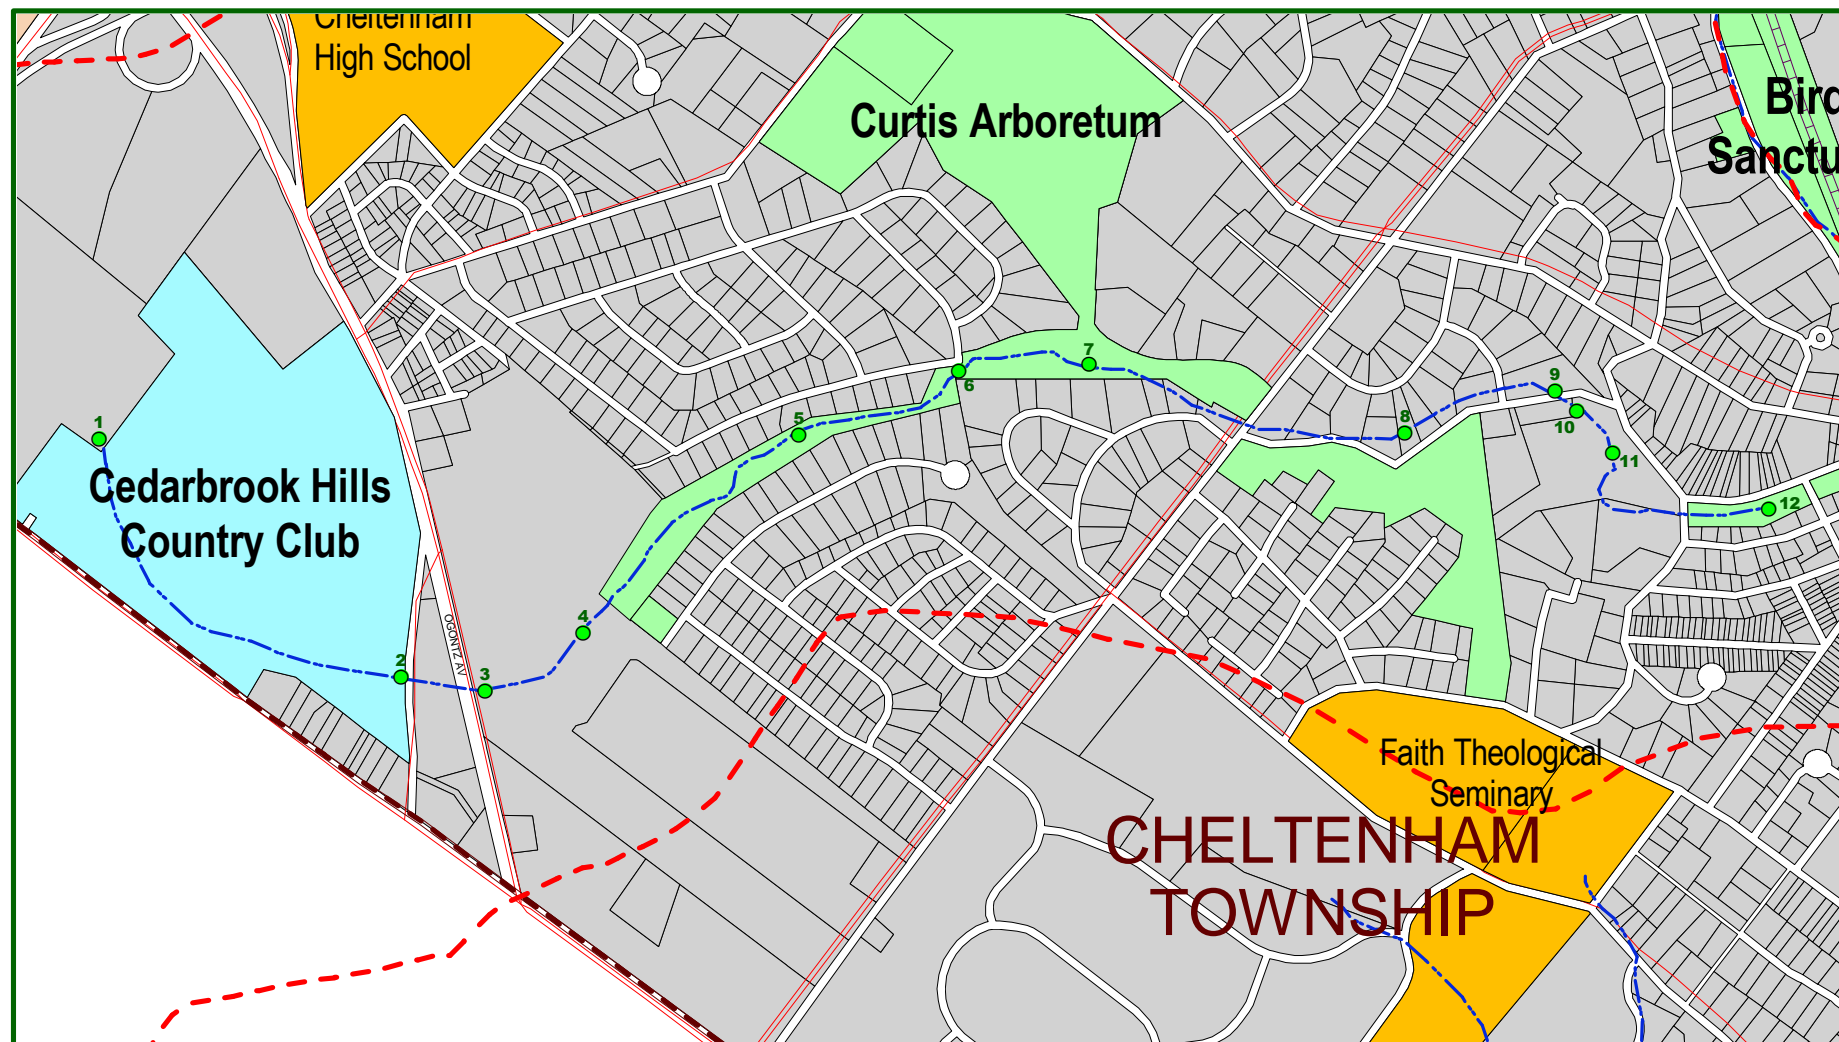
1. The headwaters of Rock Creek come primarily from an outfall that empties behind the Pathmark Supermarket upstream of the Cedarbrook Country Club.  
**Action/BMP** : Encourage shopping center management to consider several bioswales in the massive parking lot's impervious surface to treat NPS pollution and detain stormwater before discharge into Rock Creek.

2. As the stream exits the golf course it enters a pipe 100 feet from Limekiln Pike. Coming out on the south side of Ogontz Ave., the creek has a much greater volume and is severely polluted.  
**Action/BMP** : Continue to monitor the water quality. Encourage Golf course to participate in the Audubon Cooperative Sanctuary Program (ACSP).

3. Philadelphia Water Department (PWD) storm sewer, discharges into the Mill Creek under Greenwood Street. The PWD acknowledges the existence of a combined sewer overflow into the storm sewer. Odors exist from sewage and the sanitary sewage is apparent to the naked eye.  
**Action/BMP** : Continued PWD and township monitoring.

4. From Ogontz Avenue to the footbridge at the foot of Wistar Drive, the creek is very polluted. The creek has steep banks on both sides with extensive erosion. The east side is bounded by the Cheltenham Square Mall parking lot (the runoff of which contributes to the flooding of the stream) while Cedarbrook Middle School borders the creek on the west side. This entire reach of the stream has been used as an informal dump. A sanitary sewer pipe is buried under or alongside the creek.  
**Action/BMP** : Involve Cheltenham Square Mall and the Middle School in routine cleanups. Restore the riparian buffers that have eroded along the Mill Creek banks. Have Cedarbrook Middle School adopt the creek as a school project to monitor water quality and biological indicators.

5. The half-mile stretch of Rock Creek from the Wistar Drive footbridge to the Curtis Arboretum is owned and managed by Cheltenham Township and has the potential to be a wonderful beautiful wooded stream.  
**Action/BMP** : Develop routine community clean-up days. Consider a greenway or trail along Rock Creek, with Curtis Arboretum as a hub.

6. A side stream entering from Cedarbrook Middle School contains rust colored material (land use history of former landfill). Some of the houses on the western side of the creek have lawns mowed right up to the stream bank. Some residents have dumped leaves and other yard cuttings down the stream bank. In this reach small fish, frogs, and ducks swimming and feeding were observed.  
**Action/BMP** : Investigate and monitor rust colored discharge. Develop homeowner education program geared towards residents and the management of their land, especially in altering mowing close to the creek.
