**RUNWAY FRICTION MEASUREMENTS
AND
AIRFIELD PAVEMENT CONDITION SURVEY
MARINE CORPS AIR STATION (HELICOPTER)
JACKSONVILLE, N.C.**

Subj: Airfield Pavement Condition Survey and Runway Friction
Measurements, Marine Corps Air Station (Helicopter), New River,
Jacksonville, North Carolina

1. Enclosure (1) contains the results of field tests and visual
statistical evaluation of the pavement at the airfield and is submitted
in accordance with reference (a).

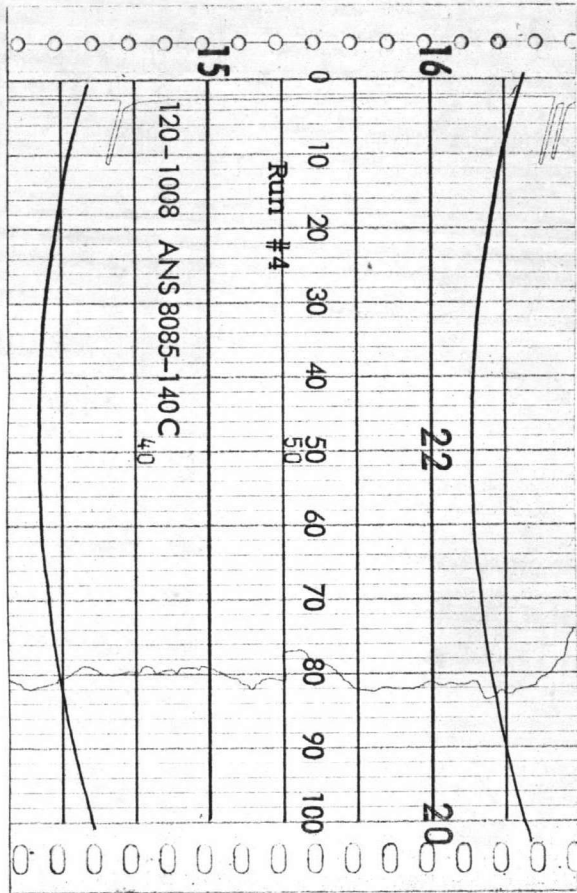
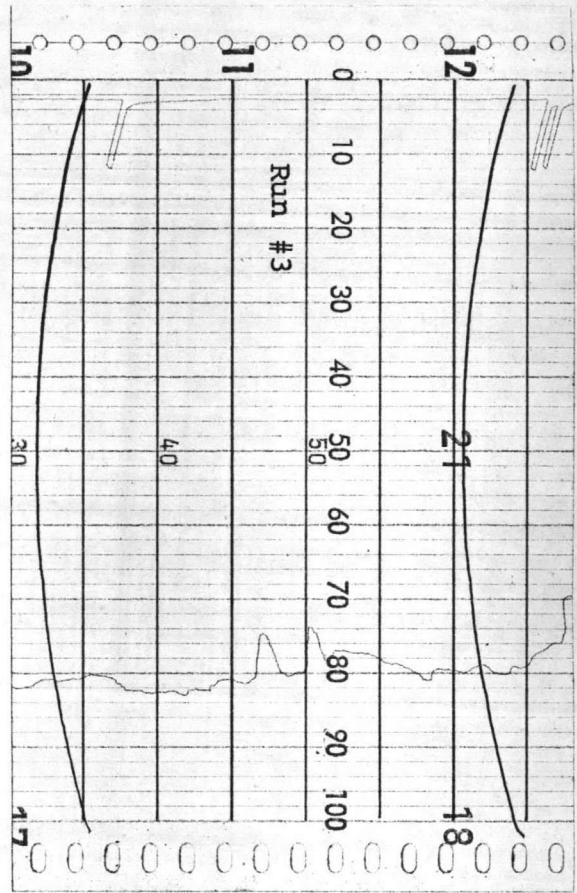
MCAS (H) New River, N.C.
Runway 5-23
Test Section "A"

REMARKS: Excellent drainage on test section.

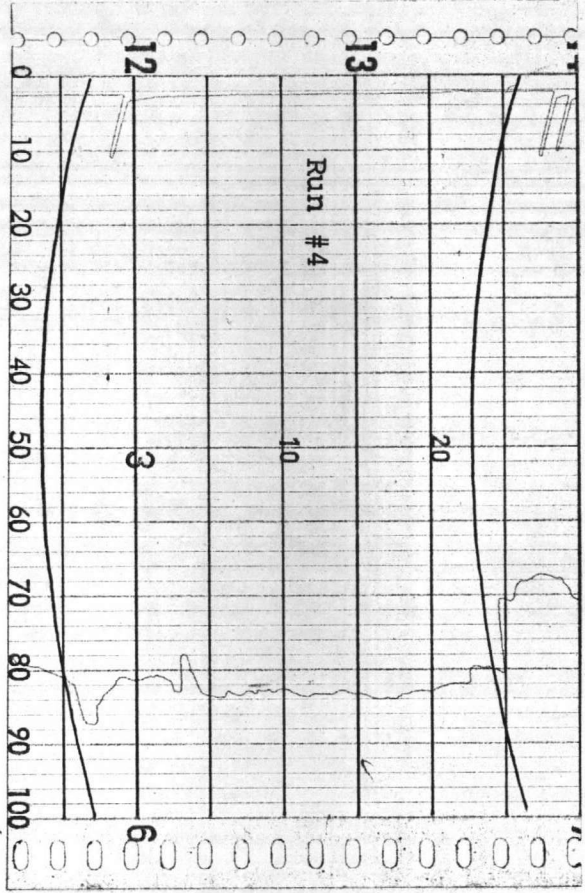
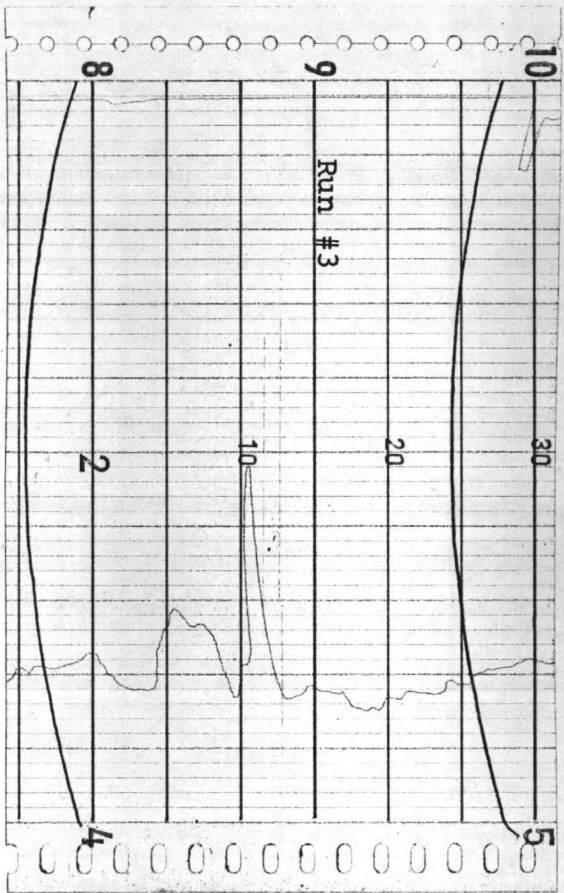
MCAS (H) New River, N.C.
 Runway 5-23
 Test Section "B"

REMARKS: Excellent drainage on test section.
Slight ponding station 36+00 to 38+00.
