OPERATING EXPERIENCE SUMMARY

U.S. Department of Energy
Office of Health, Safety and Security
OE Summary 2006-14
December 8, 2006

Wearing Arc Flash Clothing Can Save Your Life

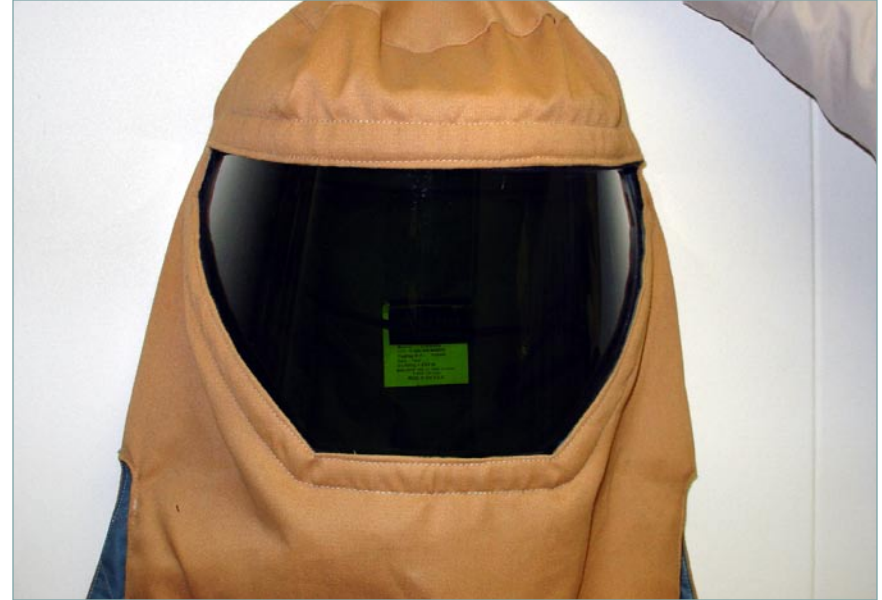
Figure 1-3. New flash hood

The electrician’s PPE prevented him from being injured when the arc flash occurred. Figure 1-2 shows the condition of the 65-calorie flash hood after it was exposed to the tremendous heat energy of the arc flash; the inside of the hood looked like new. For comparison purposes, Figure 1-3 shows a new flash hood similar to the one worn by the electrician.
