**U.S. Department of Energy
Office of Health, Safety and Security**

Accident Investigation Report

**Fatality at the Strategic Petroleum Reserve
Bryan Mound Site, September 13, 2011**

November 2011

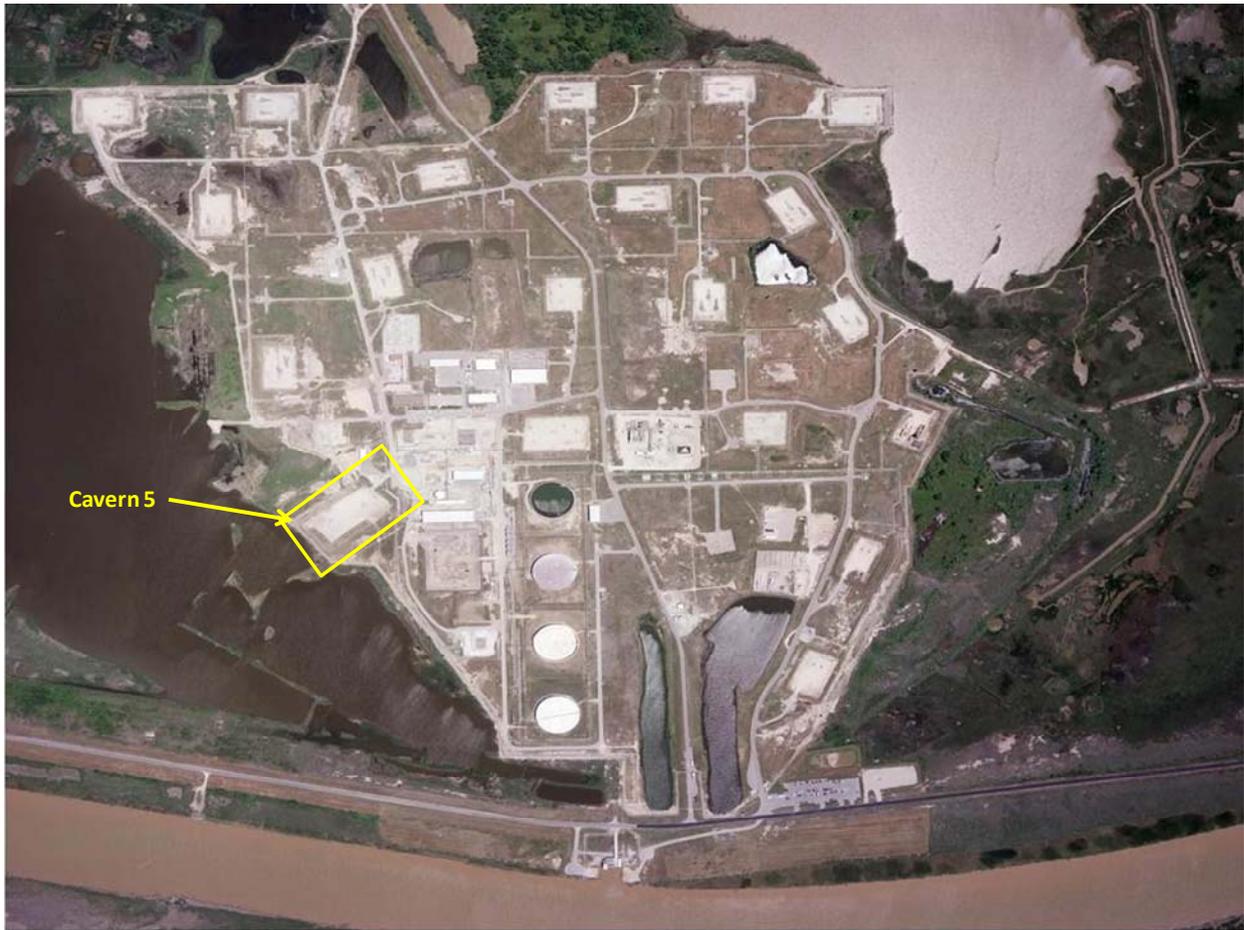
Figure 2-1: Cavern 5 at Bryan Mound

On the morning of September 13, 2011, subcontractor employees were performing grass cutting activities at the Cavern 5 area (Figure 2-1) of the SPR-BM site using two front deck mowers. At about 1125 hours a front deck mower (Mower 1) operated by a recently-hired untrained subcontractor employee, Grass Cutter #1 (GC1), struck three large elevated pipes.

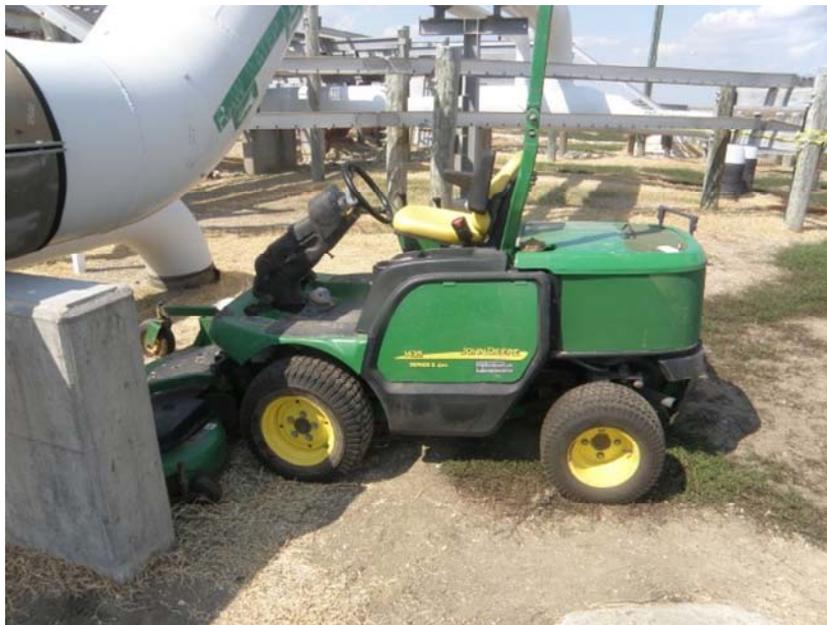
Figure 2-10: Mower 1, John Deere 1435 Front Mower Series II Involved in the Accident

At the time of the accident GC1 was riding a John Deere Model 1435 Front Mower Series II (Figure 2-10). The mower was designed with a number of operator controls that may have been pertinent to this accident. In addition, the Operator's Manual for this mower provides a number of safety instructions pertinent to the accident that are examined in the following sections as well as the maintenance program for this mower.

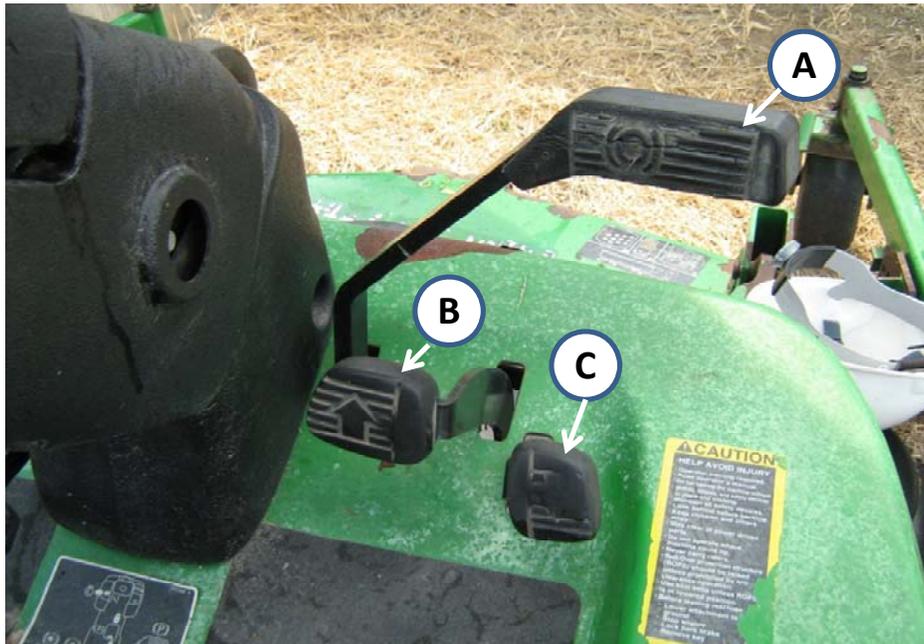
Figure 2-16: Configuration of Right Pedals on Mower 1

The most predominant error precursors related to this accident had to do with the training/experience of GC1 in the operation of Mower 1. *Unfamiliarity with Task/First Time, Lack of Knowledge (faulty mental model), New Technique not used Before and Lack of Proficiency/Inexperience* were all error precursors that existed prior to the accident. Mower 1 involved in the accident is a complex piece of equipment with multiple controls. Interviews with personnel at the site and from the independent expert/consulting engineer on agricultural and grounds maintenance equipment all indicated that it takes time to learn how to operate the equipment controls and get comfortable with the mower. The use of these controls to regulate the speed, direction and braking of the mower is not intuitively obvious to an inexperienced operator. For example there are three foot pedals on the right hand side of the mower (Figure 2-16). One extended pedal above the other two is the master brake and also disengages the PTO. There are two pedals below that. The larger of the two lower pedals to the left (similar in location to a brake pedal on a car) is the hydrostatic pedal that allows the machine to go forward. The more the pedal is depressed the faster the mower goes forward. The smaller of the two pedals on the right side is the hydrostatic control pedal that controls the unit going in reverse. The more that pedal is depressed the faster the unit goes in reverse. The mower is designed so that the maximum reverse speed is less than the maximum forward speed. This complexity of operation makes it even more important to ensure that only competent personnel (qualified operators) are allowed to operate the equipment.

- A – Master Brake Pedal**
- B – Forward Pedal**
- C – Reverse Pedal**
