# Yukon Delta National Wildlife Refuge

*Contaminant Assessment*

Yukon Delta National Wildlife Refuge  
Contaminant Assessment

October 2009

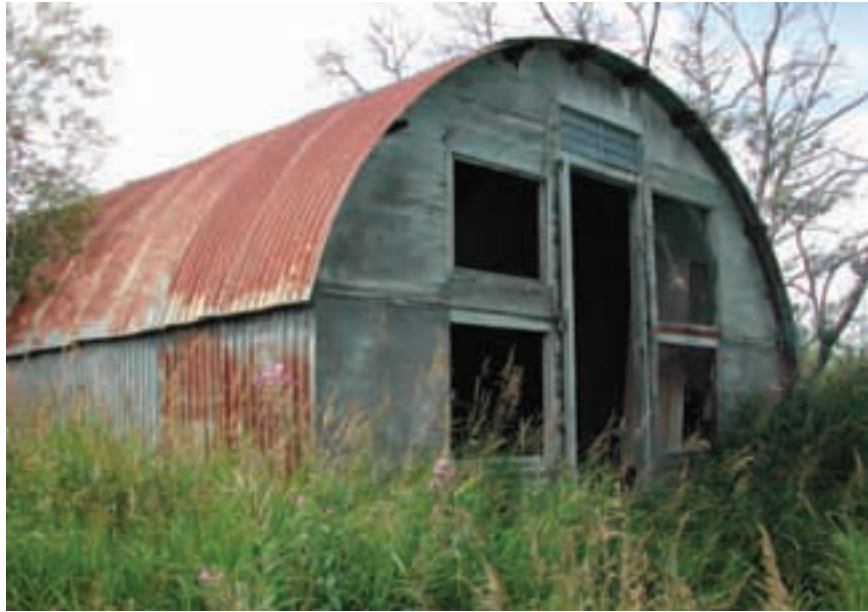
*Todd Army Airfield quonset hut surrounded by vegetation. D. Rudis/USFWS photo*

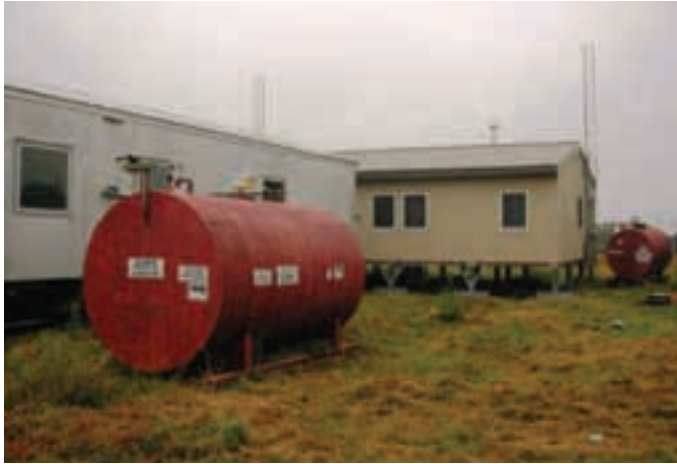
*Alaska Army National Guard (ANG) building and fuel supply tank in Akiachak. Most villages in the refuge have similar ANG buildings and associated fuel tanks. D. Rudis/USFWS*

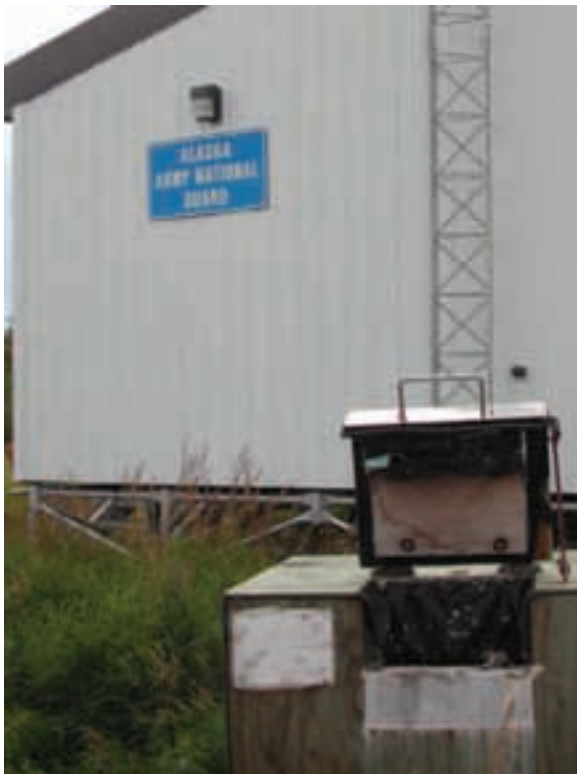
*Napakiak community honey bucket dumping station located adjacent to the ANG site. D. Rudis/USFWS photo*

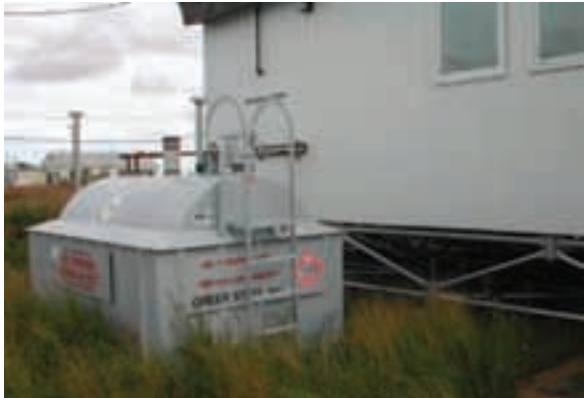
*Napakiak ANG facility with a modern fuel storage tank.  
D. Rudis/USFWS photo*

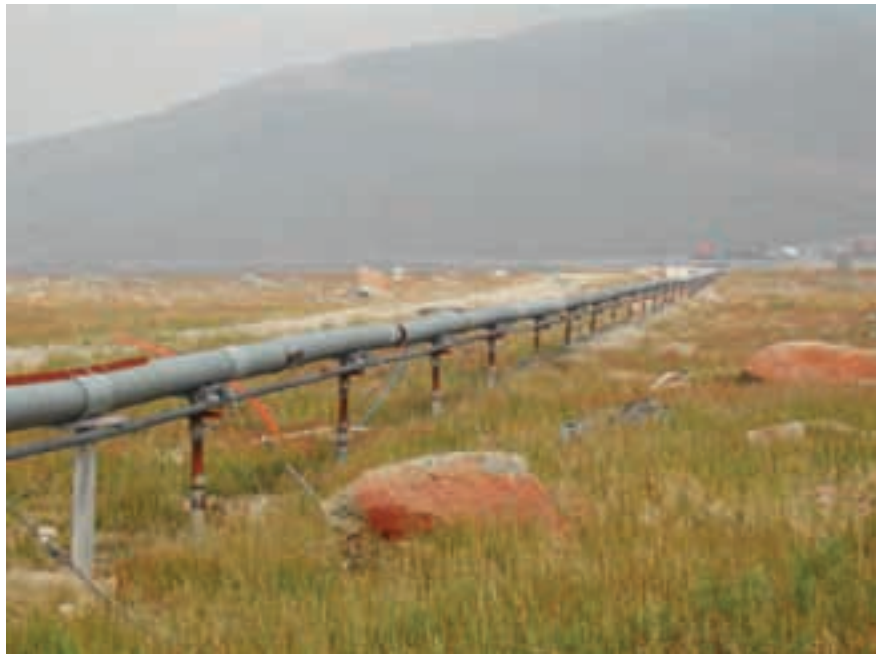
*Pipelines at the Cape Romanzof LRRS carried fuel to the facility. D. Rudis/USFWS photo*

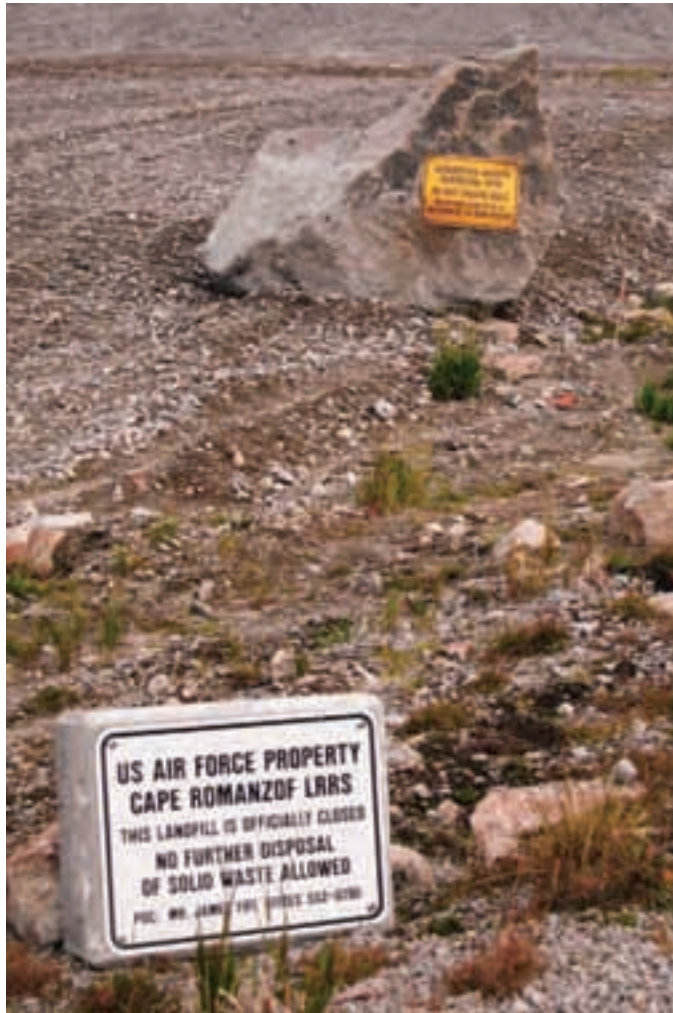
*The asbestos landfill is signed as a closed area at the Cape Romanzof LRRS. D. Rudis/USFWS photo*

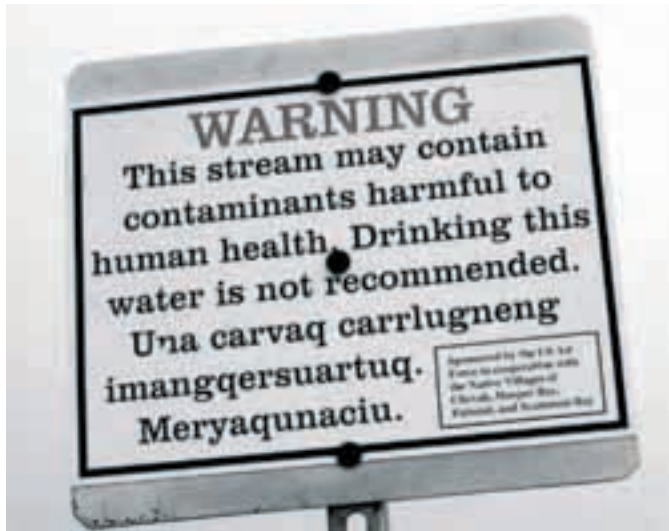
Contaminant warning signs at the Cape Romanzof LRRS are posted in both English and Yup'ik. D. Rudis/USFWS photo

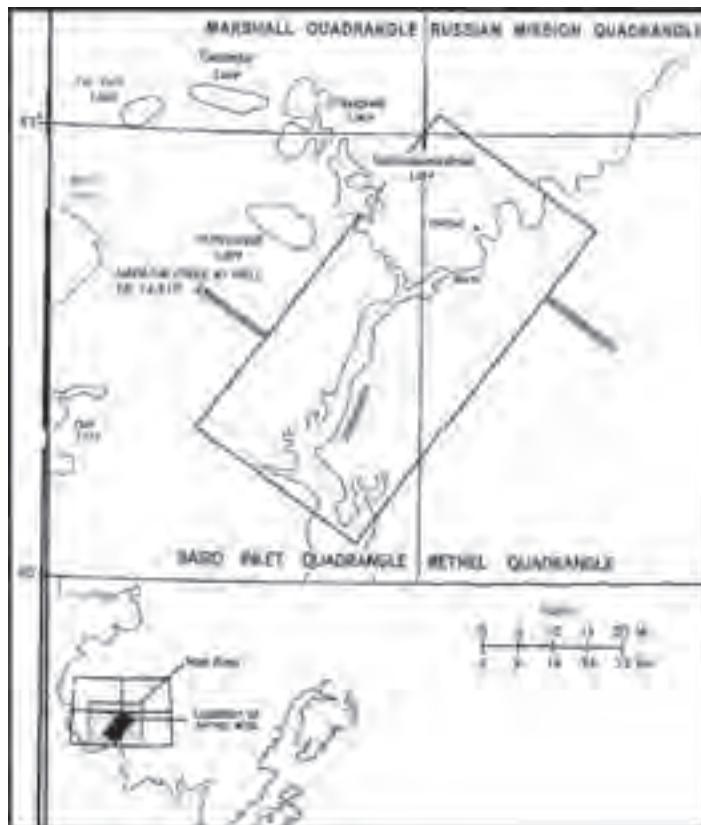
**Figure 10. Napatuk Creek Well Number 1 is located on the lower Kuskokwim River and the area of a 1994 survey for oil and gas.**

The Amoco report conclusions state that these data suggest that petroleum hydrocarbon-contaminated soils are limited to soils above the permafrost within the low, marshy area draining to the east of the drill pad, and near the trash pit of the old camp located south of the pad. Barium and other metals that were elevated and hydrocarbons are likely from the drilling mud additives, lubricants, and fuels used during the original drilling operation. The report concludes that remediation of the existing soil contamination would be more destructive than natural degradation, so Amoco has no plans to remediate soils at this site.

After the scheduled cleanup by Amoco, a September 1996 site visit to Hole Number 1 by the Refuge manager found debris remaining onsite, including the wellhead, trash, pilings, and other debris. An onsite berm was found to have hydrocarbon odors. The Service is unaware of any additional site cleanup or sampling at this site.

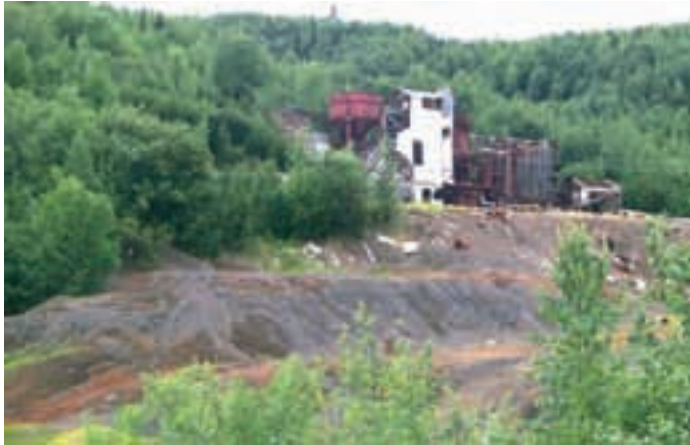
*In early 2008, the U.S. Environmental Protection Agency reevaluated the Red Devil Mine, determining that the site's Hazard Ranking Score was high enough to make the mine site eligible for placement on the Superfund National Priorities List. BLM photo.*
